Appendix D

Photographs

Report No.: SZCR240700286108

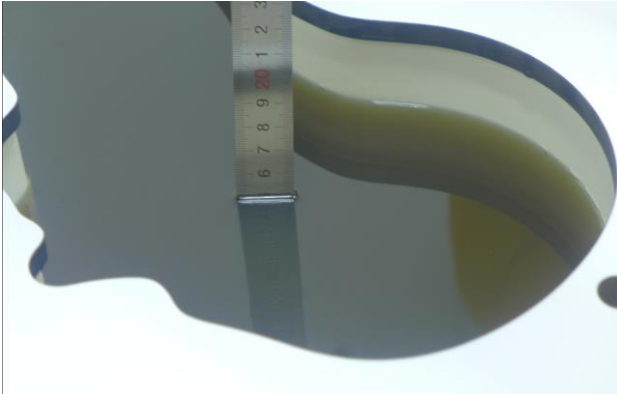
Photo 1: Tissue Simulant Liquid for HBBL600-10000MHz	NA

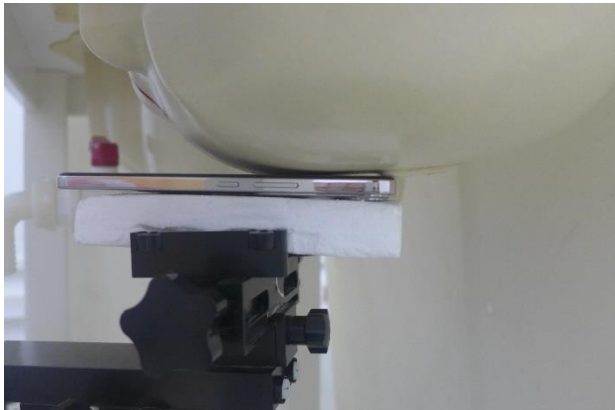
<p>Photo 2: Left cheek</p>

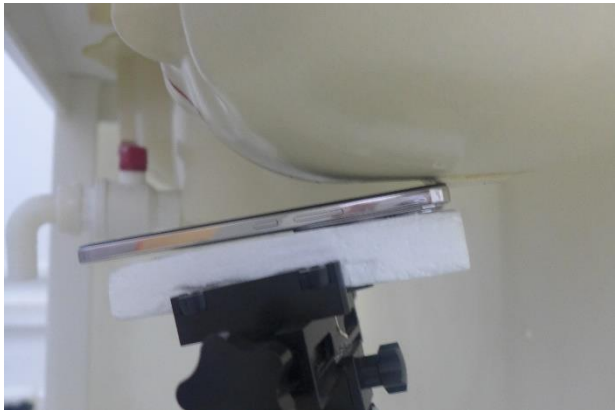
<p>Photo 3: Left tilted</p>

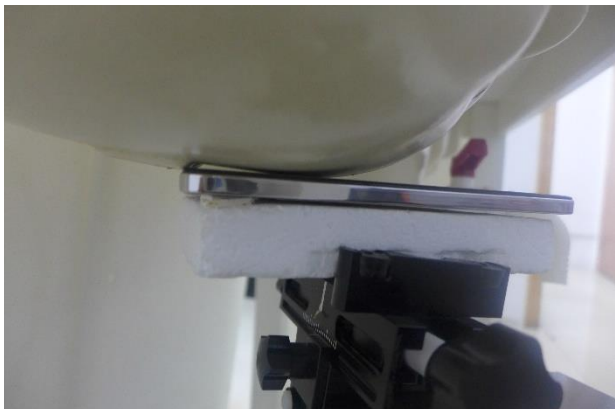
<p>Photo 4: Right cheek</p>

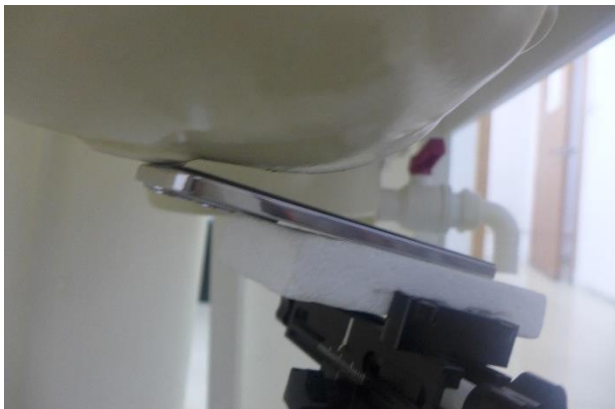
<p>Photo 5: Right tilted</p>

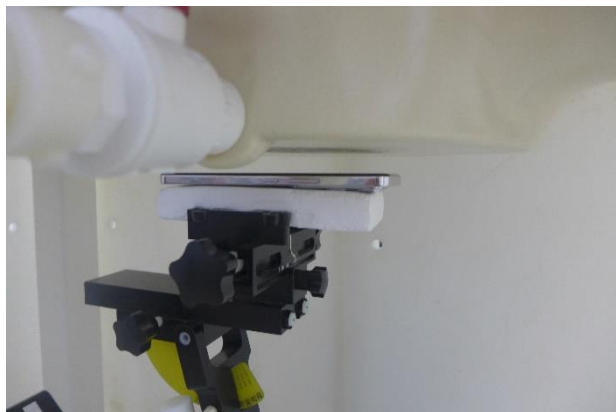
Photo 6: Front side 15mm

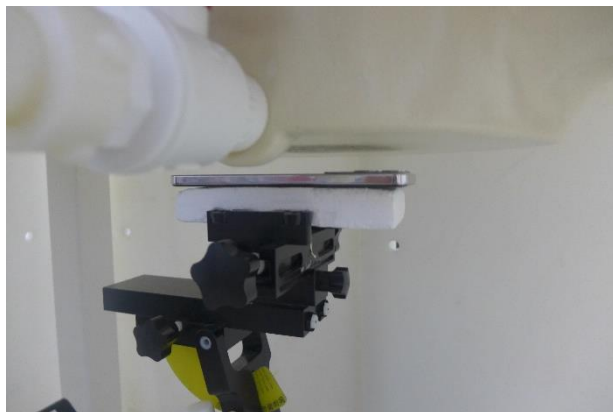
Photo 7: Back side 15mm

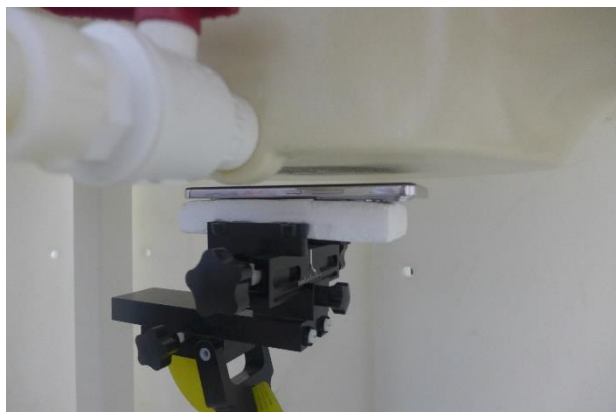
Photo 8: Front side 10mm

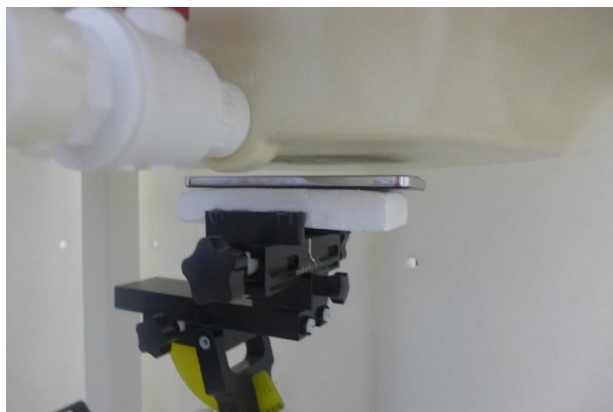
Photo 9: Back side 10mm

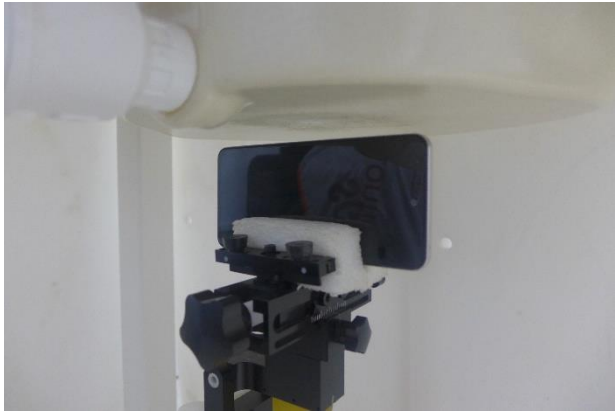
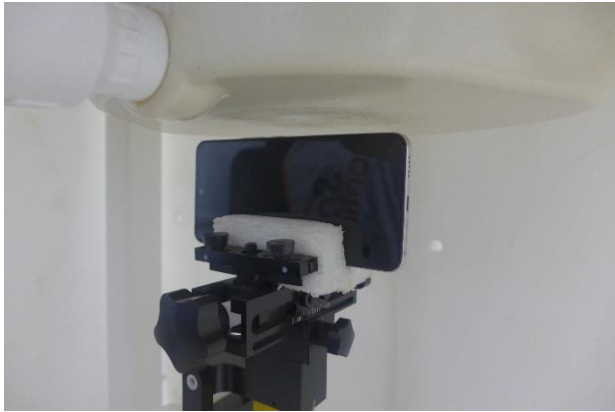
Photo 10: Left side 10mm	Photo 11: Right side 10mm

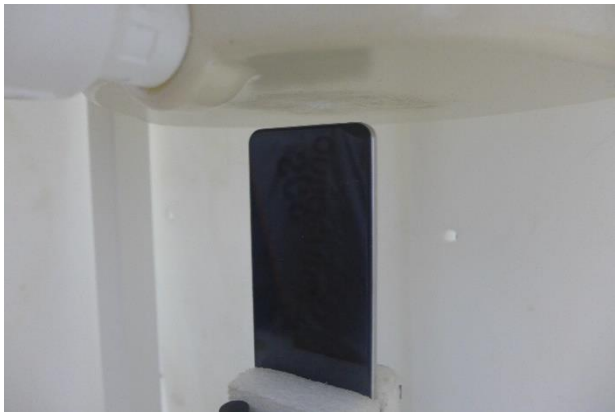
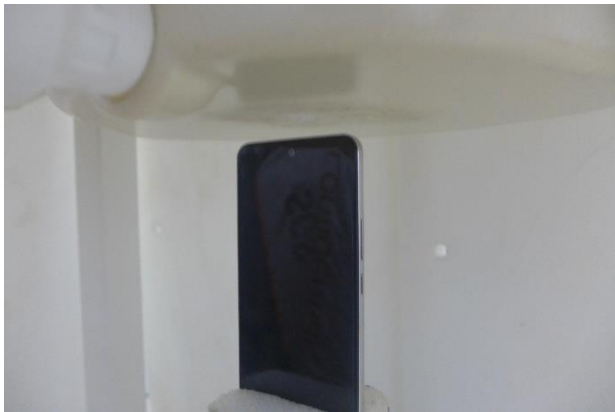
Photo 12: Bottom side 10mm	Photo 13: Top side 10mm

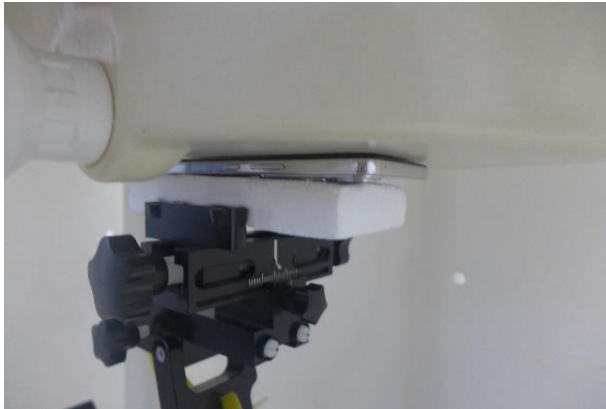
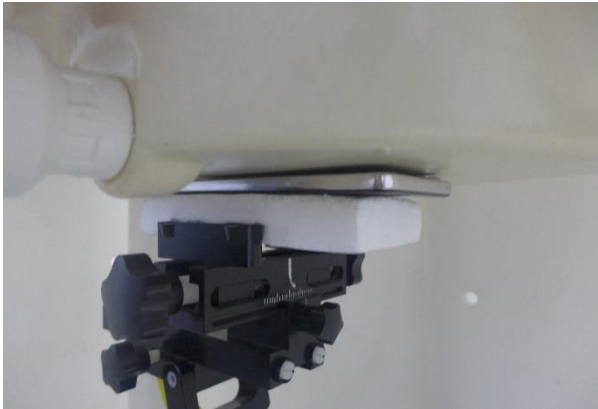
Photo 14: Front side 0mm	Photo 15: Back side 0mm

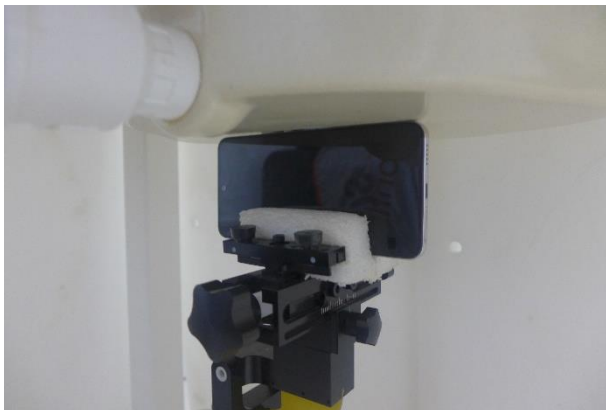
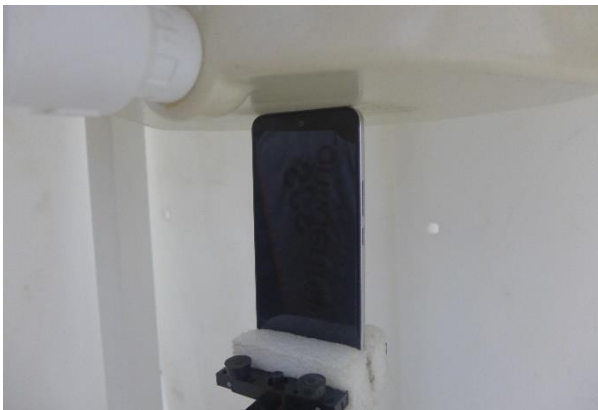
Photo 16: Right side 0mm	Photo 17: Top side 0mm

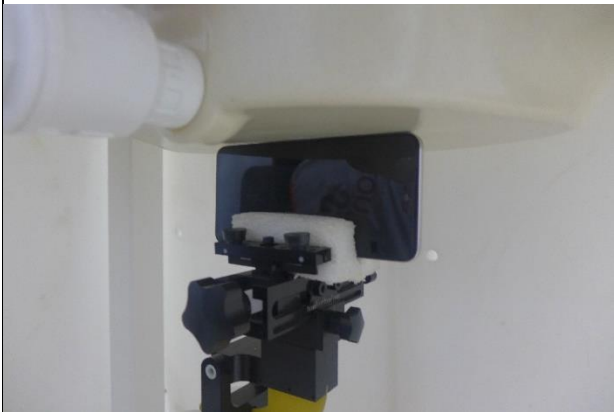
<p>Photo 18: Left side 0mm</p>

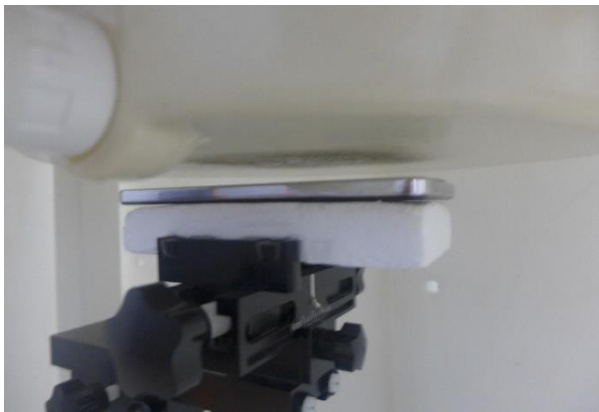
<p>Photo 19: Back side 13mm</p>

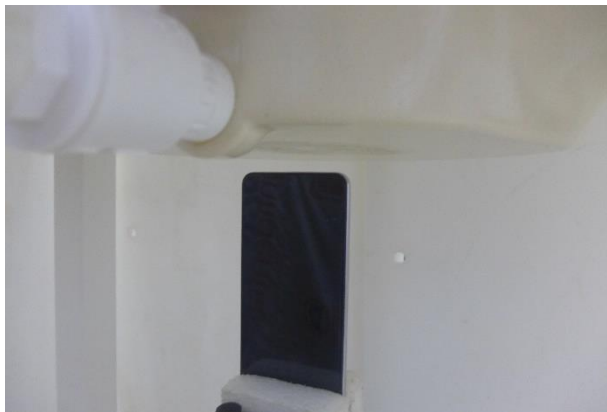
<p>Photo 20: Top side 14mm</p>

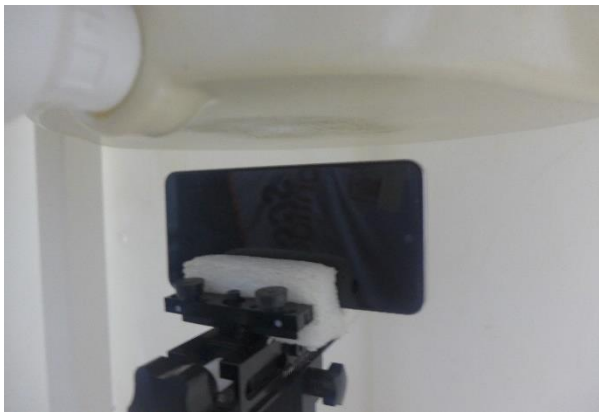
<p>Photo 21: Left side 17mm</p>

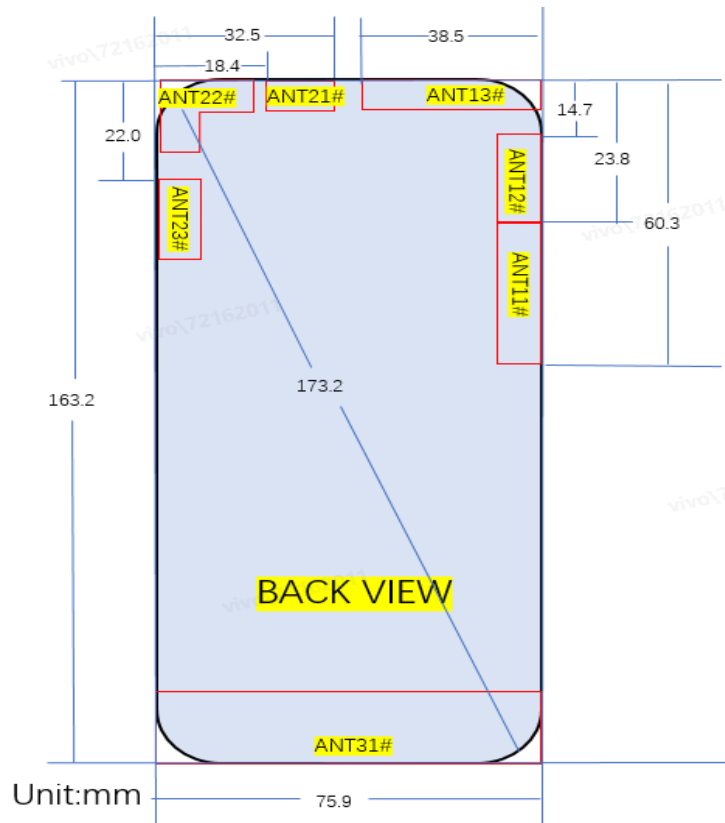
4. EUT Antenna Locations

Antenna	TX Band
Ant 11#	LTE: B4/7/38/41/66 NR: n7/38/41/66/77/78
Ant 12#	NR: n77/78
Ant 13#	GSM:850/1900 WCDMA:B2/4/5 LTE: B2/4/5/7/12/13/17/26/66/38/41 NR: n2/5/7/26/66/38/41
Ant 21#	NR: n77/78
Ant 23#	NR: n77/78
Ant 31#	GSM:850/1900 WCDMA:B2/4/5 LTE: B2/4/5/7/12/13/17/26/66/38/41 NR: n2/5/7/26/66/38/41
Ant 22#	WiFi2.4G/5G/BT
