Registration number: W6M21903-18923-C-1  
FCC ID: 2AUISION8I

# ***Worldwide Testing Services(Taiwan) Co., Ltd.***

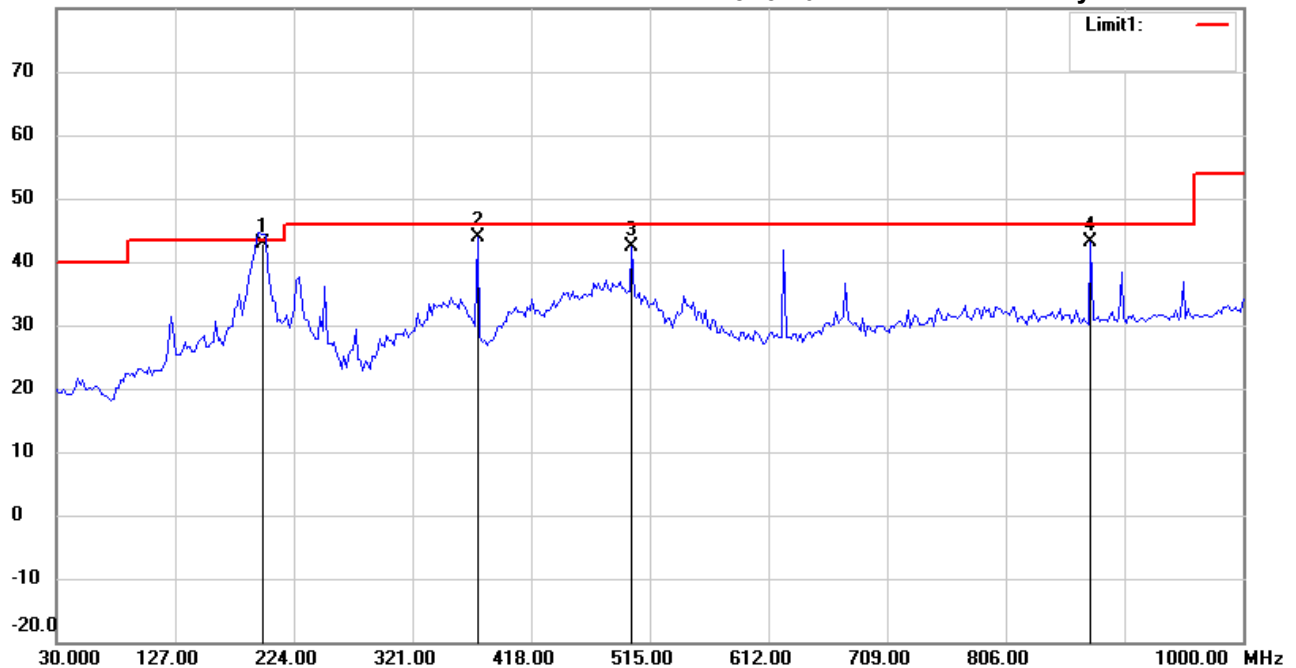
Site : Chamber

Condition : FCC\_part 15 RE-Class C\_30-1000MHz

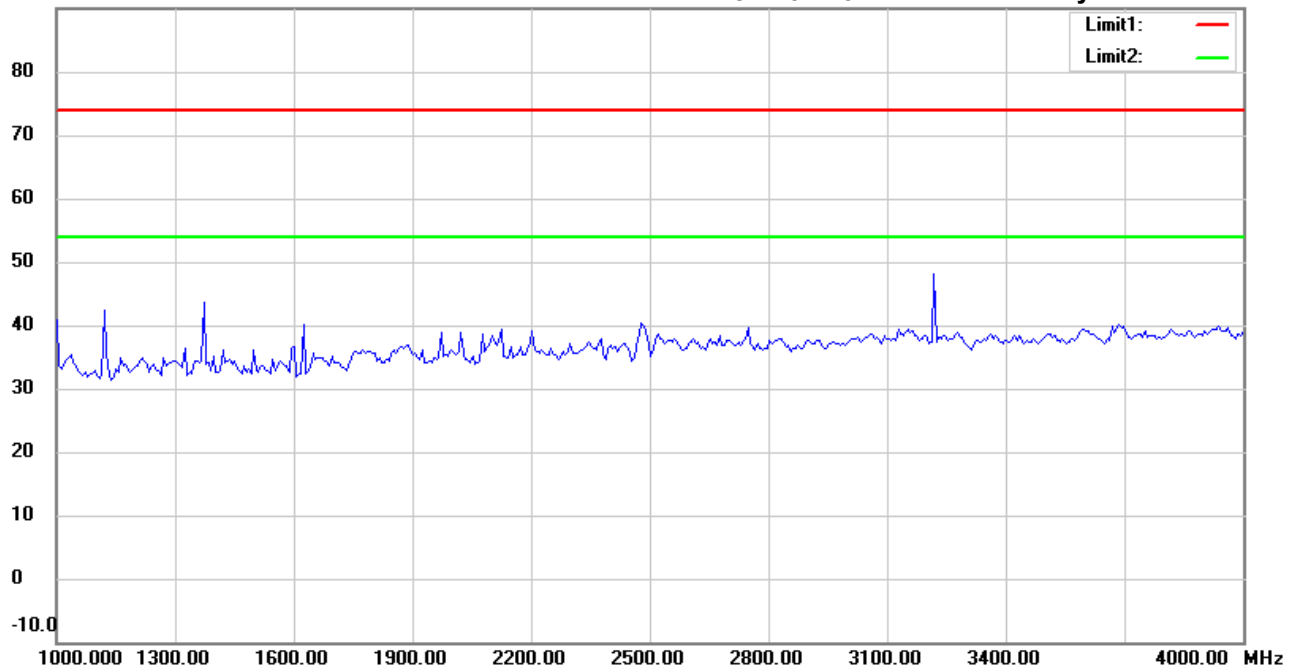
Site : Chamber

Condition : FCC\_part 15 RE-Class C\_Above 1GHz\_PK

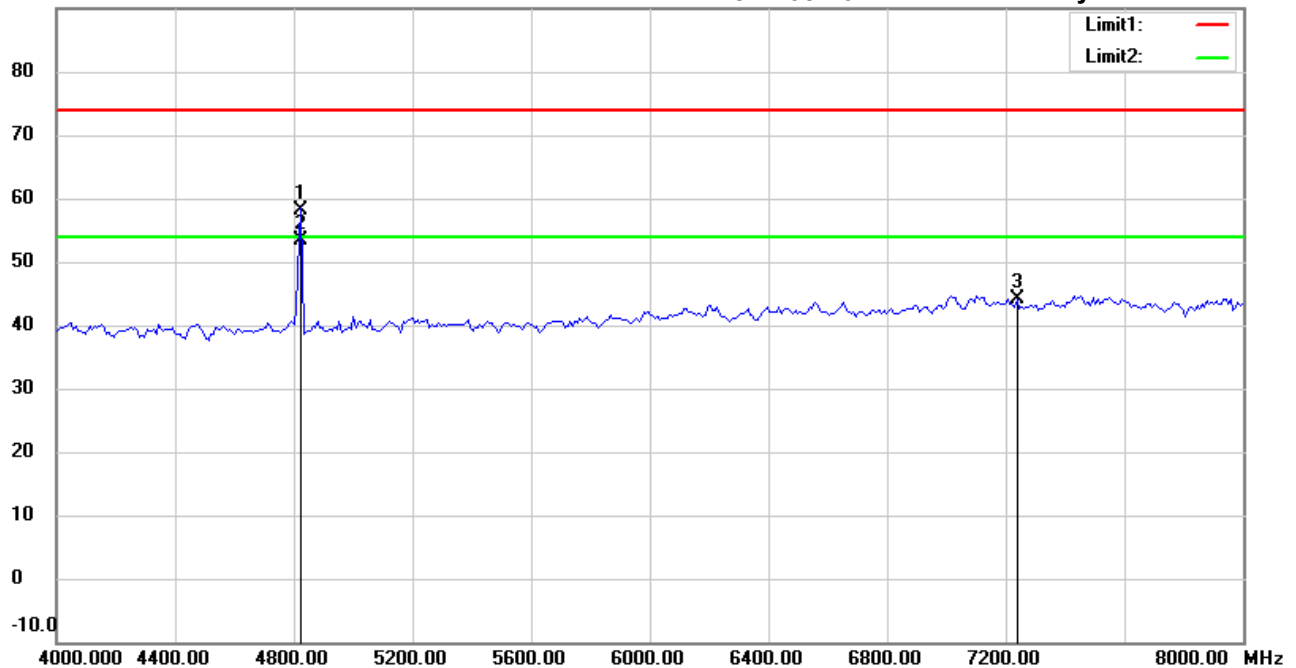
Site : Chamber

Condition : FCC\_part 15 RE-Class C\_Above 1GHz\_PK
