# Radiated Emission Measurement

Condition : FCC\_part 15E RE\_Above 1GHz\_PK

EUT : W6M21903-18922

Test Mode : TX 802.11a CH48

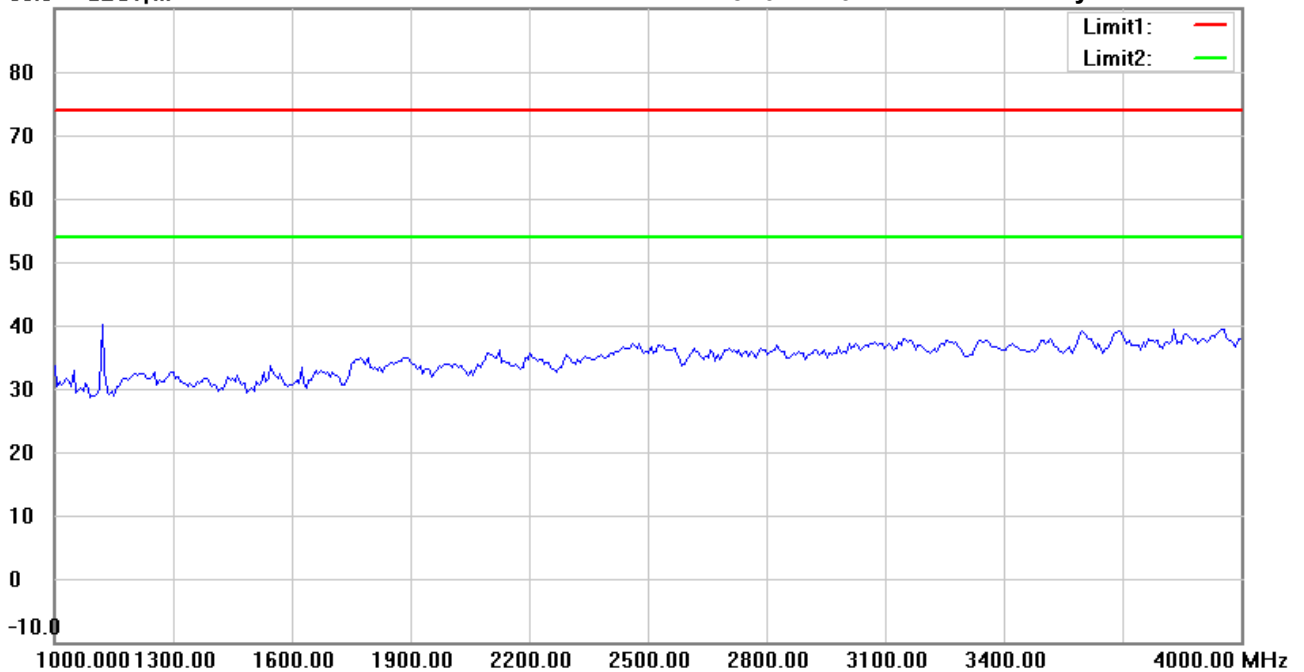
Site : Chamber

Condition : FCC\_part 15E RE\_Above 1GHz\_PK

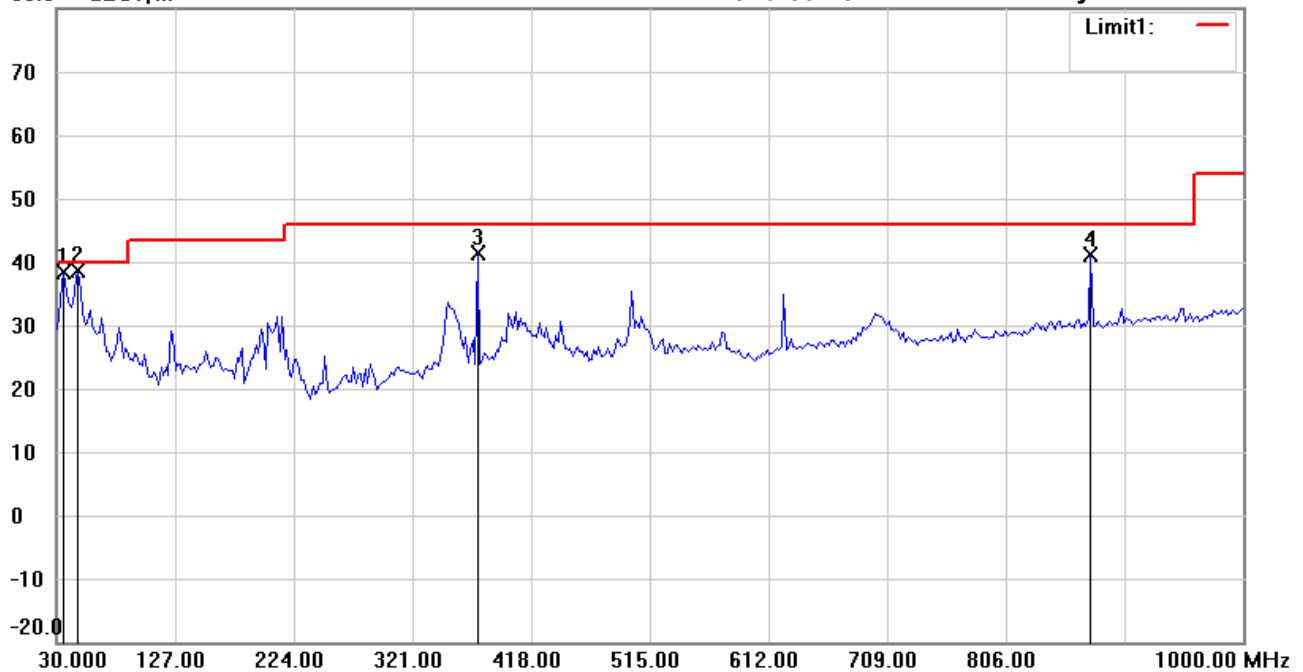
Site : Chamber

Condition : FCC\_part 15 RE-Class E\_30-1000MHz

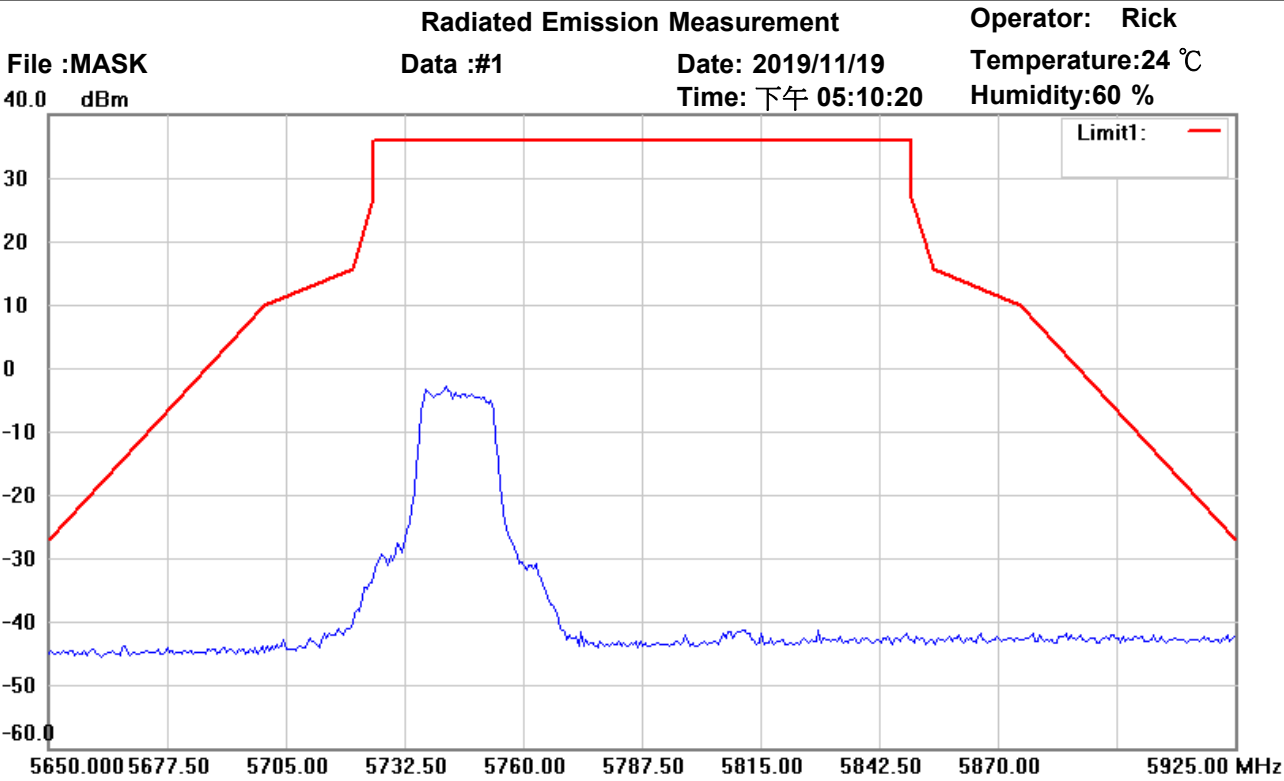
Site : Chamber  
Condition : FCC\_5G Band4 Mask  
EUT : W6M21903-18922  
M/N:  
Test Mode : 802.11a TX CH149  
Note :

Polarization: *Horizontal*  
Power : POE 48V  
Distance: 3m
