# FCC MPE REPORT

**Report No.:** 20250417G09090X-E-1  
**Product Name:** Microwave Oven  
**Trade Name:** Midea  
**Model Tested:** EM720C2CC-PM0A  
**FCC ID:** 2AULTXM720CYY-PM1  
**Applicant:** THAI TOSHIBA ELECTRIC INDUSTRIES COMPANY LIMITED  
**Received Date:** 2025.04.23  
**Test Data:** 2025.04.23-2025.04.25  
**Issued by:** CCIC Southern Testing Co., Ltd.  
**Lab Location:** Electronic Testing Building, No.43 Shahe Road, Xili Street, Nanshan District, Shenzhen, Guangdong, China  
Query E-Mail: [manager@ccic-set.com](mailto:manager@ccic-set.com),  
Feedback E-Mail: [integrity@ccic-set.com](mailto:integrity@ccic-set.com),  
Report Query Tel: 0755-26627338, Feedback Tel: 0755-86185963

## MAXIMUM PERMISSIBLE EXPOSURE (MPE)

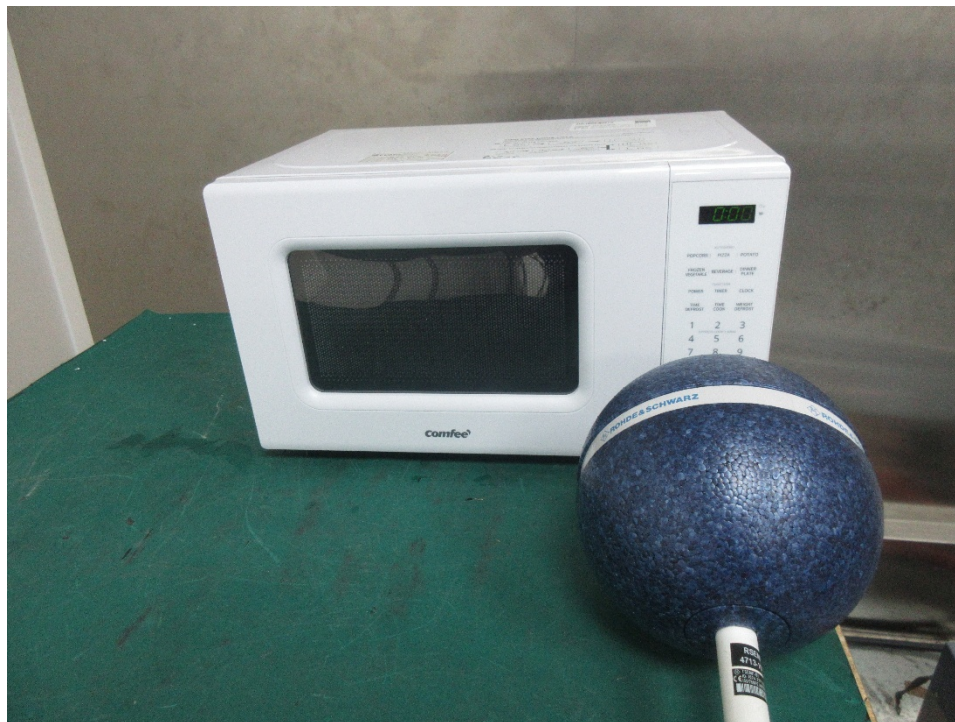
#### 1.2.5 Test setup photo

The EUT was set-up according to the FCC MP-5 and FCC Part 18 for radiation Hazard measurement. The measurement was using a microwave leakage meter to measure the radiation leakage in the as-received condition with the oven door closed. A 770mL water load in a breaker was located in the center of the oven and the microwave oven was set to maximum power. While the oven operating, the microwave meter will check the leakage and then record the maximum leakage.
