## Appendix G: Conducted Spurious Emission

## Test Result

13. EUT PHOTO

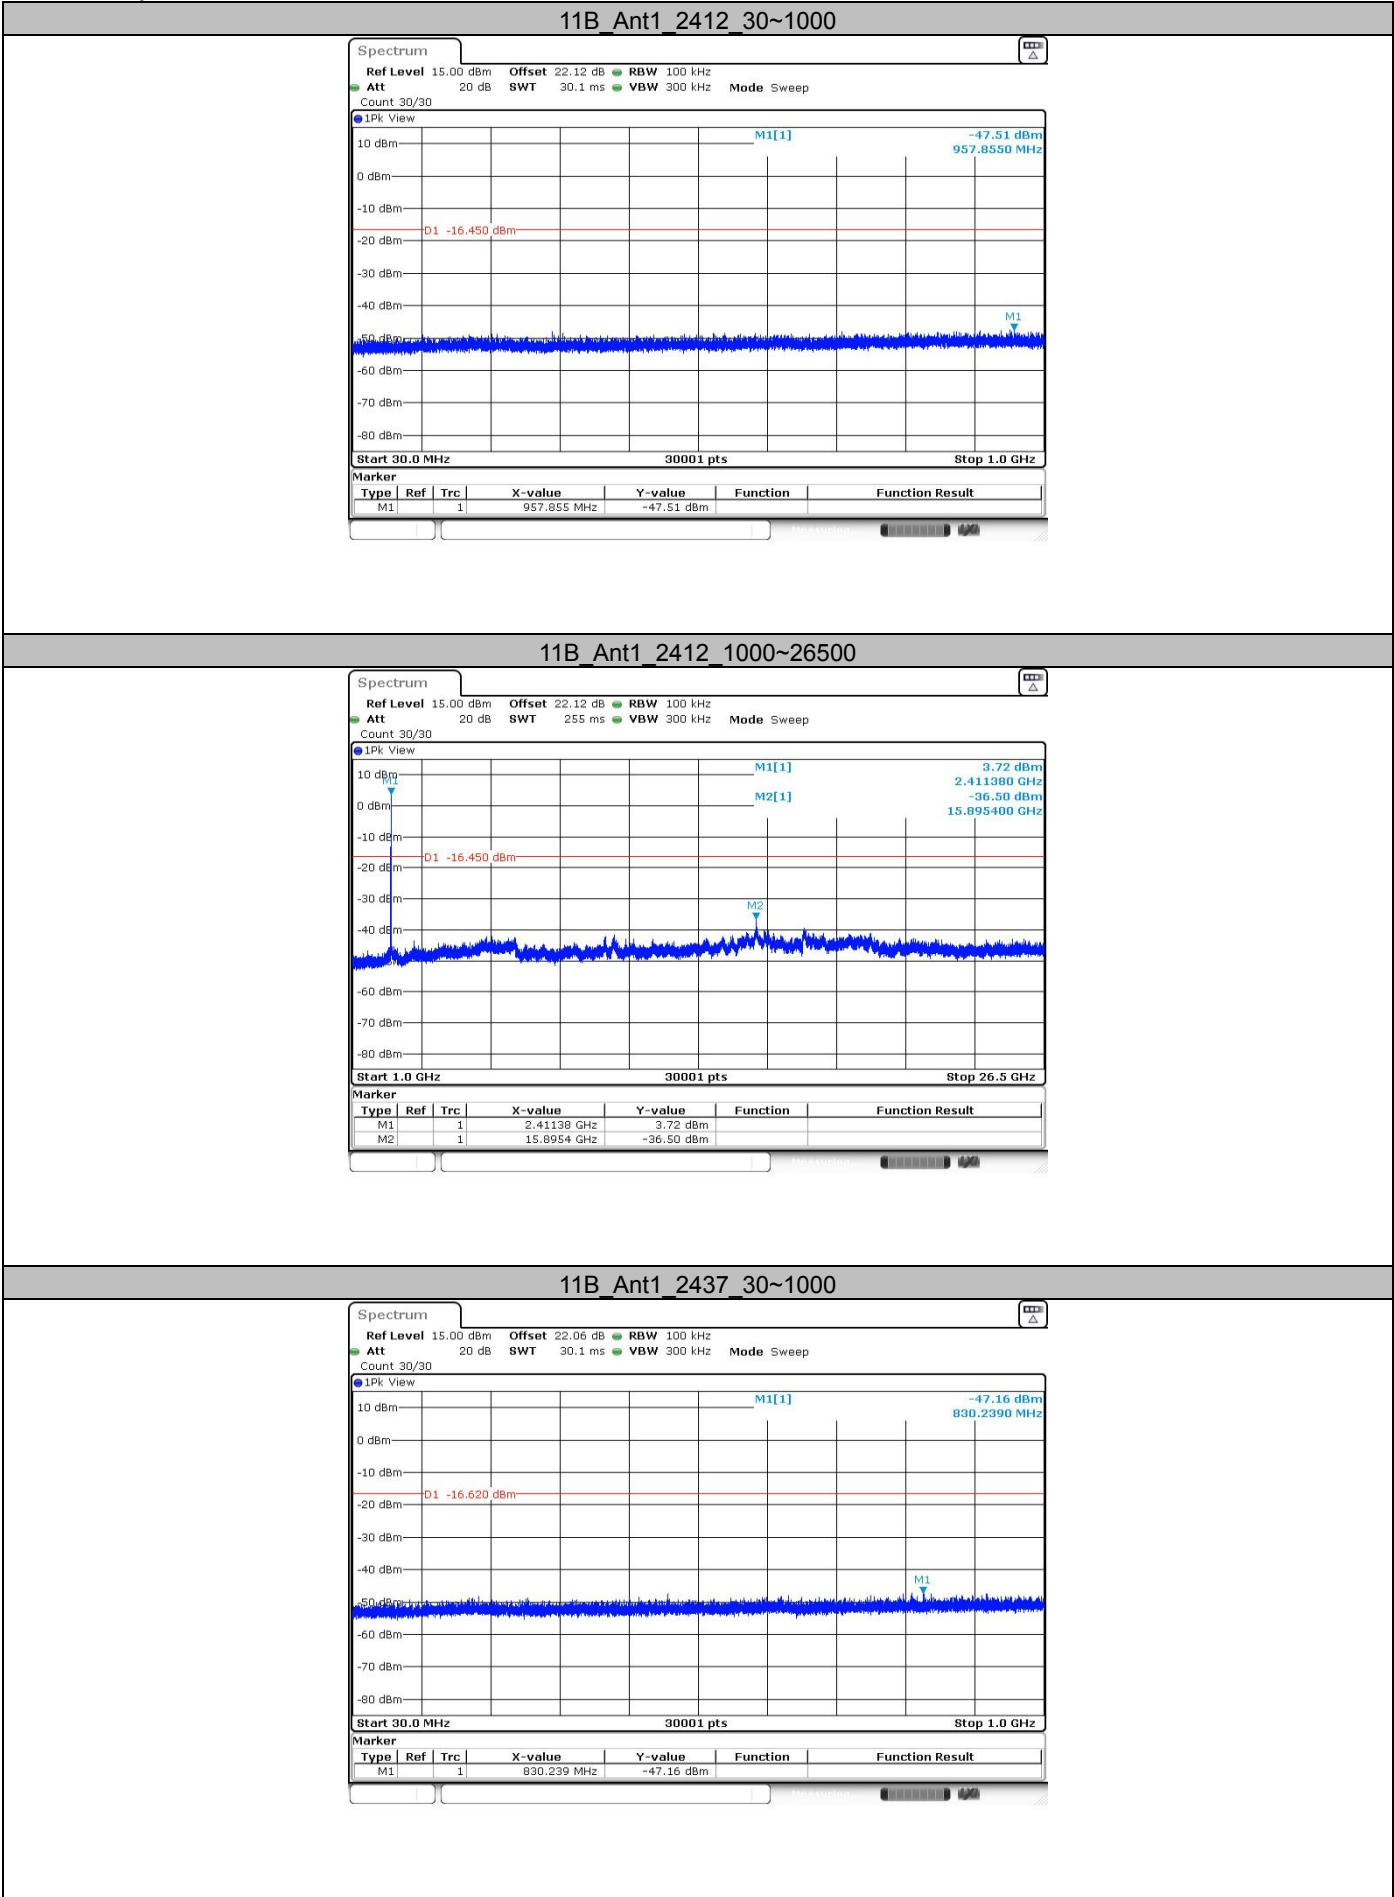
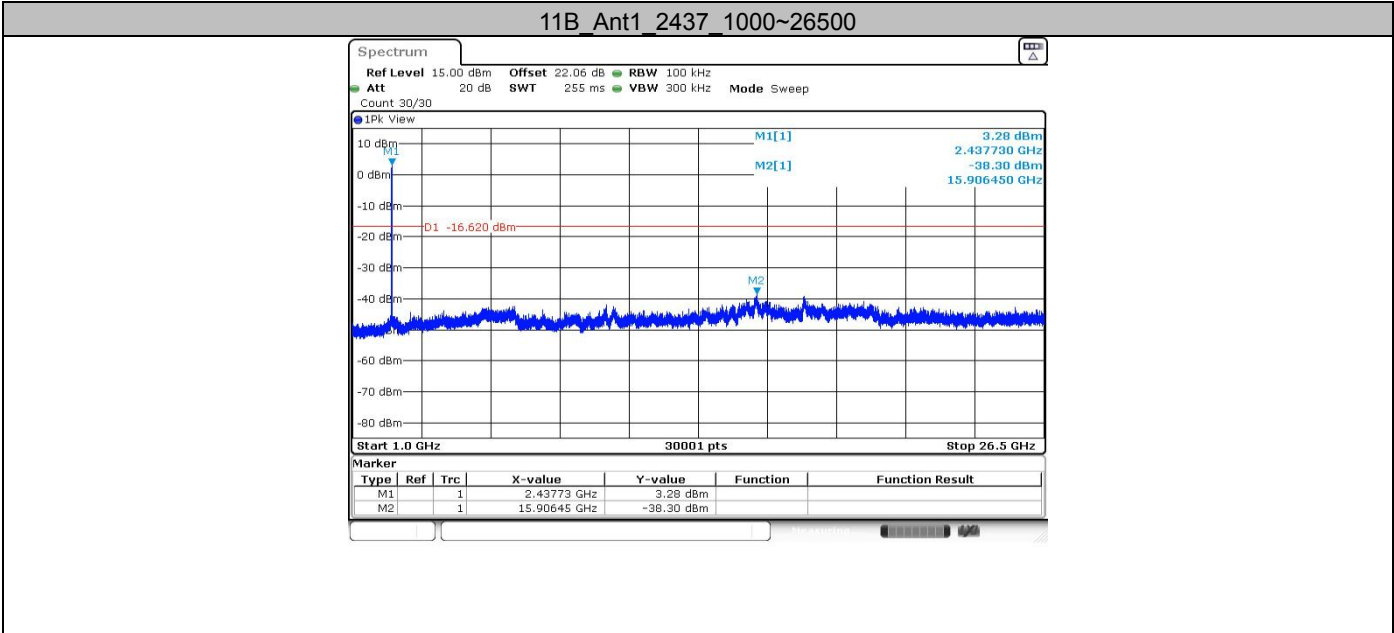
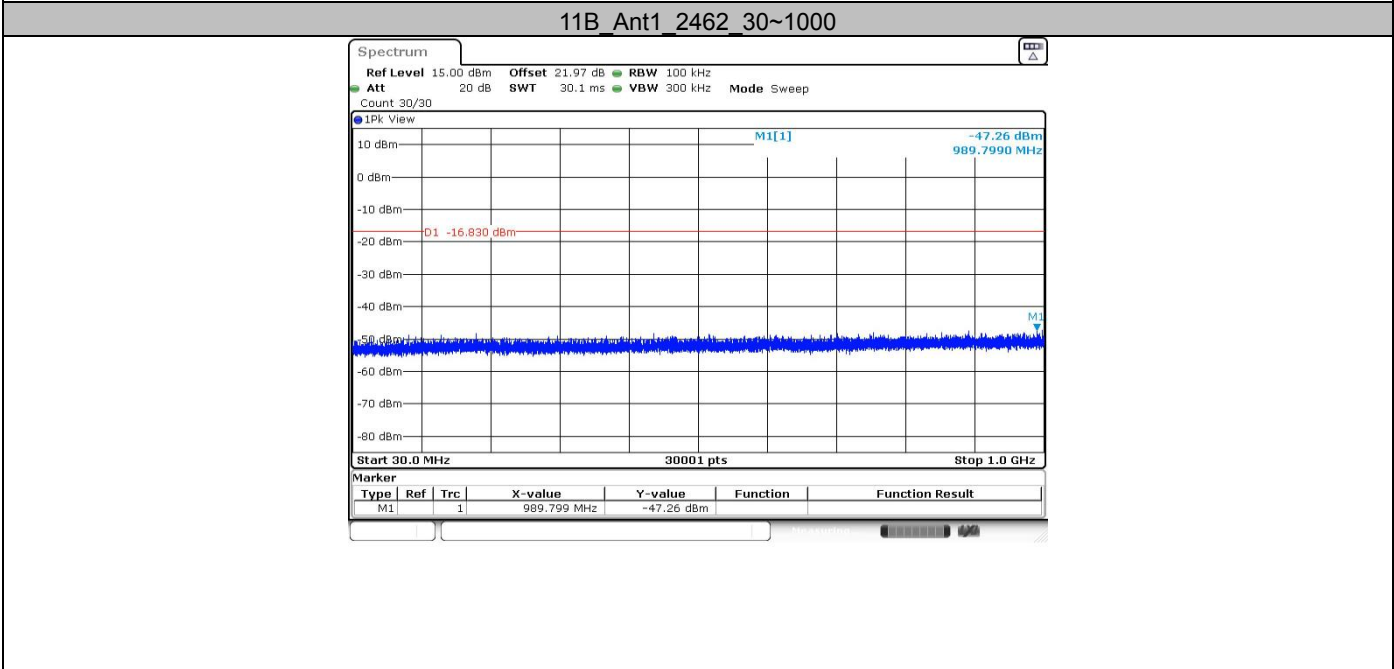
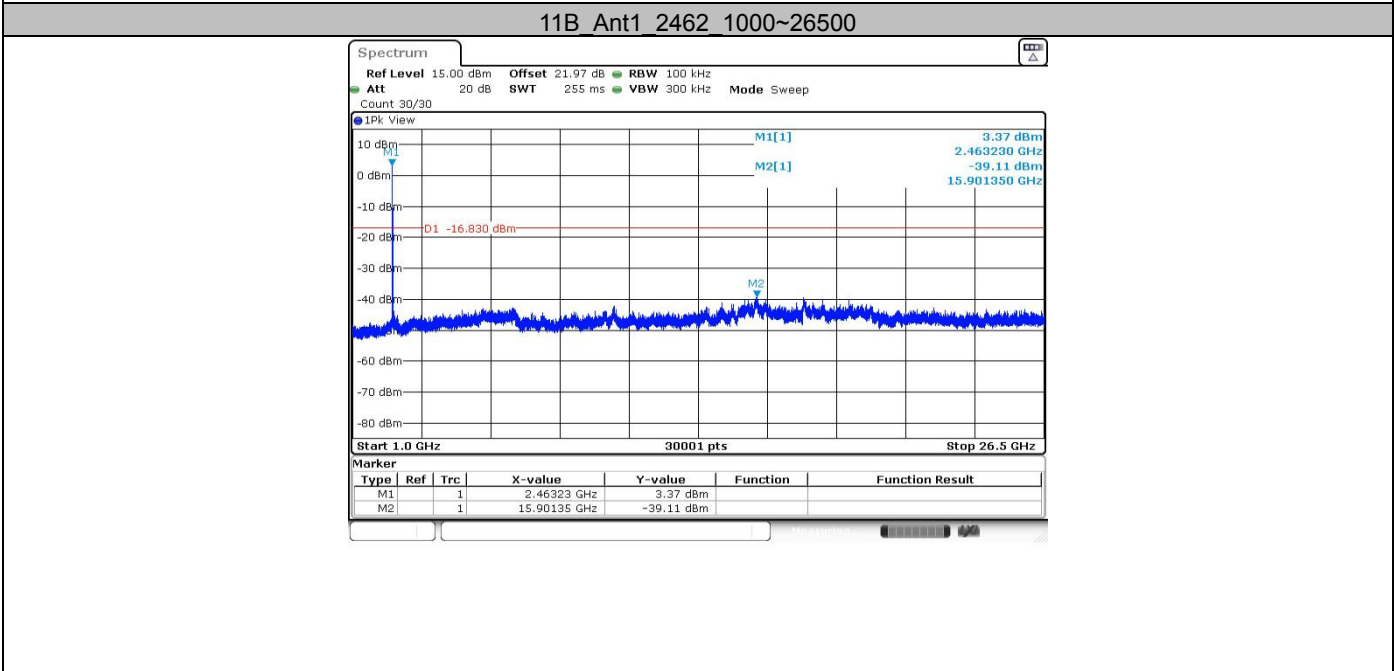
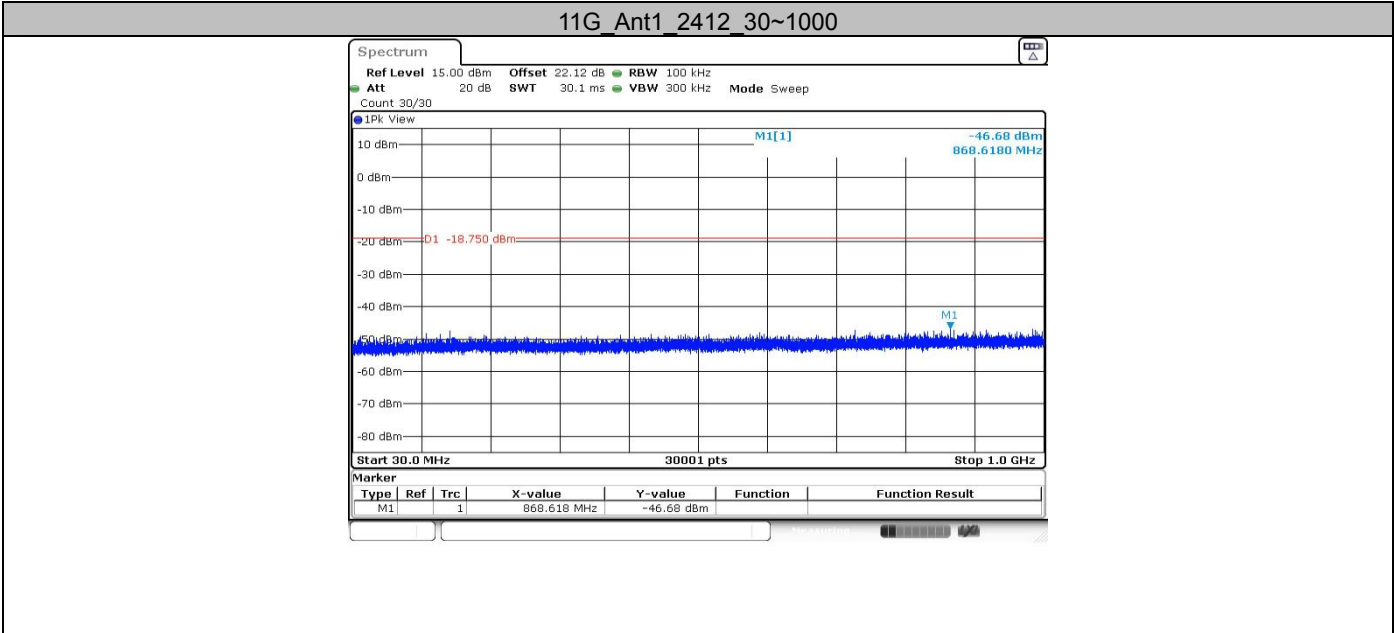
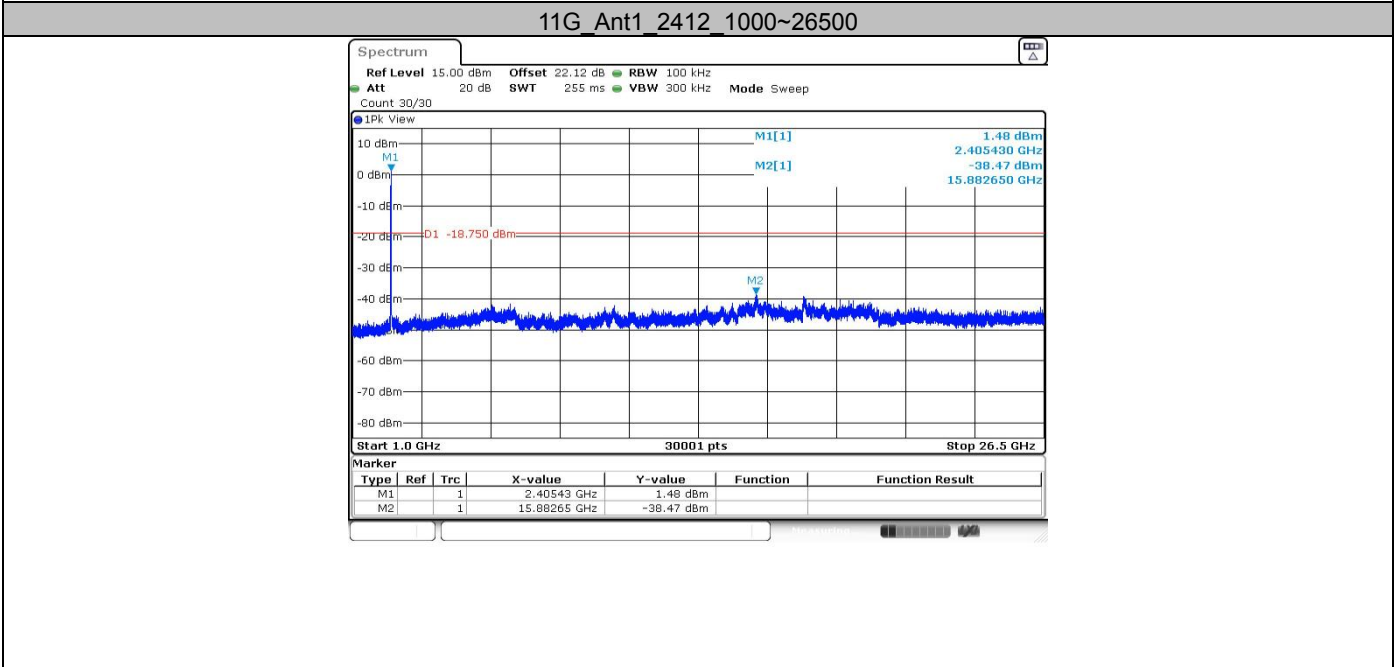
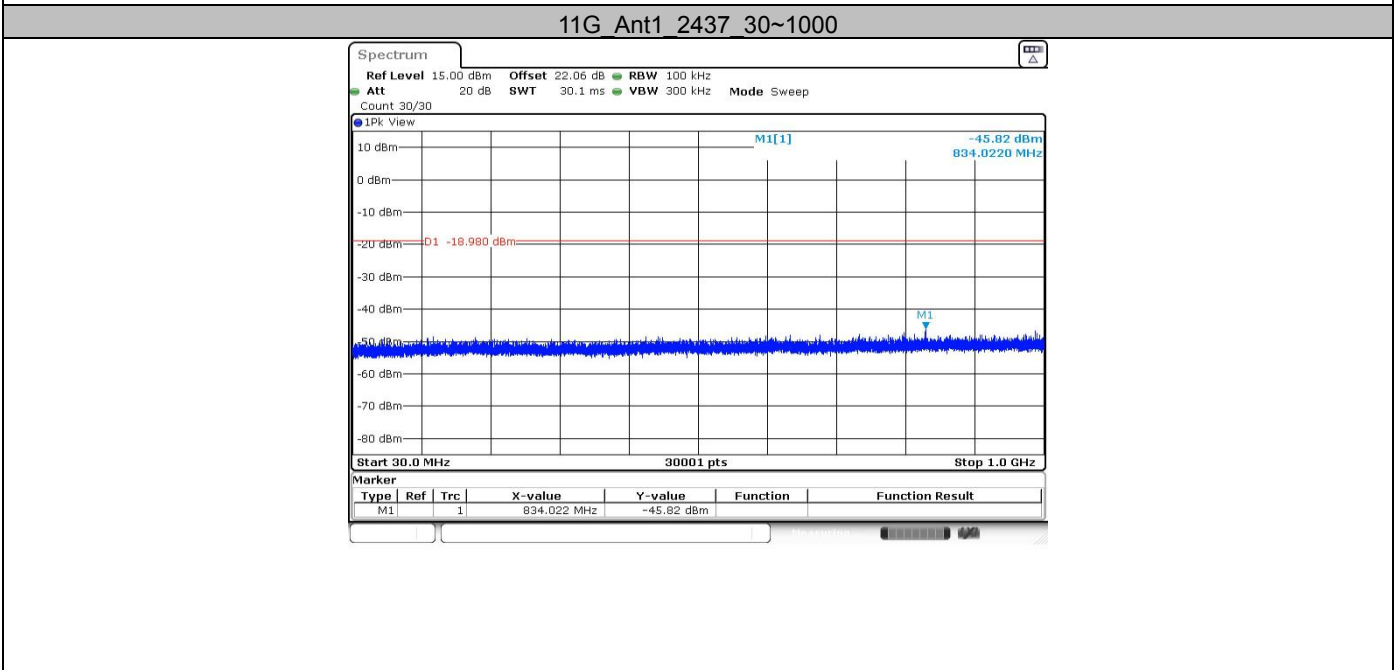
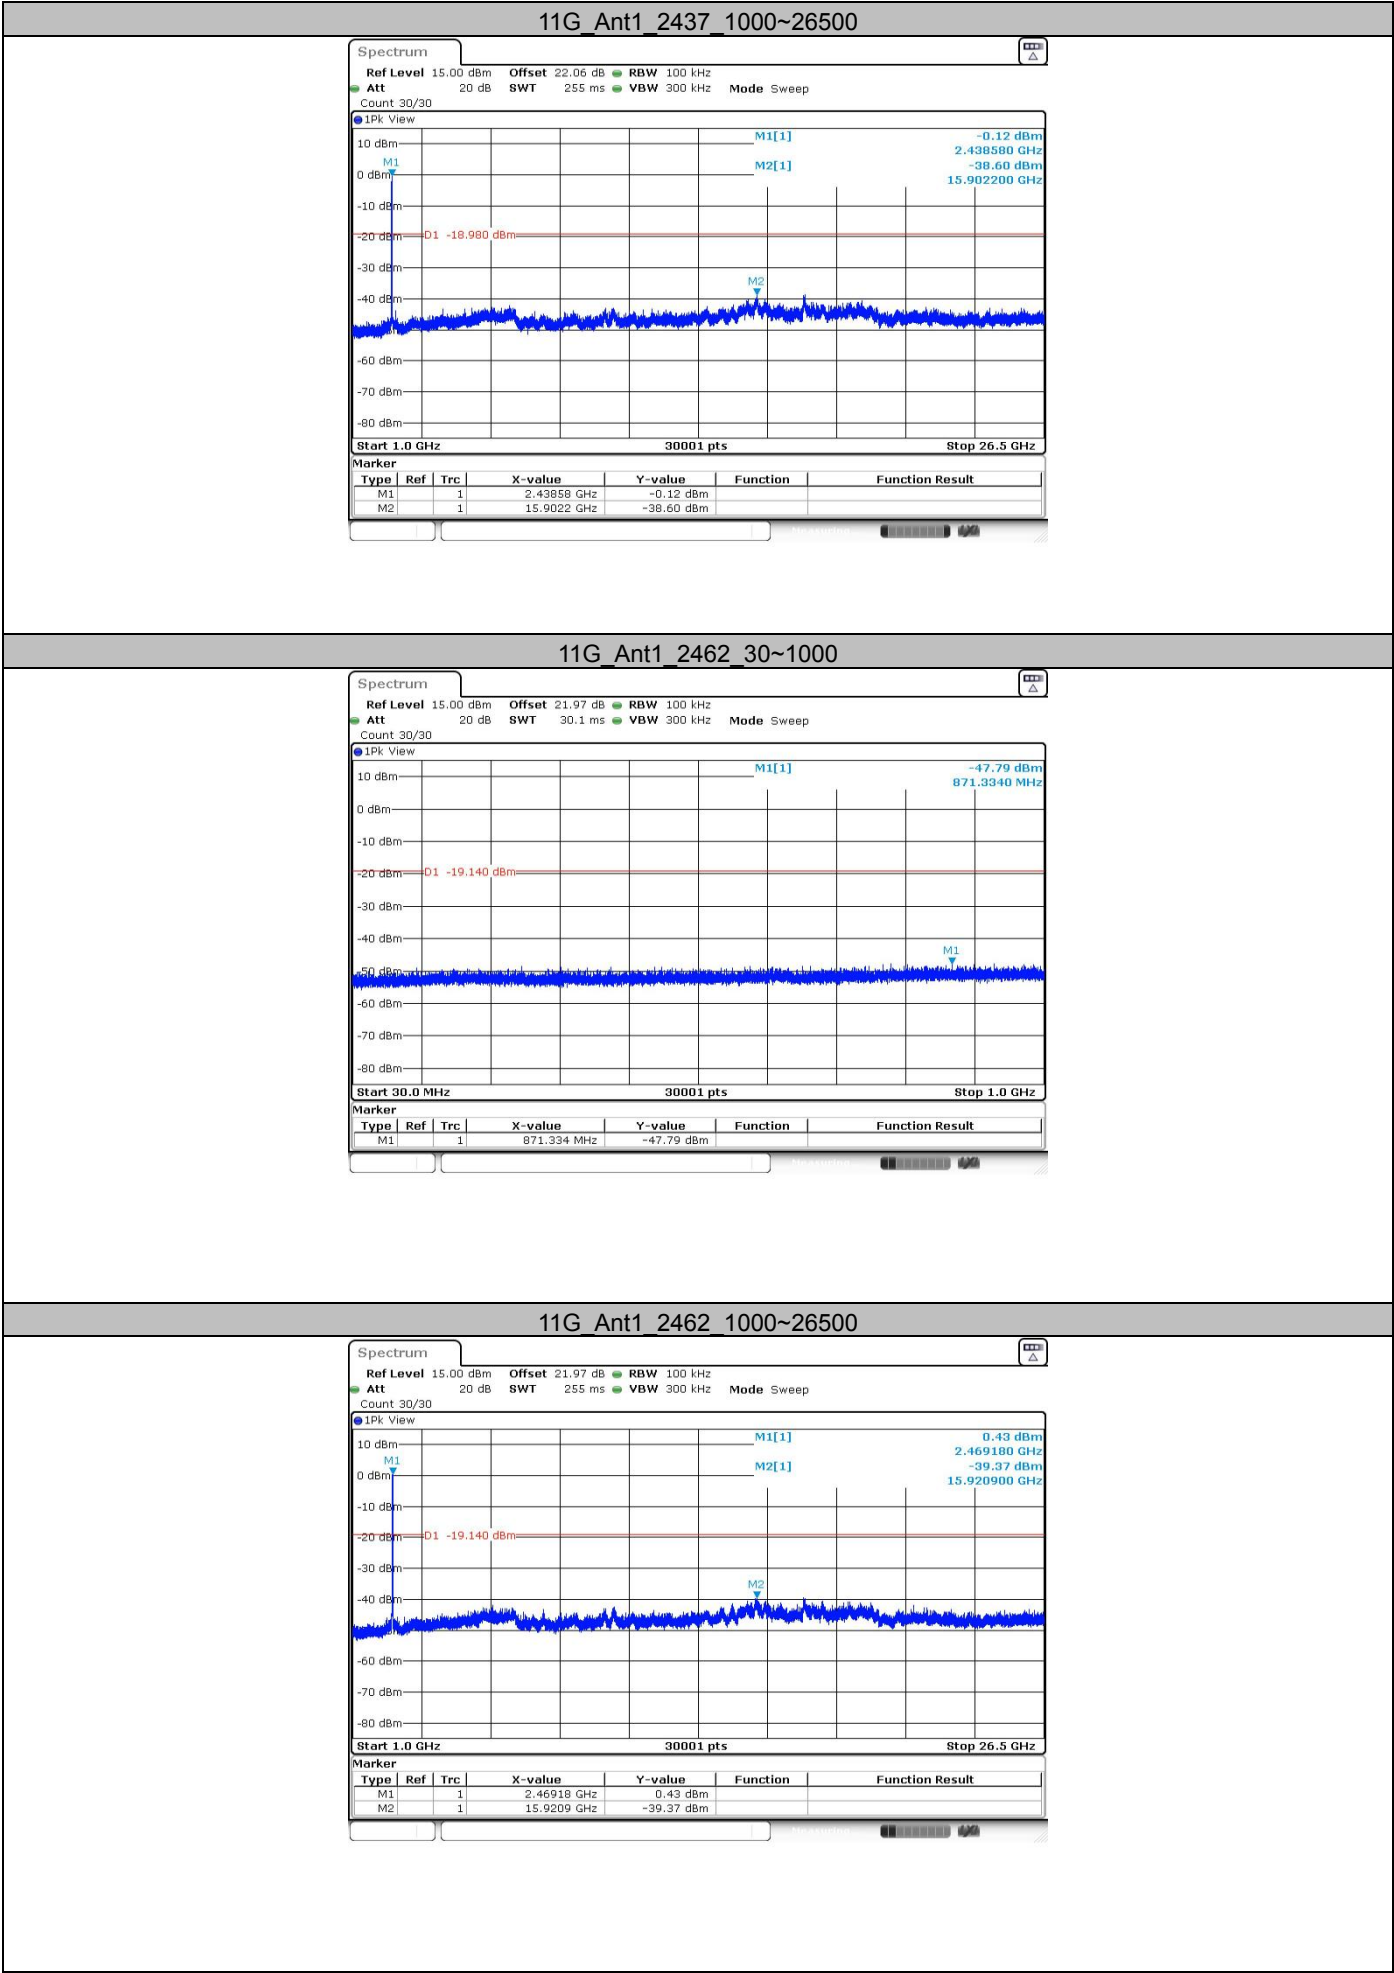
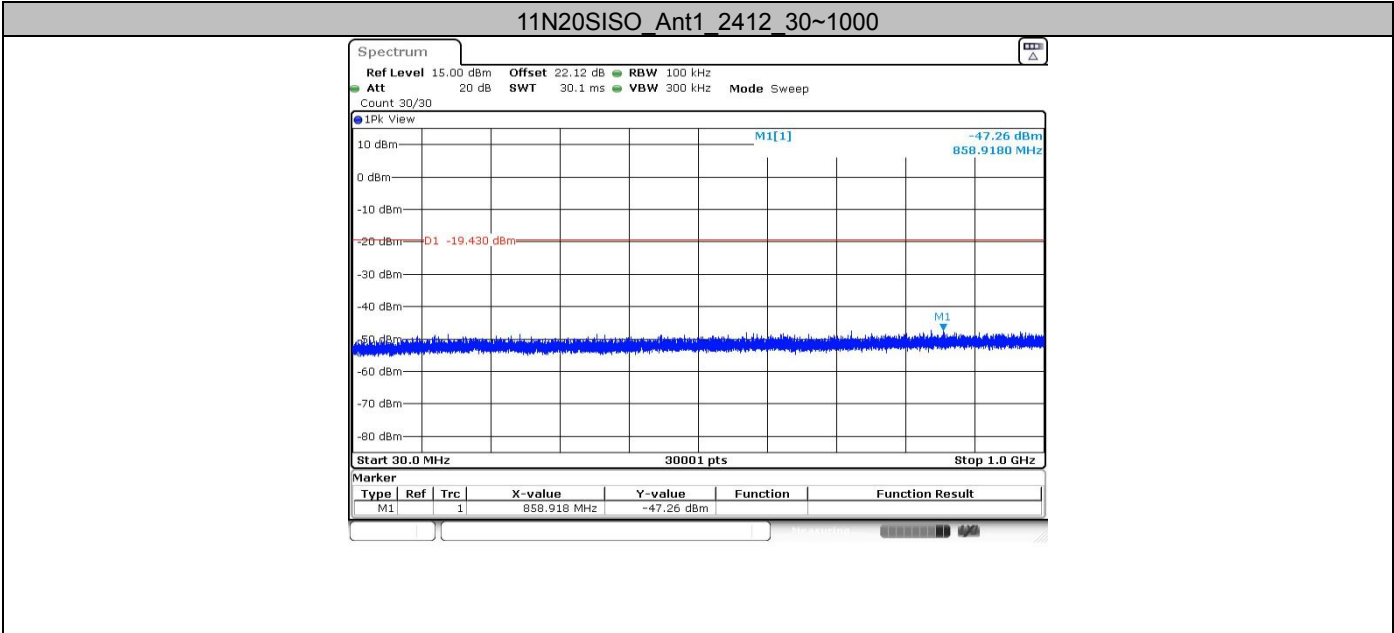
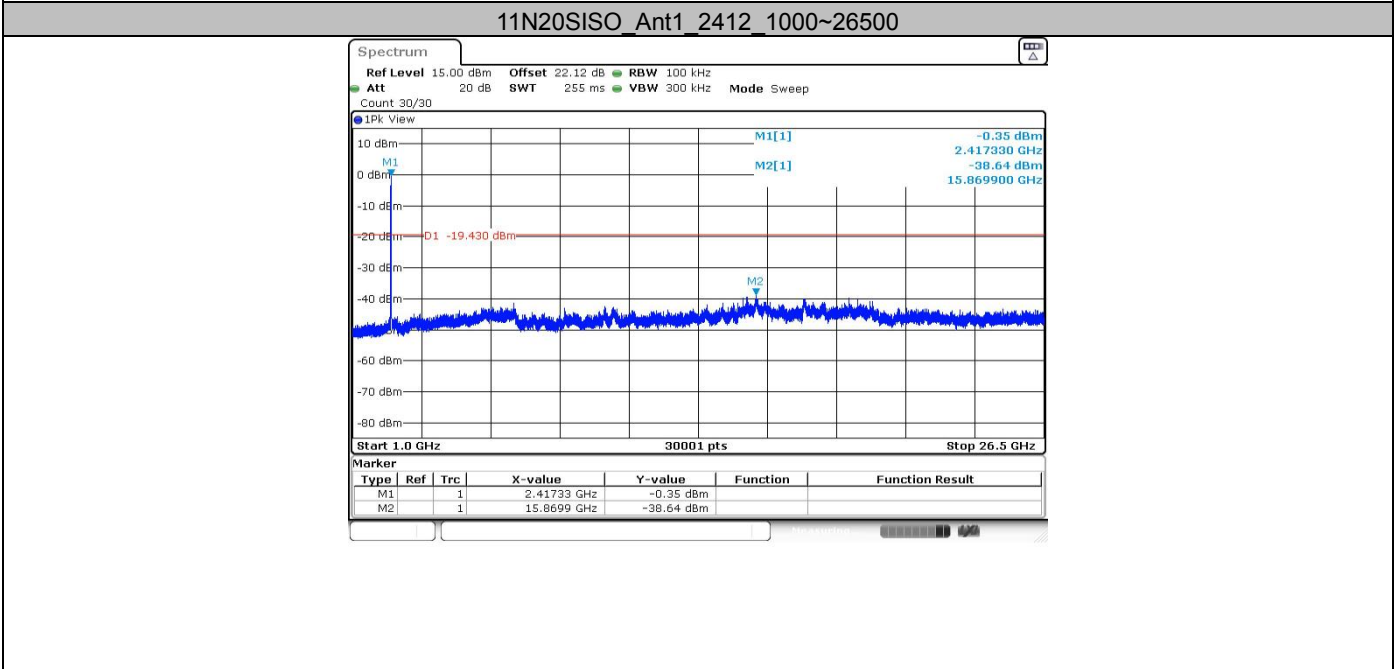
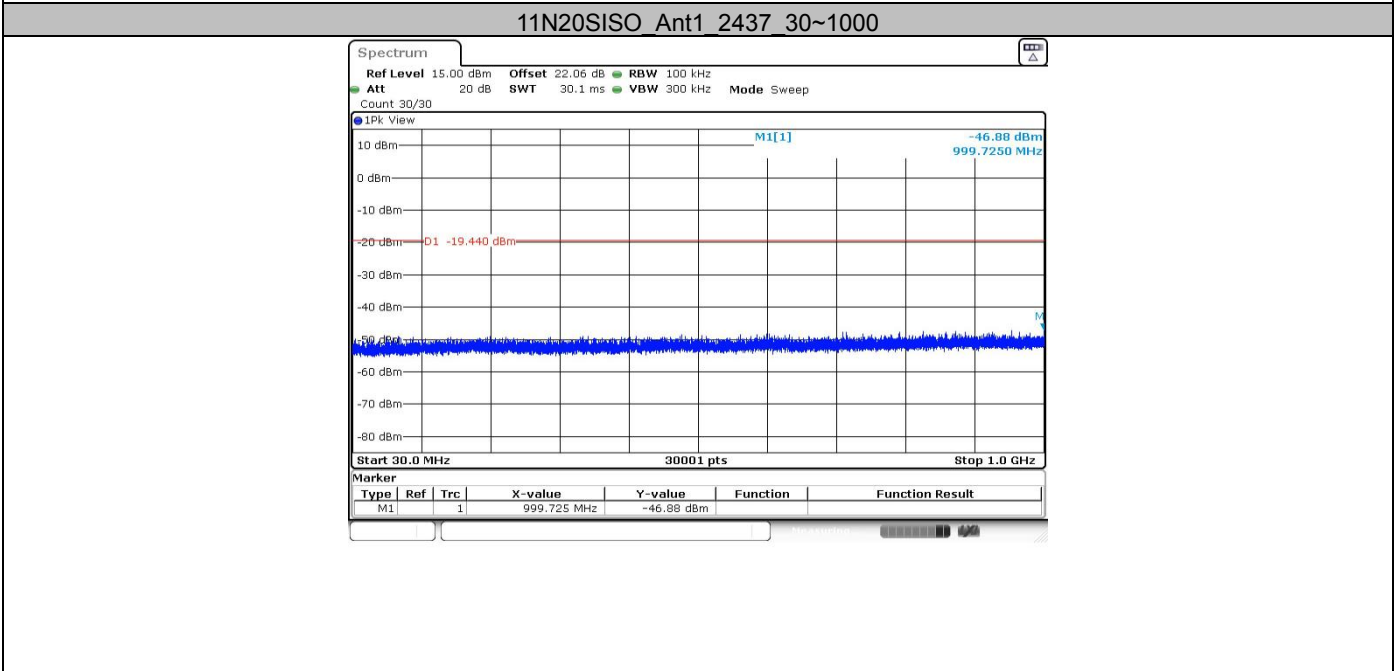
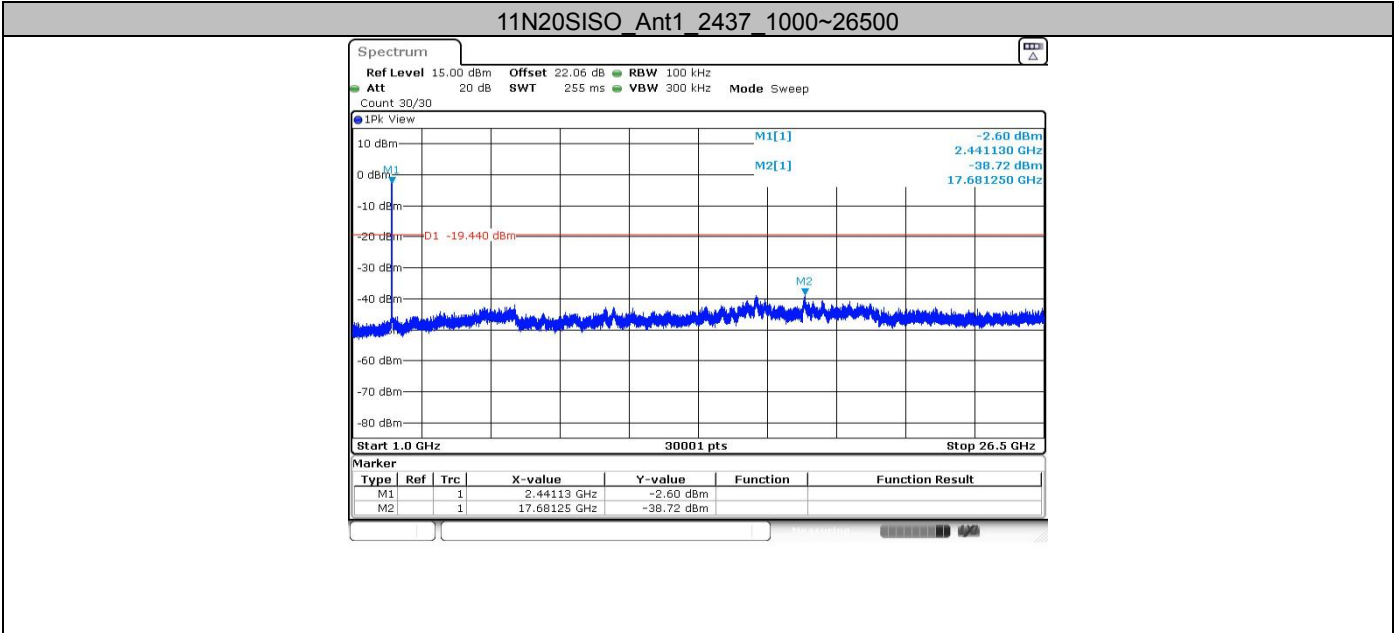
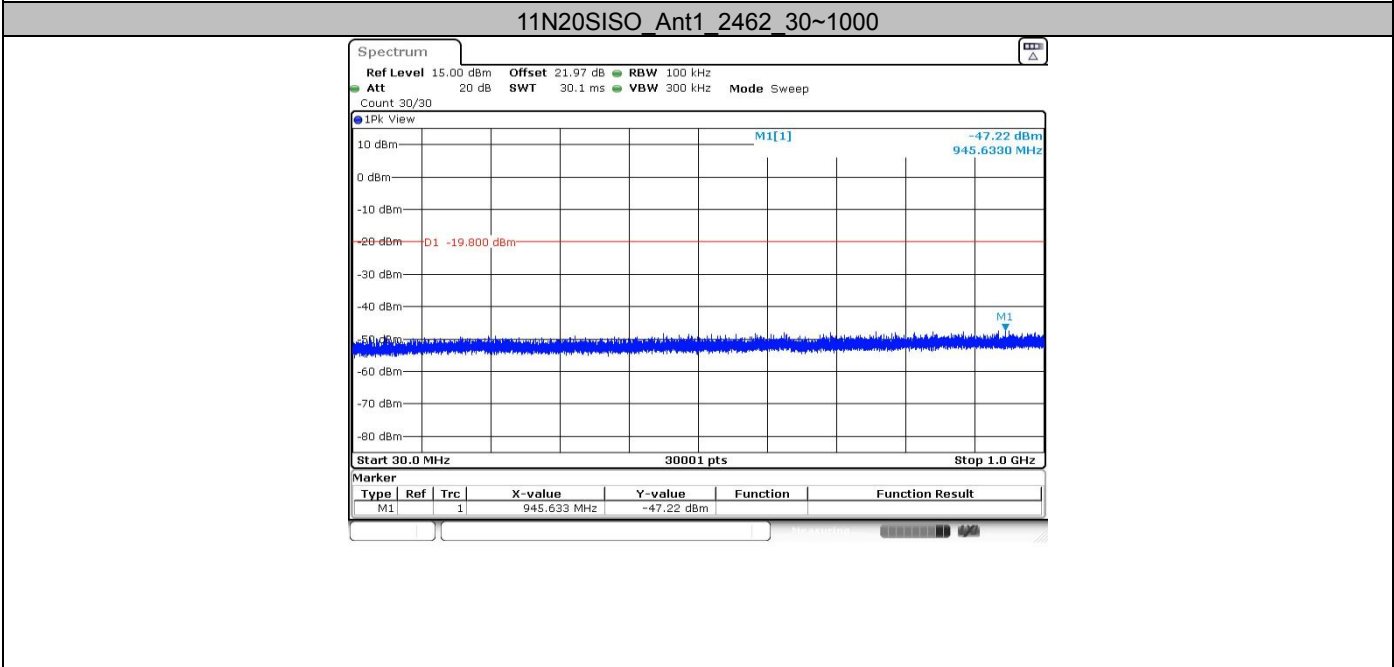
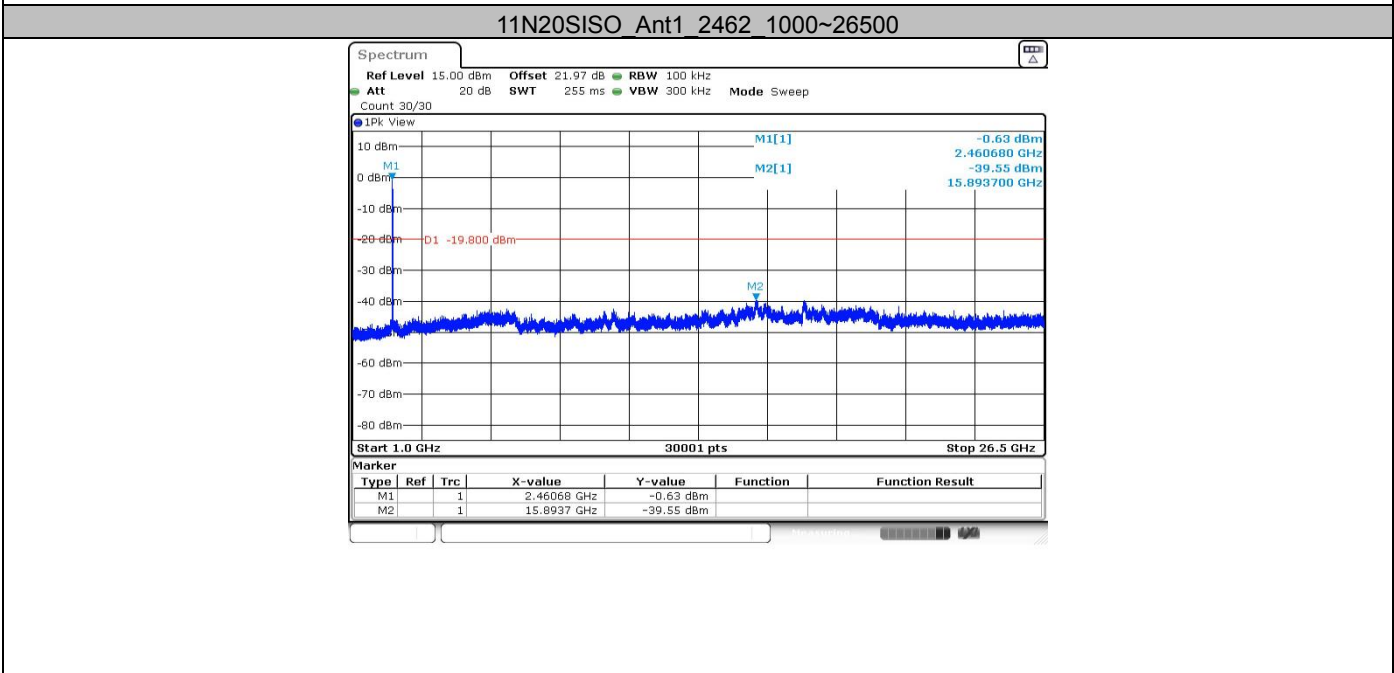
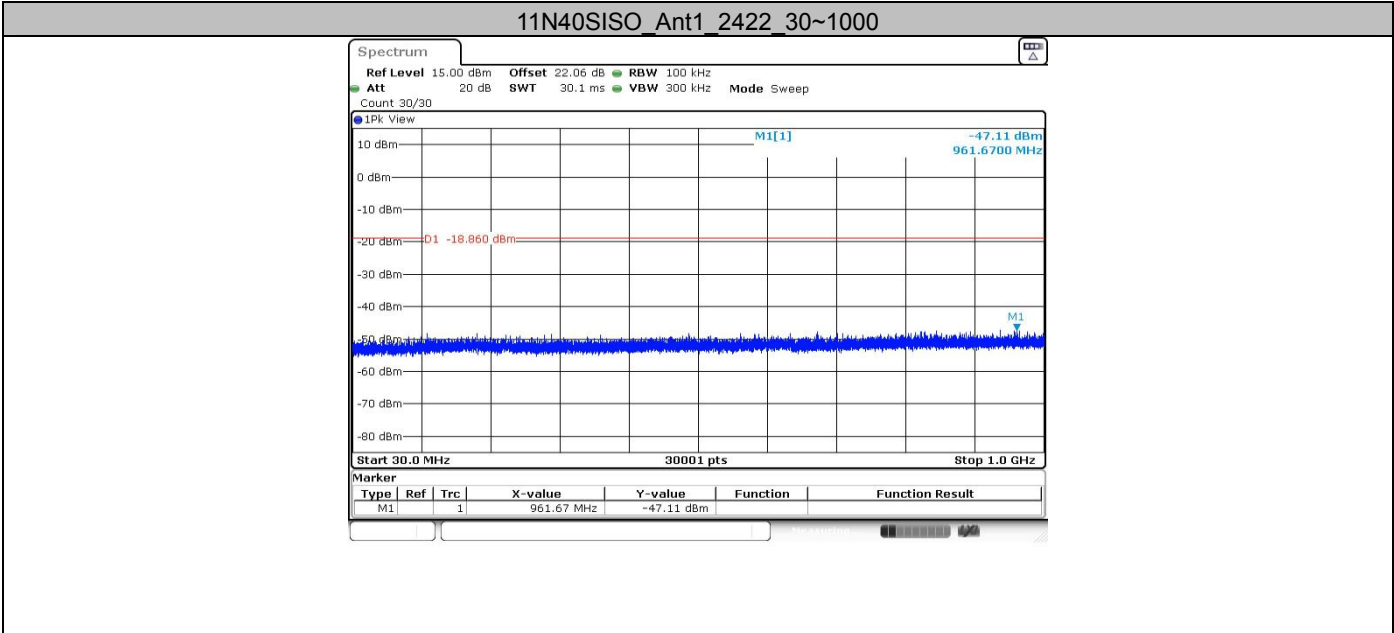
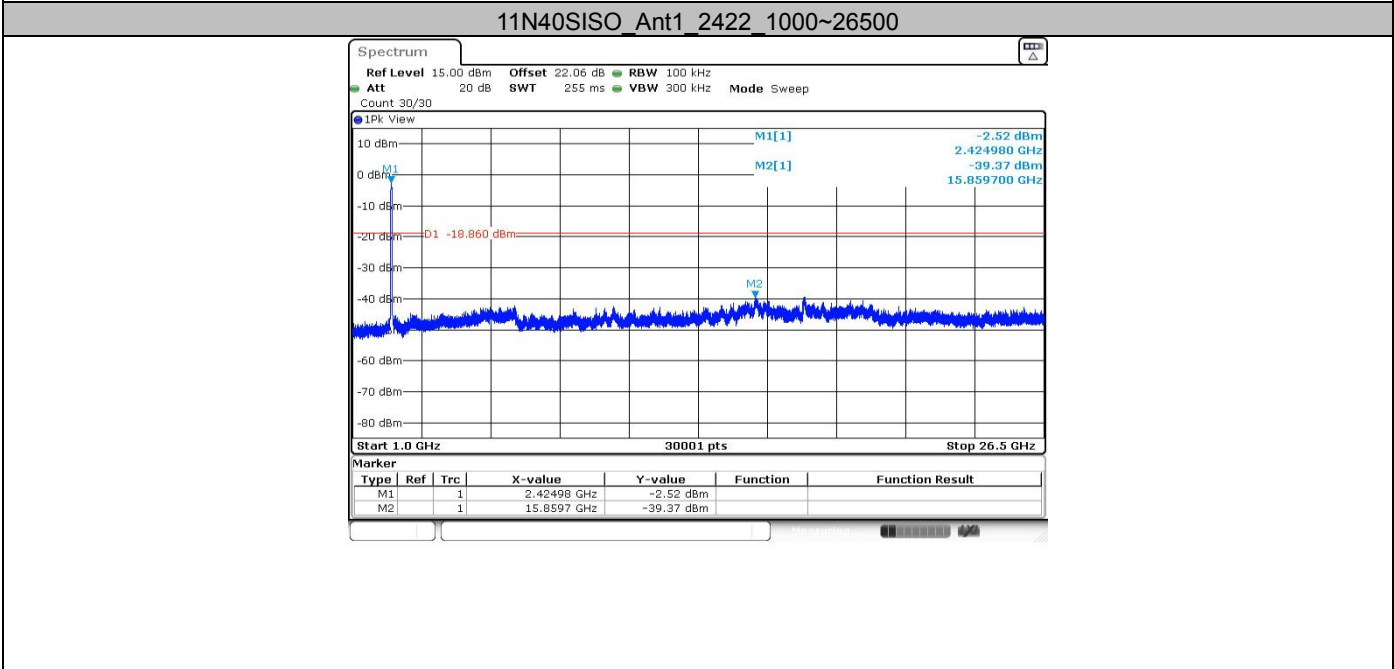
Test Graphs

| TestMode | Antenna | Frequency[MHz] | FreqRange [Mhz] | RefLevel [dBm] | Result [dBm] | Limit [dBm] | Verdict |

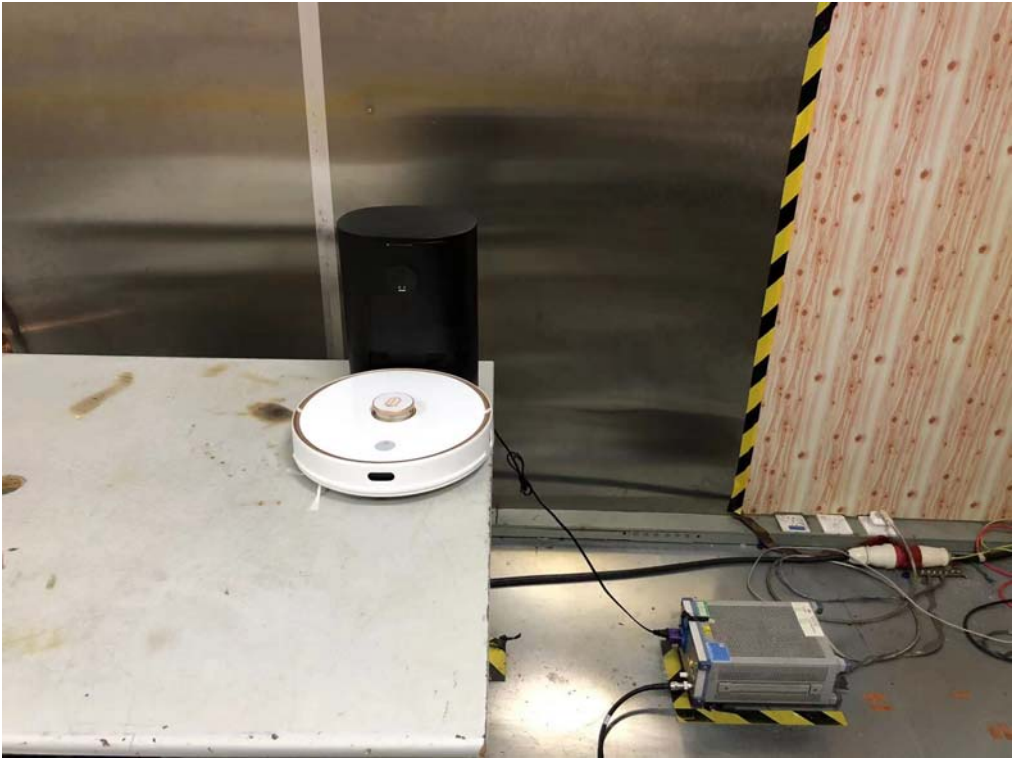
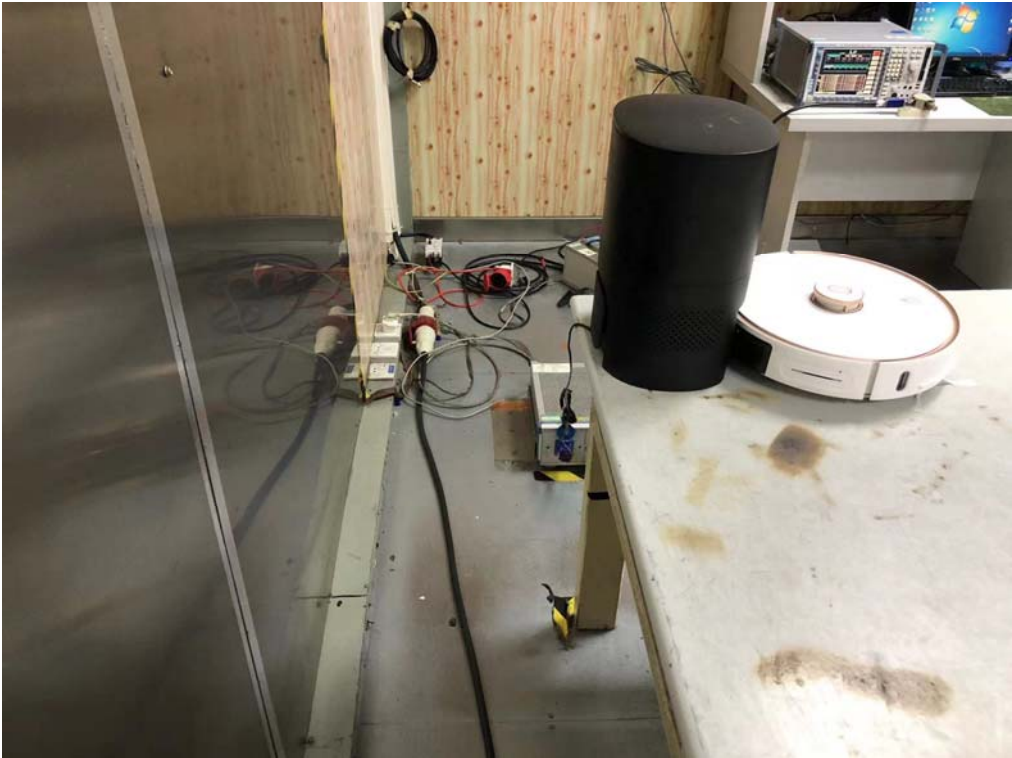
Conducted Test

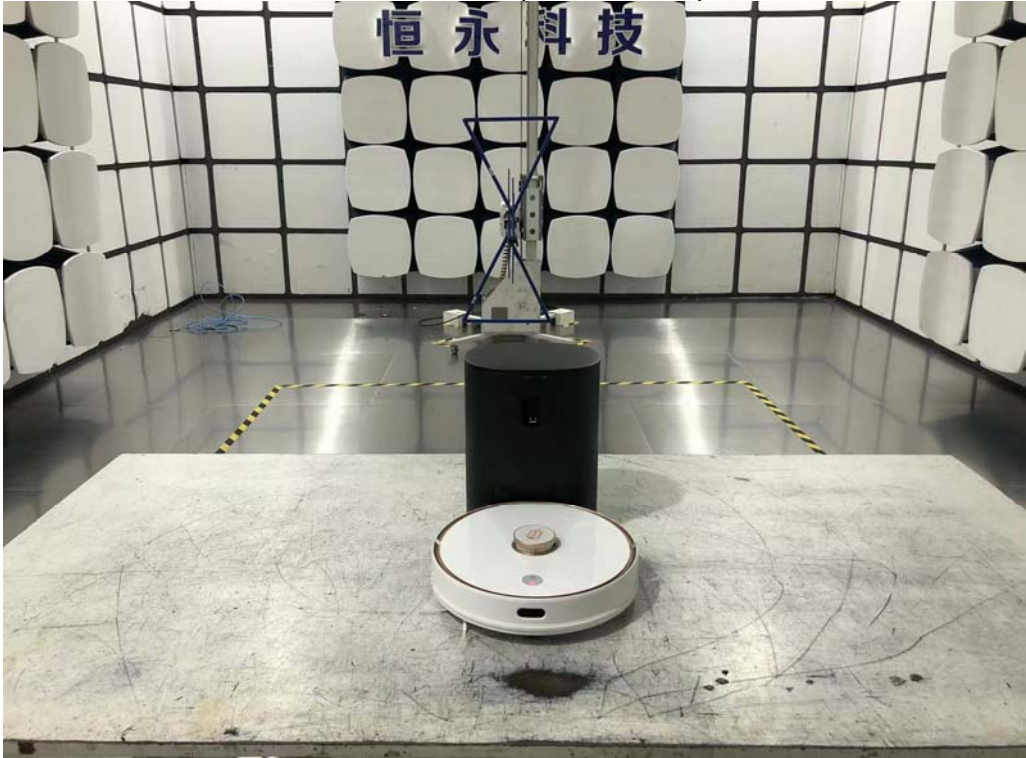
Radiated Test (Below 1GHz)

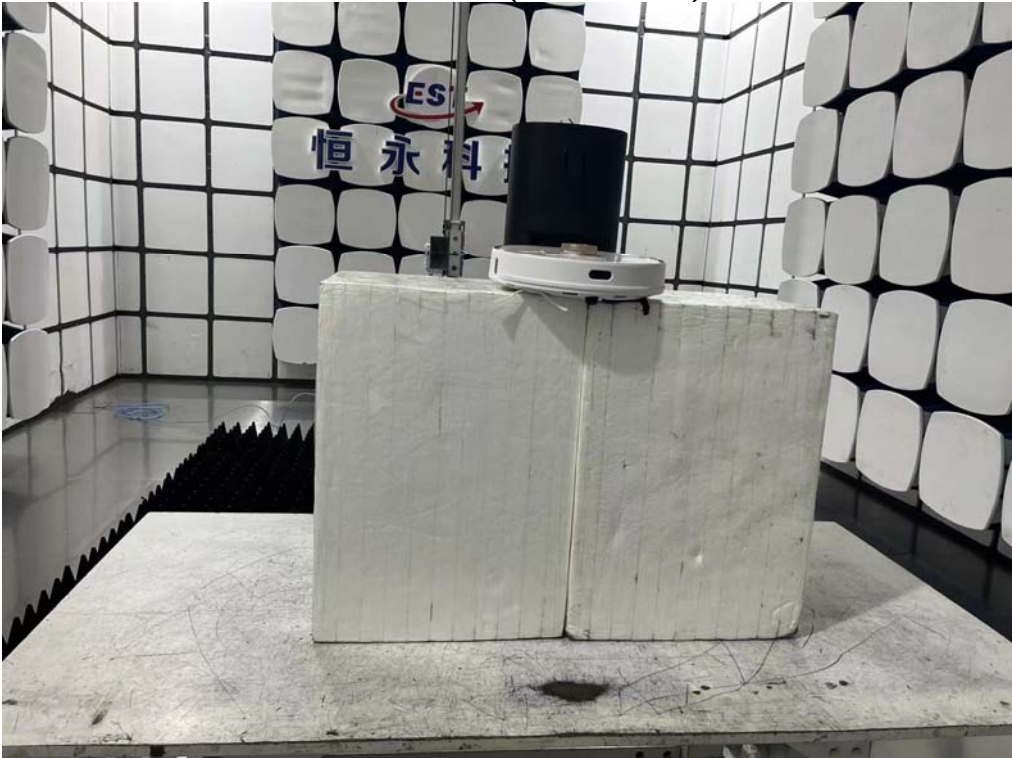
Radiated Test (Above 1GHz)
