Appendix D. Photographs of the Test Set-Up

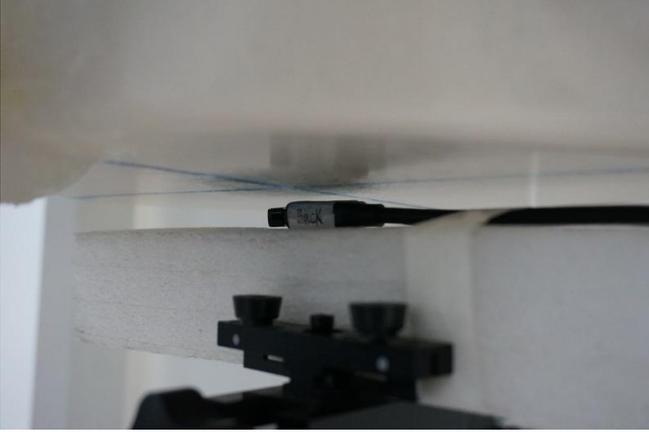
A photograph showing a top-down view of a test setup. A black device is positioned on a white foam block. A blue laser line is visible, intersecting the device. A black mechanical fixture is positioned below the foam block.

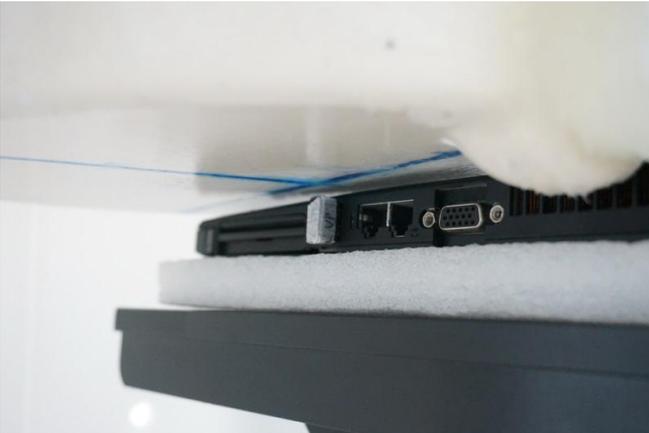
A photograph showing a front view of the test setup. The black device is on the white foam block, with a blue laser line intersecting it. The black mechanical fixture is visible below.

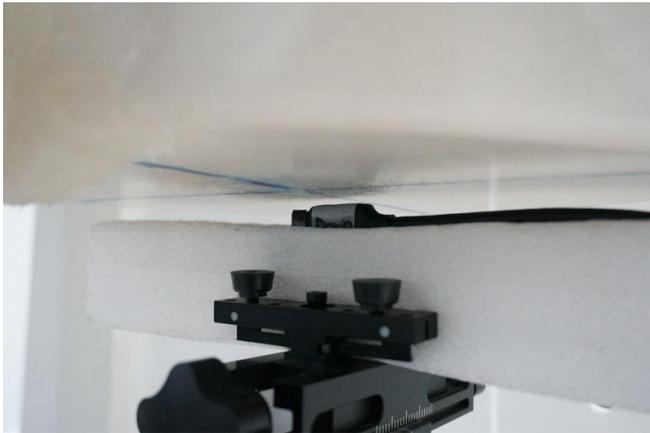
A photograph showing a back view of the test setup. The black device is on the white foam block, with a blue laser line intersecting it. The black mechanical fixture is visible below.

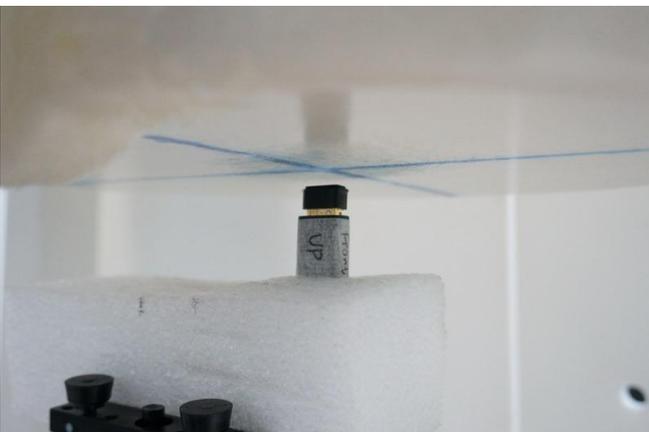
Photo 5: Tip Side_0.5cm

A photograph showing a side view of the test setup. The black device is on the white foam block, with a blue laser line intersecting it. The black mechanical fixture is visible below.
