## Appendix B: photographs of test setup

## Appendix C: photographs of EUT

Reference to the test report no. BLA-EMC-202503-A2701

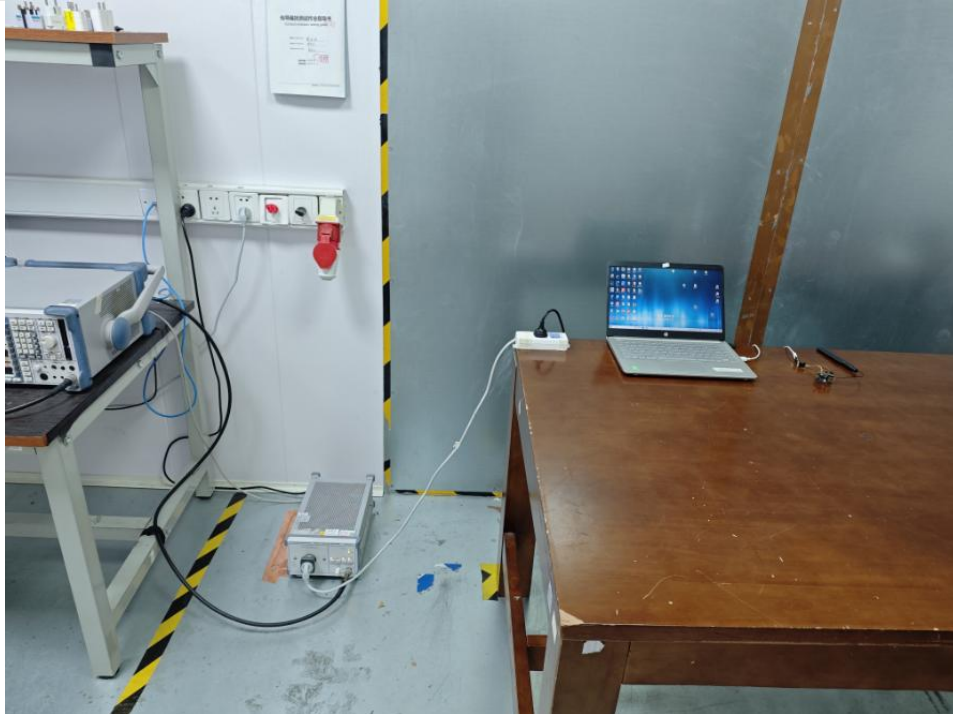
Conducted emissions at AC power line (150kHz-30MHz)
