-6dB Bandwidth

## APPENDIX II:PHOTOS OF TEST SETUP

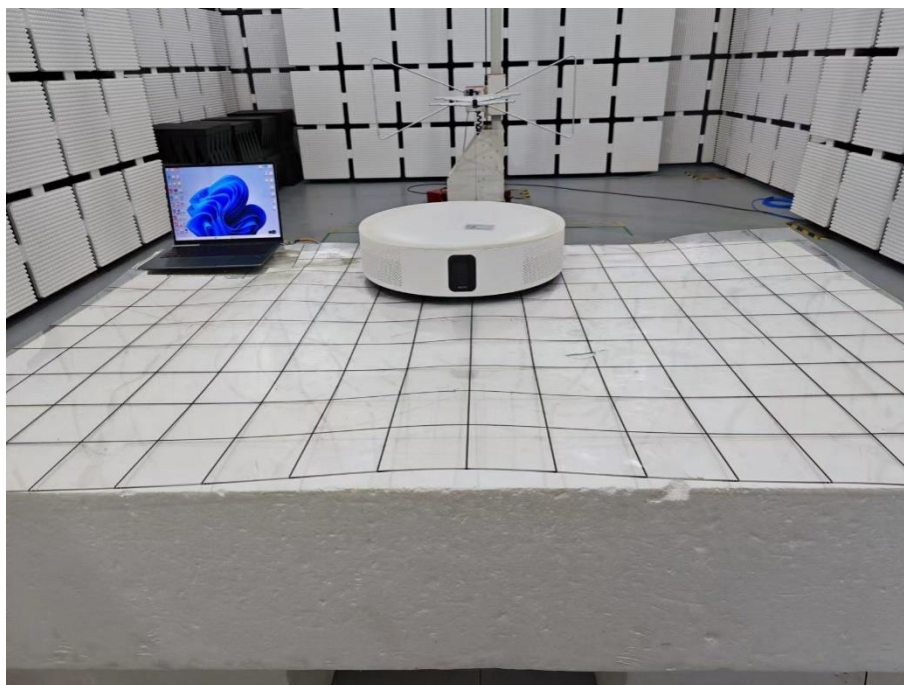
**Radiated Spurious Emission Test Setup Photo - Below 1GHz**

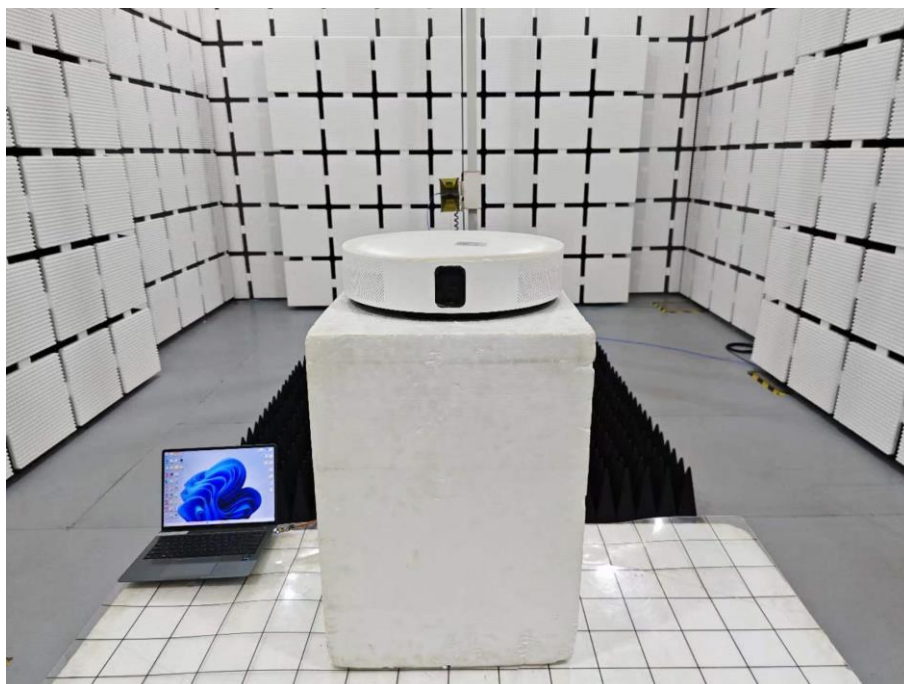
**Radiated Spurious Emission Test Setup Photo - Above 1GHz**

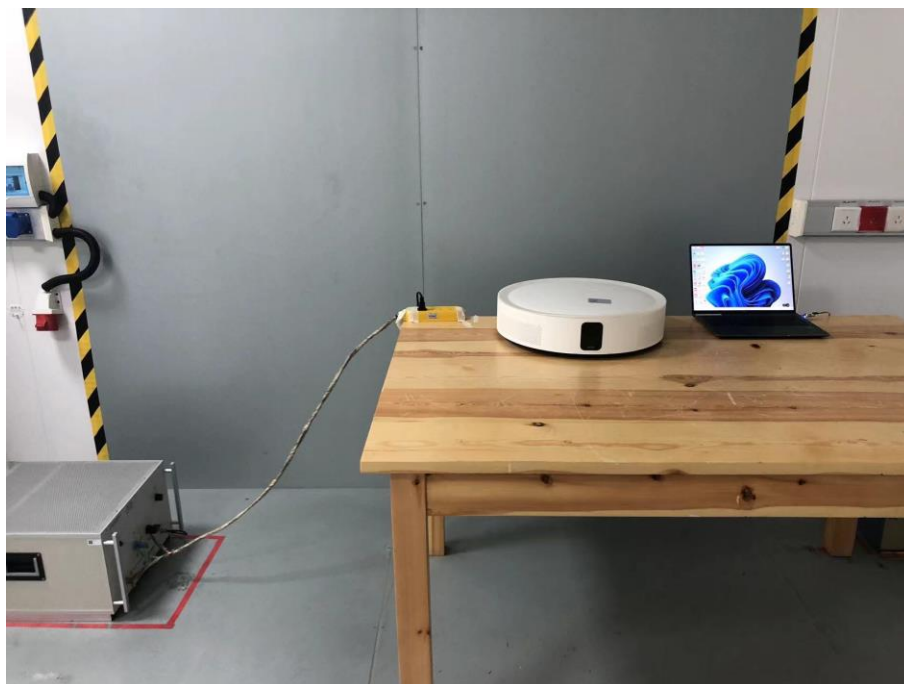
### Conducted Emission Test Setup Photo
