## Appendix B: photographs of test setup

Reference to the test report no. BLA-EMC-202504-A3501

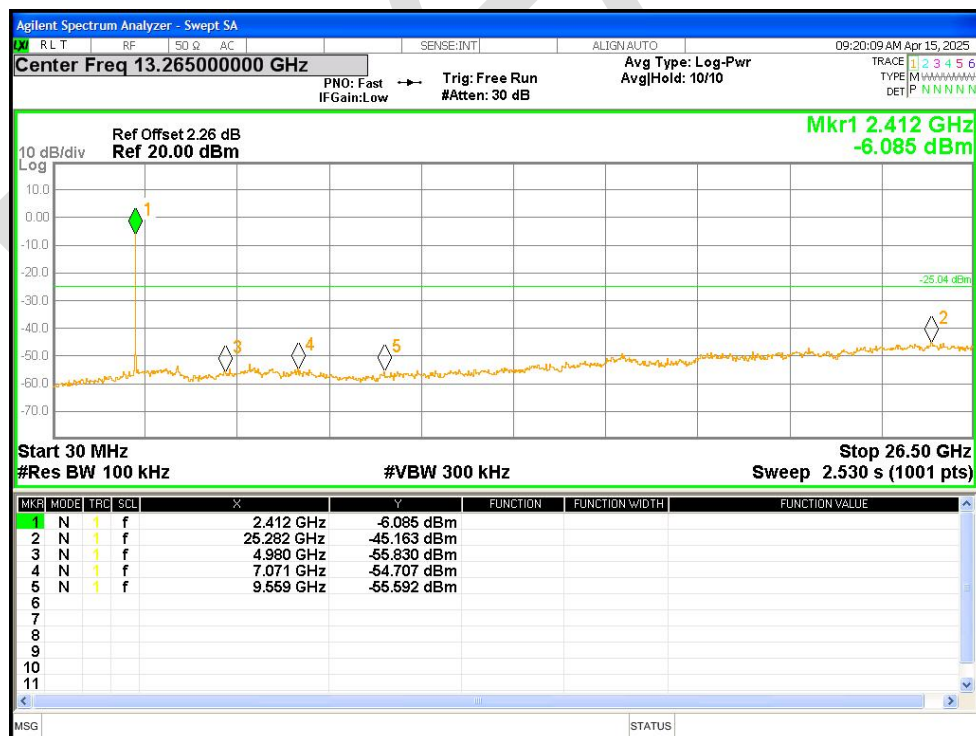
### Tx. Spurious NVNT n20 2412MHz Ant1 Emission
