## 6 Photographs of the Test Setup

## 7 Photographs of the EUT

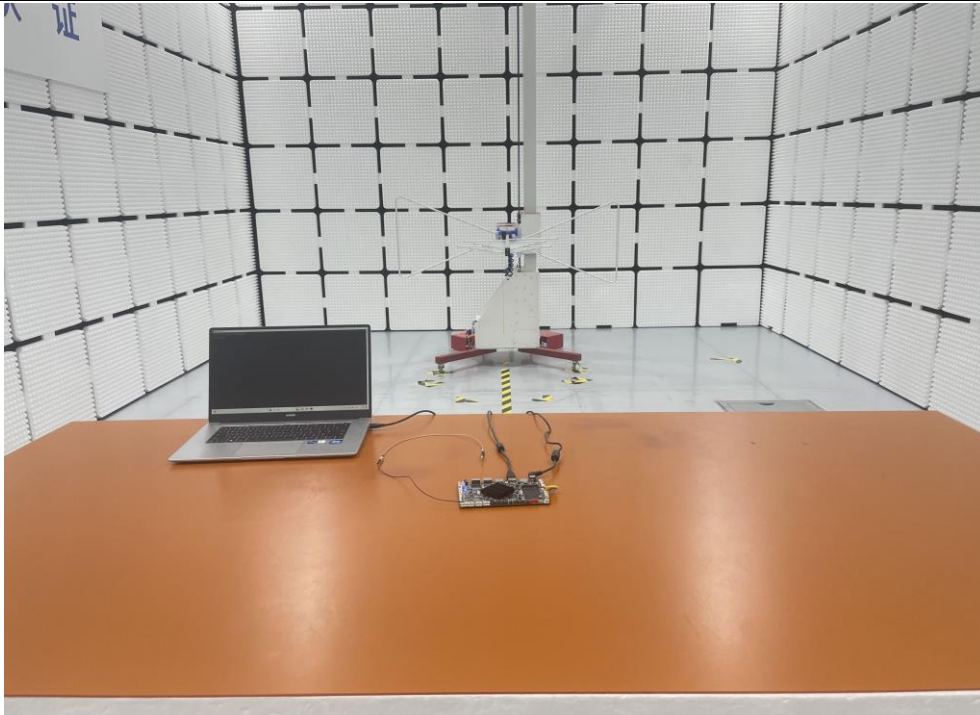
Radiated Emission Below 1GHz

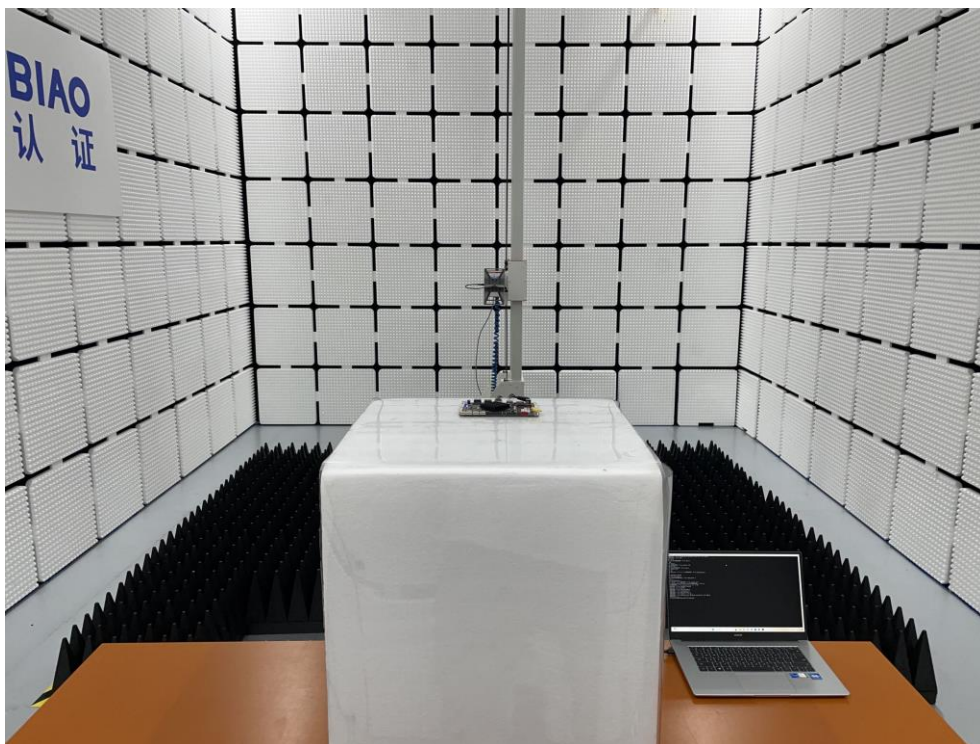
Radiated Emission Above 1GHz

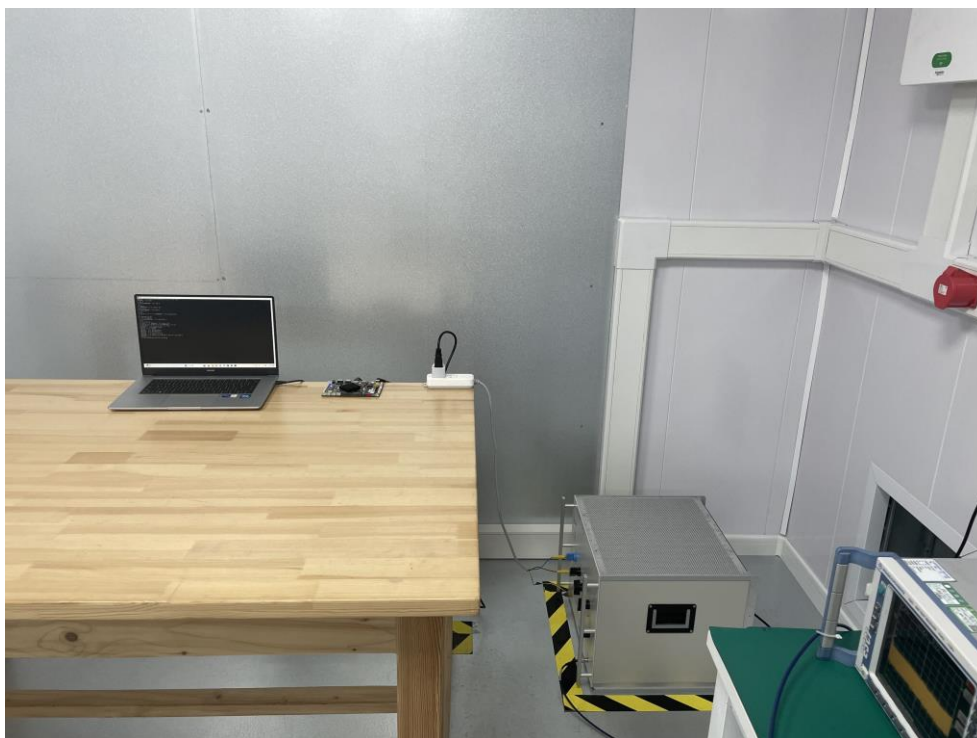
Conducted emission
