8733 Bluetooth chip:

## 6 Photographs of the Test Setup

## 7 Photographs of the EUT

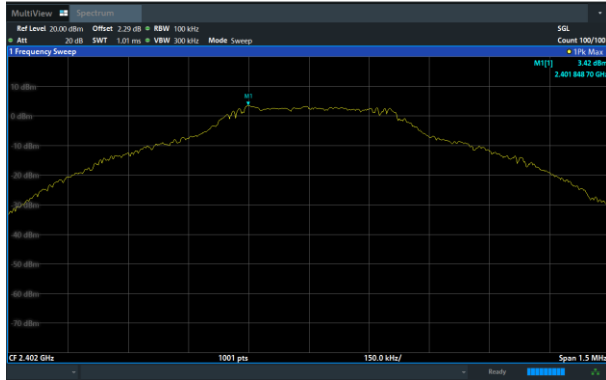
GFSK on Channel 00

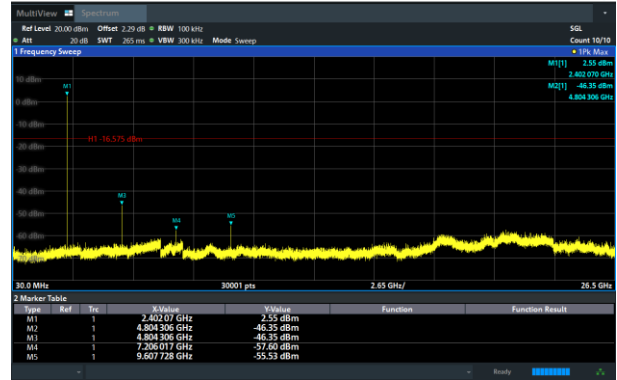
GFSK on Channel 00

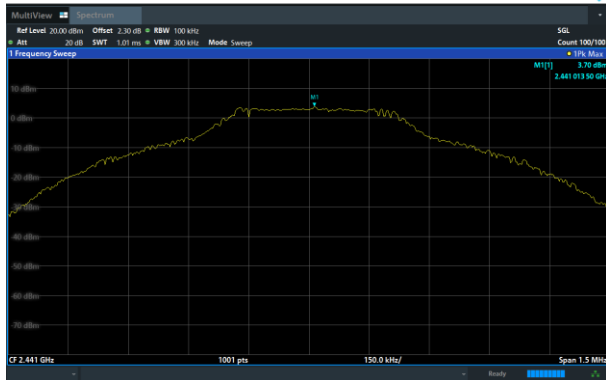
GFSK on Channel 39

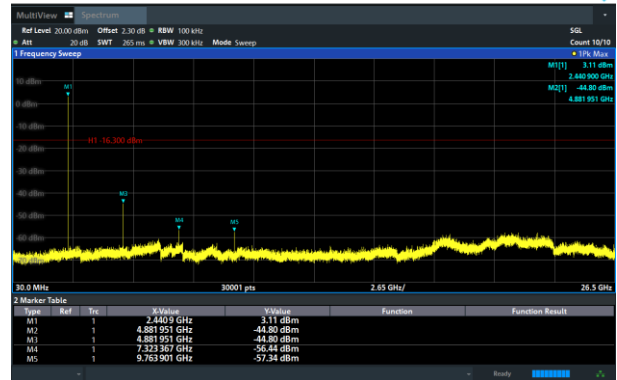
GFSK on Channel 39

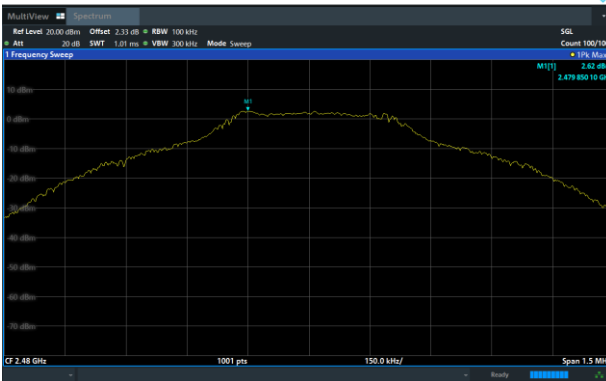
GFSK on Channel 78

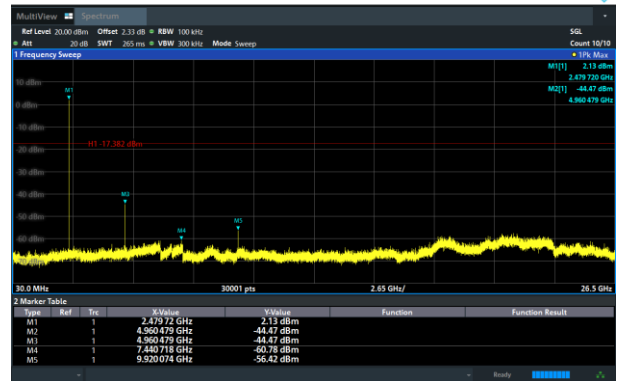
GFSK on Channel 78

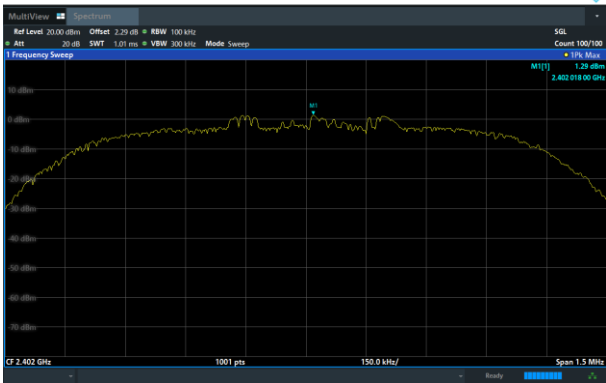
$\pi/4$ -DQPSK on Channel 00

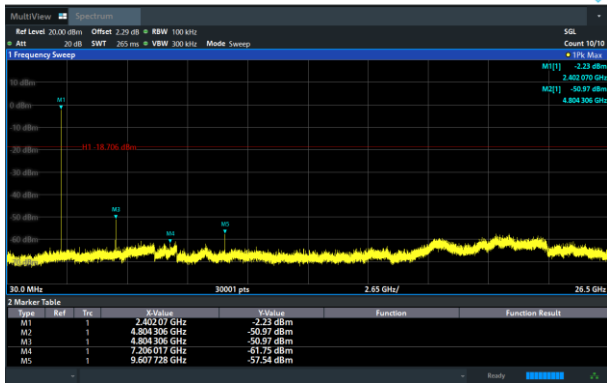
$\pi/4$ -DQPSK on Channel 00

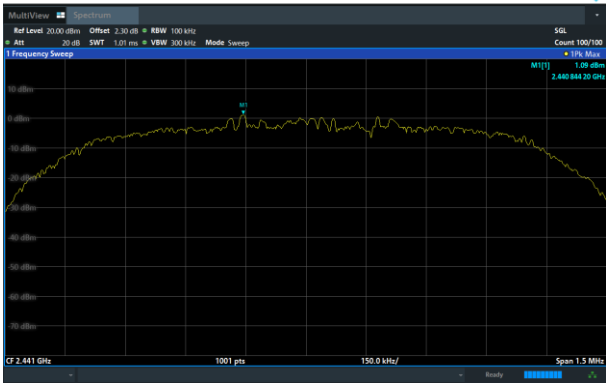
$\pi/4$ -DQPSK on Channel 39

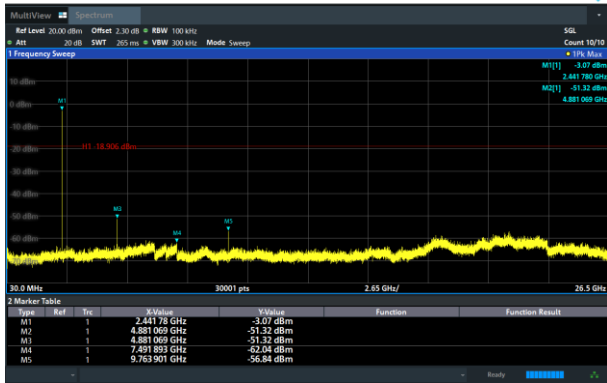
$\pi/4$ -DQPSK on Channel 39

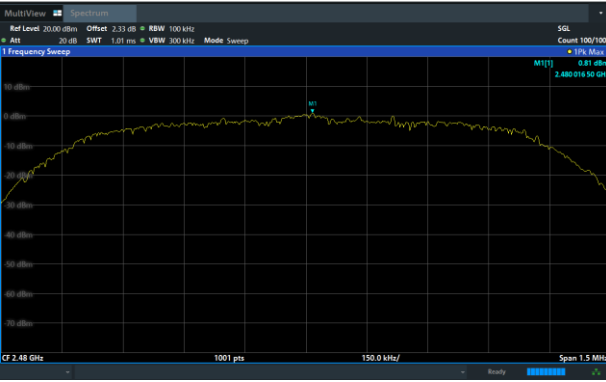
$\pi/4$ -DQPSK on Channel 78

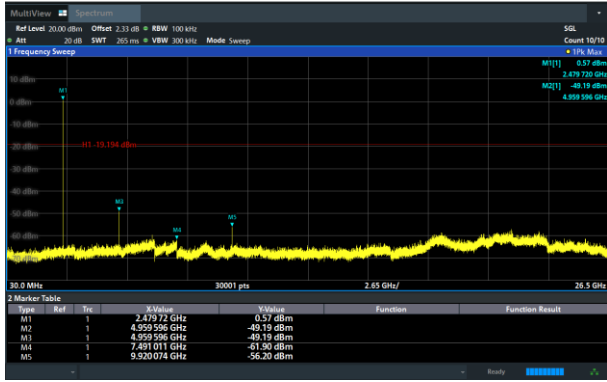
$\pi/4$ -DQPSK on Channel 78

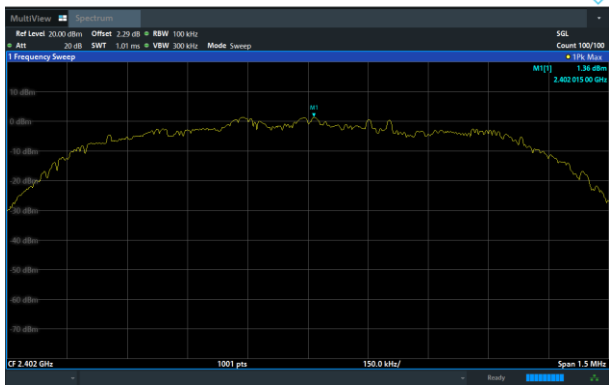
8DPSK on Channel 00

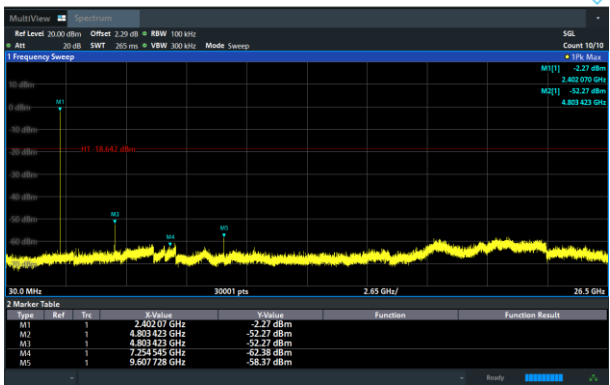
8DPSK on Channel 00

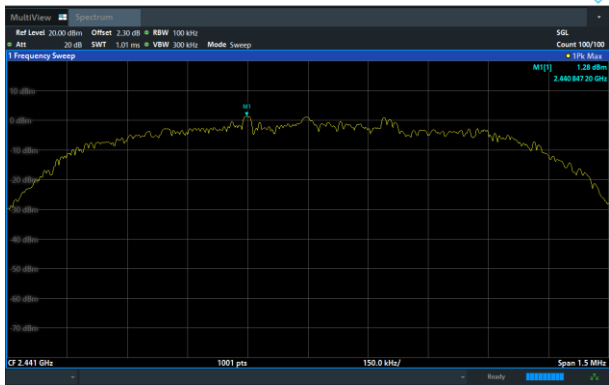
8DPSK on Channel 39

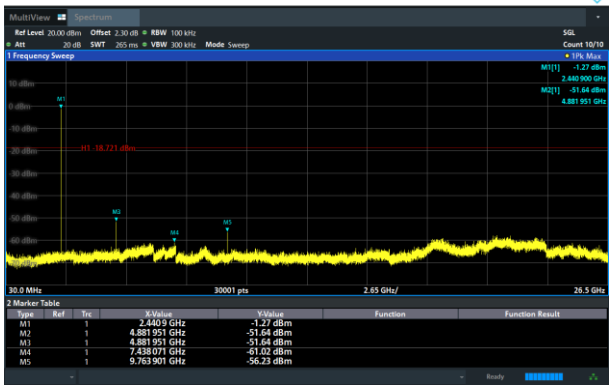
8DPSK on Channel 39

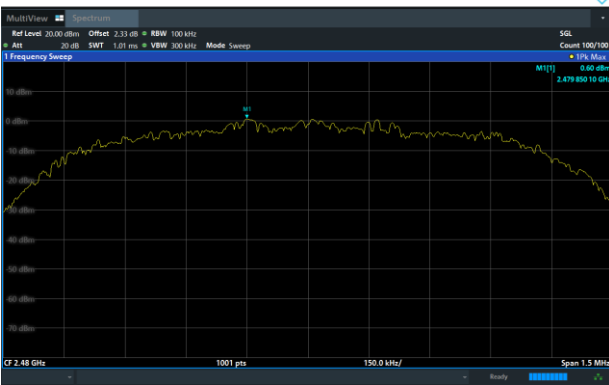
8DPSK on Channel 78

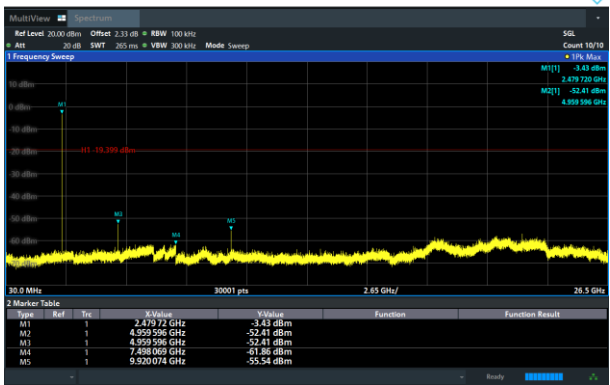
8DPSK on Channel 78

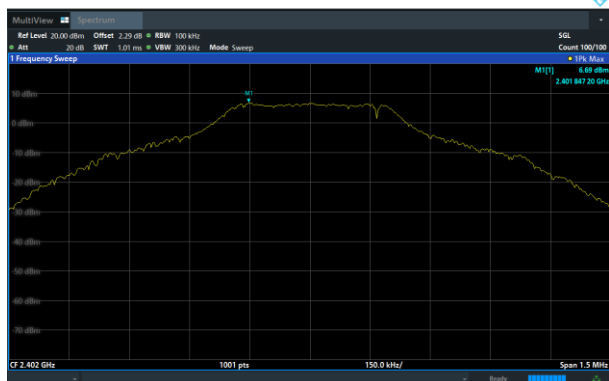
GFSK on Channel 00

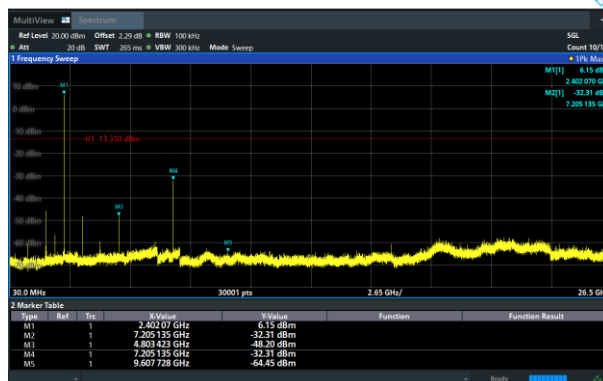
GFSK on Channel 00

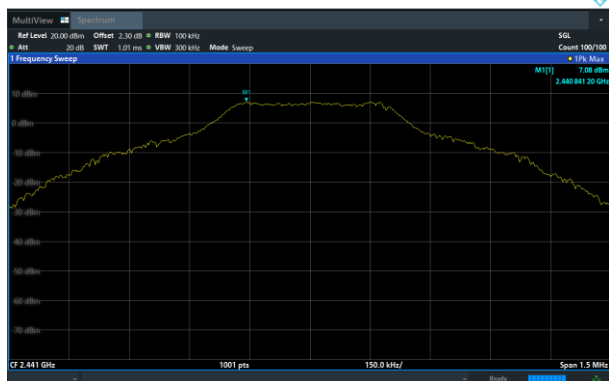
GFSK on Channel 39

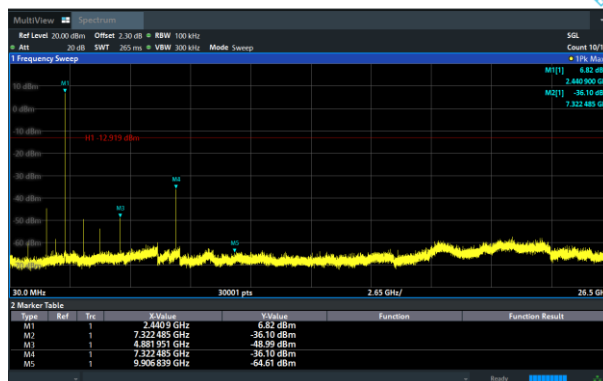
GFSK on Channel 39

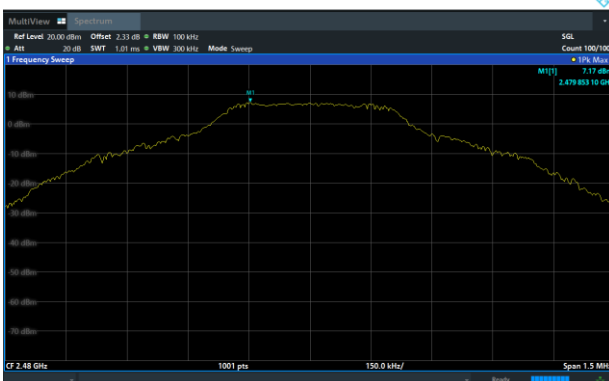
GFSK on Channel 78

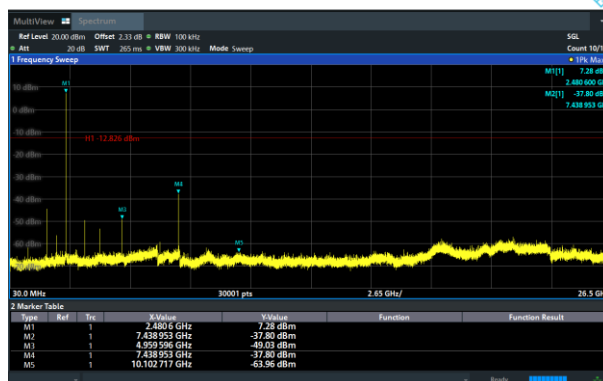
GFSK on Channel 78

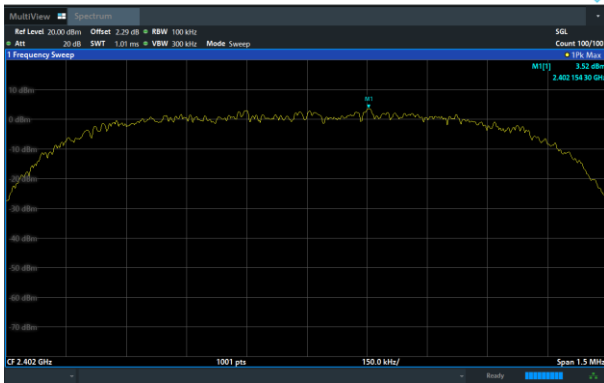
$\pi/4$ -DQPSK on Channel 00

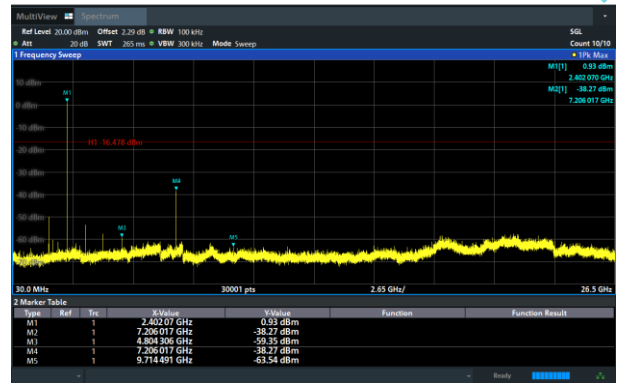
$\pi/4$ -DQPSK on Channel 00

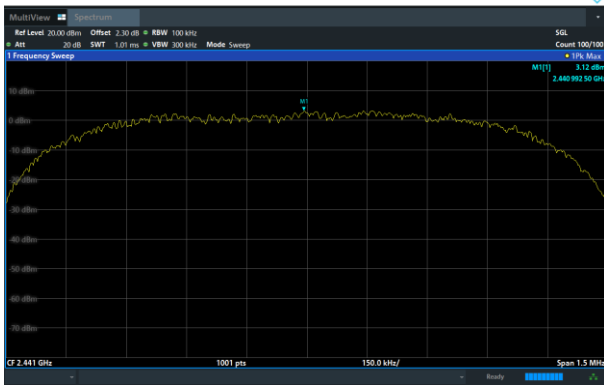
$\pi/4$ -DQPSK on Channel 39

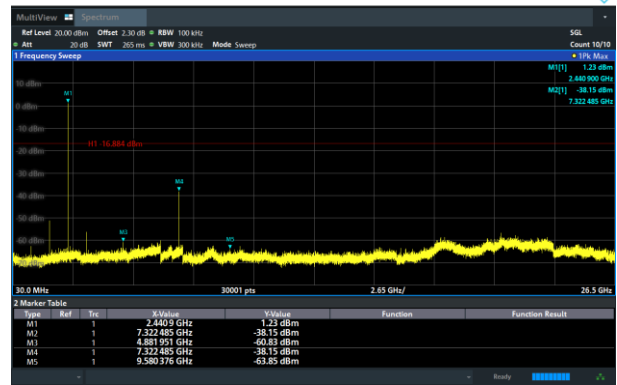
$\pi/4$ -DQPSK on Channel 39

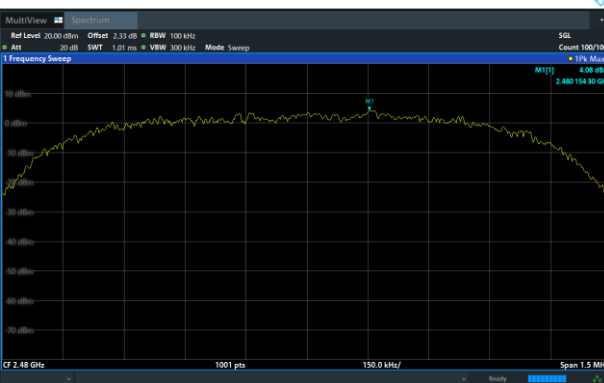
$\pi/4$ -DQPSK on Channel 78

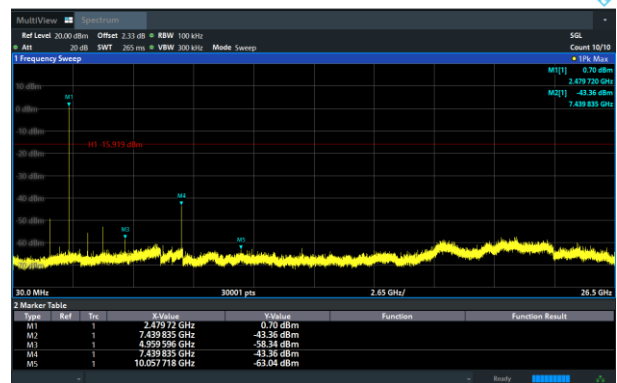
$\pi/4$ -DQPSK on Channel 78

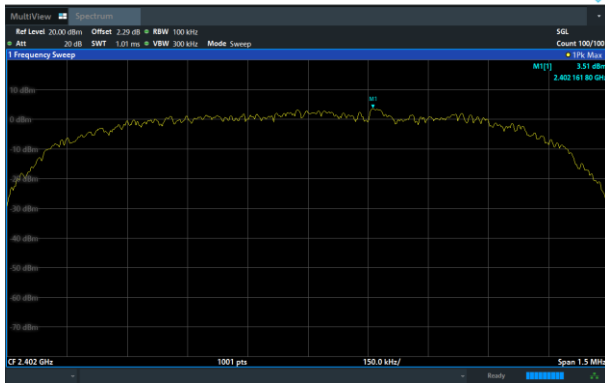
8DPSK on Channel 00

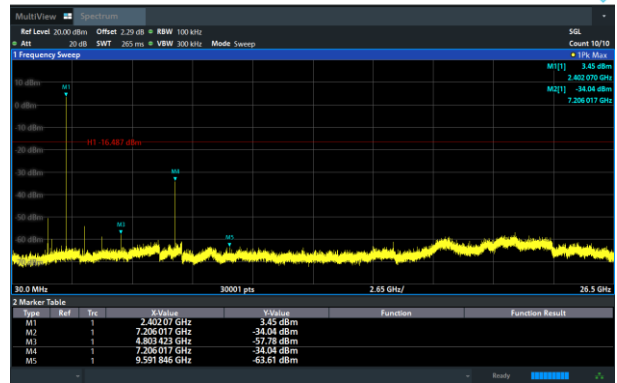
8DPSK on Channel 00

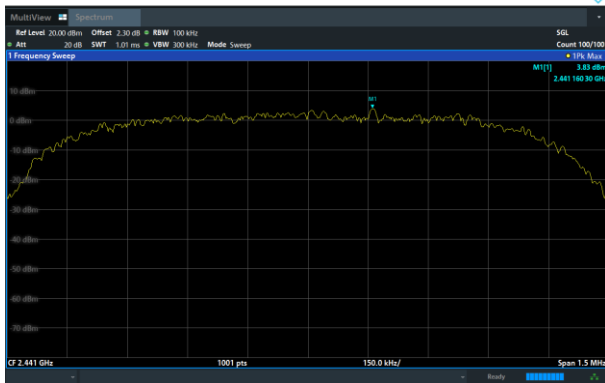
8DPSK on Channel 39

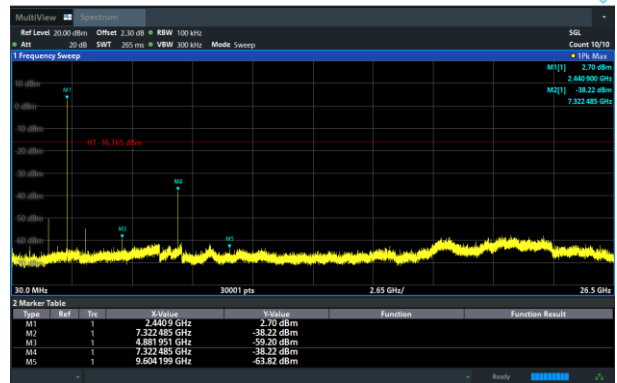
8DPSK on Channel 39

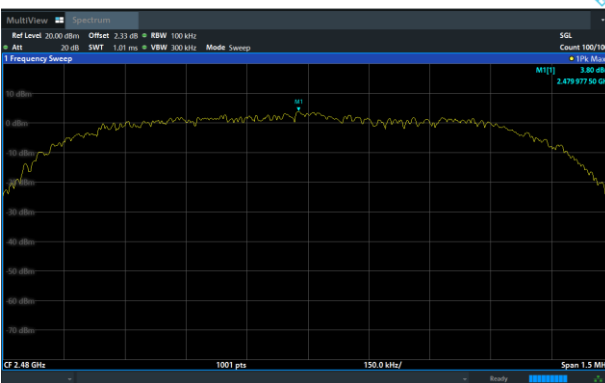
8DPSK on Channel 78

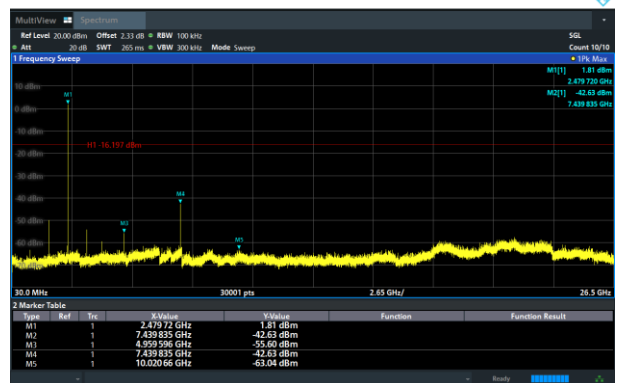
8DPSK on Channel 78

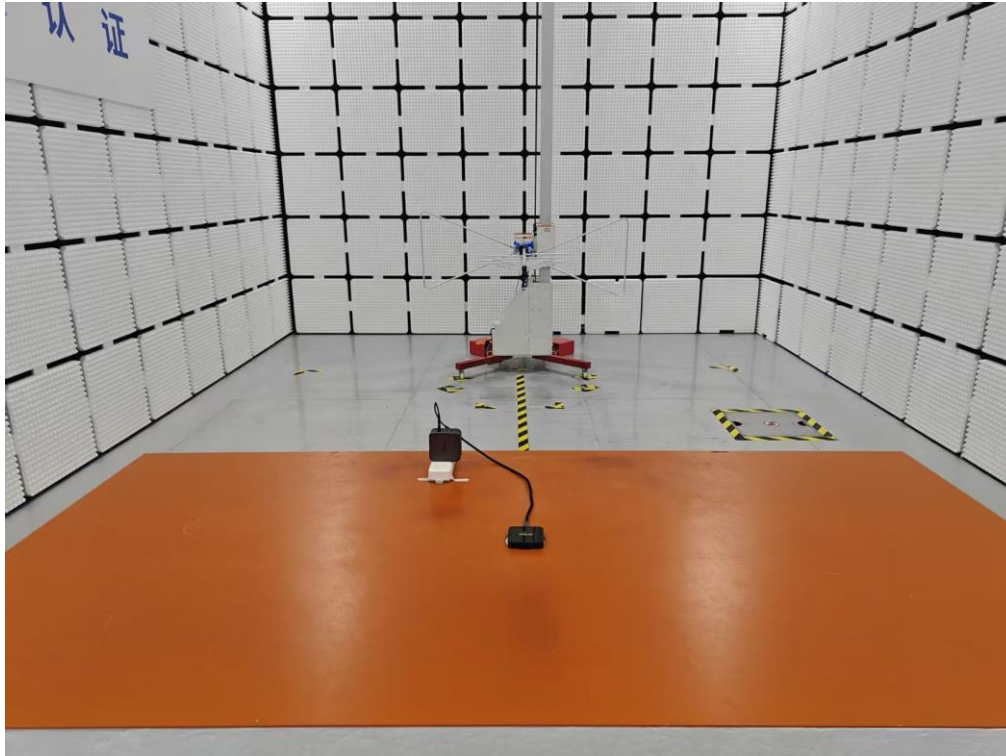
Radiated Emission Below 1GHz

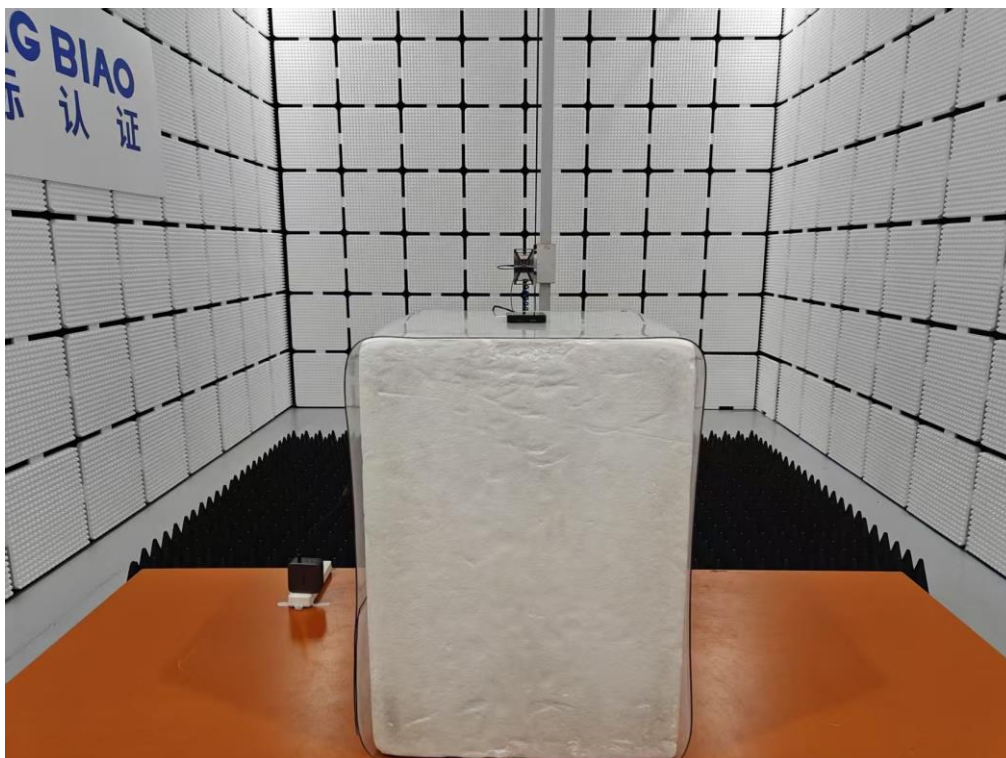
Radiated Emission Above 1GHz

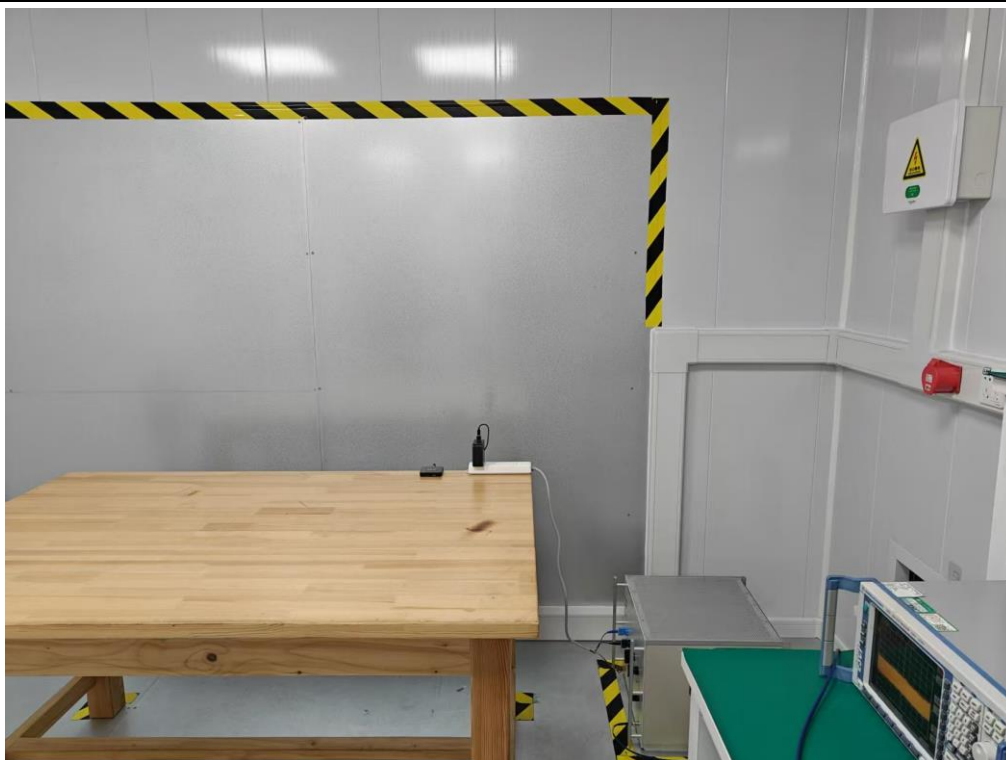
Conducted emission
