# Radiated Emission Measurement

Condition : FCC\_part 15 RE-Class C\_Above 1GHz\_PK

EUT : W6M22311-23076

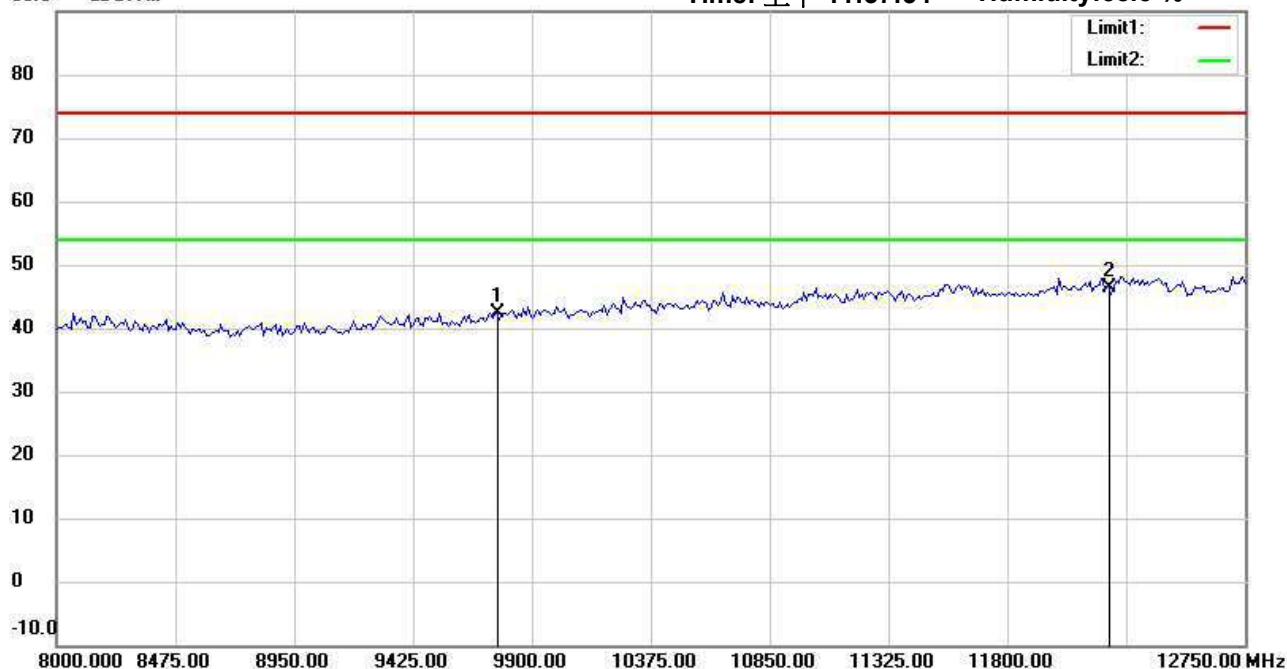
Condition : FCC\_part 15 RE-Class C\_Above 1GHz\_PK

EUT : W6M22311-23076

Test Mode : TX 2440MHz

Polarization: Vertical

Distance: 3m

| Mk. | Frequency (MHz) | Reading (dBuV) | Detector | Corr. factor (dB/m) | Result (dBuV/m) | Limit (dBuV/m) | Ant.Pos (cm) | Tab.Pos (deg.) | Margin (dB) | Comment |
|---|---|---|---|---|---|---|---|---|---|---|
| | 9760.000 | 35.04 | peak | 7.24 | 42.28 | 74.00 | 150 | 273 | -31.72 | |
| * | 12200.000 | 32.83 | peak | 13.50 | 46.33 | 74.00 | 150 | 63 | -27.67 | |

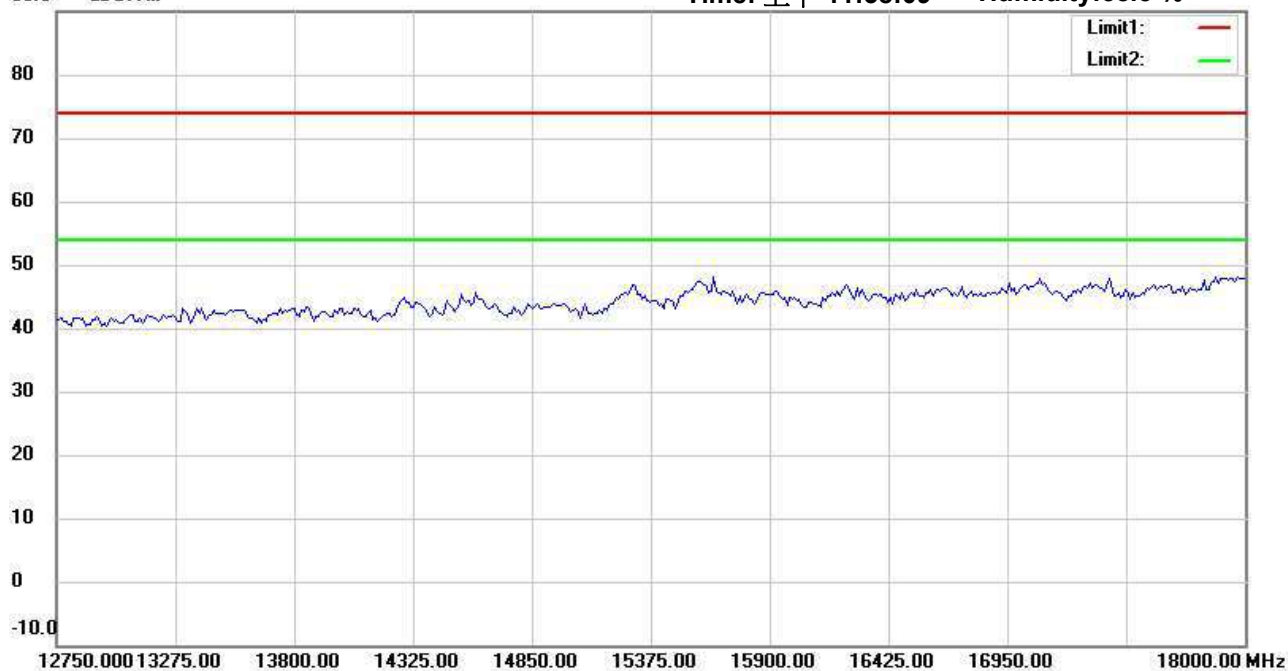
Condition : FCC\_part 15 RE-Class C\_Above 1GHz\_PK

EUT : W6M22311-23076

Test Mode : TX 2440MHz

Polarization: Vertical

Distance: 3m

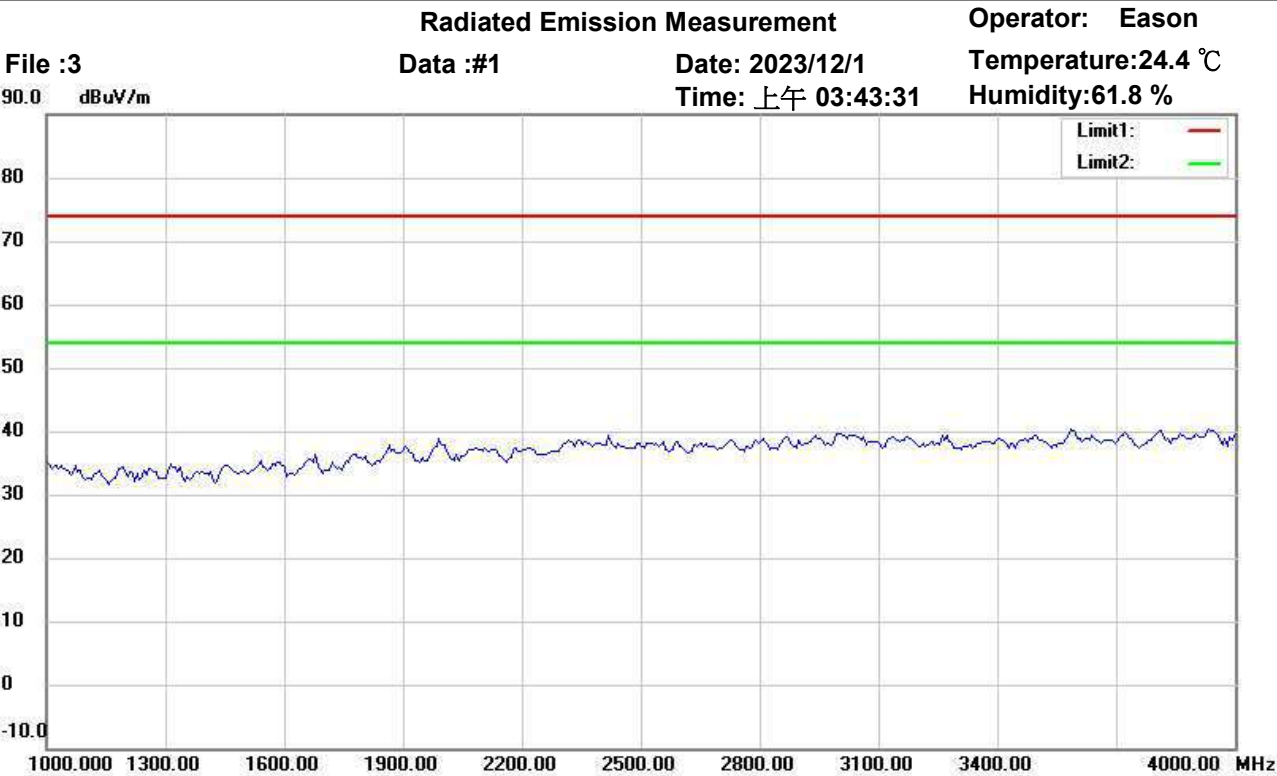
Site : Chamber  
Condition : FCC\_part 15 RE-Class C\_Above 1GHz\_PK  
EUT : W6M22311-23076  
M/N:  
Test Mode : TX 802.11n20 CH1  
Note :

Polarization: Horizontal  
Power : 120 Va.c.  
Distance: 3m
