## Appendix F: Conducted Spurious Emission

### Test Result

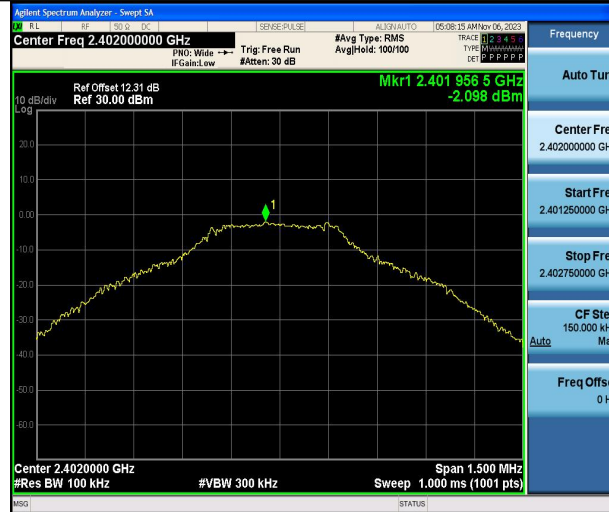
DH5\_Ant1\_2402\_0~Reference

| Test Mode | Antenna | Freq(MHz) | Freq Range [MHz] | RefLevel [dBm] | Result [dBm] | Limit [dBm] | Verdict |
|---|---|---|---|---|---|---|---|
| DH5 | Ant1 | 2402 | Reference | -2.10 | -2.10 | --- | PASS |

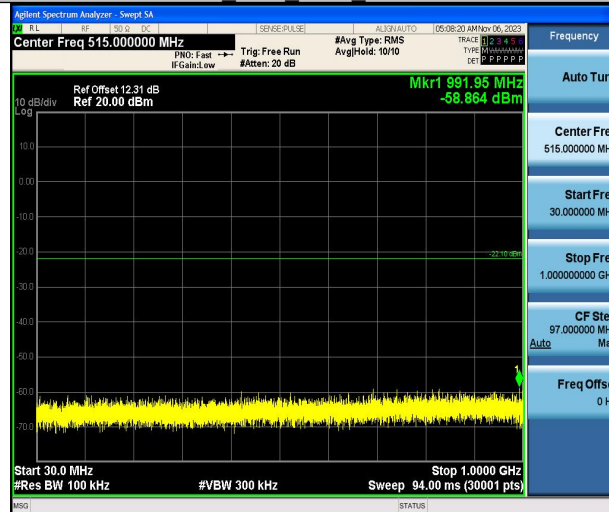
DH5\_Ant1\_2402\_30~1000

| Test Mode | Antenna | Freq(MHz) | Freq Range [MHz] | RefLevel [dBm] | Result [dBm] | Limit [dBm] | Verdict |
|---|---|---|---|---|---|---|---|
| | | | 30~1000 | -2.10 | -58.86 | $\leq -22.1$ | PASS |

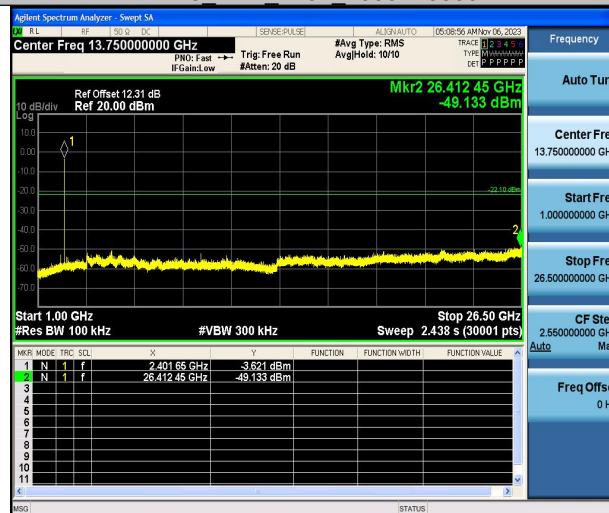
DH5\_Ant1\_2402\_1000~26500

| Test Mode | Antenna | Freq(MHz) | Freq Range [MHz] | RefLevel [dBm] | Result [dBm] | Limit [dBm] | Verdict |
|---|---|---|---|---|---|---|---|
| | | | 1000~26500 | -2.10 | -49.13 | $\leq -22.1$ | PASS |

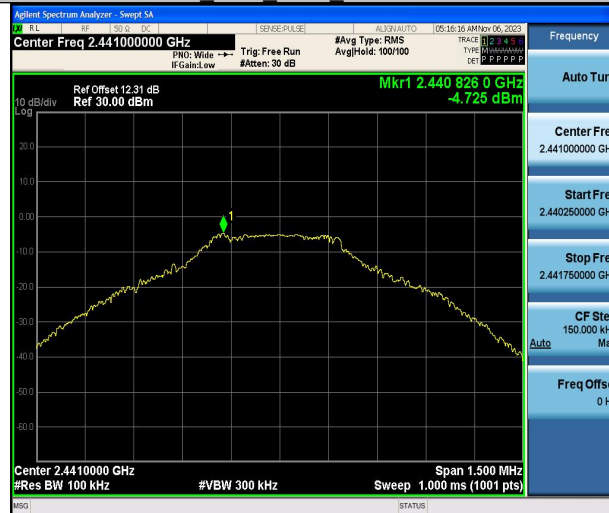
## DH5\_Ant1\_2441\_0~Reference

| Test Mode | Antenna | Freq(MHz) | Freq Range [MHz] | RefLevel [dBm] | Result [dBm] | Limit [dBm] | Verdict |
|---|---|---|---|---|---|---|---|
| | | 2441 | Reference | -4.73 | -4.73 | --- | PASS |

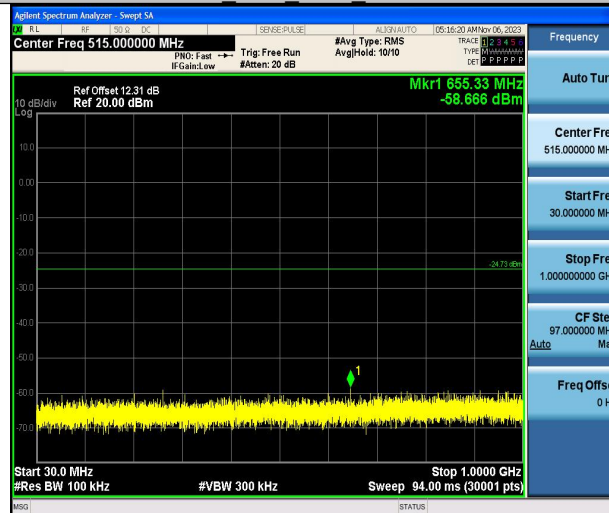
## DH5\_Ant1\_2441\_30~1000

| Test Mode | Antenna | Freq(MHz) | Freq Range [MHz] | RefLevel [dBm] | Result [dBm] | Limit [dBm] | Verdict |
|---|---|---|---|---|---|---|---|
| | | | 30~1000 | -4.73 | -58.67 | $\leq -24.73$ | PASS |

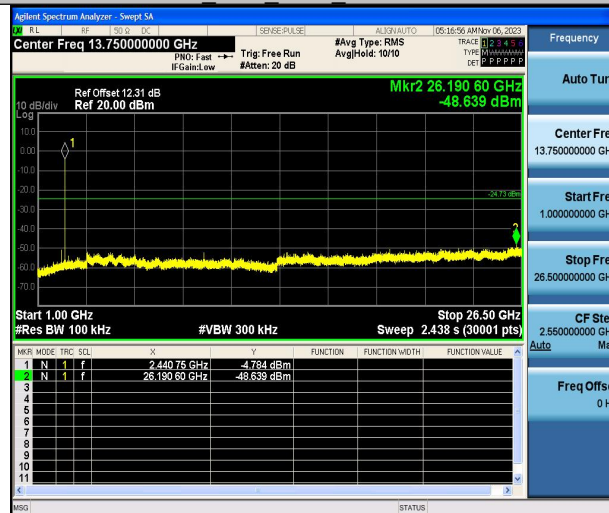
## DH5\_Ant1\_2441\_1000~26500

| Test Mode | Antenna | Freq(MHz) | Freq Range [MHz] | RefLevel [dBm] | Result [dBm] | Limit [dBm] | Verdict |
|---|---|---|---|---|---|---|---|
| | | | 1000~26500 | -4.73 | -48.64 | $\leq -24.73$ | PASS |

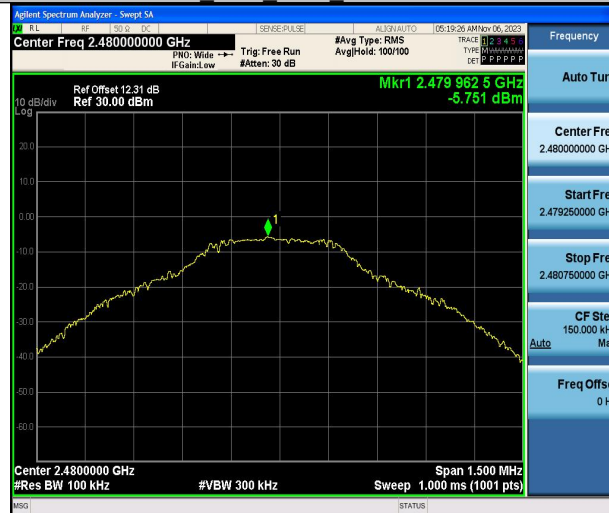
## DH5\_Ant1\_2480\_0~Reference

| Test Mode | Antenna | Freq(MHz) | Freq Range [MHz] | RefLevel [dBm] | Result [dBm] | Limit [dBm] | Verdict |
|---|---|---|---|---|---|---|---|
| | | 2480 | Reference | -5.75 | -5.75 | --- | PASS |

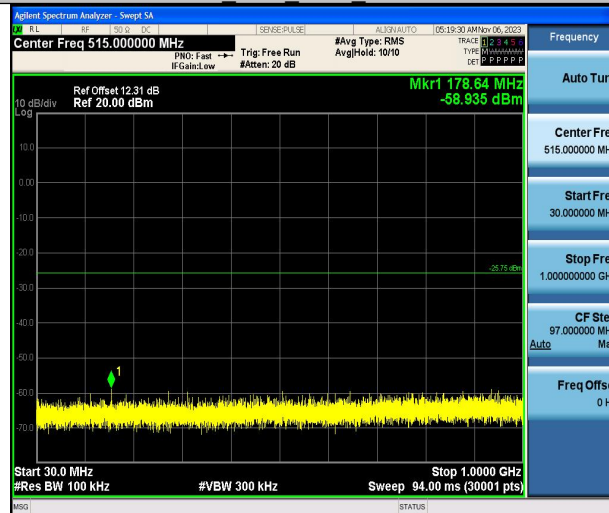
## DH5\_Ant1\_2480\_30~1000

| Test Mode | Antenna | Freq(MHz) | Freq Range [MHz] | RefLevel [dBm] | Result [dBm] | Limit [dBm] | Verdict |
|---|---|---|---|---|---|---|---|
| | | | 30~1000 | -5.75 | -58.94 | $\leq -25.75$ | PASS |

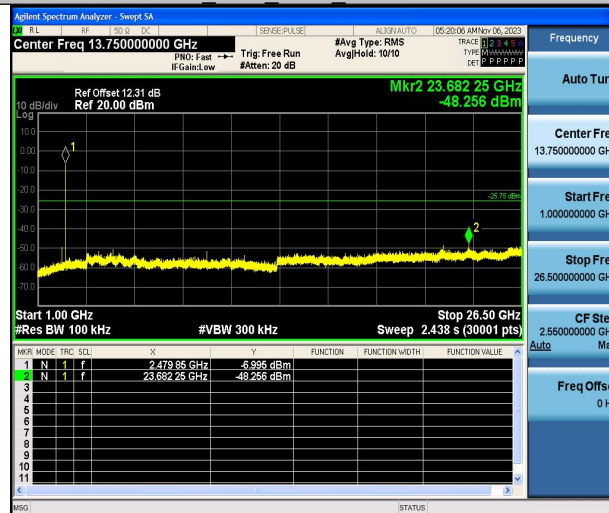
## DH5\_Ant1\_2480\_1000~26500

| Test Mode | Antenna | Freq(MHz) | Freq Range [MHz] | RefLevel [dBm] | Result [dBm] | Limit [dBm] | Verdict |
|---|---|---|---|---|---|---|---|
| | | | 1000~26500 | -5.75 | -48.26 | $\leq -25.75$ | PASS |

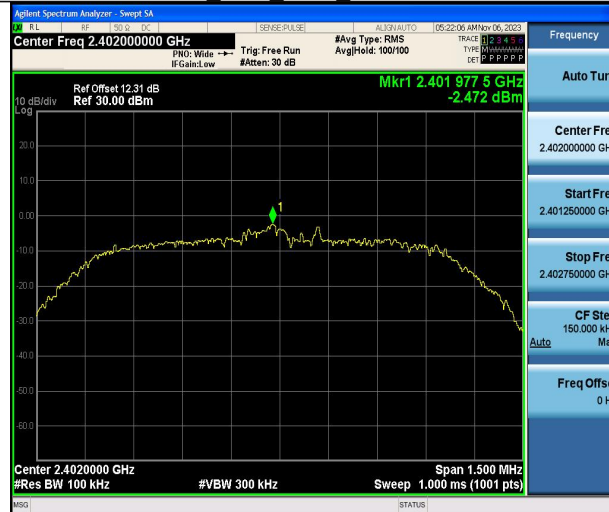
## 2DH5\_Ant1\_2402\_0~Reference

| Test Mode | Antenna | Freq(MHz) | Freq Range [MHz] | RefLevel [dBm] | Result [dBm] | Limit [dBm] | Verdict |
|---|---|---|---|---|---|---|---|
| 2DH5 | Ant1 | 2402 | Reference | -2.47 | -2.47 | --- | PASS |

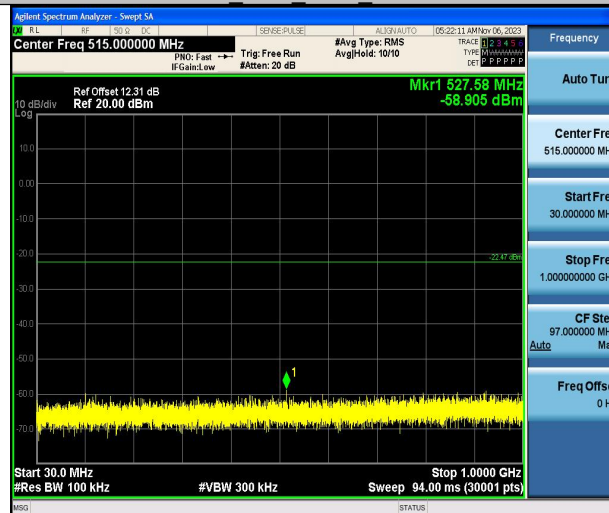
## 2DH5\_Ant1\_2402\_30~1000

| Test Mode | Antenna | Freq(MHz) | Freq Range [MHz] | RefLevel [dBm] | Result [dBm] | Limit [dBm] | Verdict |
|---|---|---|---|---|---|---|---|
| | | | 30~1000 | -2.47 | -58.91 | $\leq -22.47$ | PASS |

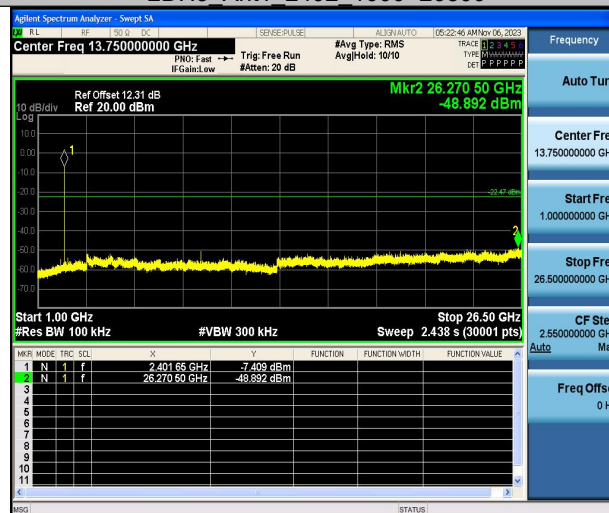
## 2DH5\_Ant1\_2402\_1000~26500

| Test Mode | Antenna | Freq(MHz) | Freq Range [MHz] | RefLevel [dBm] | Result [dBm] | Limit [dBm] | Verdict |
|---|---|---|---|---|---|---|---|
| | | | 1000~26500 | -2.47 | -48.89 | $\leq -22.47$ | PASS |

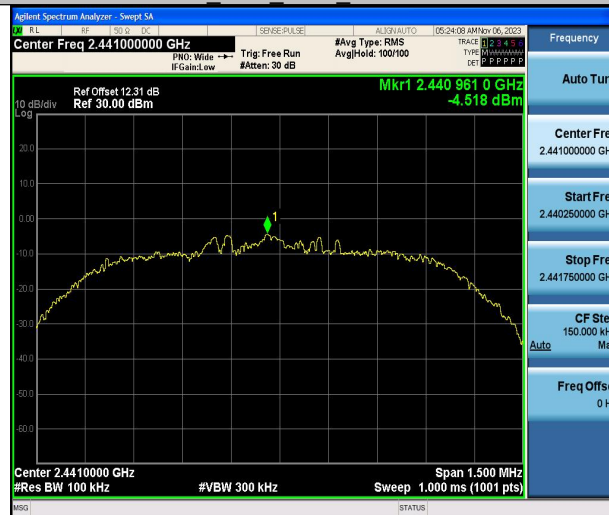
## 2DH5 Ant1 2441 0~Reference

| Test Mode | Antenna | Freq(MHz) | Freq Range [MHz] | RefLevel [dBm] | Result [dBm] | Limit [dBm] | Verdict |
|---|---|---|---|---|---|---|---|
| | | 2441 | Reference | -4.52 | -4.52 | --- | PASS |

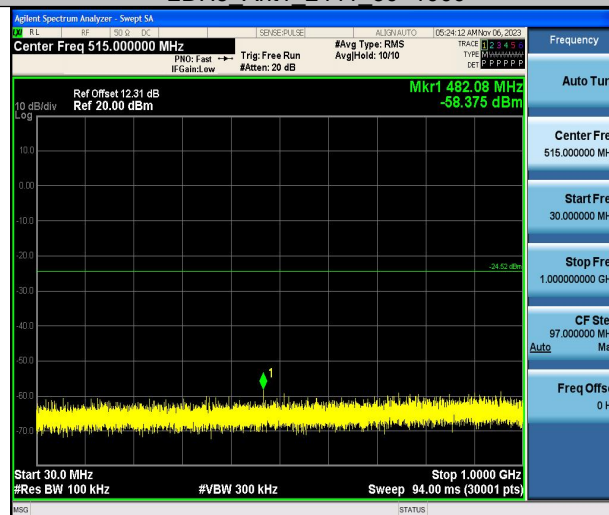
## 2DH5 Ant1 2441 30~1000

| Test Mode | Antenna | Freq(MHz) | Freq Range [MHz] | RefLevel [dBm] | Result [dBm] | Limit [dBm] | Verdict |
|---|---|---|---|---|---|---|---|
| | | | 30~1000 | -4.52 | -58.38 | $\leq -24.52$ | PASS |

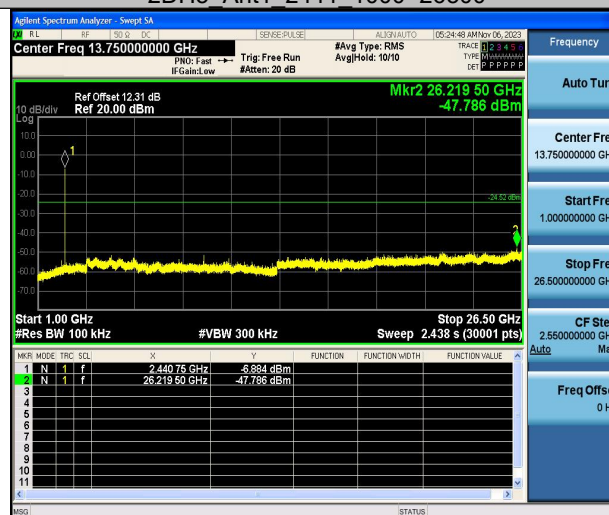
## 2DH5 Ant1 2441 1000~26500

| Test Mode | Antenna | Freq(MHz) | Freq Range [MHz] | RefLevel [dBm] | Result [dBm] | Limit [dBm] | Verdict |
|---|---|---|---|---|---|---|---|
| | | | 1000~26500 | -4.52 | -47.79 | $\leq -24.52$ | PASS |

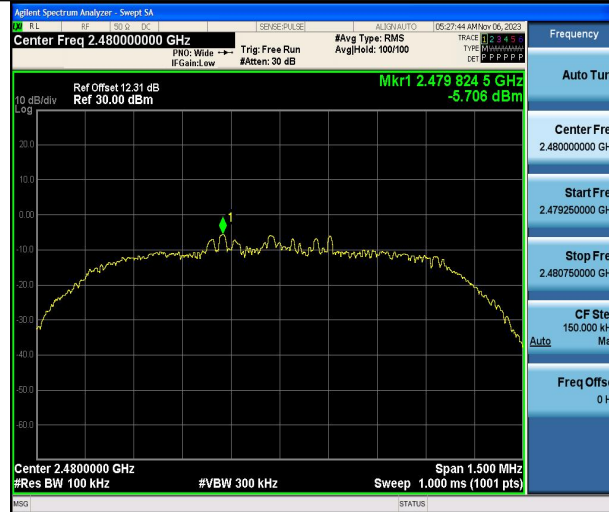
## 2DH5 Ant1 2480 0~Reference

| Test Mode | Antenna | Freq(MHz) | Freq Range [MHz] | RefLevel [dBm] | Result [dBm] | Limit [dBm] | Verdict |
|---|---|---|---|---|---|---|---|
| | | 2480 | Reference | -5.71 | -5.71 | --- | PASS |

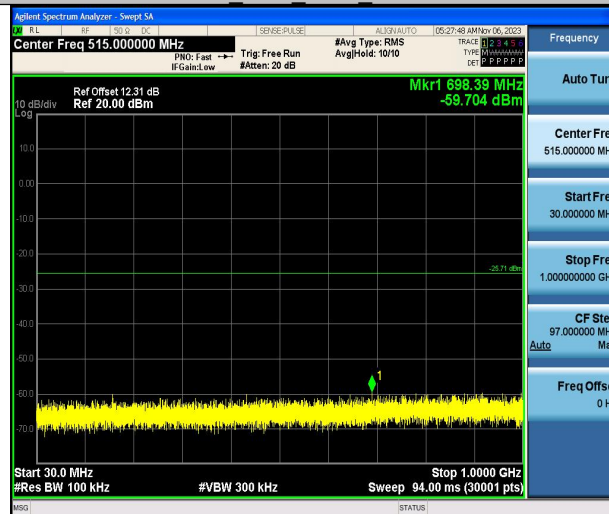
## 2DH5 Ant1 2480 30~1000

| Test Mode | Antenna | Freq(MHz) | Freq Range [MHz] | RefLevel [dBm] | Result [dBm] | Limit [dBm] | Verdict |
|---|---|---|---|---|---|---|---|
| | | | 30~1000 | -5.71 | -59.7 | $\leq -25.71$ | PASS |

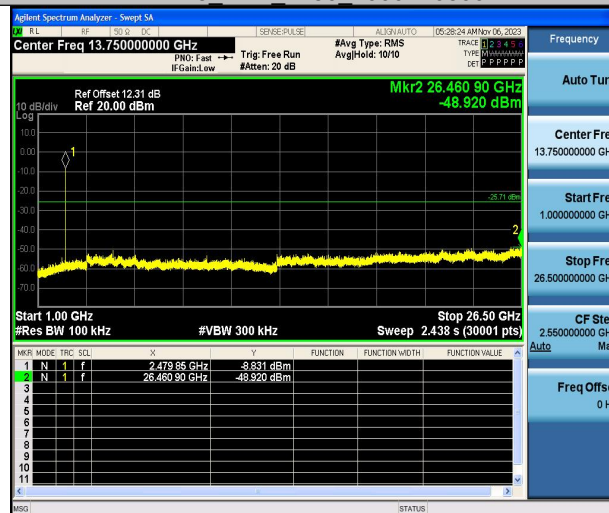
## 2DH5 Ant1 2480 1000~26500

| Test Mode | Antenna | Freq(MHz) | Freq Range [MHz] | RefLevel [dBm] | Result [dBm] | Limit [dBm] | Verdict |
|---|---|---|---|---|---|---|---|
| | | | 1000~26500 | -5.71 | -48.92 | $\leq -25.71$ | PASS |
