## 802.11g

## 5 Test Setup Photos of the EUT

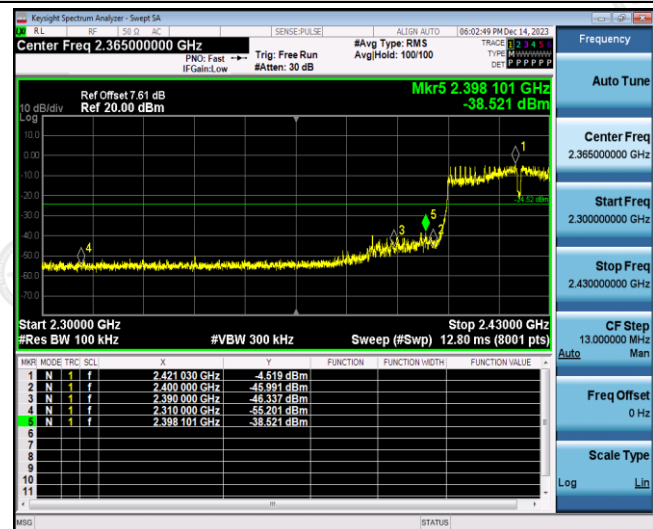
**Band-edge Measurements for RF Conducted Emissions:**

Left bandedge
