## Appendix G: Conducted Spurious Emission Test Result

## Appendix H: Reference level measurement Test Result

## 14. TEST SETUP PHOTO

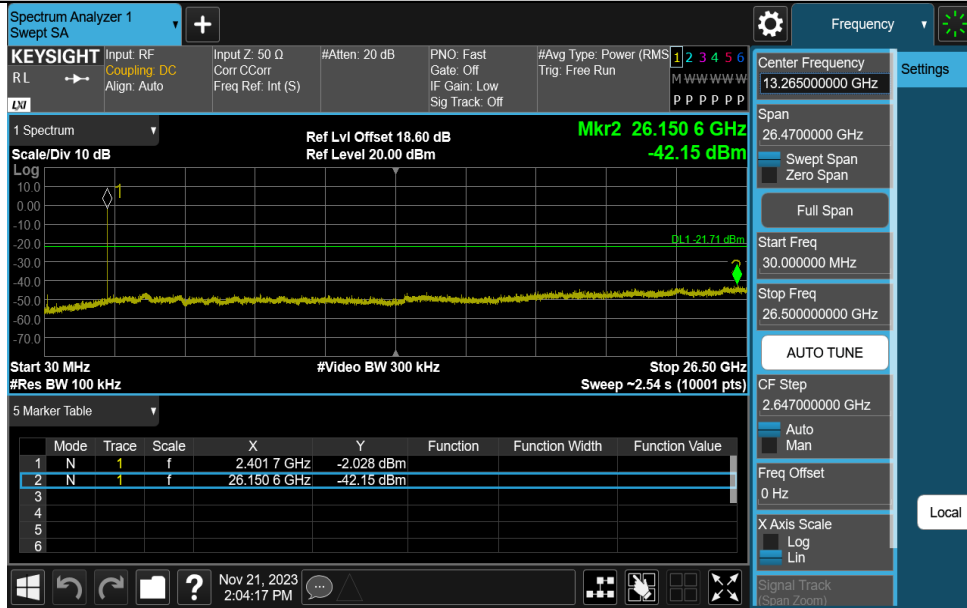
### DH5-Ant1-2402-30~26500-PASS

| Test Mode | Antenna | Frequency[MHz] | FreqRange<br>[MHz] | RefLevel<br>[dBm] | Result<br>[dBm] | Limit<br>[dBm] | Verdict |
|---|---|---|---|---|---|---|---|
| DH5 | Ant1 | 2402 | 30~26500 | -1.71 | -42.15 | $\leq -21.71$ | PASS |

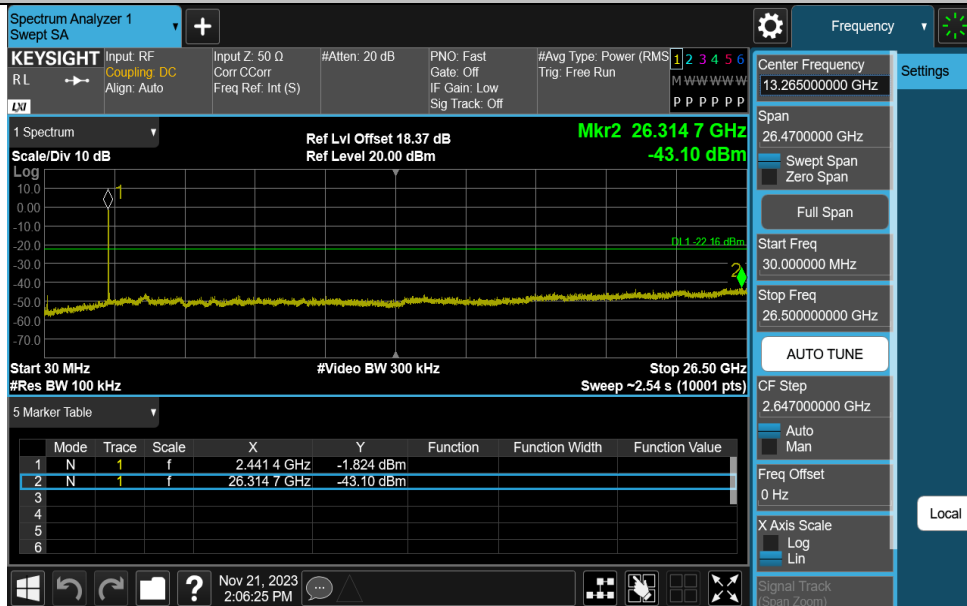
### DH5-Ant1-2441-30~26500-PASS

| Test Mode | Antenna | Frequency[MHz] | FreqRange<br>[MHz] | RefLevel<br>[dBm] | Result<br>[dBm] | Limit<br>[dBm] | Verdict |
|---|---|---|---|---|---|---|---|
| DH5 | Ant1 | 2441 | 30~26500 | -2.16 | -43.1 | $\leq -22.16$ | PASS |

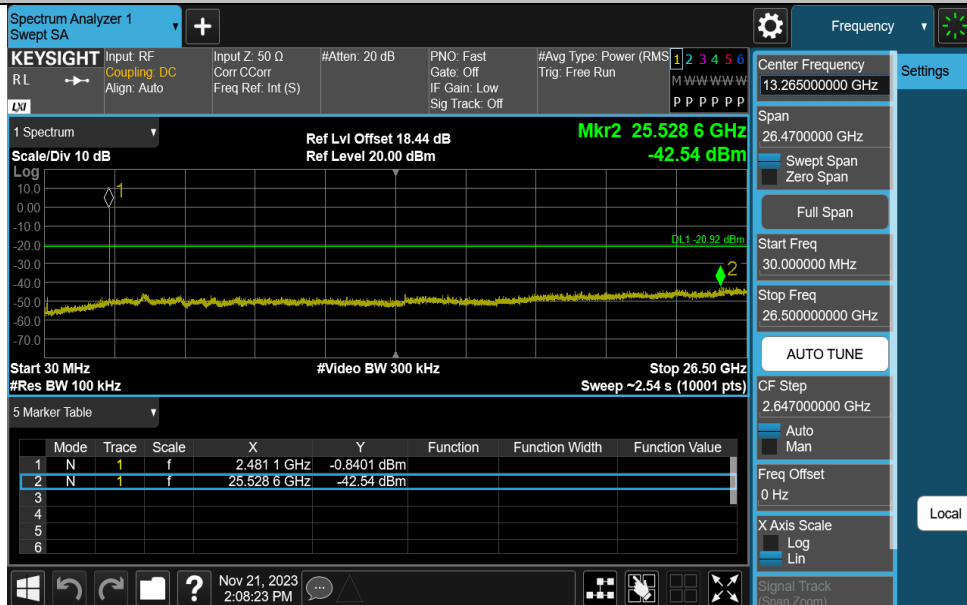
### DH5-Ant1-2480-30~26500-PASS

| Test Mode | Antenna | Frequency[MHz] | FreqRange<br>[MHz] | RefLevel<br>[dBm] | Result<br>[dBm] | Limit<br>[dBm] | Verdict |
|---|---|---|---|---|---|---|---|
| DH5 | Ant1 | 2480 | 30~26500 | -0.92 | -42.54 | $\leq -20.92$ | PASS |

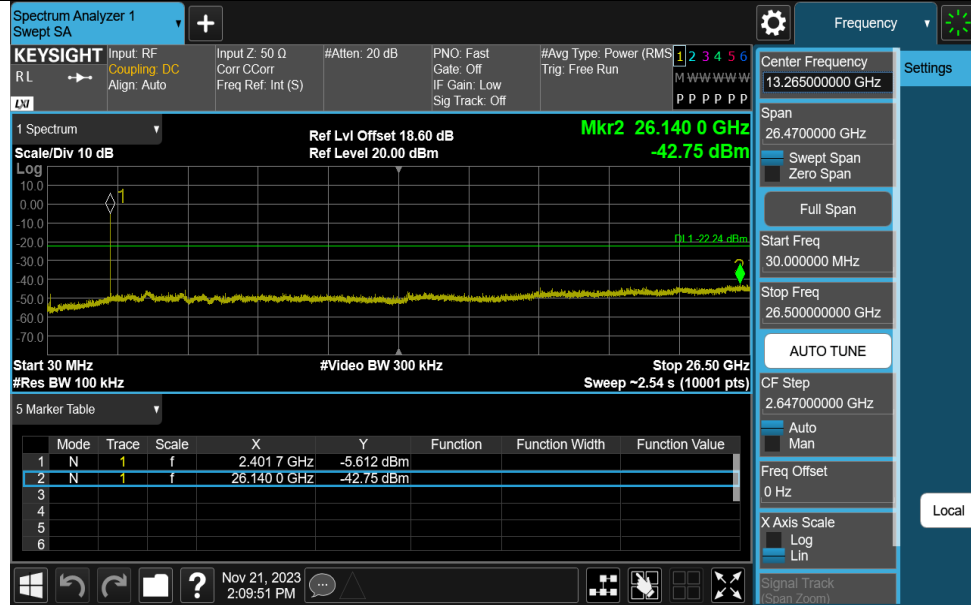
## 2DH5-Ant1-2402-30~26500-PASS

| Test Mode | Antenna | Frequency[MHz] | FreqRange<br>[MHz] | RefLevel<br>[dBm] | Result<br>[dBm] | Limit<br>[dBm] | Verdict |
|---|---|---|---|---|---|---|---|
| 2DH5 | Ant1 | 2402 | 30~26500 | -2.24 | -42.75 | $\leq -22.24$ | PASS |

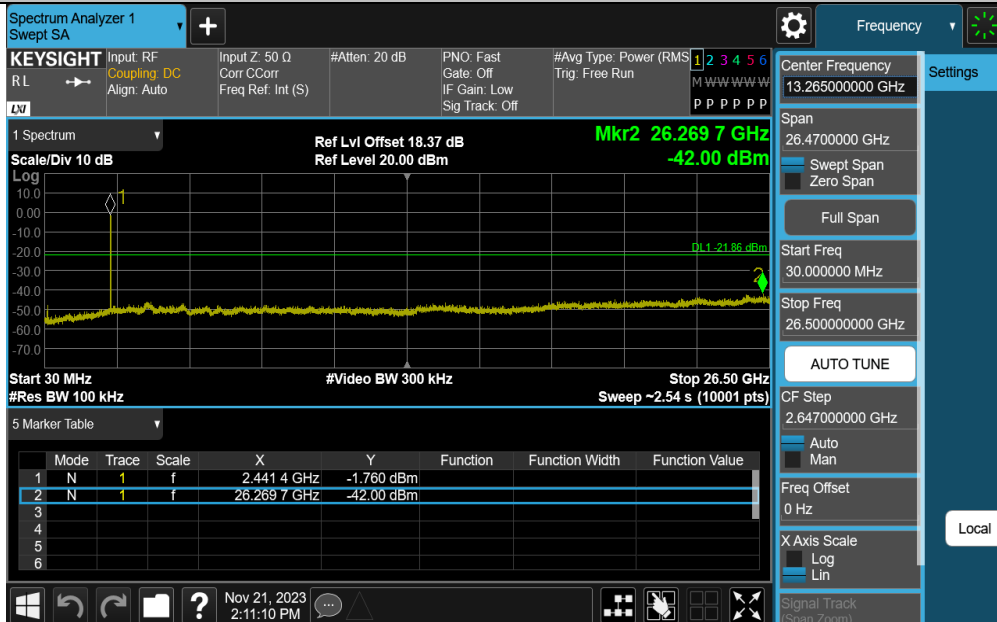
## 2DH5-Ant1-2441-30~26500-PASS

| Test Mode | Antenna | Frequency[MHz] | FreqRange<br>[MHz] | RefLevel<br>[dBm] | Result<br>[dBm] | Limit<br>[dBm] | Verdict |
|---|---|---|---|---|---|---|---|
| 2DH5 | Ant1 | 2441 | 30~26500 | -1.86 | -42.00 | $\leq -21.86$ | PASS |

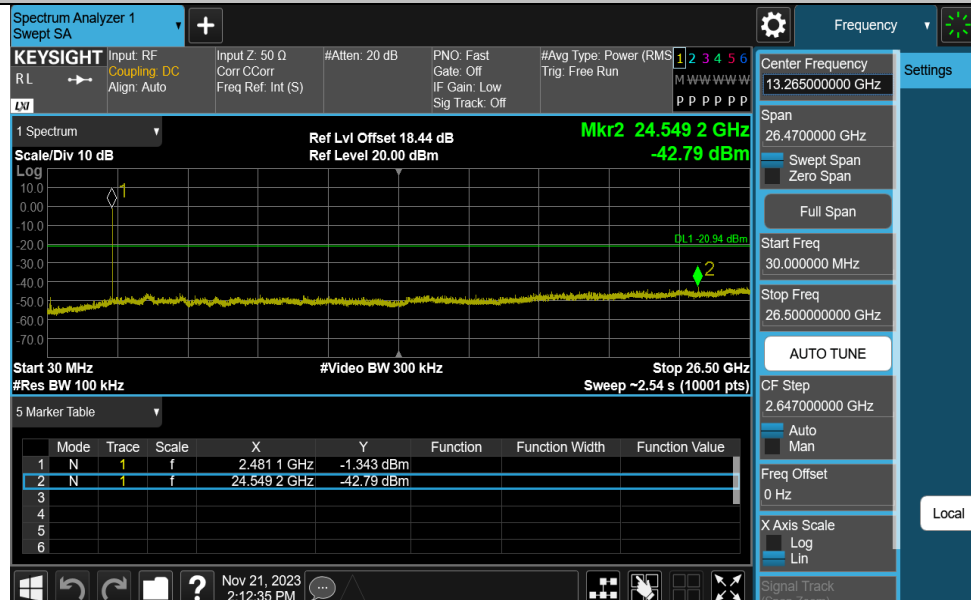
## 2DH5-Ant1-2480-30~26500-PASS

| Test Mode | Antenna | Frequency[MHz] | FreqRange<br>[MHz] | RefLevel<br>[dBm] | Result<br>[dBm] | Limit<br>[dBm] | Verdict |
|---|---|---|---|---|---|---|---|
| 2DH5 | Ant1 | 2480 | 30~26500 | -0.94 | -42.79 | $\leq -20.94$ | PASS |

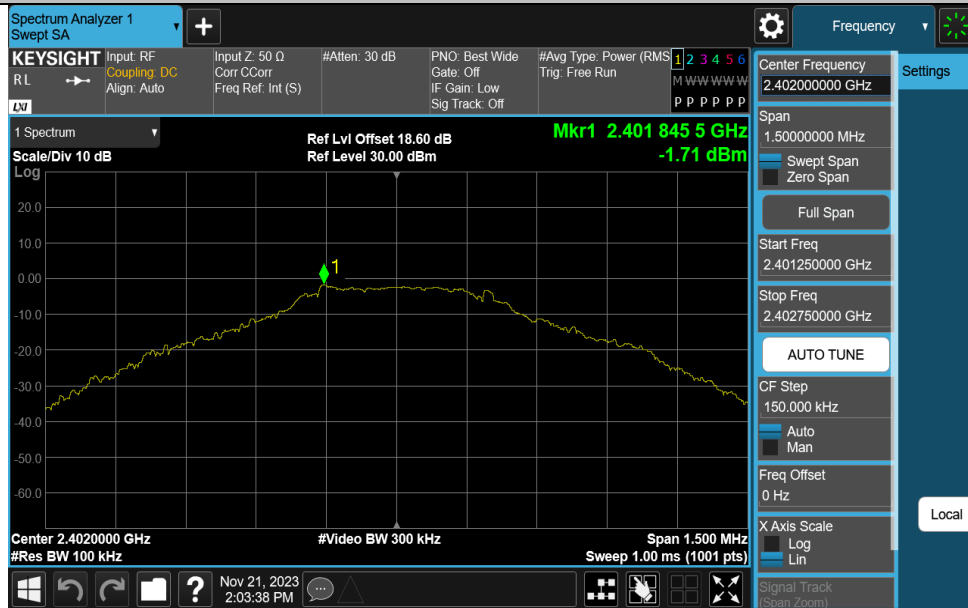
## DH5-Ant1-2402-PASS

| TestMode | Antenna | Freq(MHz) | Max.Point[MHz] | Result[dBm] |
|---|---|---|---|---|
| DH5 | Ant1 | 2402 | 2401.85 | -1.71 |

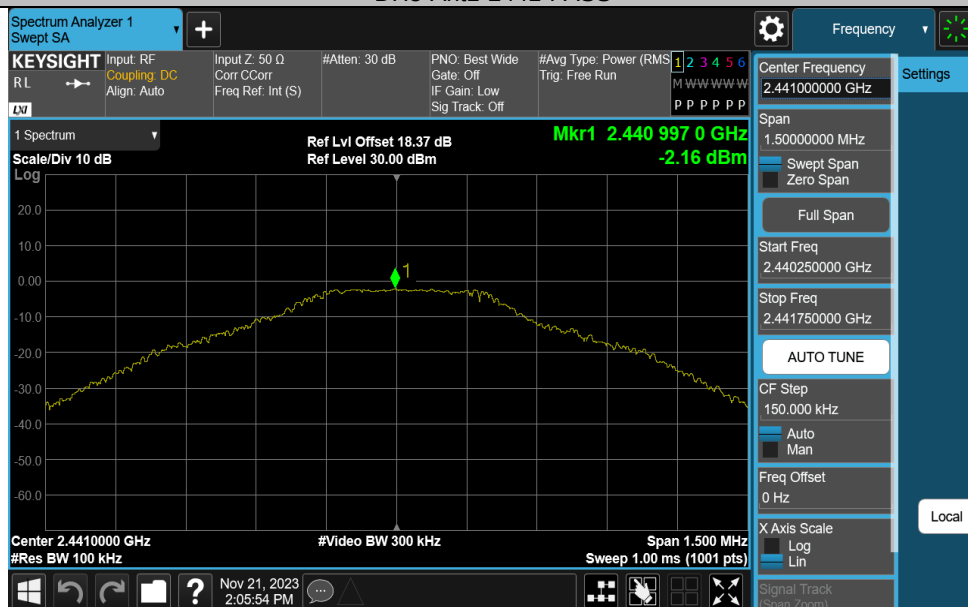
## DH5-Ant1-2441-PASS

| TestMode | Antenna | Freq(MHz) | Max.Point[MHz] | Result[dBm] |
|---|---|---|---|---|
| DH5 | Ant1 | 2441 | 2441.00 | -2.16 |

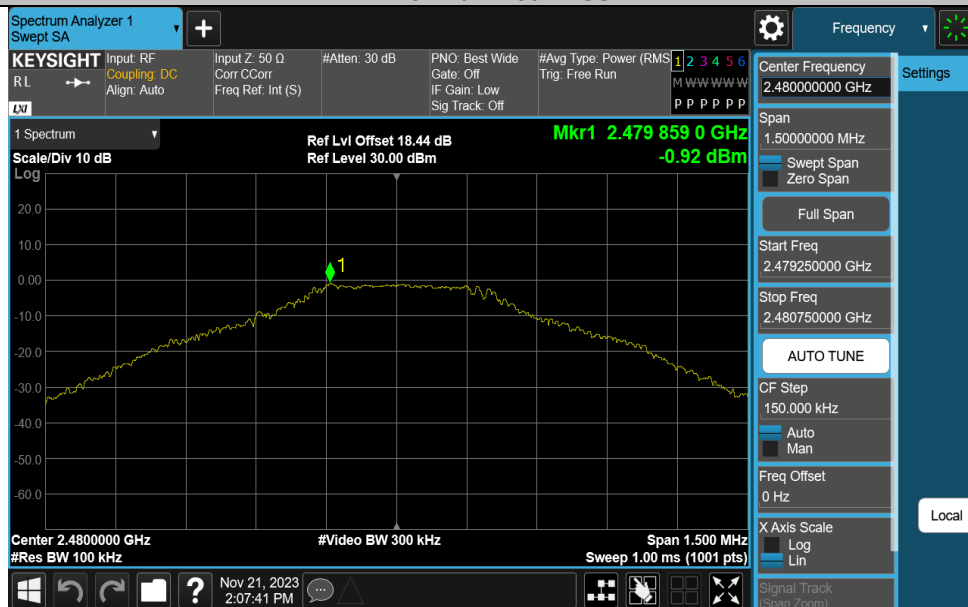
## DH5-Ant1-2480-PASS

| TestMode | Antenna | Freq(MHz) | Max.Point[MHz] | Result[dBm] |
|---|---|---|---|---|
| DH5 | Ant1 | 2480 | 2479.86 | -0.92 |

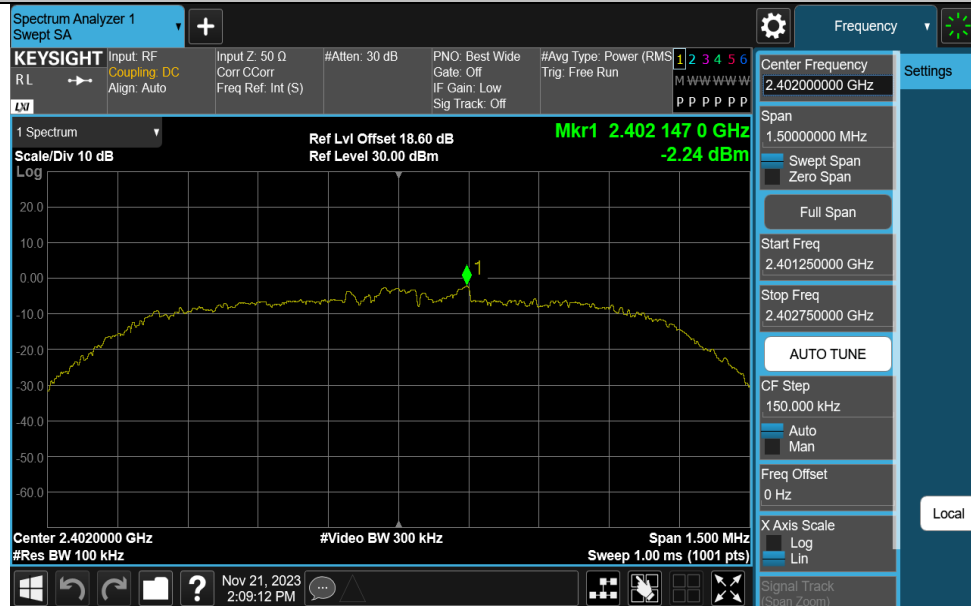
### 2DH5-Ant1-2402-PASS

| TestMode | Antenna | Freq(MHz) | Max.Point[MHz] | Result[dBm] |
|---|---|---|---|---|
| 2DH5 | Ant1 | 2402 | 2402.15 | -2.24 |

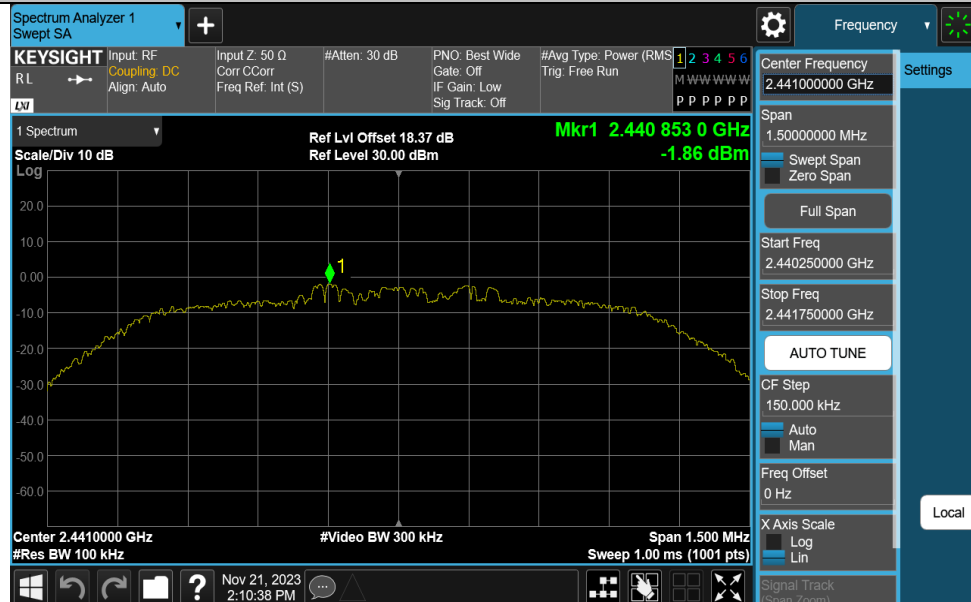
### 2DH5-Ant1-2441-PASS

| TestMode | Antenna | Freq(MHz) | Max.Point[MHz] | Result[dBm] |
|---|---|---|---|---|
| 2DH5 | Ant1 | 2441 | 2440.85 | -1.86 |

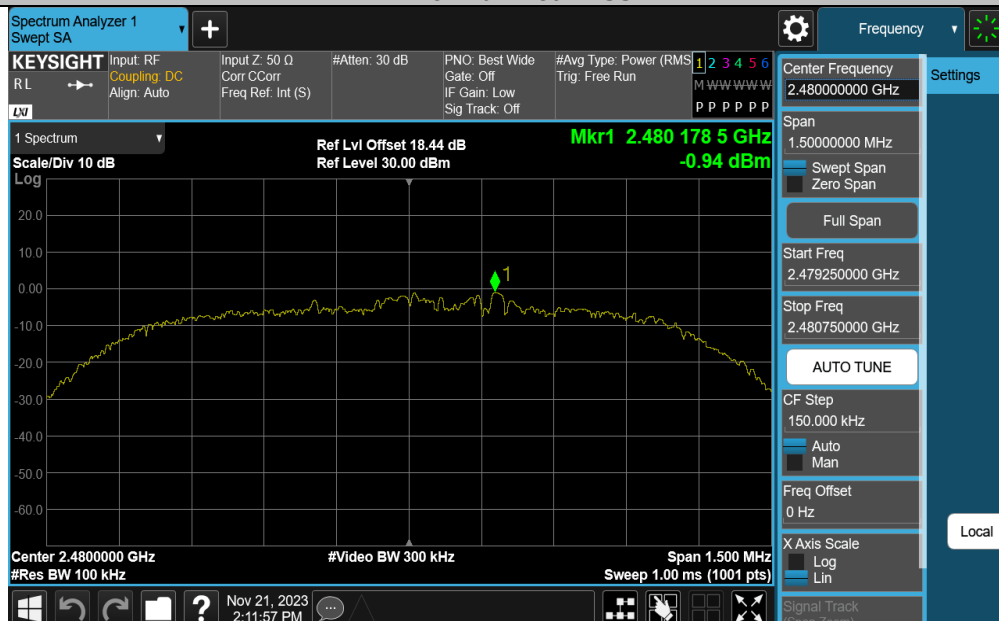
### 2DH5-Ant1-2480-PASS

| TestMode | Antenna | Freq(MHz) | Max.Point[MHz] | Result[dBm] |
|---|---|---|---|---|
| 2DH5 | Ant1 | 2480 | 2480.18 | -0.94 |

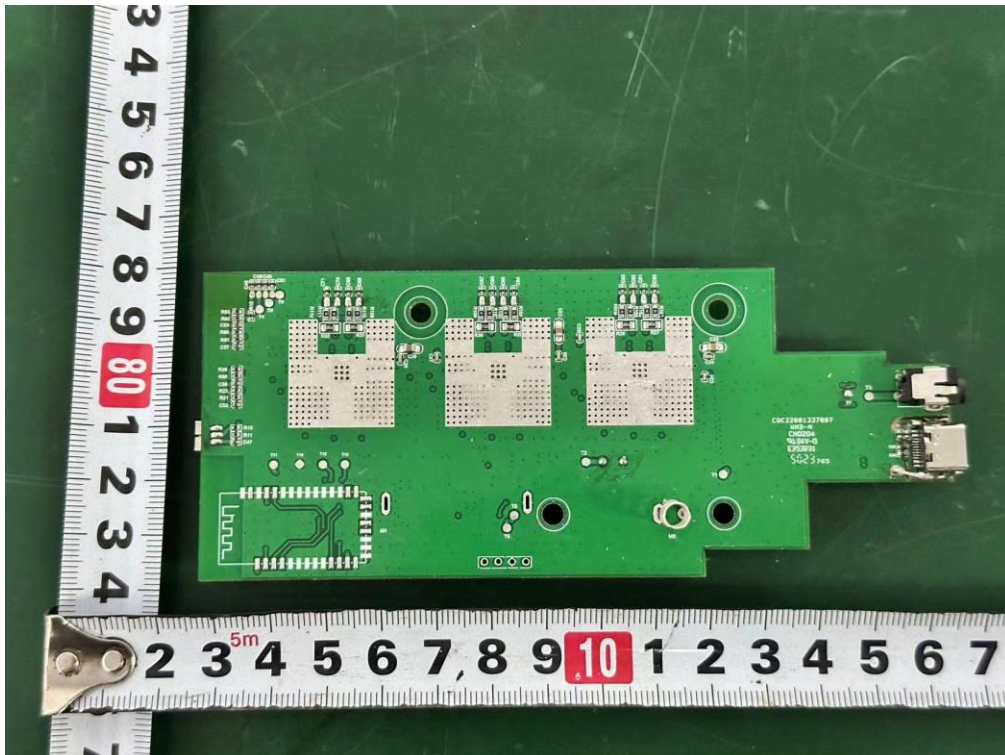
Bluetooth  
Antenna
