US Tech Test Report:
FCC ID:
IC:
Test Report Number:
Issue Date:
Customer:
Model:

FCC Part 15.247 Certification
2BFVO-CAPMDSEN
N/A
24-0113
August 27, 2024
GE Grid Solutions
Cap MD

TEST CONFIGURATION PHOTOGRAPHS

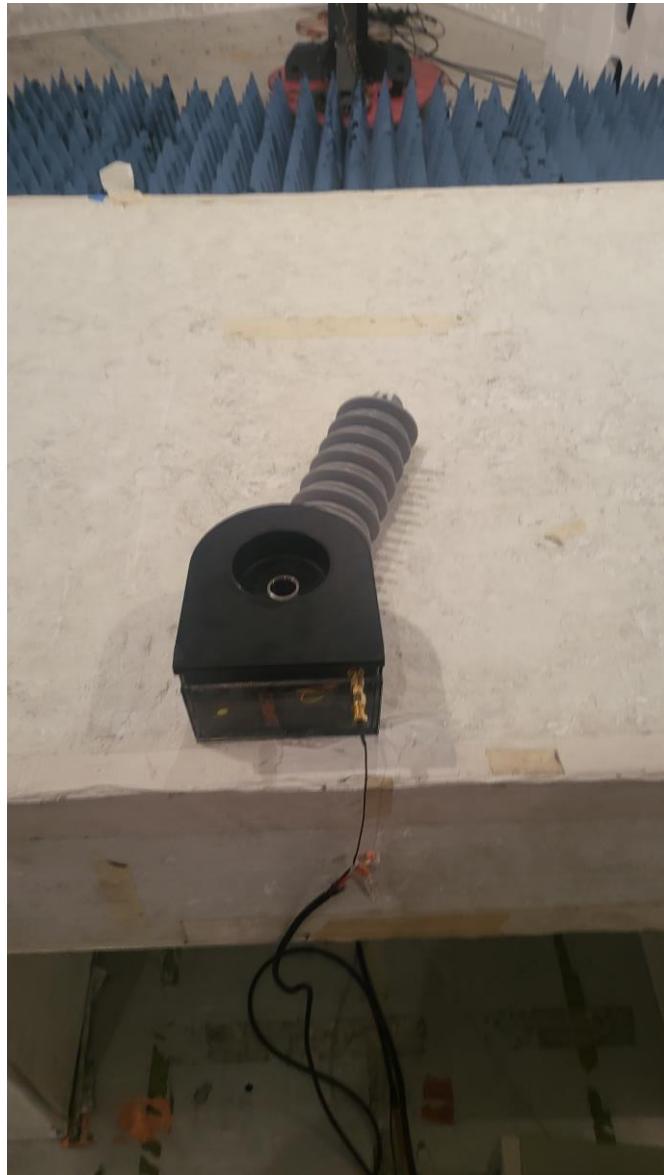
Figure 1. EUT on foam table top

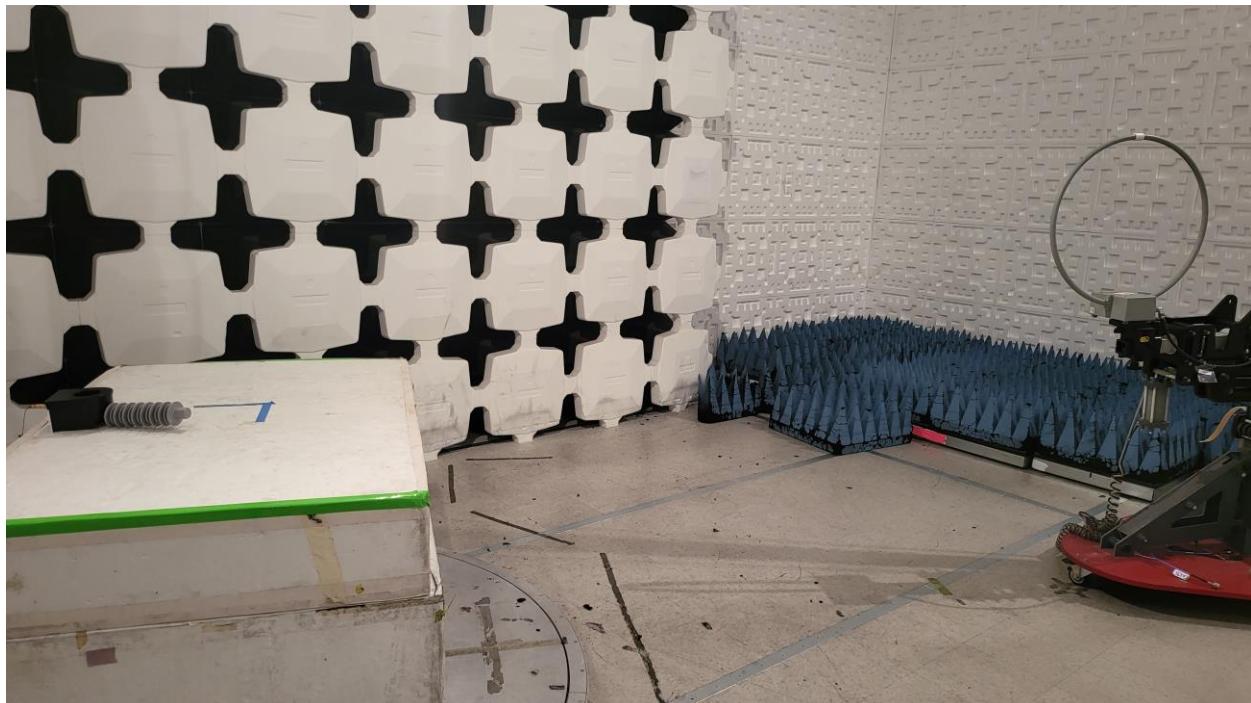
Figure 2. Radiated Emissions Test Setup, .15 MHz to 30 MHz

Note: EUT positioned all three orthogonal orientations during pre-scans. Worst case configuration used for final measurements.

Note: Loop antenna positioned in all three orthogonal positions during testing.

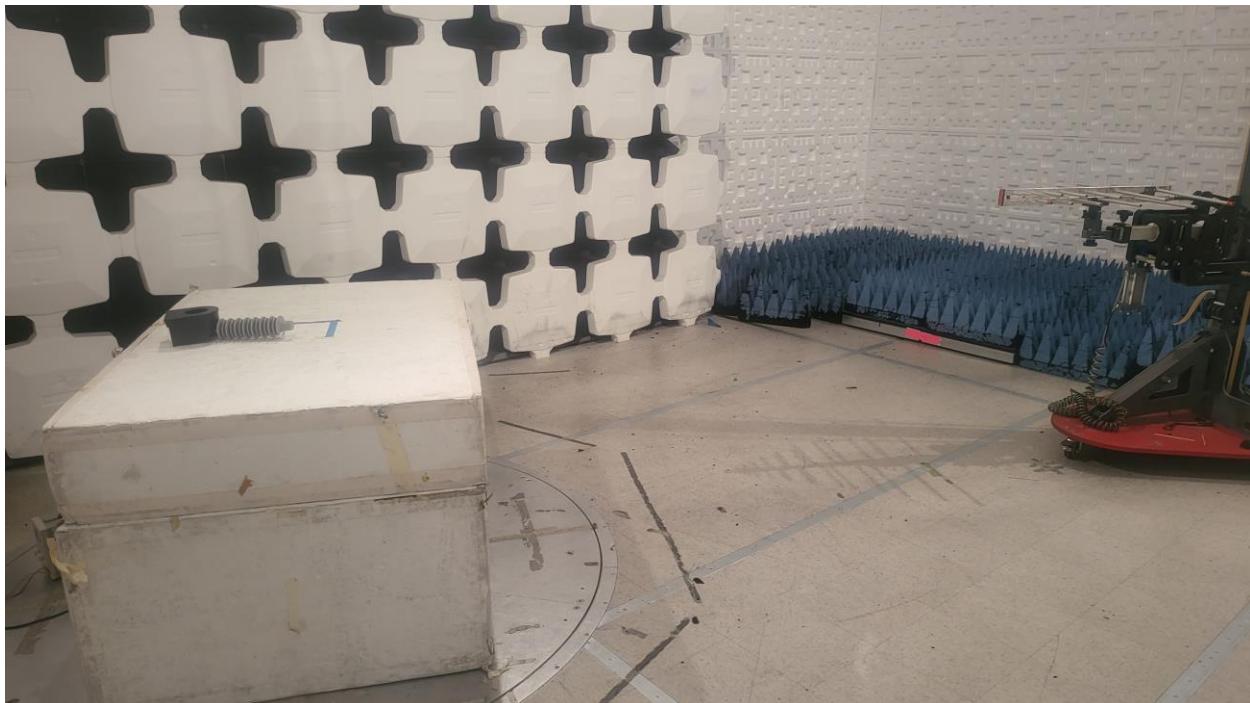
Figure 4. Radiated Emissions Test Setup, 200 MHz to 1GHz

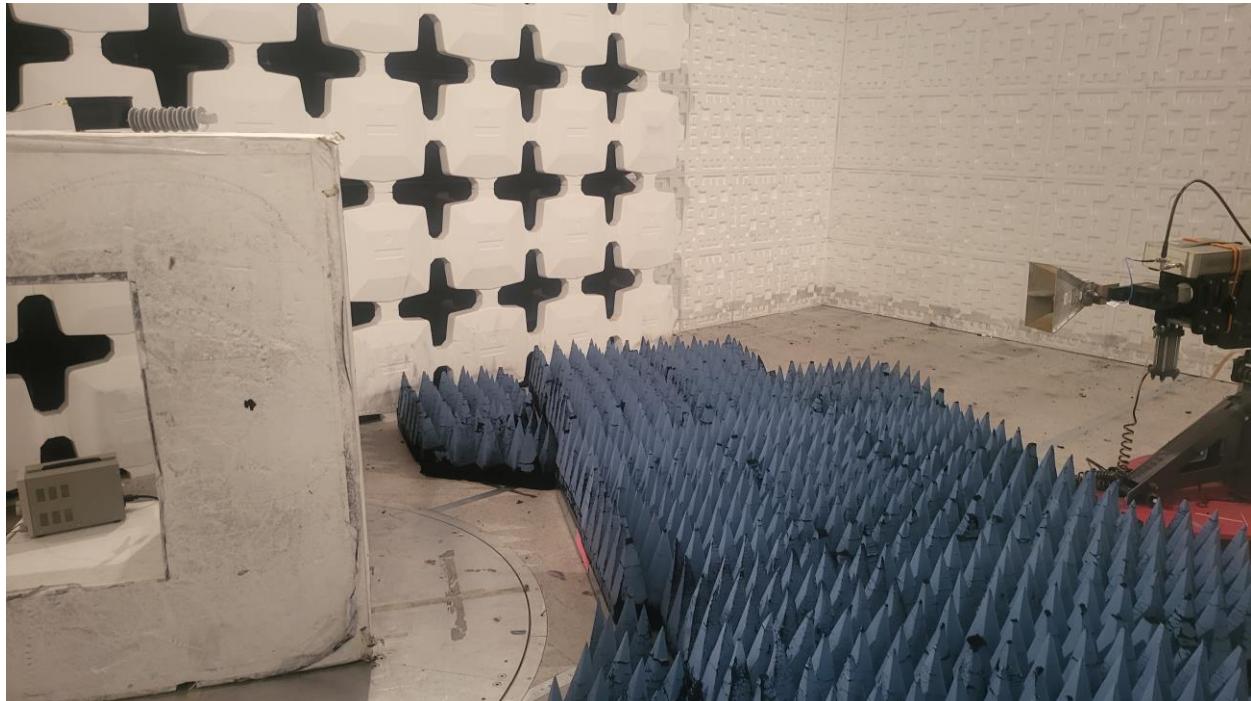
Figure 5. Radiated Emission Test Setup, above 1 GHz
