## Appendix B: photographs of test setup

## Appendix C: photographs of EUT

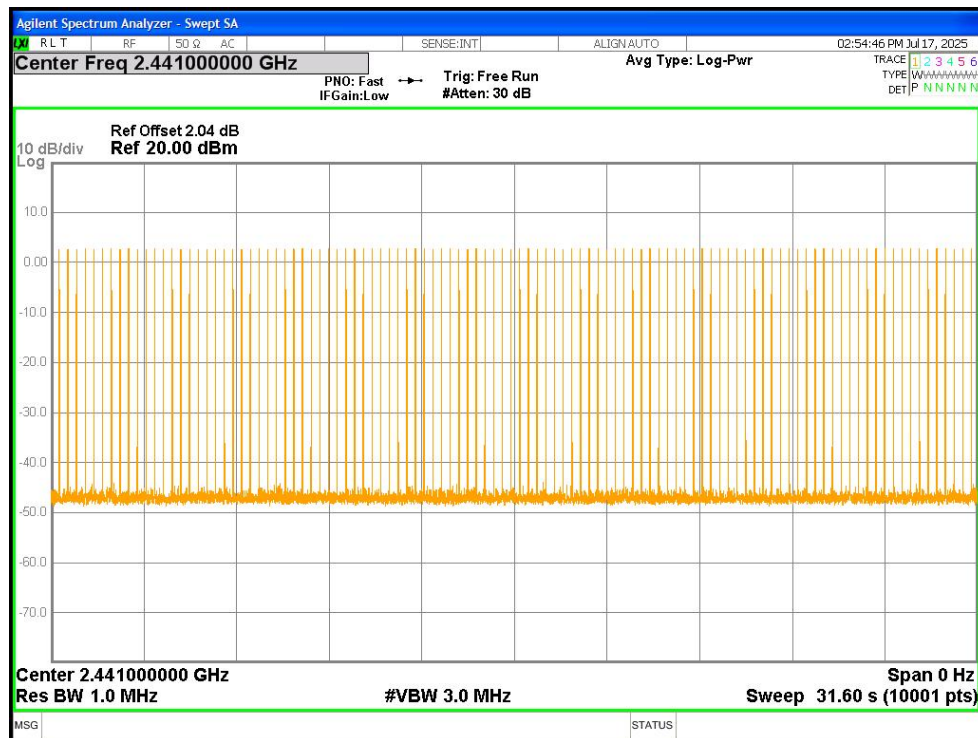
Dwell NVNT 2-DH1 2441MHz Ant1 One Burst

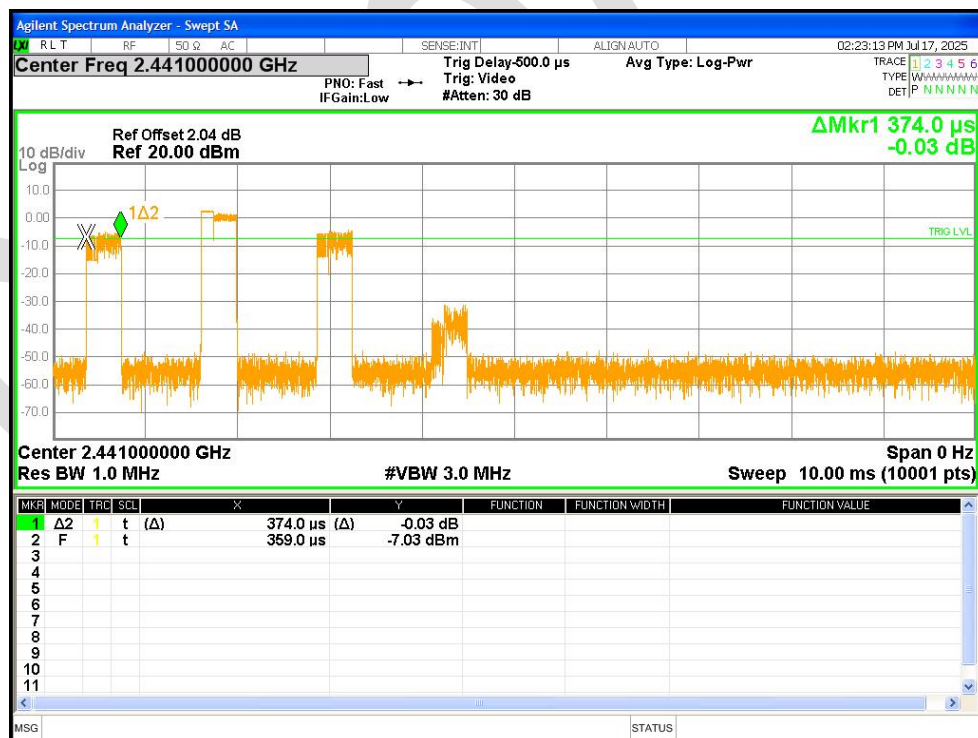
Dwell NVNT 2-DH1 2441MHz Ant1 Accumulated

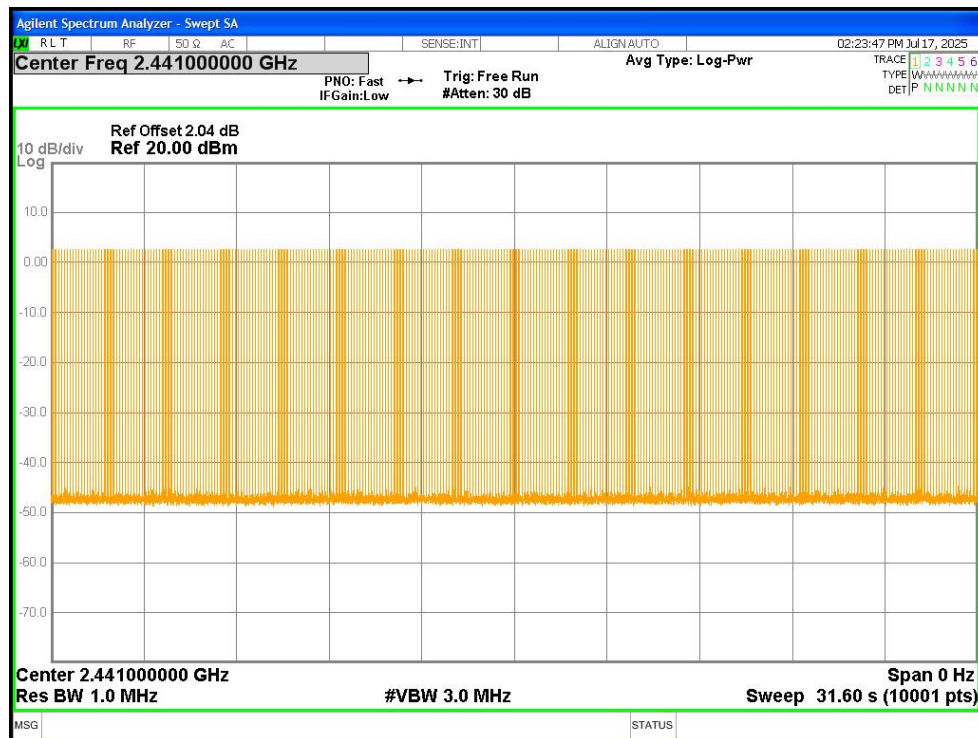
Dwell NVNT 2-DH5 2441MHz Ant1 One Burst

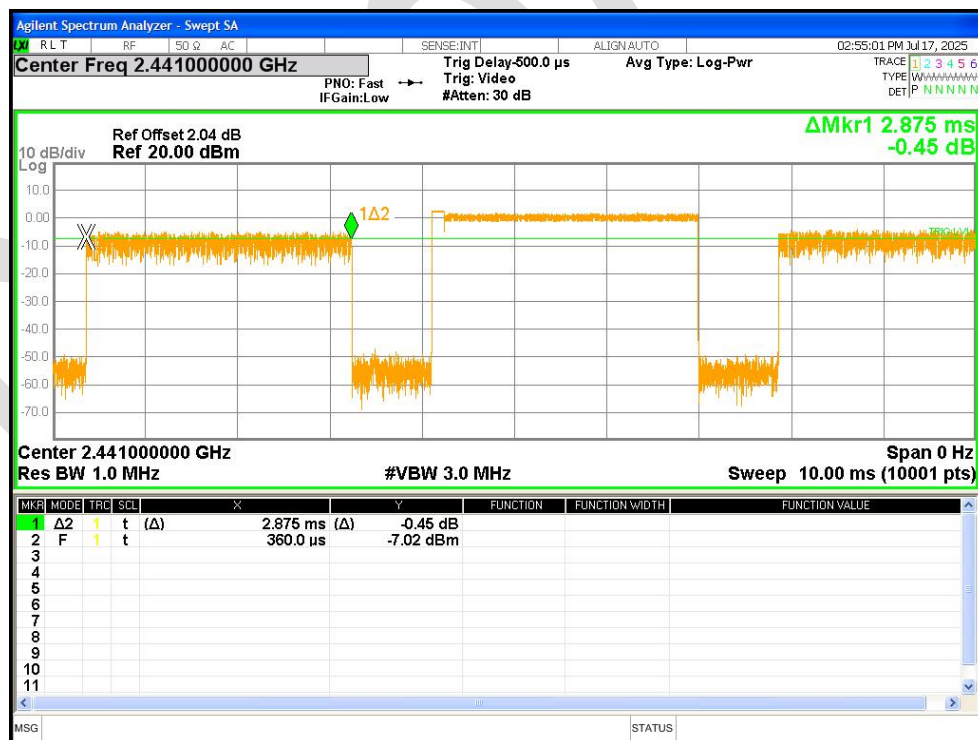
Dwell NVNT 2-DH5 2441MHz Ant1 Accumulated

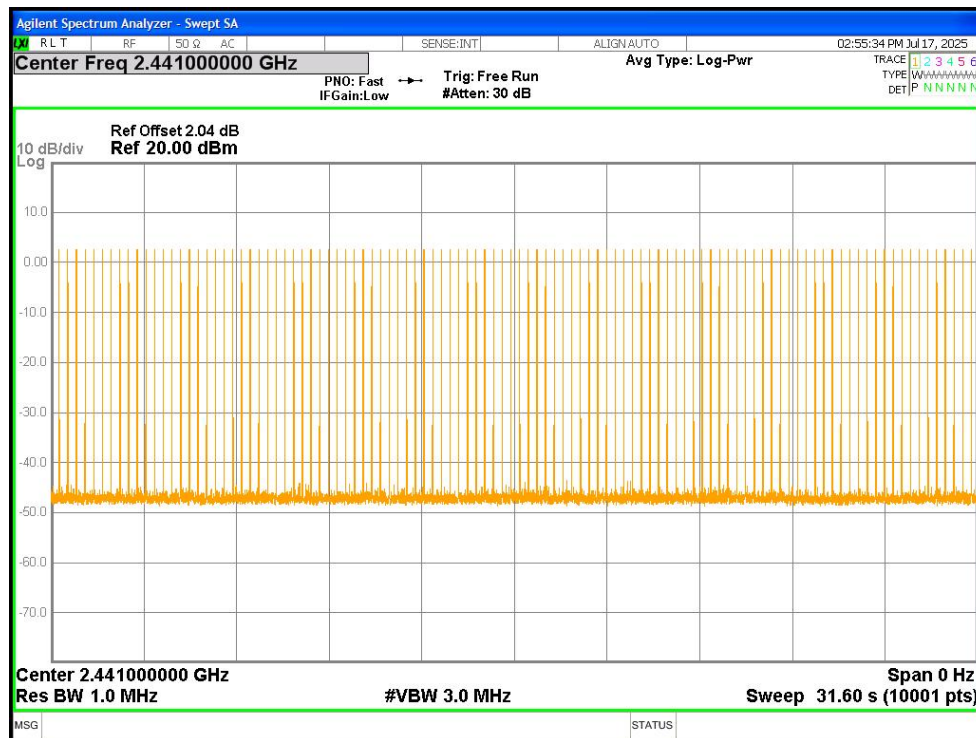
Dwell NVNT 3-DH1 2441MHz Ant1 One Burst

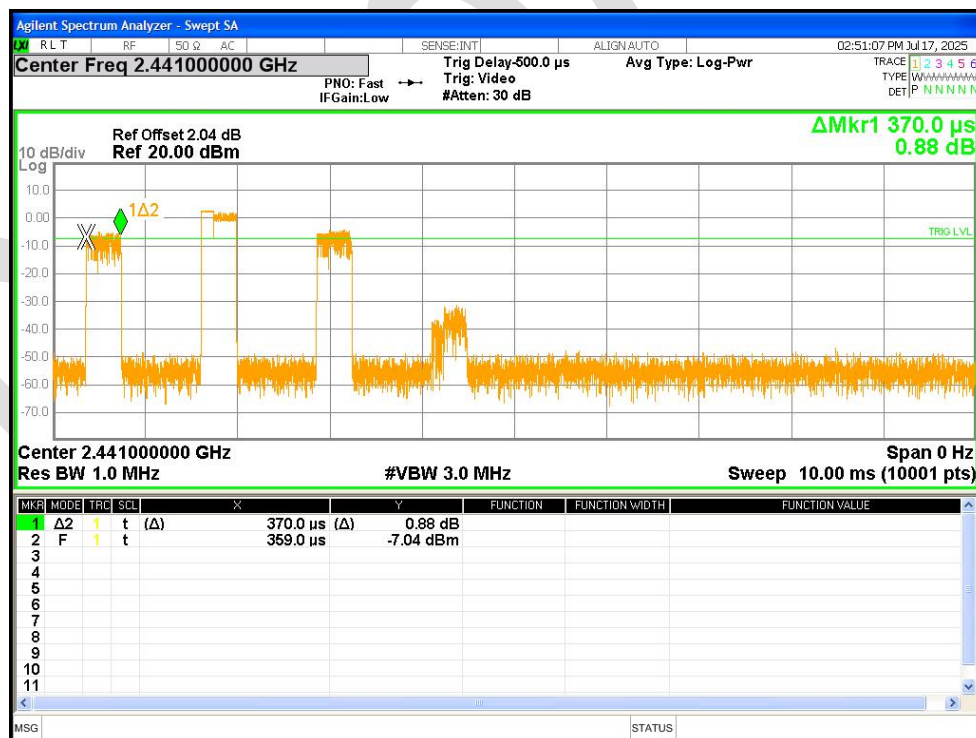
Dwell NVNT 3-DH1 2441MHz Ant1 Accumulated

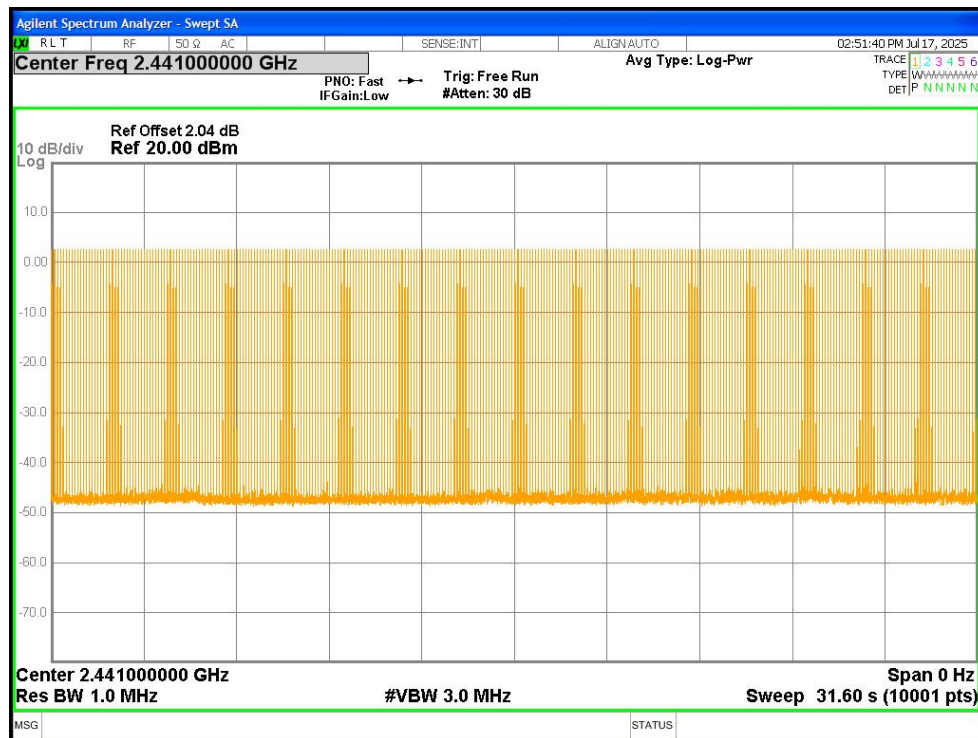
Dwell NVNT 3-DH5 2441MHz Ant1 One Burst

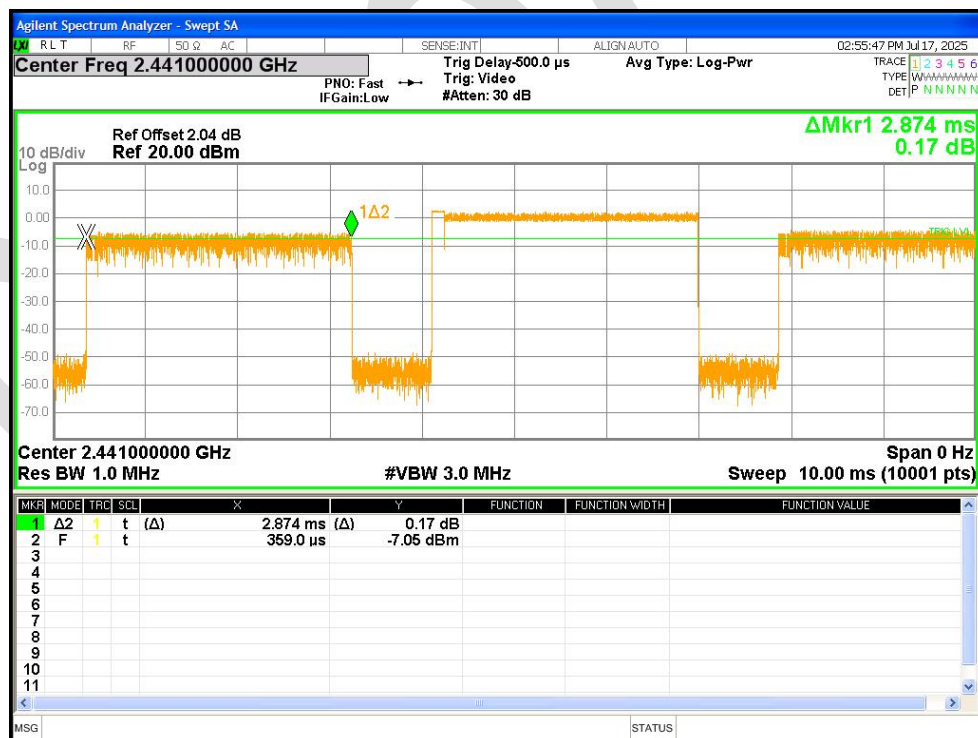
Dwell NVNT 3-DH5 2441MHz Ant1 Accumulated

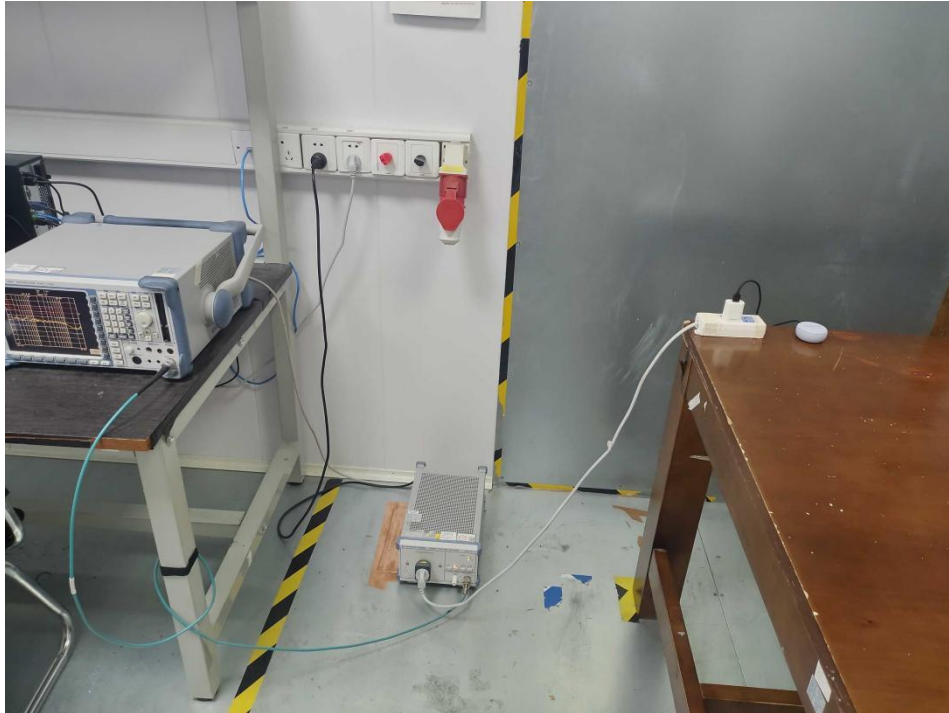
Conducted emissions at AC power line (150kHz-30MHz)

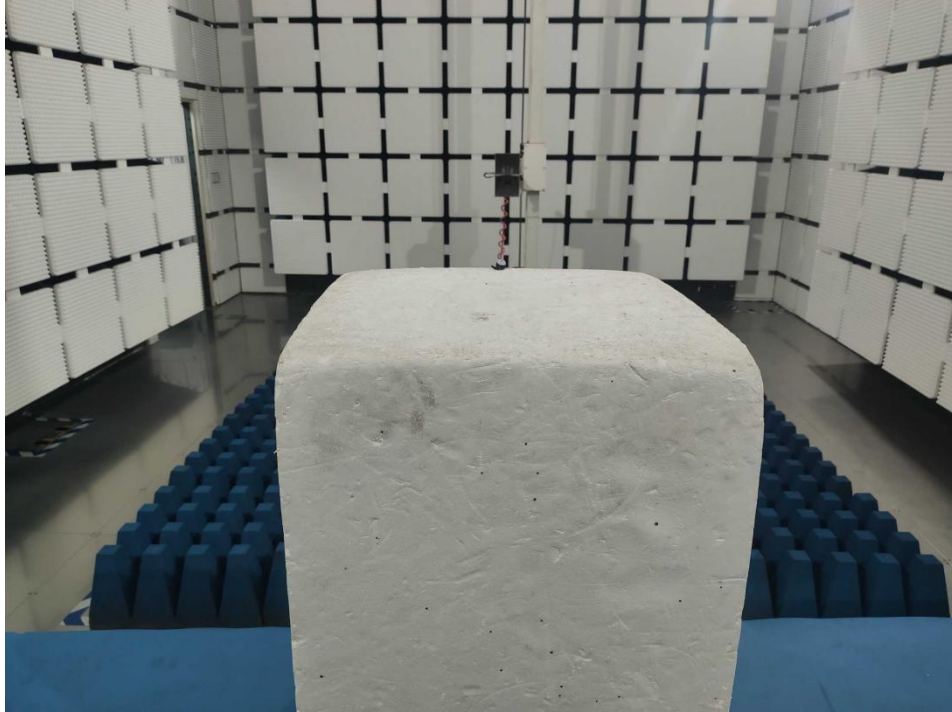
Radiated Emissions (above 1GHz)
