## Appendix B: photographs of test setup

Reference to the test report no. BLA-EMC-202507-A1301

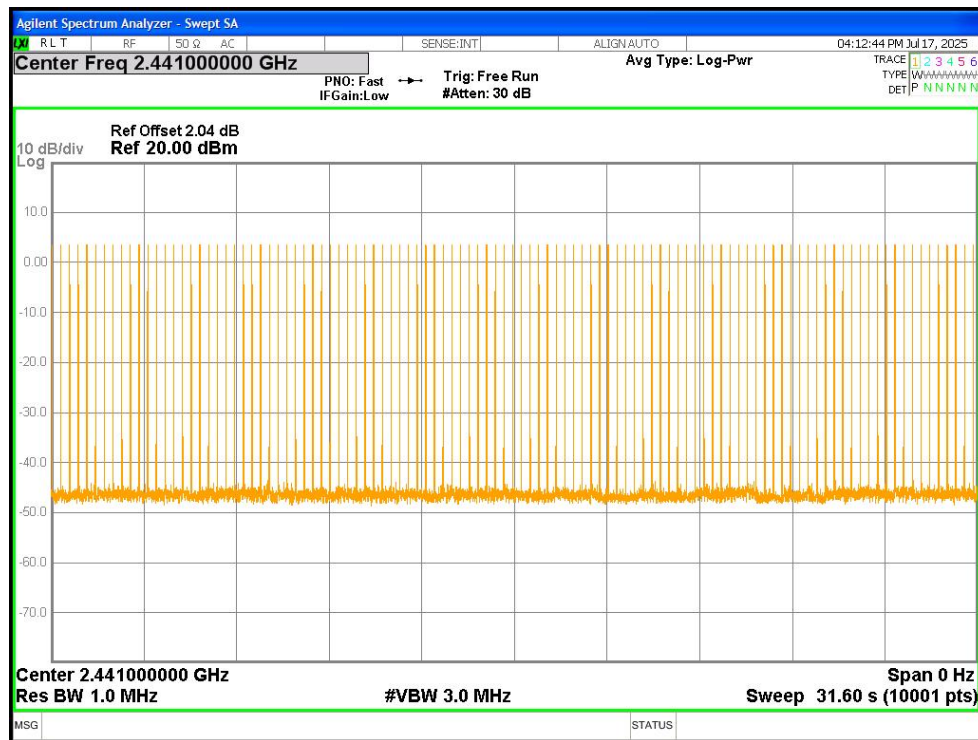
Dwell NVNT 2-DH1 2441MHz Ant1 One Burst

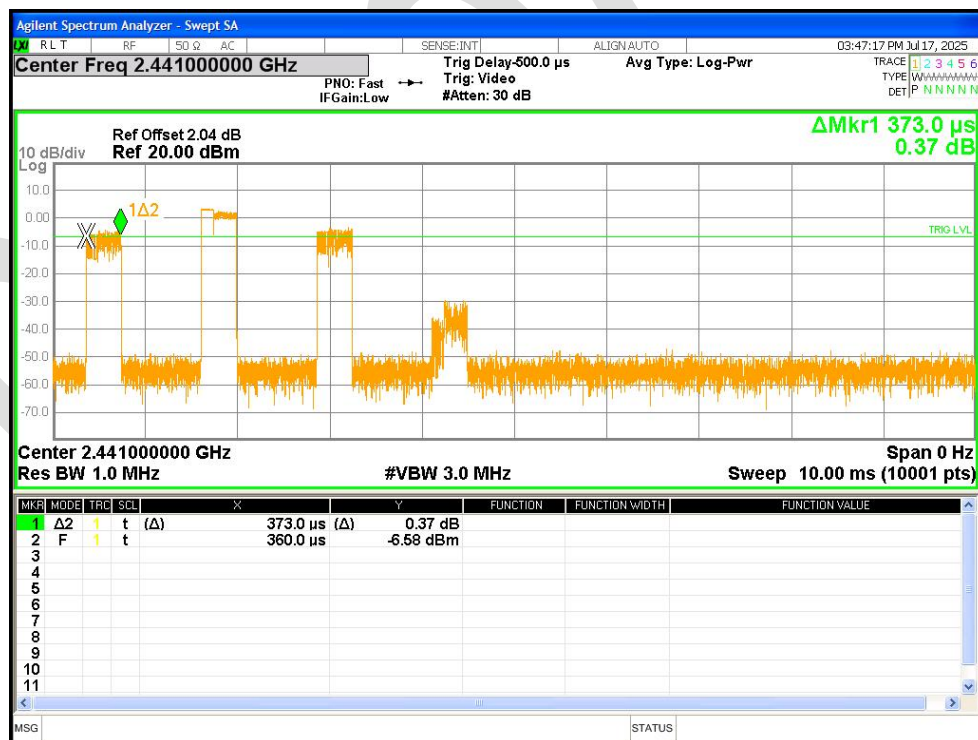
Dwell NVNT 2-DH1 2441MHz Ant1 Accumulated

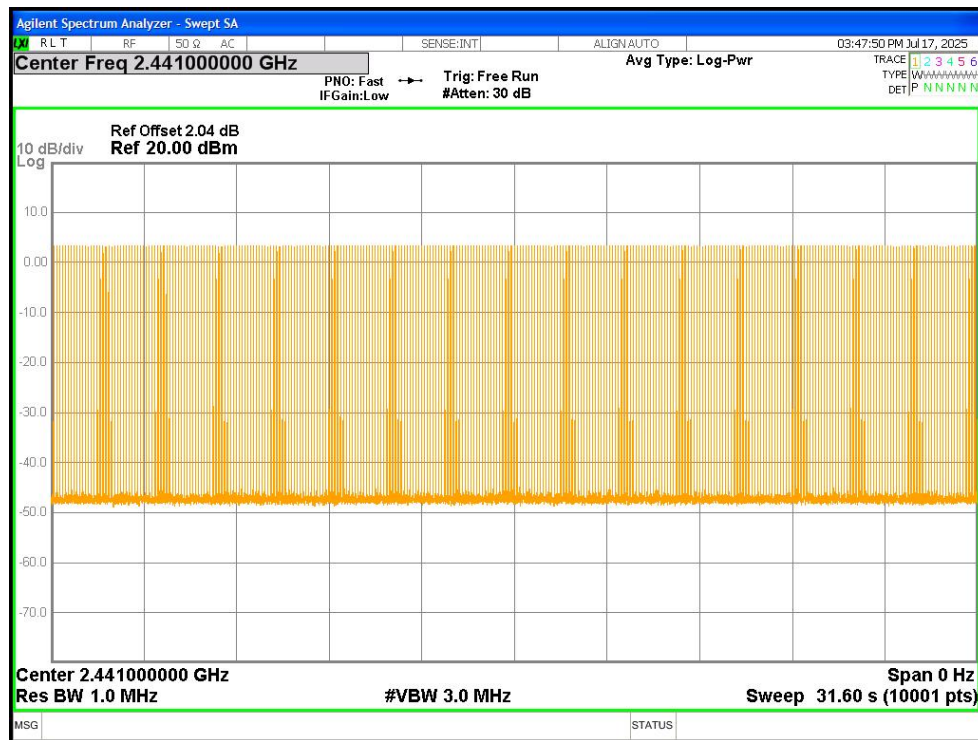
Dwell NVNT 2-DH5 2441MHz Ant1 One Burst

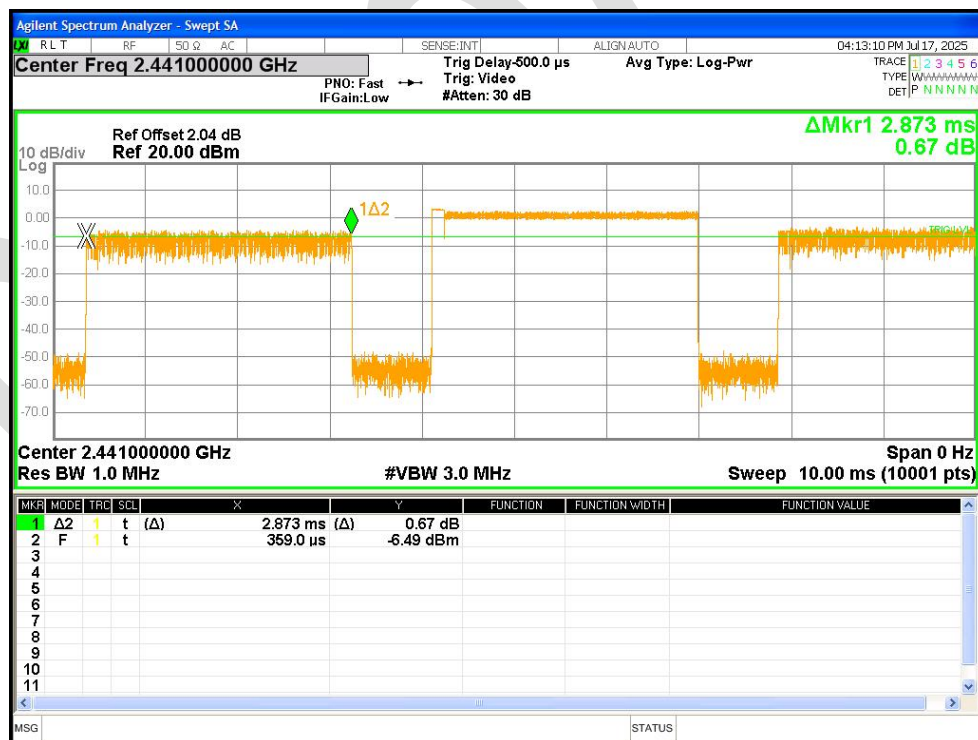
Dwell NVNT 2-DH5 2441MHz Ant1 Accumulated

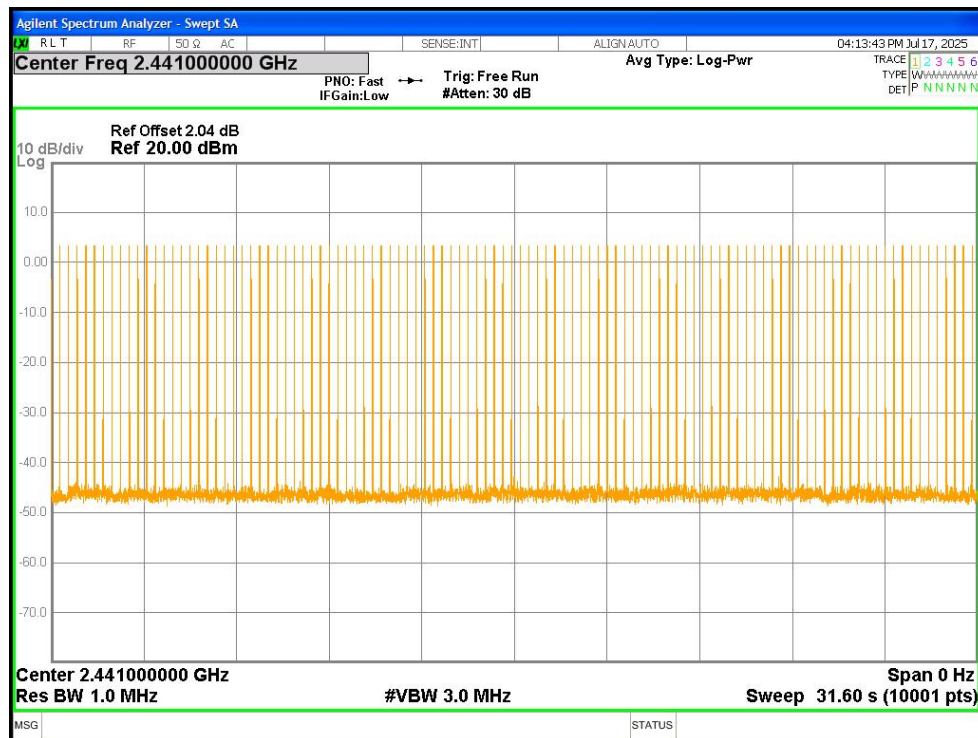
Dwell NVNT 3-DH1 2441MHz Ant1 One Burst

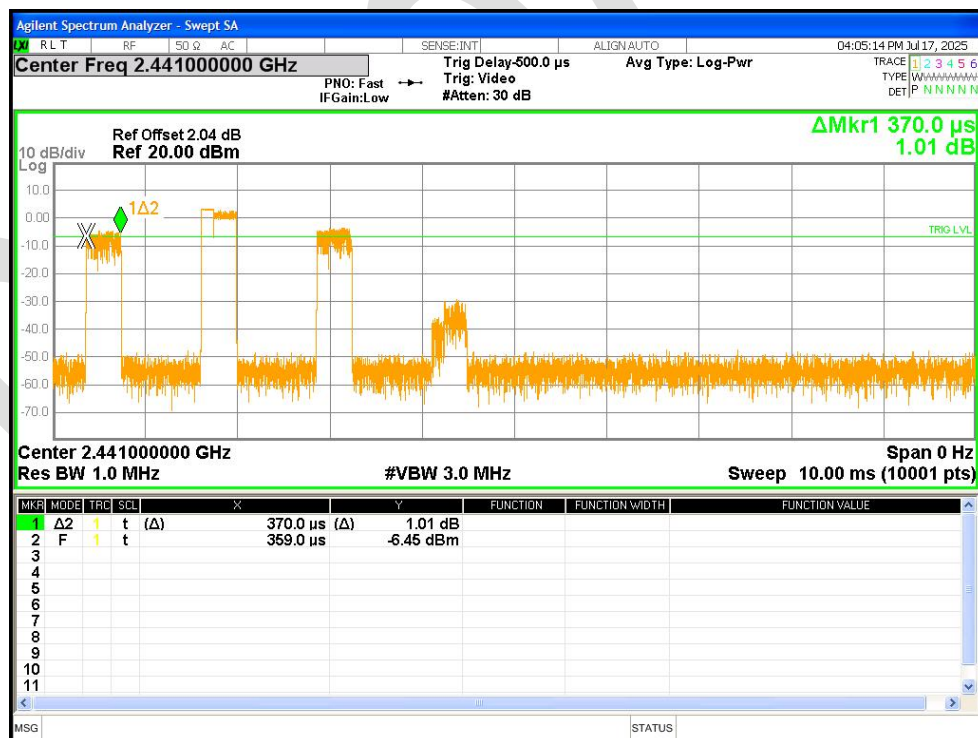
Dwell NVNT 3-DH1 2441MHz Ant1 Accumulated

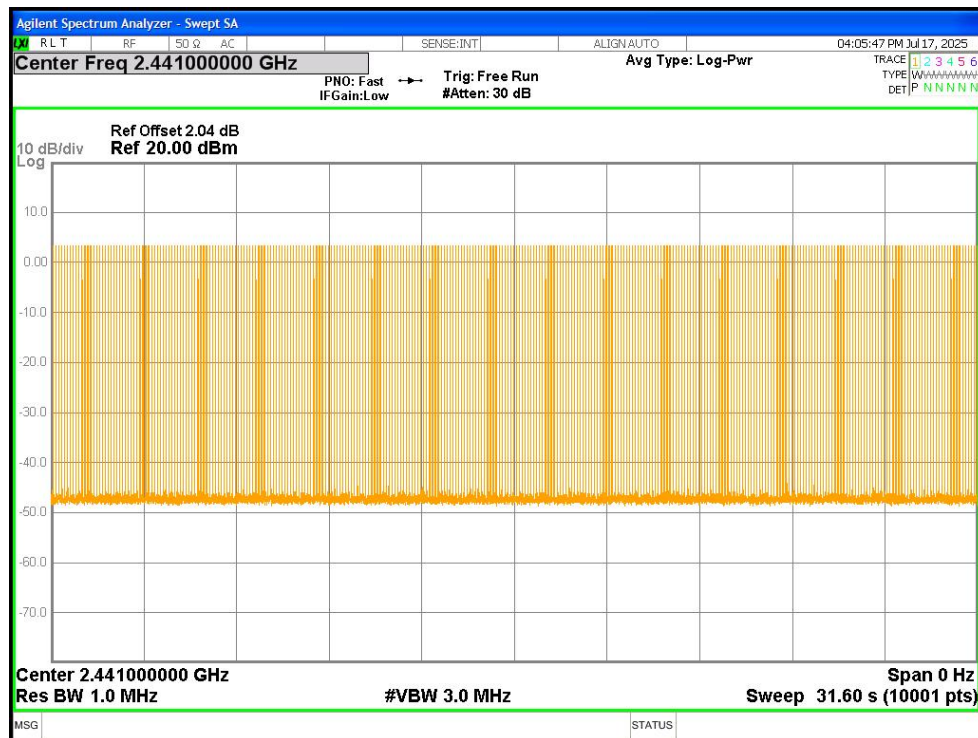
Dwell NVNT 3-DH5 2441MHz Ant1 One Burst

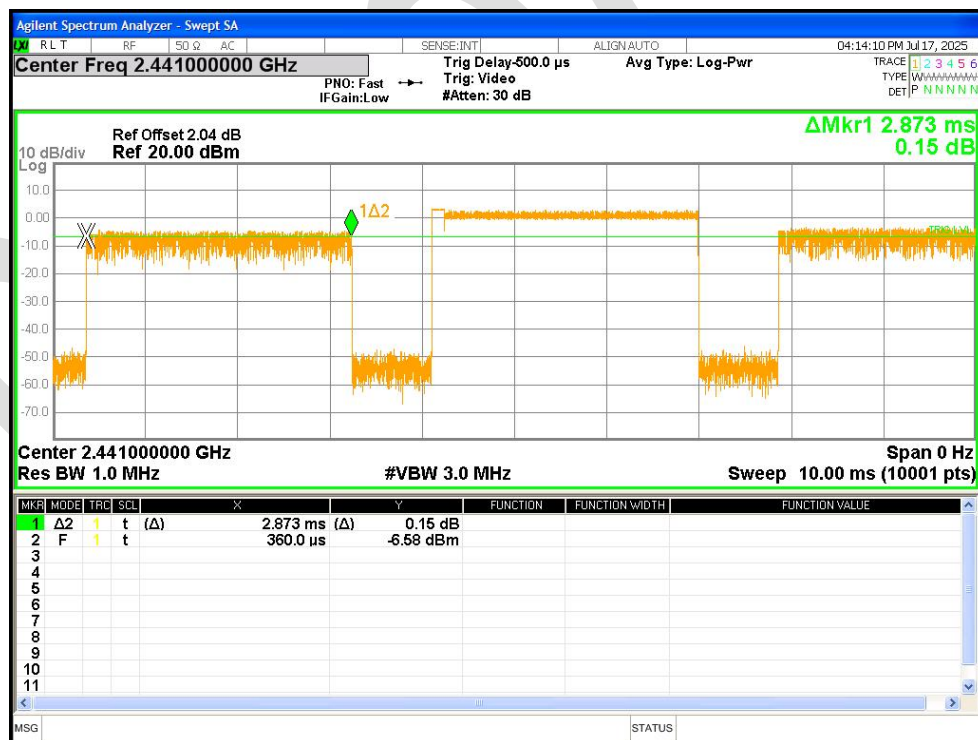
Dwell NVNT 3-DH5 2441MHz Ant1 Accumulated

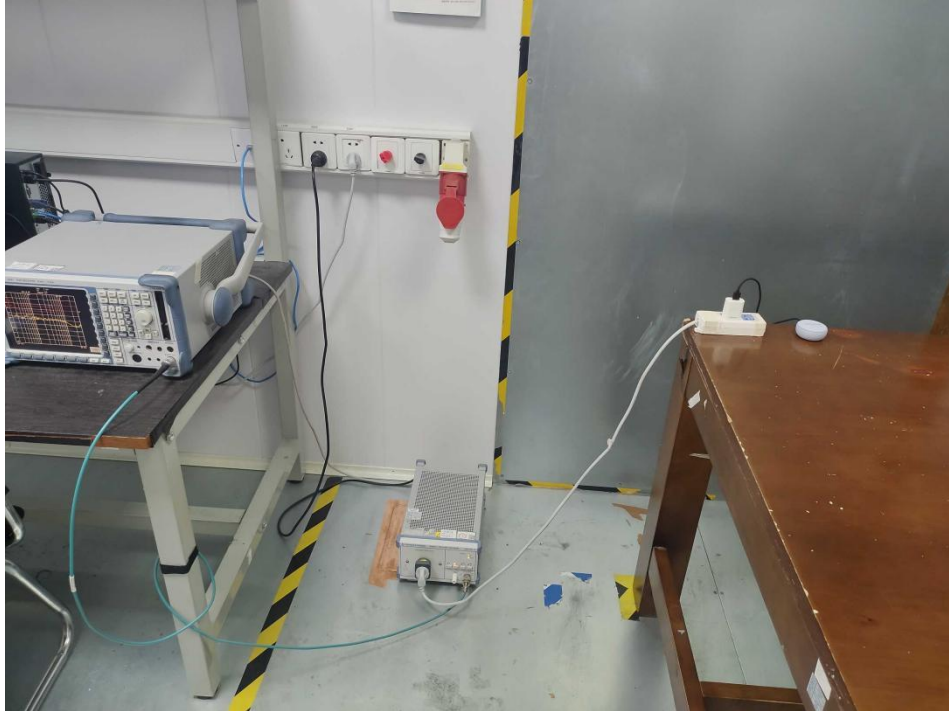
Conducted emissions at AC power line (150kHz-30MHz)

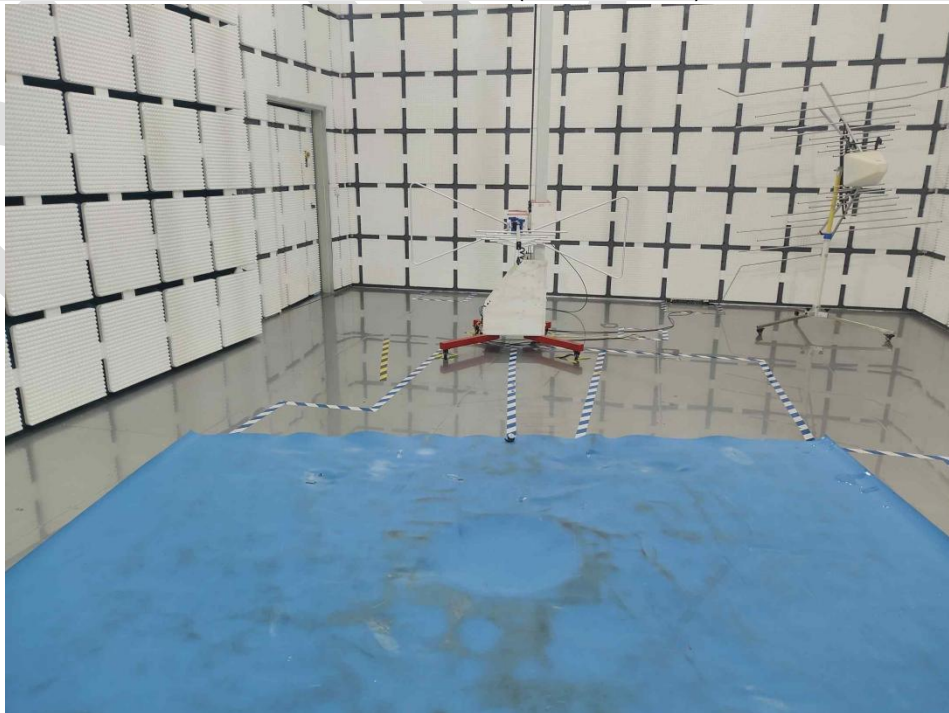
Radiated Emissions (30MHz-1GHz)

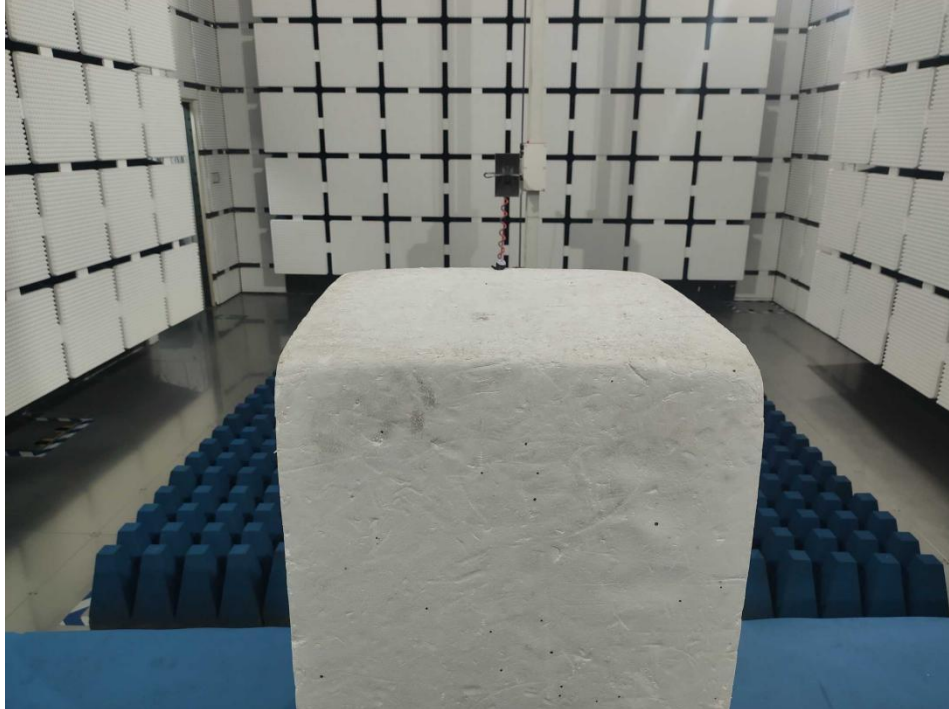
Radiated Emissions (above 1GHz)
