BLE 1M

## 6 Photographs of the Test Setup

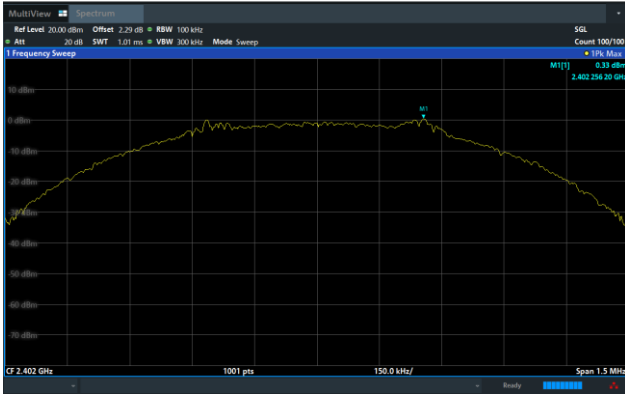
GFSK on Channel 00

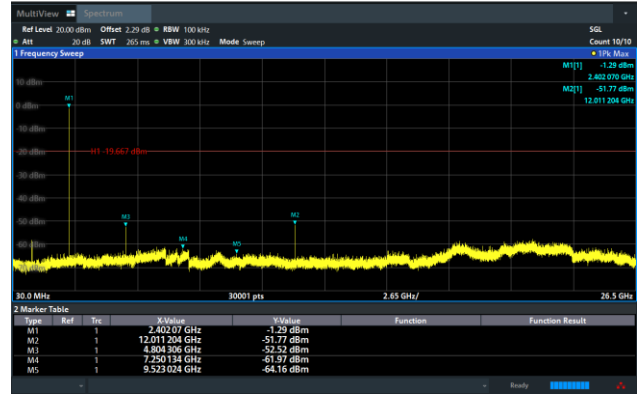
GFSK on Channel 00

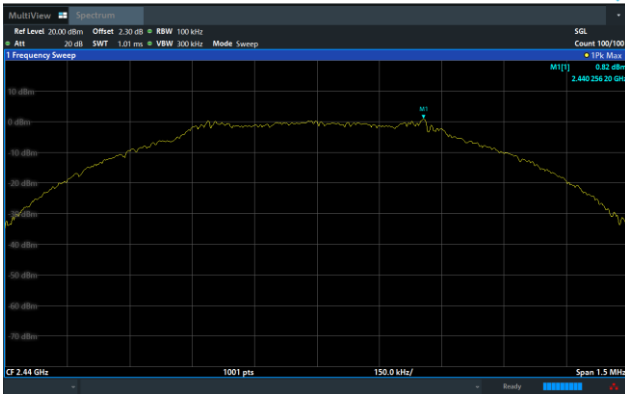
GFSK on Channel 19

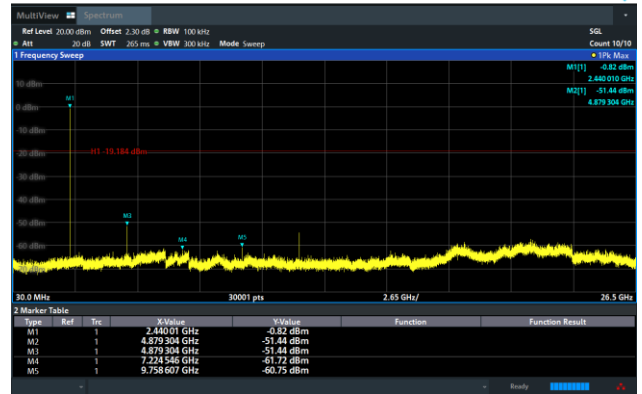
GFSK on Channel 19

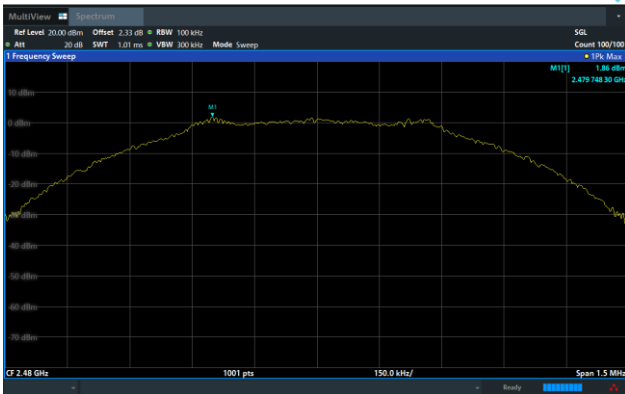
GFSK on Channel 39

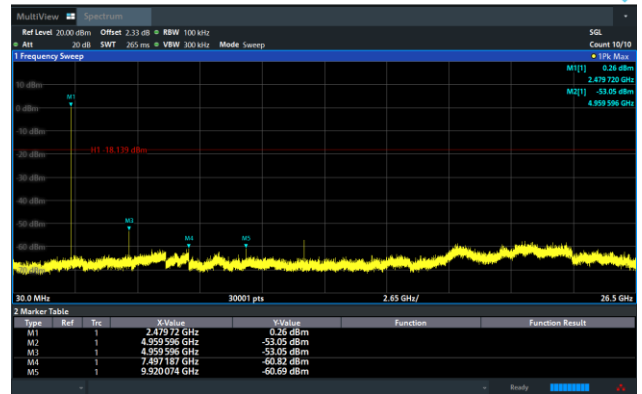
GFSK on Channel 39

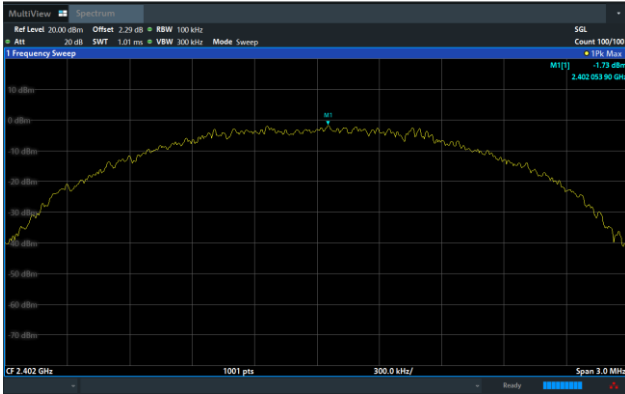
GFSK on Channel 00

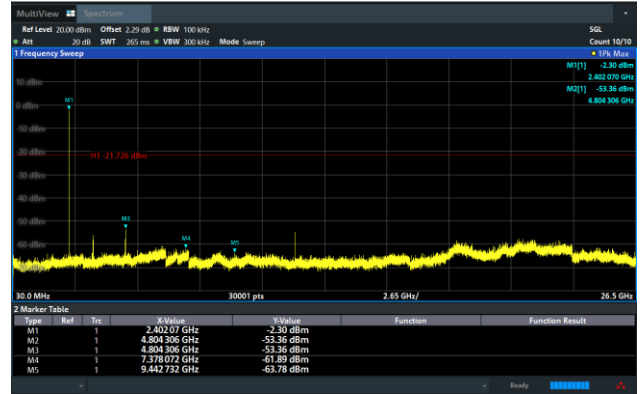
GFSK on Channel 00

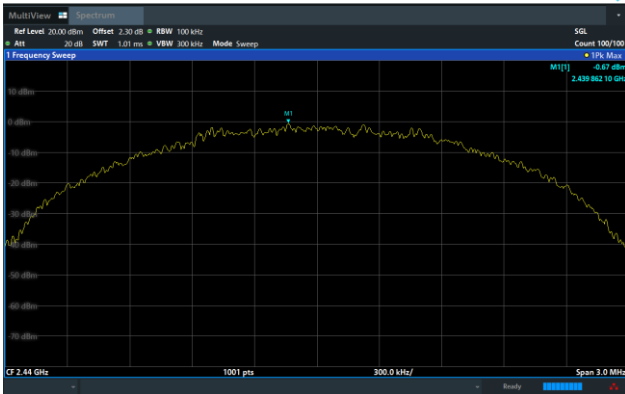
GFSK on Channel 19

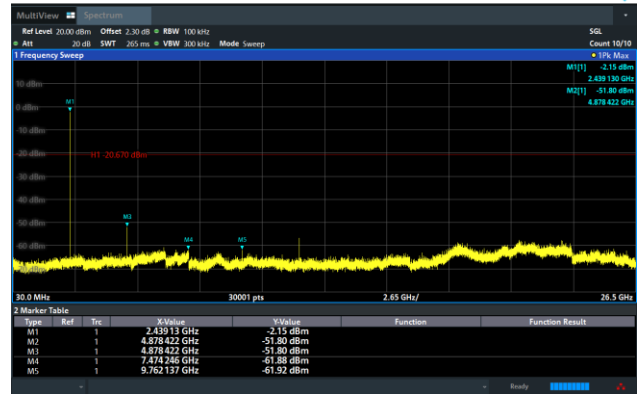
GFSK on Channel 19

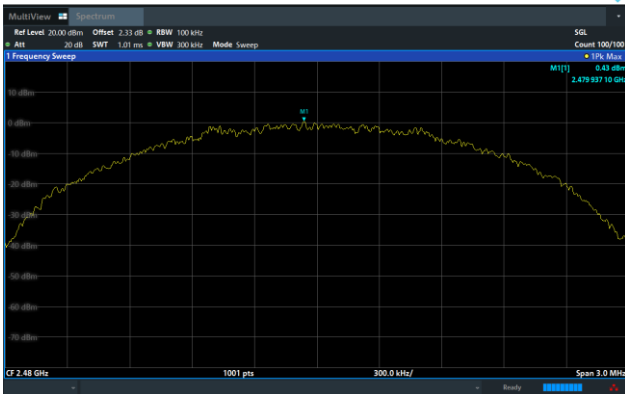
GFSK on Channel 39

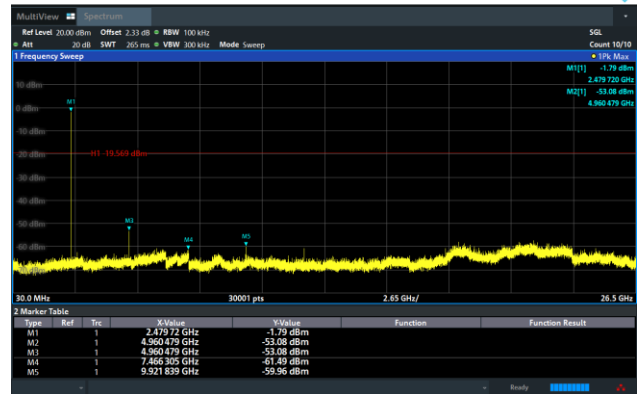
GFSK on Channel 39

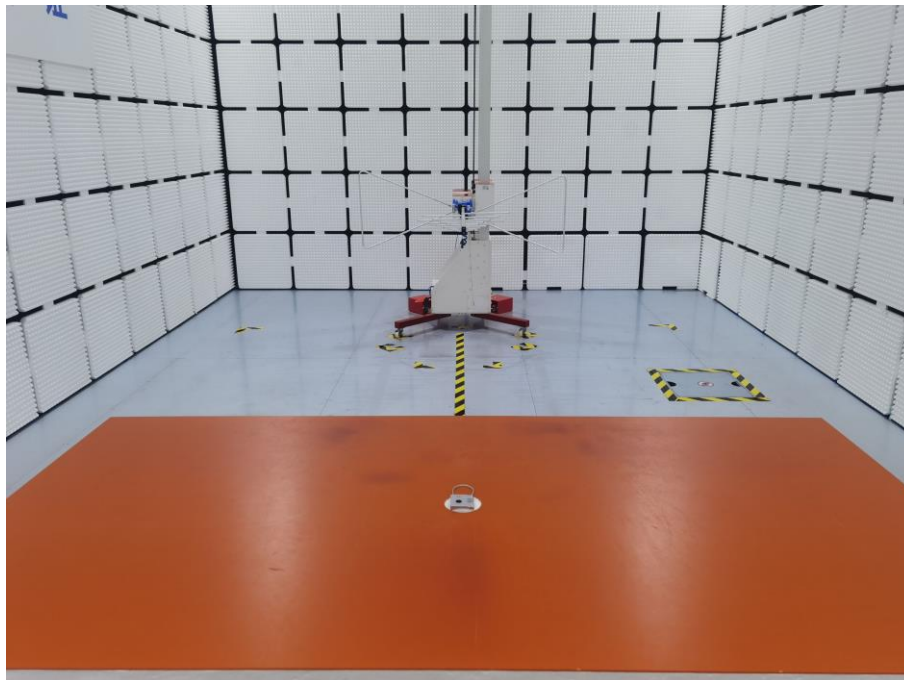
Radiated Emission Below 1GHz

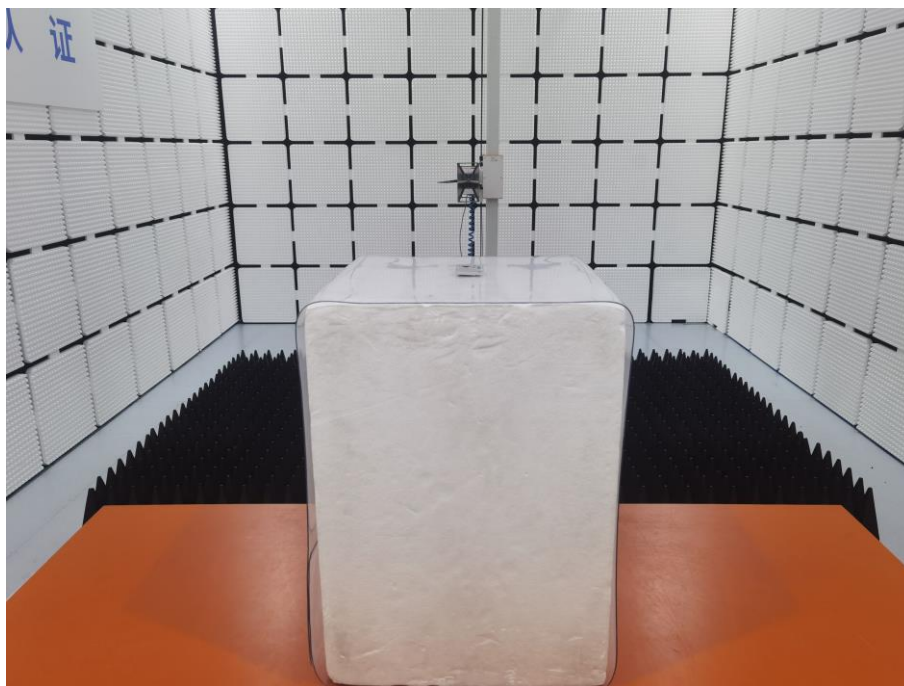
Radiated Emission Above 1GHz
