### 3.4. Bandwidth

#### FCC CFR Title 47 Part 15 Subpart E Section 15.407(a) & (e)

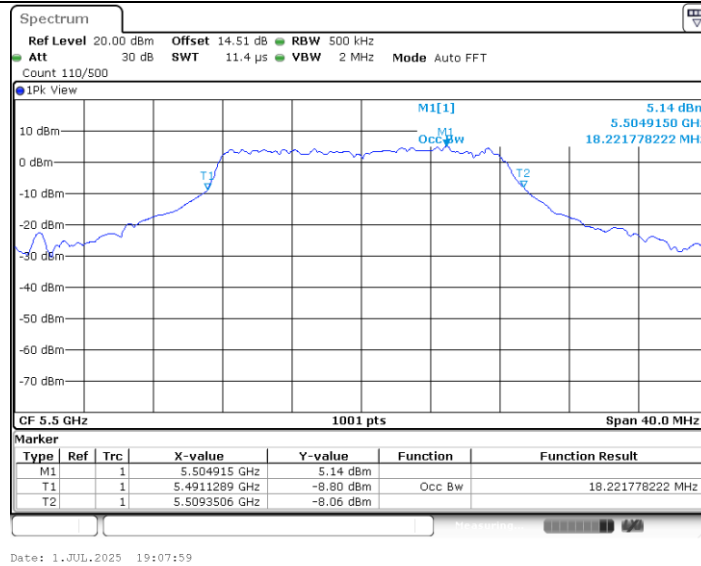
## 11A\_Ant1\_5500

| TestMode | Antenna | Freq (MHz) | OCB [MHz] | 26db EBW [MHz] |
|---|---|---|---|---|
| | | 5500 | 18.222 | 25.16 |

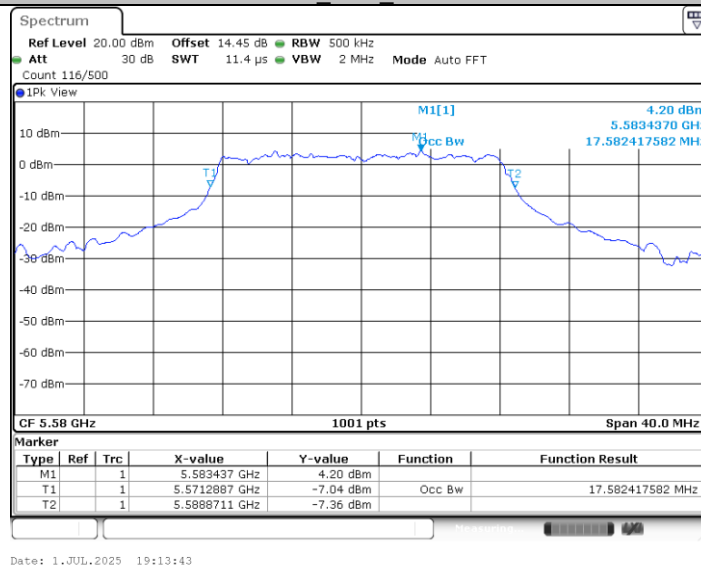
## 11A\_Ant1\_5580

| TestMode | Antenna | Freq (MHz) | OCB [MHz] | 26db EBW [MHz] |
|---|---|---|---|---|
| | | 5580 | 17.582 | 26.40 |

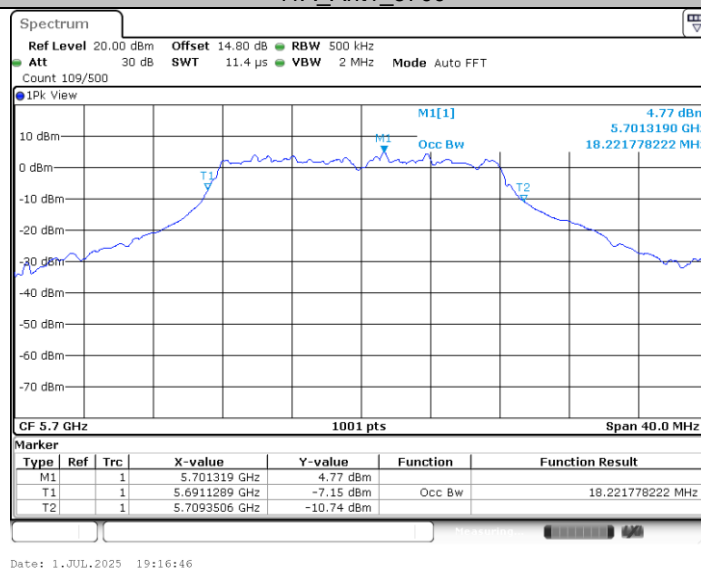
## 11A\_Ant1\_5700

| TestMode | Antenna | Freq (MHz) | OCB [MHz] | 26db EBW [MHz] |
|---|---|---|---|---|
| | | 5700 | 18.222 | 26.48 |

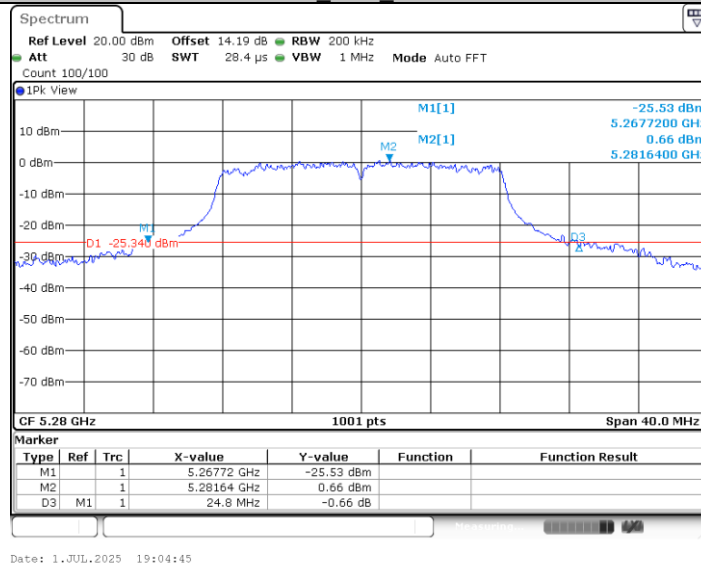
## 11A\_Ant1\_5280

| TestMode | Antenna | Freq (MHz) | OCB [MHz] | 26db EBW [MHz] |
|---|---|---|---|---|
| | | 5280 | 17.622 | 24.80 |

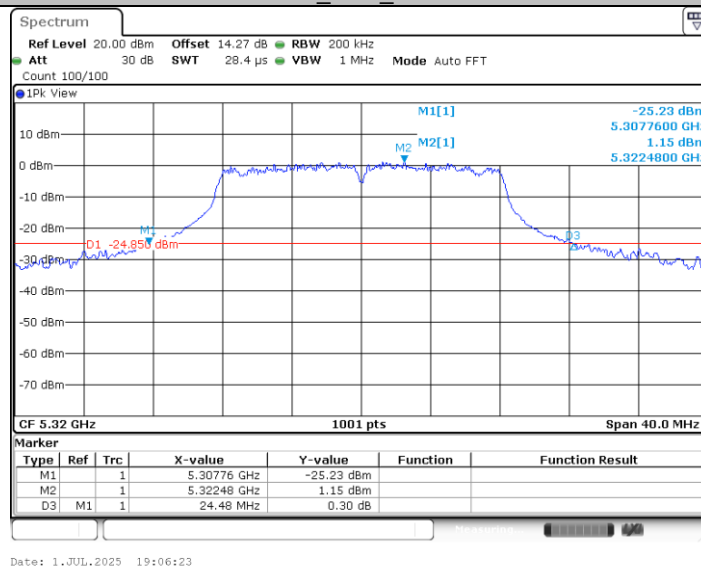
## 11A\_Ant1\_5320

| TestMode | Antenna | Freq (MHz) | OCB [MHz] | 26db EBW [MHz] |
|---|---|---|---|---|
| | | 5320 | 17.542 | 24.48 |
