## Tx. Spurious NVNT ac20 5825MHz Ant1 Emission

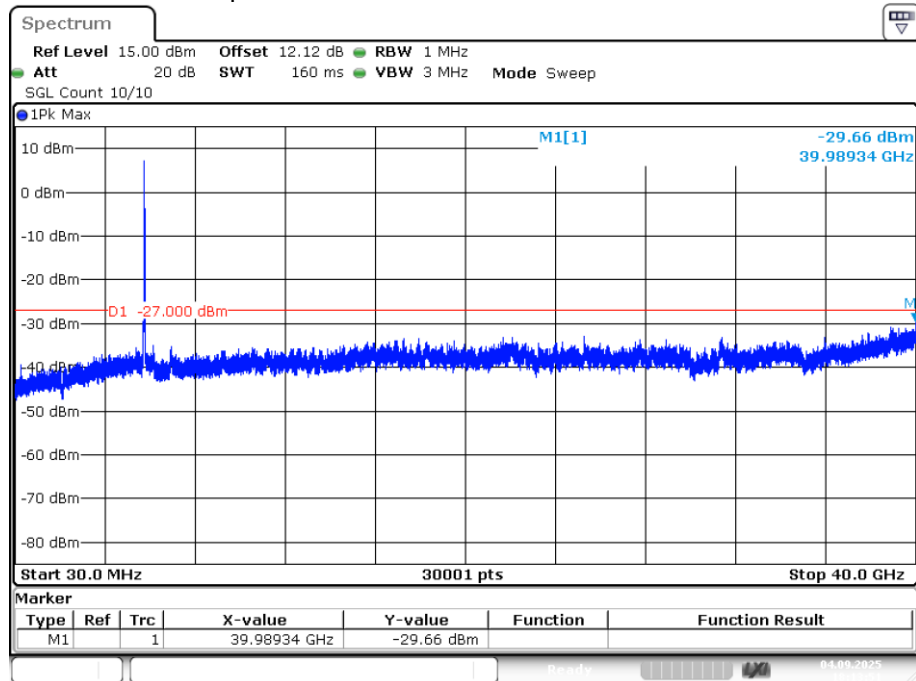
## Tx. Spurious NVNT ac40 5755MHz Ant1 Emission

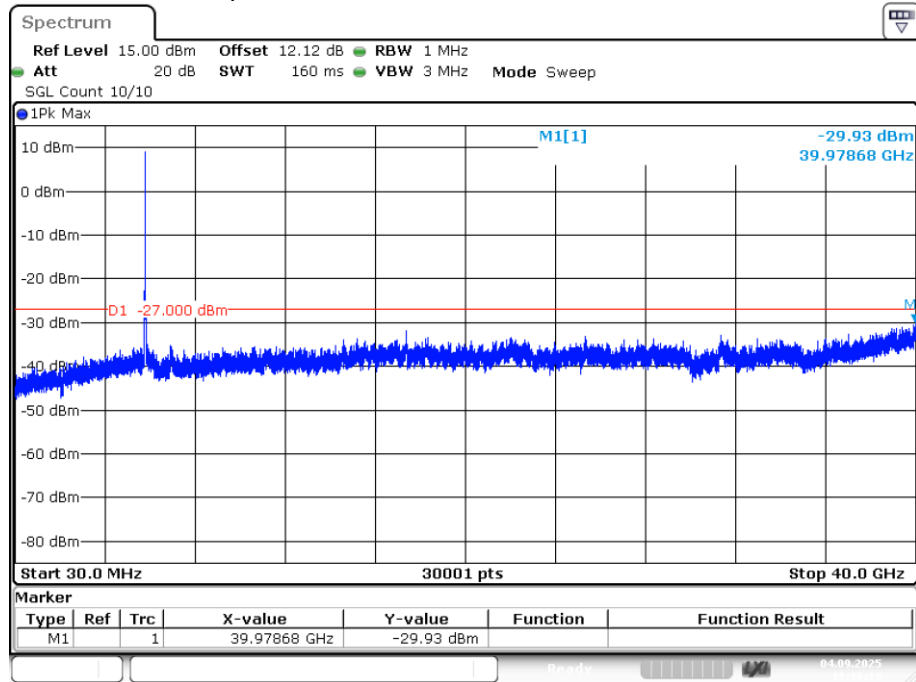
## Tx. Spurious NVNT ac40 5795MHz Ant1 Emission

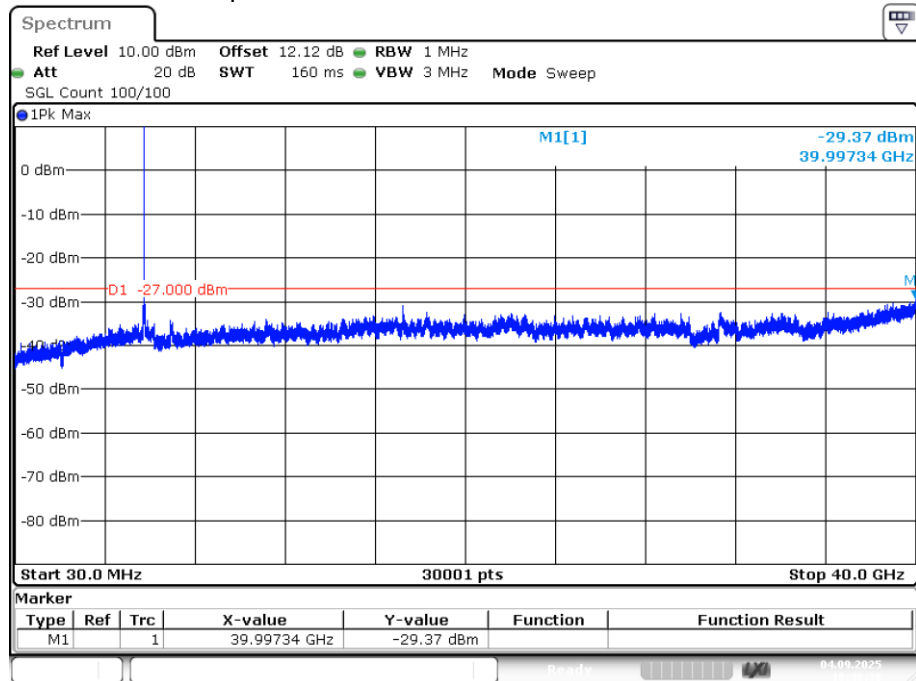
## Tx. Spurious NVNT ax20 5745MHz Ant1 Emission

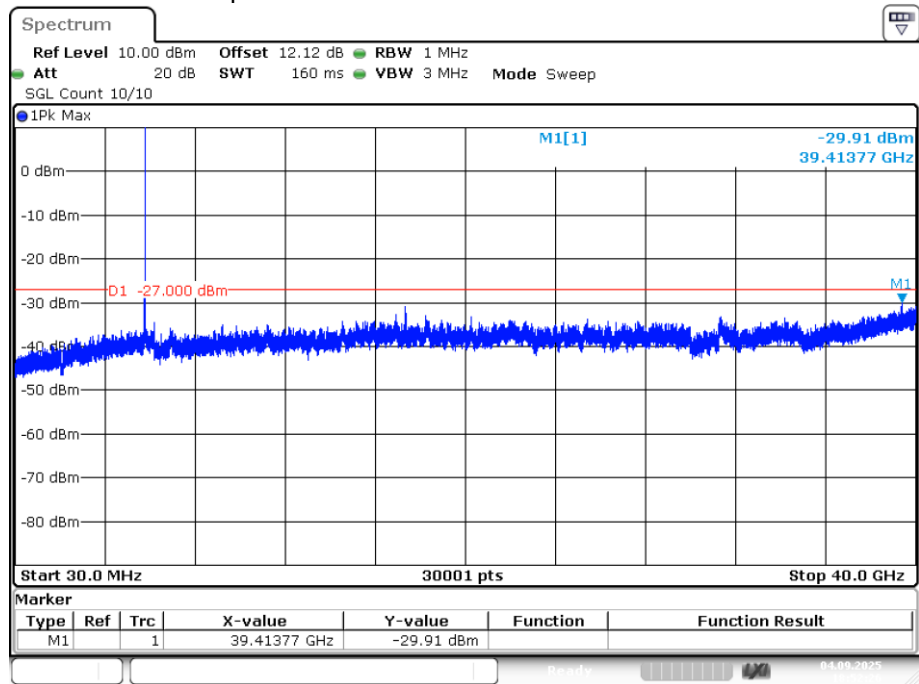
## Tx. Spurious NVNT ax20 5785MHz Ant1 Emission

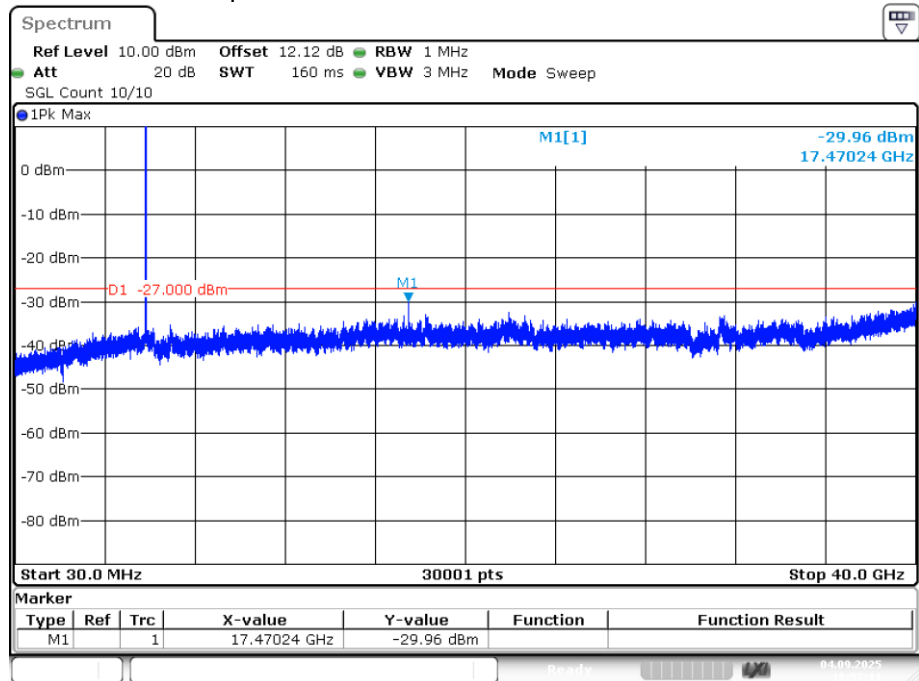
## Tx. Spurious NVNT ax20 5825MHz Ant1 Emission

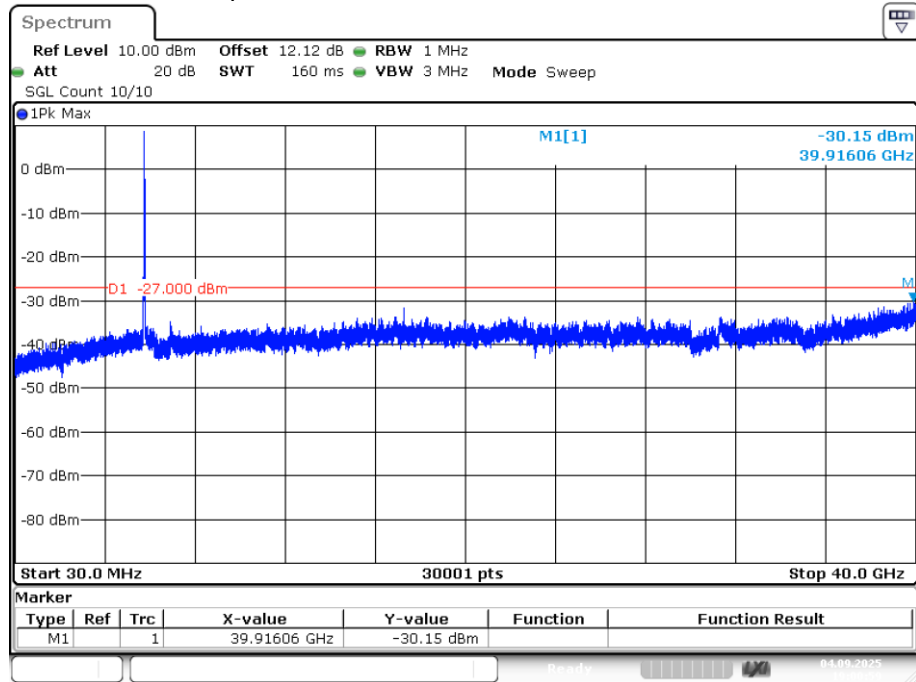
## Tx. Spurious NVNT ax40 5755MHz Ant1 Emission

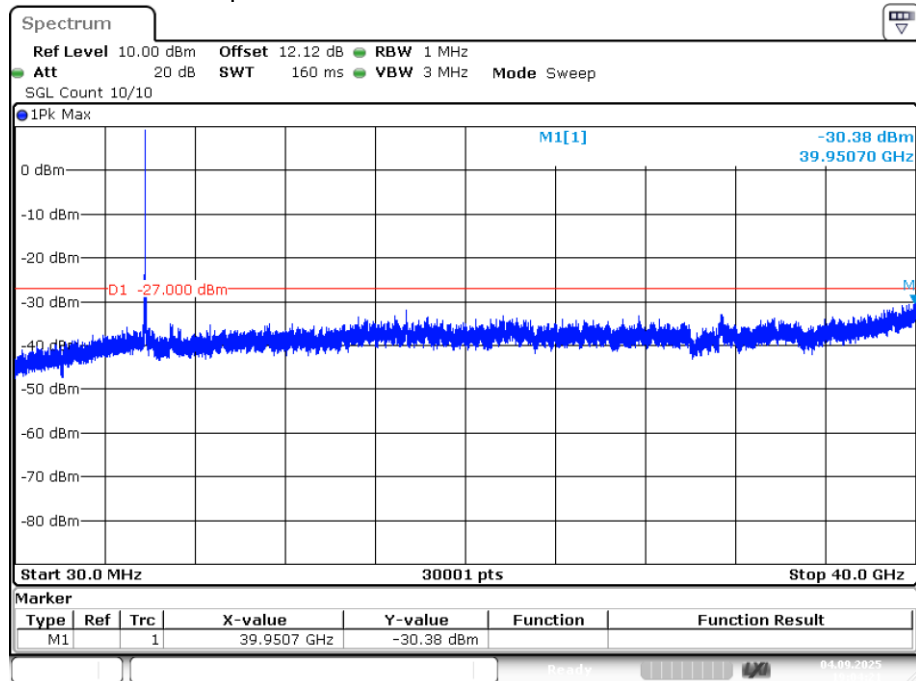
## Tx. Spurious NVNT ax40 5795MHz Ant1 Emission

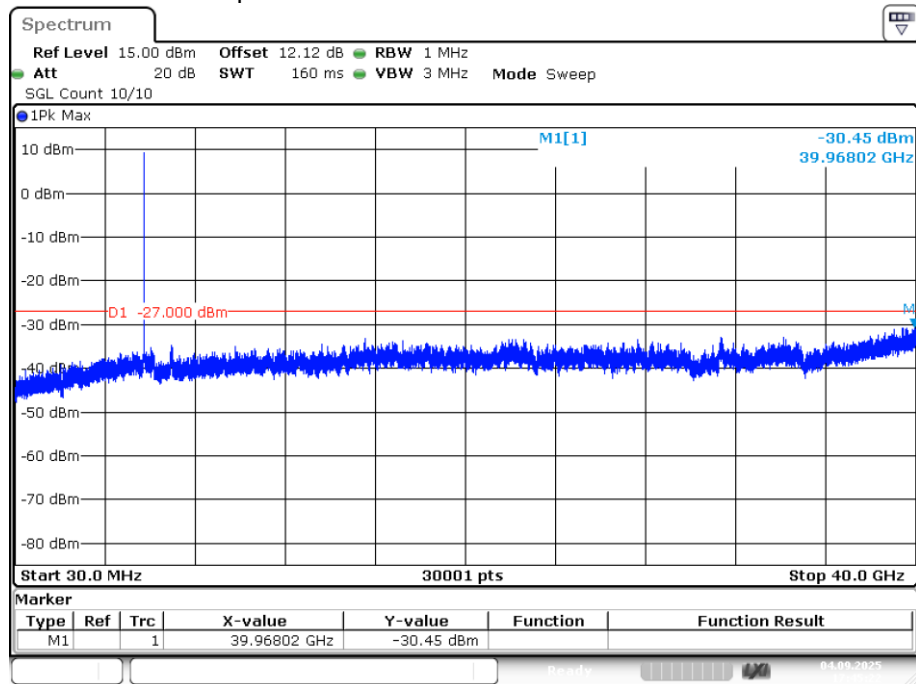
## Tx. Spurious NVNT n20 5745MHz Ant1 Emission

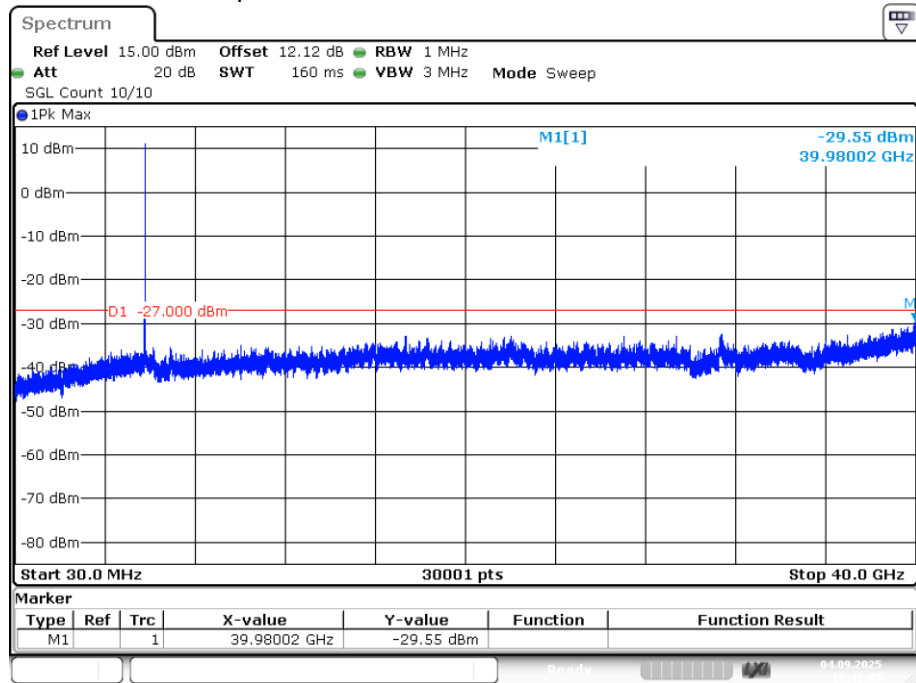
## Tx. Spurious NVNT n20 5785MHz Ant1 Emission

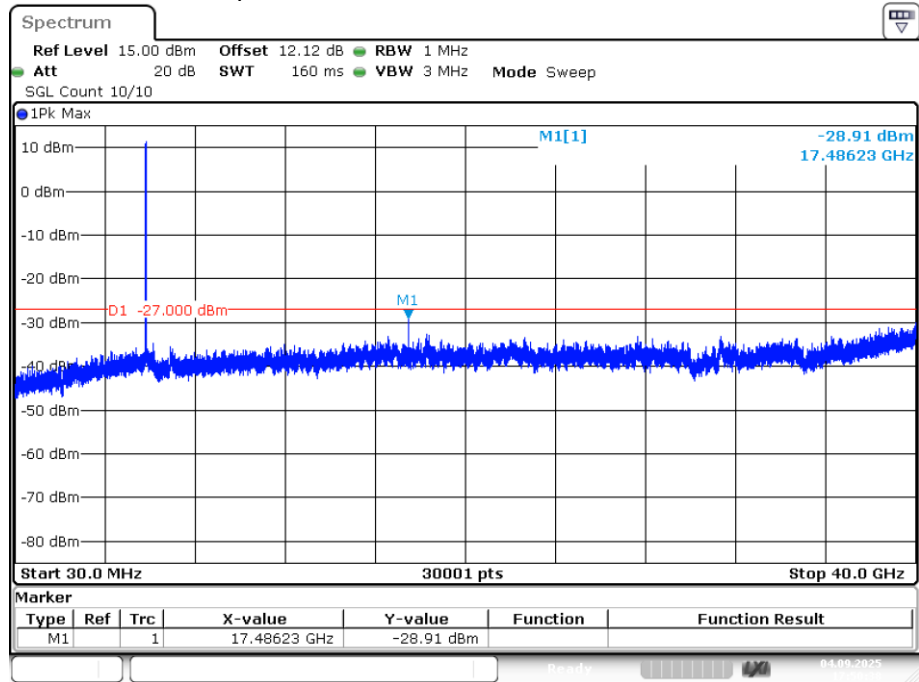
## Tx. Spurious NVNT n20 5825MHz Ant1 Emission

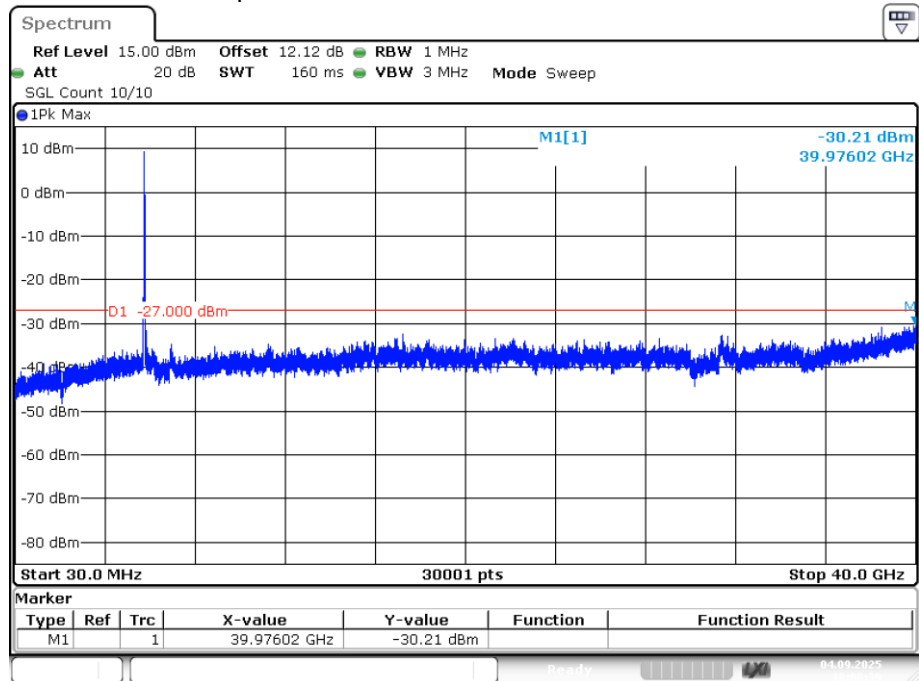
## Tx. Spurious NVNT n40 5755MHz Ant1 Emission

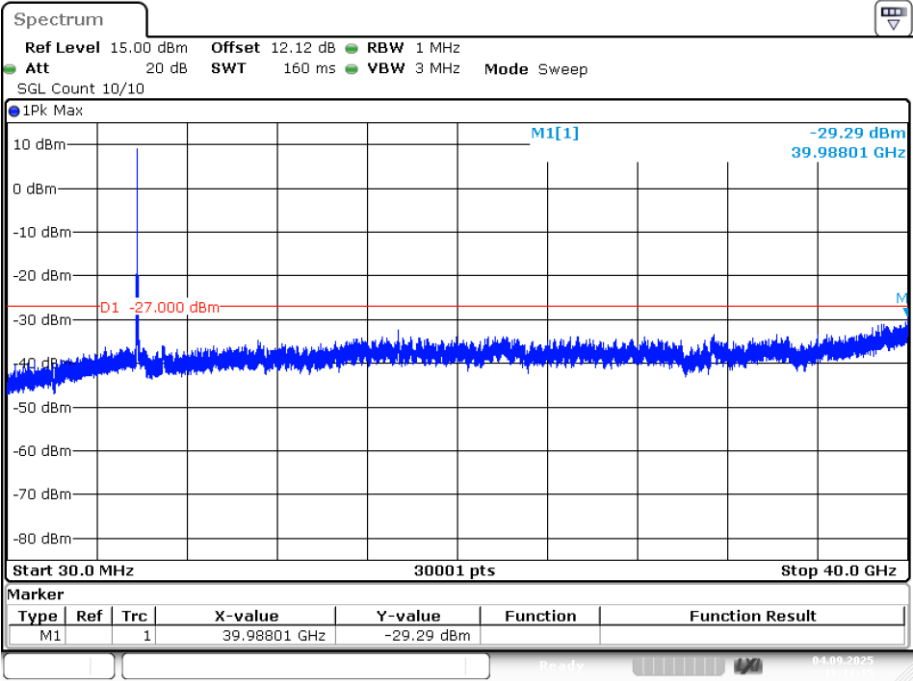
Tx. Spurious NVNT n40 5795MHz Ant1 Emission
