Appendix D: Dwell Time

## Appendix G: Conducted Spurious Emission

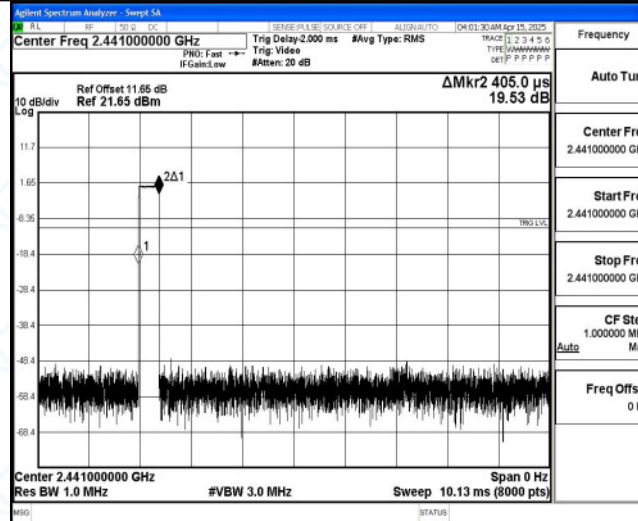
DH1\_Ant1\_Hop

| TestMode | Antenna | Freq(MHz) | BurstWidth<br>[ms] | TotalHops<br>[Num] | Result[s] | Limit[s] | Verdict |
|---|---|---|---|---|---|---|---|
| DH1 | Ant1 | Hop | 0.405 | 320 | 0.13 | ≤0.4 | PASS |

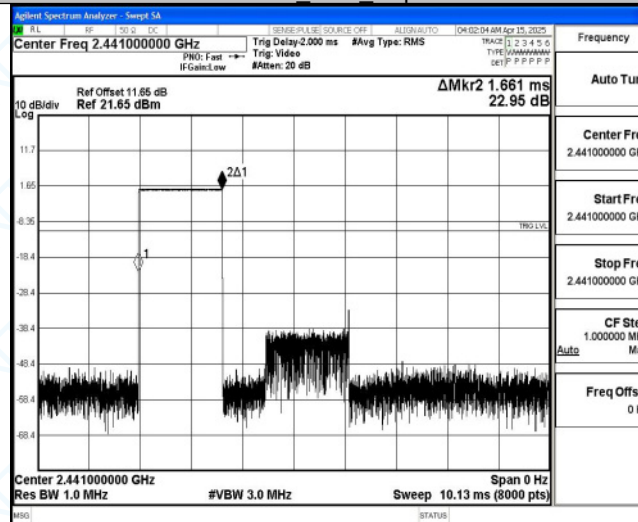
DH3\_Ant1\_Hop

| TestMode | Antenna | Freq(MHz) | BurstWidth<br>[ms] | TotalHops<br>[Num] | Result[s] | Limit[s] | Verdict |
|---|---|---|---|---|---|---|---|
| DH3 | Ant1 | Hop | 1.661 | 160 | 0.266 | ≤0.4 | PASS |

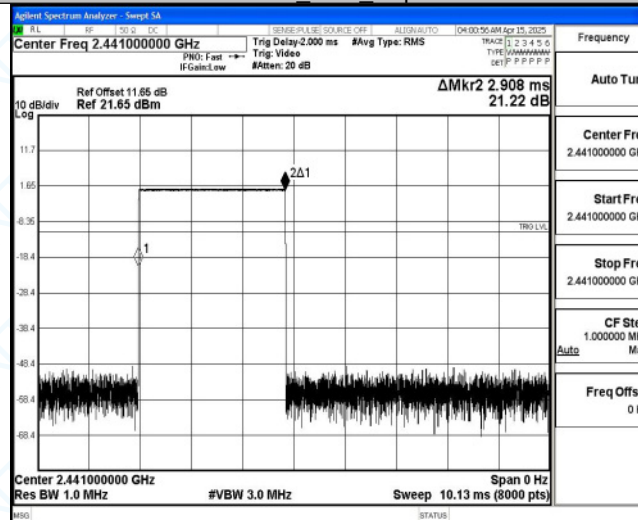
DH5\_Ant1\_Hop

| TestMode | Antenna | Freq(MHz) | BurstWidth<br>[ms] | TotalHops<br>[Num] | Result[s] | Limit[s] | Verdict |
|---|---|---|---|---|---|---|---|
| DH5 | Ant1 | Hop | 2.908 | 106.67 | 0.31 | ≤0.4 | PASS |

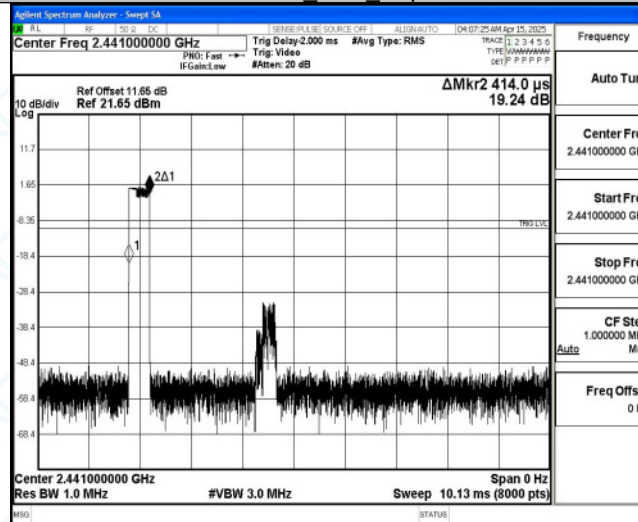
## 2DH1 Ant1 Hop

| TestMode | Antenna | Freq(MHz) | BurstWidth<br>[ms] | TotalHops<br>[Num] | Result[s] | Limit[s] | Verdict |
|---|---|---|---|---|---|---|---|
| 2DH1 | Ant1 | Hop | 0.414 | 320 | 0.132 | ≤0.4 | PASS |

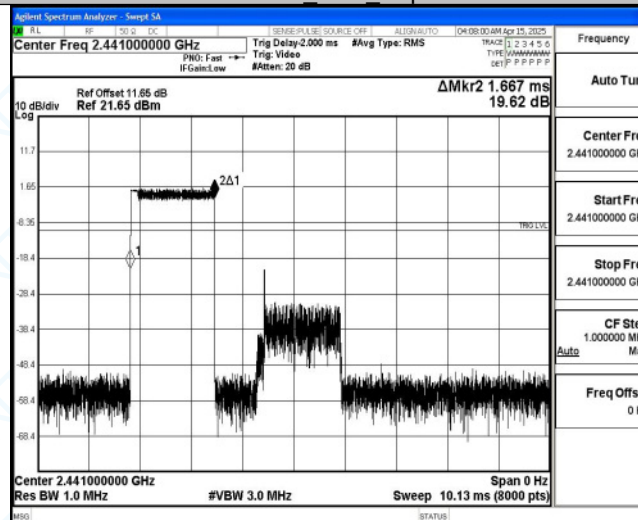
## 2DH3 Ant1 Hop

| TestMode | Antenna | Freq(MHz) | BurstWidth<br>[ms] | TotalHops<br>[Num] | Result[s] | Limit[s] | Verdict |
|---|---|---|---|---|---|---|---|
| 2DH3 | Ant1 | Hop | 1.667 | 160 | 0.267 | ≤0.4 | PASS |

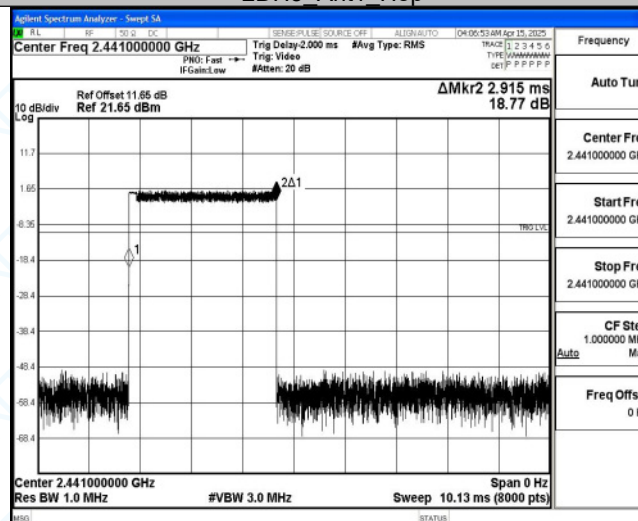
## 2DH5 Ant1 Hop

| TestMode | Antenna | Freq(MHz) | BurstWidth<br>[ms] | TotalHops<br>[Num] | Result[s] | Limit[s] | Verdict |
|---|---|---|---|---|---|---|---|
| 2DH5 | Ant1 | Hop | 2.915 | 106.67 | 0.311 | ≤0.4 | PASS |

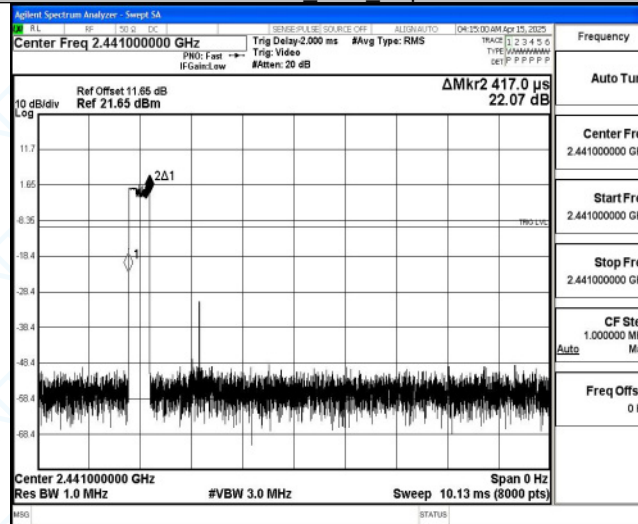
## 3DH1\_Ant1\_Hop

| TestMode | Antenna | Freq(MHz) | BurstWidth<br>[ms] | TotalHops<br>[Num] | Result[s] | Limit[s] | Verdict |
|---|---|---|---|---|---|---|---|
| 3DH1 | Ant1 | Hop | 0.417 | 320 | 0.133 | ≤0.4 | PASS |

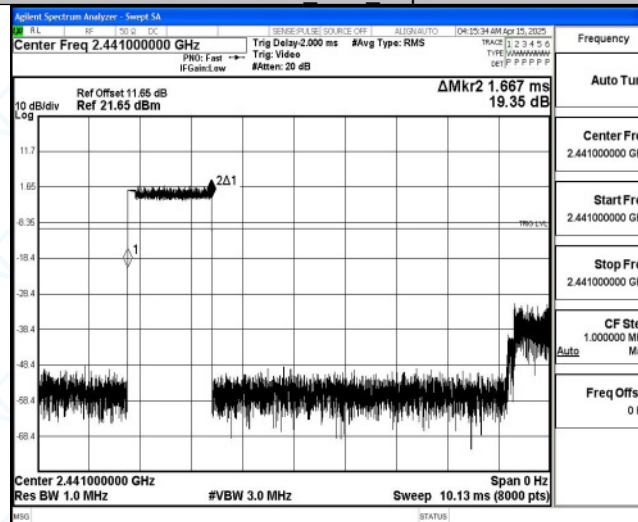
## 3DH3\_Ant1\_Hop

| TestMode | Antenna | Freq(MHz) | BurstWidth<br>[ms] | TotalHops<br>[Num] | Result[s] | Limit[s] | Verdict |
|---|---|---|---|---|---|---|---|
| 3DH3 | Ant1 | Hop | 1.667 | 160 | 0.267 | ≤0.4 | PASS |

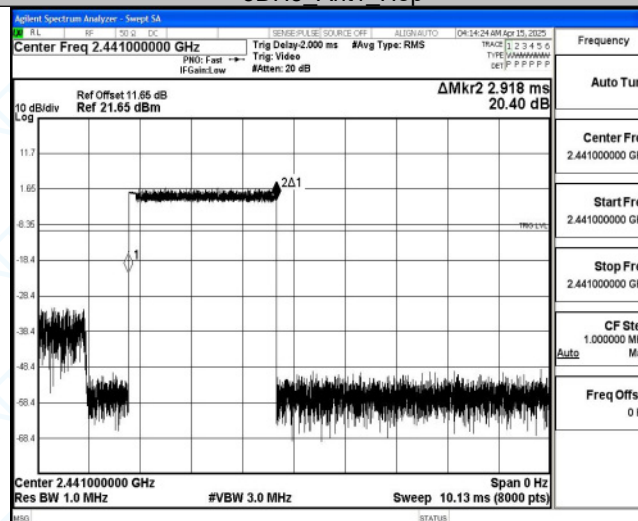
## 3DH5\_Ant1\_Hop

| TestMode | Antenna | Freq(MHz) | BurstWidth<br>[ms] | TotalHops<br>[Num] | Result[s] | Limit[s] | Verdict |
|---|---|---|---|---|---|---|---|
| 3DH5 | Ant1 | Hop | 2.918 | 106.67 | 0.311 | ≤0.4 | PASS |

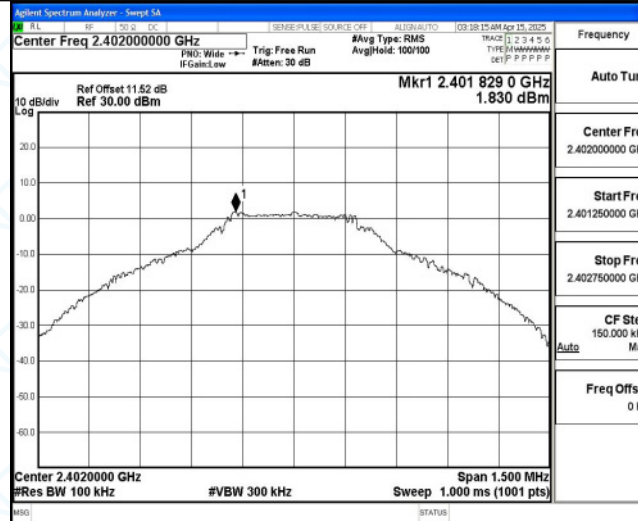
DH5\_Ant1\_2402\_0~Reference

| TestMode | Antenna | Freq(MHz) | FreqRange [MHz] | RefLevel [dBm] | Result [dBm] | Limit [dBm] | Verdict |
|---|---|---|---|---|---|---|---|
| DH5 | Ant1 | 2402 | Reference | 1.83 | 1.83 | --- | PASS |

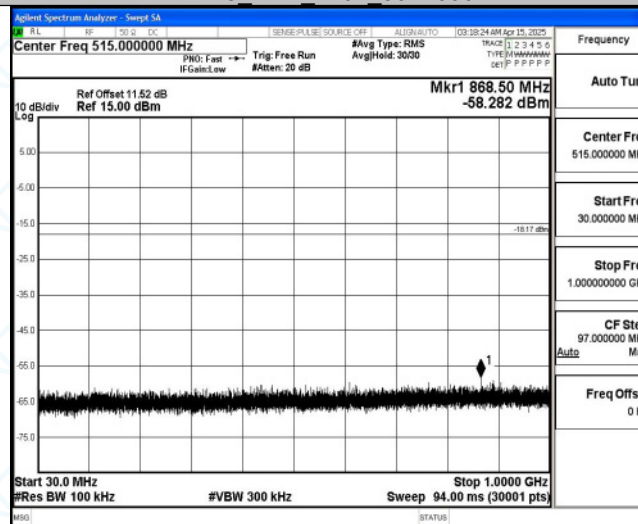
DH5\_Ant1\_2402\_30~1000

| TestMode | Antenna | Freq(MHz) | FreqRange [MHz] | RefLevel [dBm] | Result [dBm] | Limit [dBm] | Verdict |
|---|---|---|---|---|---|---|---|
| | | | 30~1000 | 1.83 | -58.28 | $\leq -18.17$ | PASS |

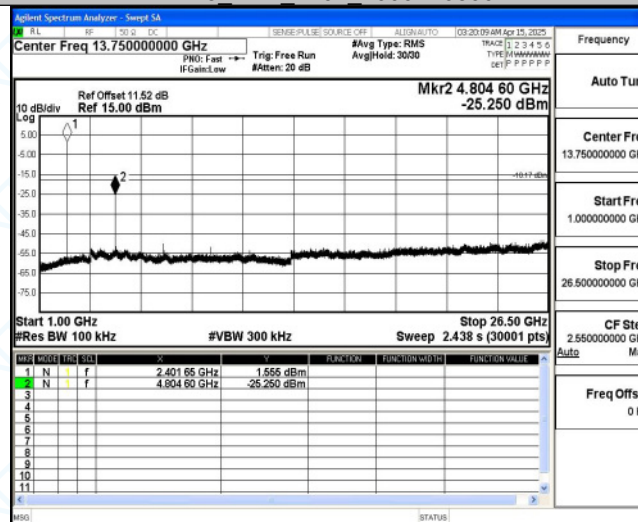
DH5\_Ant1\_2402\_1000~26500

| TestMode | Antenna | Freq(MHz) | FreqRange [MHz] | RefLevel [dBm] | Result [dBm] | Limit [dBm] | Verdict |
|---|---|---|---|---|---|---|---|
| | | | 1000~26500 | 1.83 | -25.25 | $\leq -18.17$ | PASS |

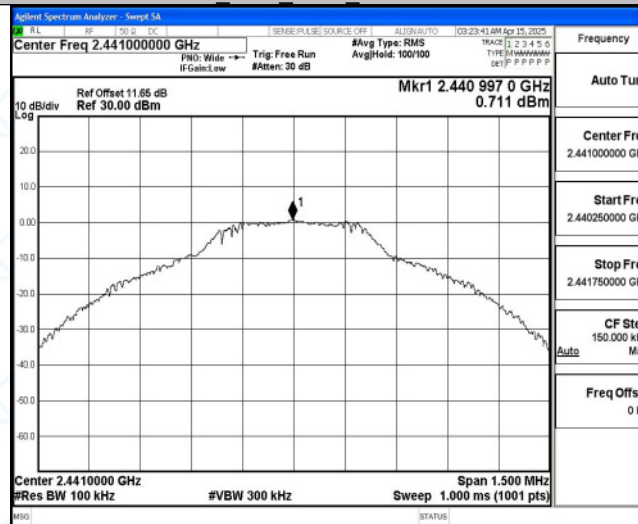
## DH5\_Ant1\_2441\_0~Reference

| TestMode | Antenna | Freq(MHz) | FreqRange [MHz] | RefLevel [dBm] | Result [dBm] | Limit [dBm] | Verdict |
|---|---|---|---|---|---|---|---|
| | | 2441 | Reference | 0.71 | 0.71 | --- | PASS |

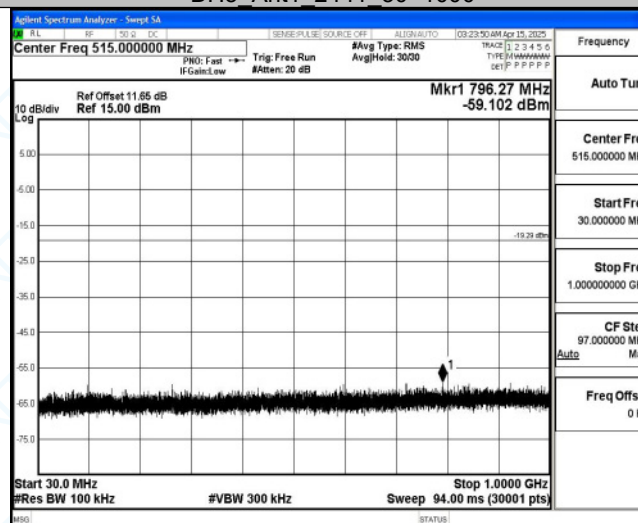
## DH5\_Ant1\_2441\_30~1000

| TestMode | Antenna | Freq(MHz) | FreqRange [MHz] | RefLevel [dBm] | Result [dBm] | Limit [dBm] | Verdict |
|---|---|---|---|---|---|---|---|
| | | | 30~1000 | 0.71 | -59.1 | $\leq -19.29$ | PASS |

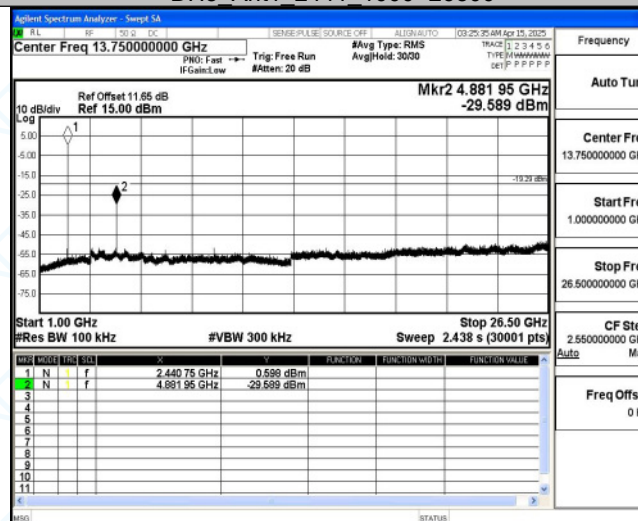
## DH5\_Ant1\_2441\_1000~26500

| TestMode | Antenna | Freq(MHz) | FreqRange [MHz] | RefLevel [dBm] | Result [dBm] | Limit [dBm] | Verdict |
|---|---|---|---|---|---|---|---|
| | | | 1000~26500 | 0.71 | -29.59 | $\leq -19.29$ | PASS |

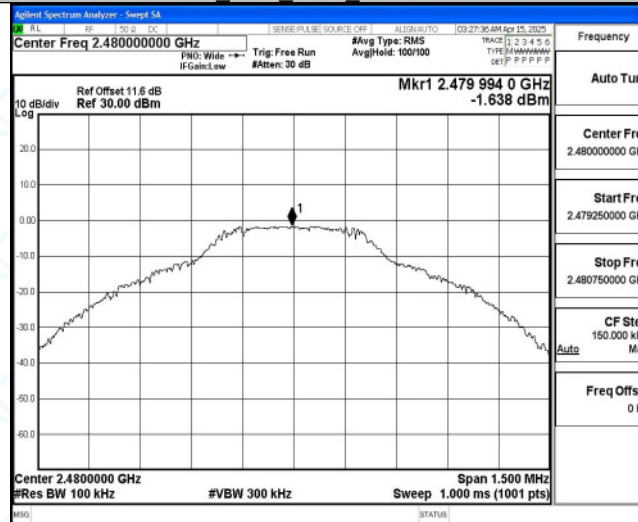
## DH5\_Ant1\_2480\_0~Reference

| TestMode | Antenna | Freq(MHz) | FreqRange [MHz] | RefLevel [dBm] | Result [dBm] | Limit [dBm] | Verdict |
|---|---|---|---|---|---|---|---|
| | | 2480 | Reference | -1.64 | -1.64 | --- | PASS |

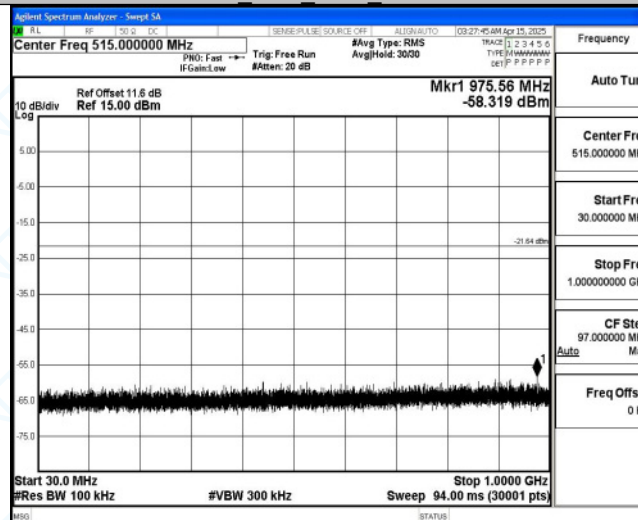
## DH5\_Ant1\_2480\_30~1000

| TestMode | Antenna | Freq(MHz) | FreqRange [MHz] | RefLevel [dBm] | Result [dBm] | Limit [dBm] | Verdict |
|---|---|---|---|---|---|---|---|
| | | | 30~1000 | -1.64 | -58.32 | $\leq -21.64$ | PASS |

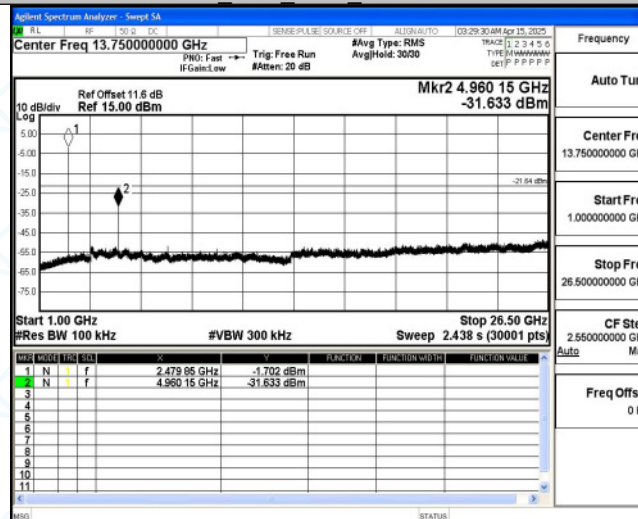
## DH5\_Ant1\_2480\_1000~26500

| TestMode | Antenna | Freq(MHz) | FreqRange [MHz] | RefLevel [dBm] | Result [dBm] | Limit [dBm] | Verdict |
|---|---|---|---|---|---|---|---|
| | | | 1000~26500 | -1.64 | -31.63 | $\leq -21.64$ | PASS |

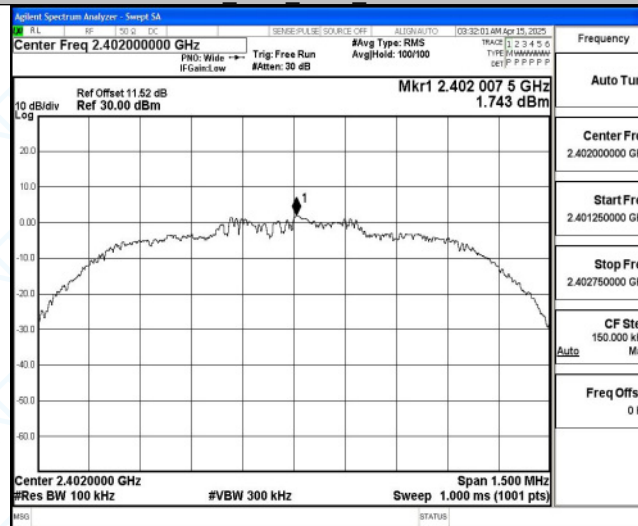
## 2DH5\_Ant1\_2402\_0~Reference

| TestMode | Antenna | Freq(MHz) | FreqRange [MHz] | RefLevel [dBm] | Result [dBm] | Limit [dBm] | Verdict |
|---|---|---|---|---|---|---|---|
| 2DH5 | Ant1 | 2402 | Reference | 1.74 | 1.74 | --- | PASS |

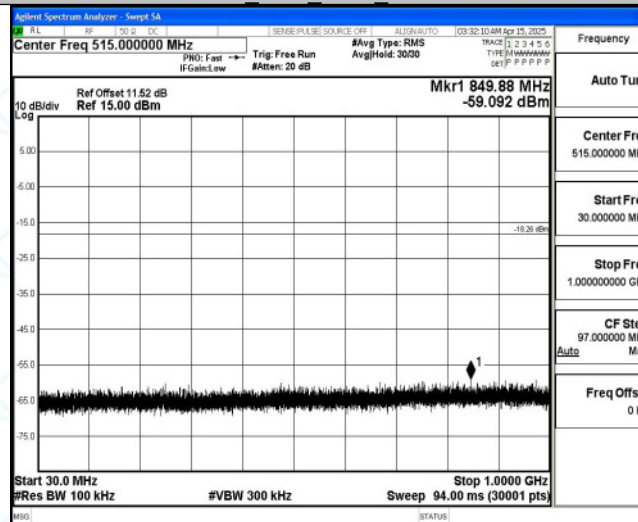
## 2DH5\_Ant1\_2402\_30~1000

| TestMode | Antenna | Freq(MHz) | FreqRange [MHz] | RefLevel [dBm] | Result [dBm] | Limit [dBm] | Verdict |
|---|---|---|---|---|---|---|---|
| | | | 30~1000 | 1.74 | -59.09 | $\leq -18.26$ | PASS |

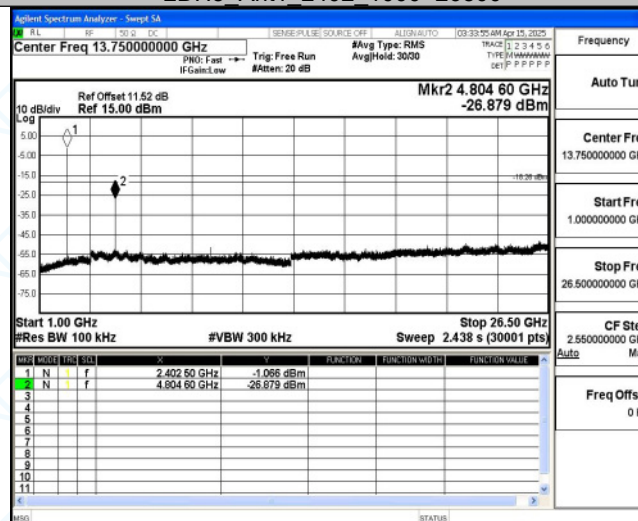
## 2DH5\_Ant1\_2402\_1000~26500

| TestMode | Antenna | Freq(MHz) | FreqRange [MHz] | RefLevel [dBm] | Result [dBm] | Limit [dBm] | Verdict |
|---|---|---|---|---|---|---|---|
| | | | 1000~26500 | 1.74 | -26.88 | $\leq -18.26$ | PASS |

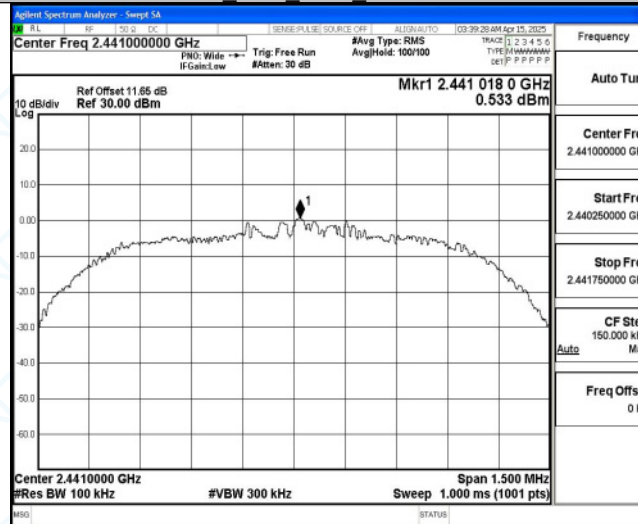
## 2DH5\_Ant1\_2441\_0~Reference

| TestMode | Antenna | Freq(MHz) | FreqRange [MHz] | RefLevel [dBm] | Result [dBm] | Limit [dBm] | Verdict |
|---|---|---|---|---|---|---|---|
| | | 2441 | Reference | 0.53 | 0.53 | --- | PASS |

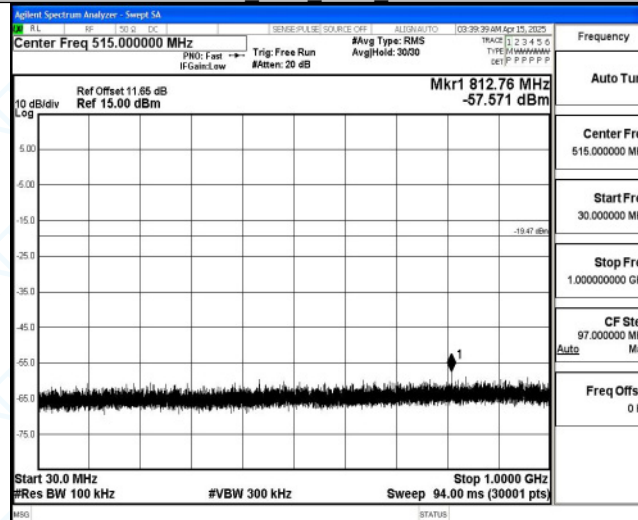
## 2DH5\_Ant1\_2441\_30~1000

| TestMode | Antenna | Freq(MHz) | FreqRange [MHz] | RefLevel [dBm] | Result [dBm] | Limit [dBm] | Verdict |
|---|---|---|---|---|---|---|---|
| | | | 30~1000 | 0.53 | -57.57 | $\leq -19.47$ | PASS |

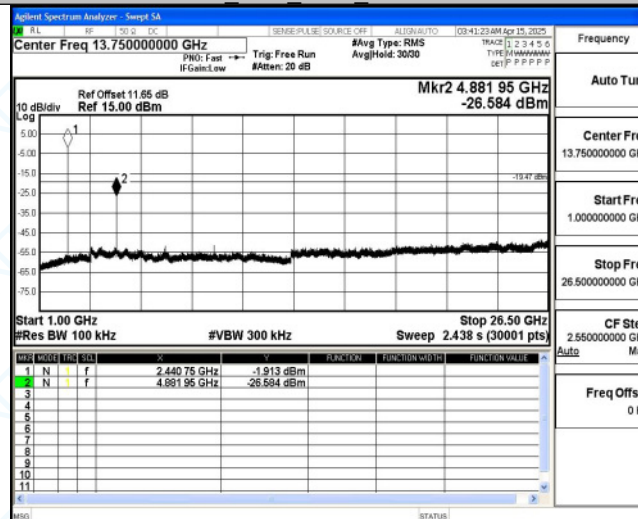
## 2DH5\_Ant1\_2441\_1000~26500

| TestMode | Antenna | Freq(MHz) | FreqRange [MHz] | RefLevel [dBm] | Result [dBm] | Limit [dBm] | Verdict |
|---|---|---|---|---|---|---|---|
| | | | 1000~26500 | 0.53 | -26.58 | $\leq -19.47$ | PASS |

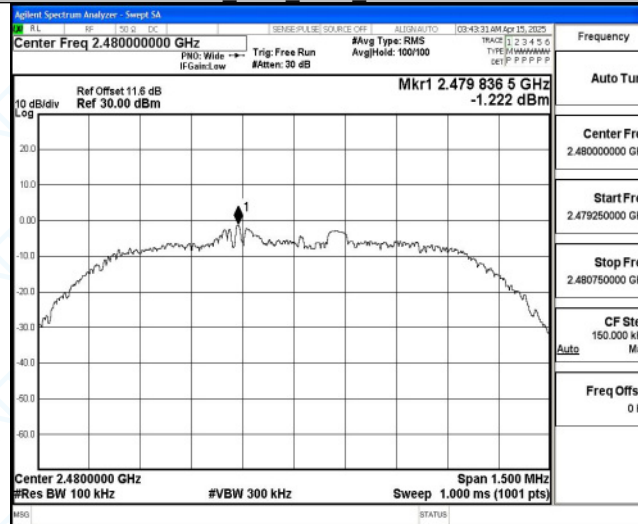
## 2DH5\_Ant1\_2480\_0~Reference

| TestMode | Antenna | Freq(MHz) | FreqRange [MHz] | RefLevel [dBm] | Result [dBm] | Limit [dBm] | Verdict |
|---|---|---|---|---|---|---|---|
| | | 2480 | Reference | -1.22 | -1.22 | --- | PASS |

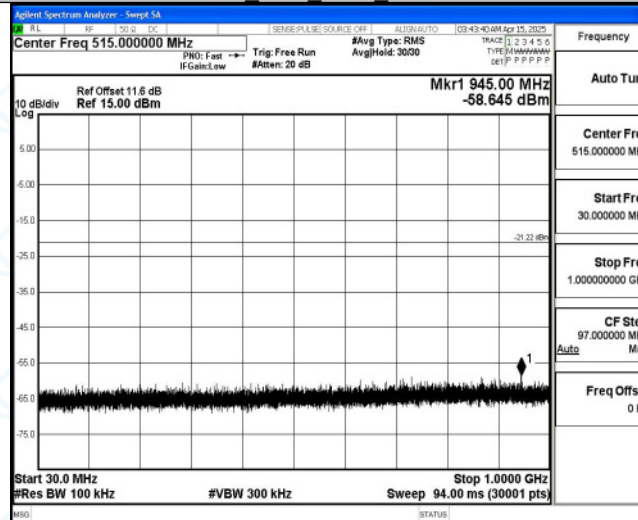
## 2DH5\_Ant1\_2480\_30~1000

| TestMode | Antenna | Freq(MHz) | FreqRange [MHz] | RefLevel [dBm] | Result [dBm] | Limit [dBm] | Verdict |
|---|---|---|---|---|---|---|---|
| | | | 30~1000 | -1.22 | -58.65 | $\leq -21.22$ | PASS |

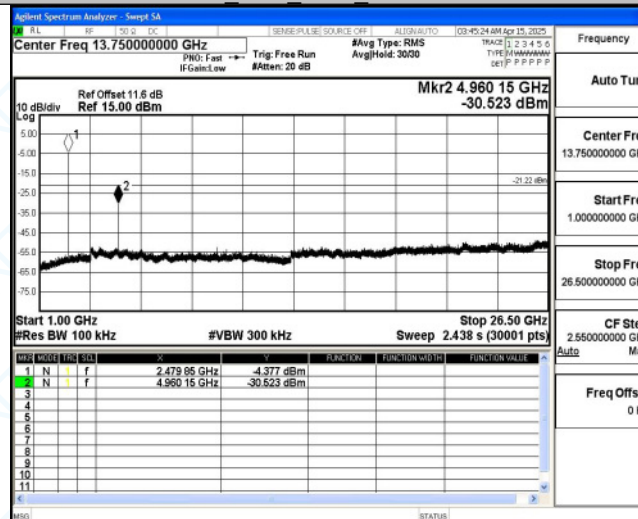
## 2DH5\_Ant1\_2480\_1000~26500

| TestMode | Antenna | Freq(MHz) | FreqRange [MHz] | RefLevel [dBm] | Result [dBm] | Limit [dBm] | Verdict |
|---|---|---|---|---|---|---|---|
| | | | 1000~26500 | -1.22 | -30.52 | $\leq -21.22$ | PASS |

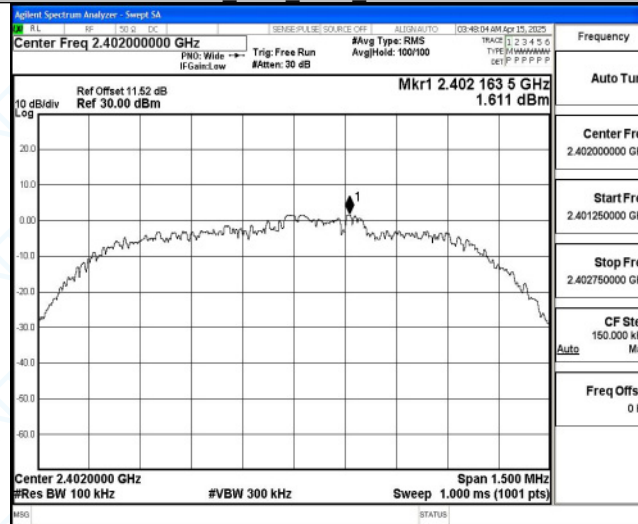
## 3DH5\_Ant1\_2402\_0~Reference

| TestMode | Antenna | Freq(MHz) | FreqRange [MHz] | RefLevel [dBm] | Result [dBm] | Limit [dBm] | Verdict |
|---|---|---|---|---|---|---|---|
| 3DH5 | Ant1 | 2402 | Reference | 1.61 | 1.61 | --- | PASS |

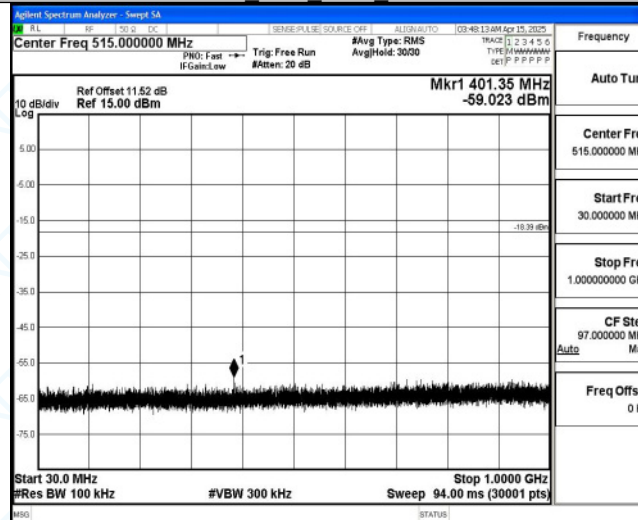
## 3DH5\_Ant1\_2402\_30~1000

| TestMode | Antenna | Freq(MHz) | FreqRange [MHz] | RefLevel [dBm] | Result [dBm] | Limit [dBm] | Verdict |
|---|---|---|---|---|---|---|---|
| | | | 30~1000 | 1.61 | -59.02 | $\leq -18.39$ | PASS |

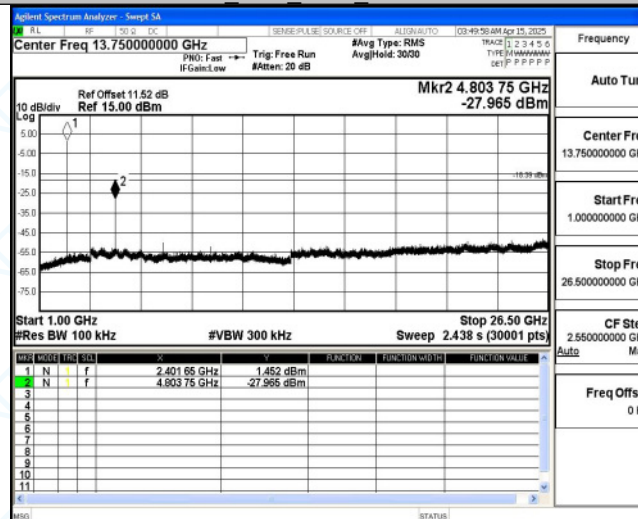
## 3DH5\_Ant1\_2402\_1000~26500

| TestMode | Antenna | Freq(MHz) | FreqRange [MHz] | RefLevel [dBm] | Result [dBm] | Limit [dBm] | Verdict |
|---|---|---|---|---|---|---|---|
| | | | 1000~26500 | 1.61 | -27.97 | $\leq -18.39$ | PASS |

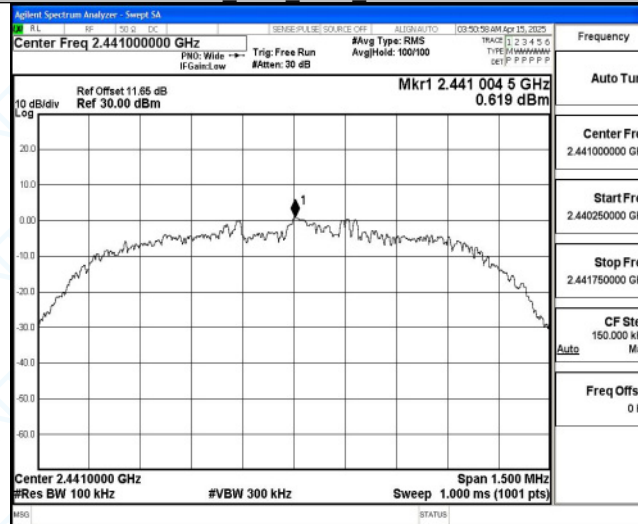
## 3DH5\_Ant1\_2441\_0~Reference

| TestMode | Antenna | Freq(MHz) | FreqRange [MHz] | RefLevel [dBm] | Result [dBm] | Limit [dBm] | Verdict |
|---|---|---|---|---|---|---|---|
| | | 2441 | Reference | 0.62 | 0.62 | --- | PASS |

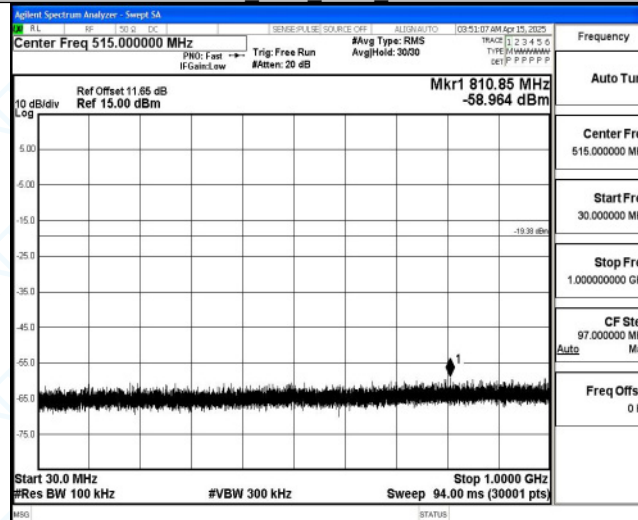
## 3DH5\_Ant1\_2441\_30~1000

| TestMode | Antenna | Freq(MHz) | FreqRange [MHz] | RefLevel [dBm] | Result [dBm] | Limit [dBm] | Verdict |
|---|---|---|---|---|---|---|---|
| | | | 30~1000 | 0.62 | -58.96 | $\leq -19.38$ | PASS |

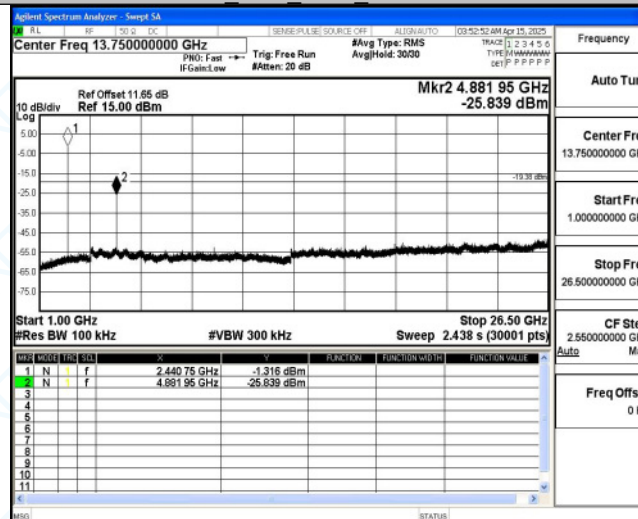
## 3DH5\_Ant1\_2441\_1000~26500

| TestMode | Antenna | Freq(MHz) | FreqRange [MHz] | RefLevel [dBm] | Result [dBm] | Limit [dBm] | Verdict |
|---|---|---|---|---|---|---|---|
| | | | 1000~26500 | 0.62 | -25.84 | $\leq -19.38$ | PASS |

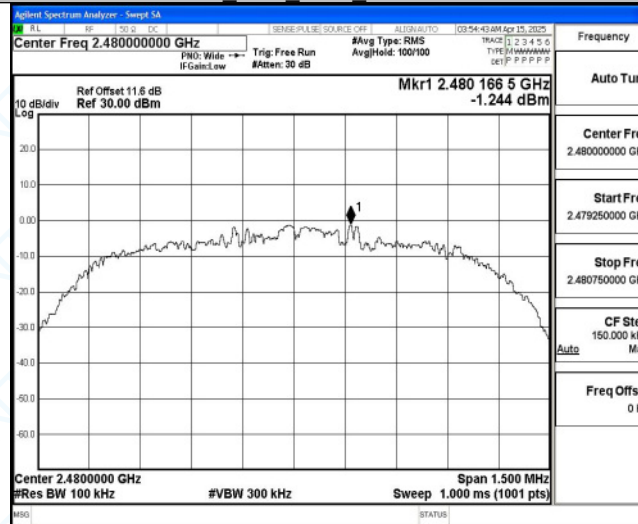
## 3DH5\_Ant1\_2480\_0~Reference

| TestMode | Antenna | Freq(MHz) | FreqRange [MHz] | RefLevel [dBm] | Result [dBm] | Limit [dBm] | Verdict |
|---|---|---|---|---|---|---|---|
| | | 2480 | Reference | -1.24 | -1.24 | --- | PASS |

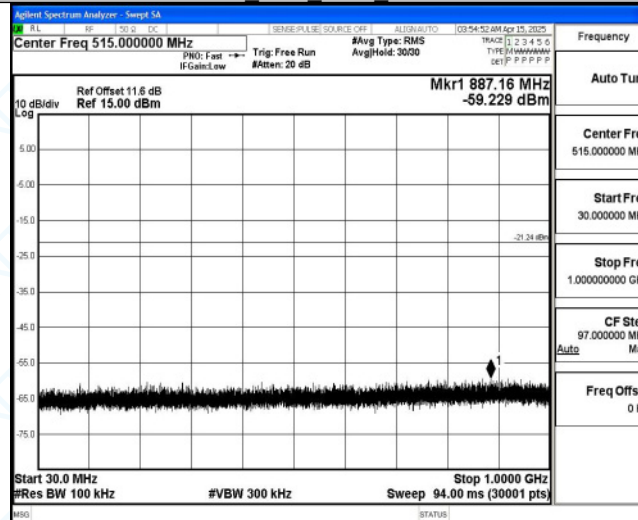
## 3DH5\_Ant1\_2480\_30~1000

| TestMode | Antenna | Freq(MHz) | FreqRange [MHz] | RefLevel [dBm] | Result [dBm] | Limit [dBm] | Verdict |
|---|---|---|---|---|---|---|---|
| | | | 30~1000 | -1.24 | -59.23 | $\leq -21.24$ | PASS |

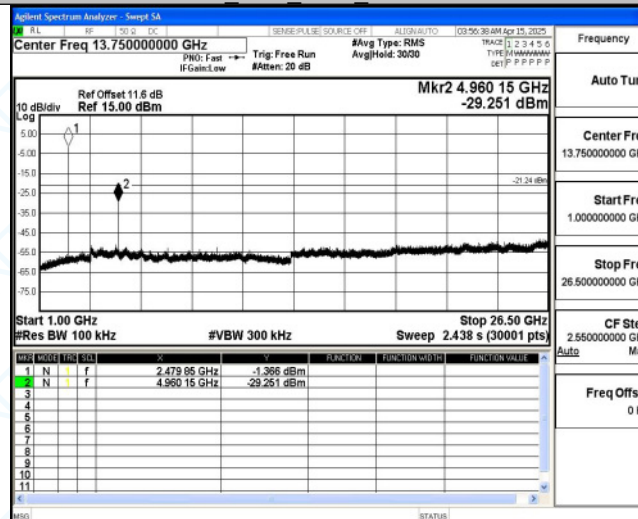
## 3DH5\_Ant1\_2480\_1000~26500

| TestMode | Antenna | Freq(MHz) | FreqRange [MHz] | RefLevel [dBm] | Result [dBm] | Limit [dBm] | Verdict |
|---|---|---|---|---|---|---|---|
| | | | 1000~26500 | -1.24 | -29.25 | $\leq -21.24$ | PASS |
