Reference to the test report no. BLA-EMC-202506-A4401

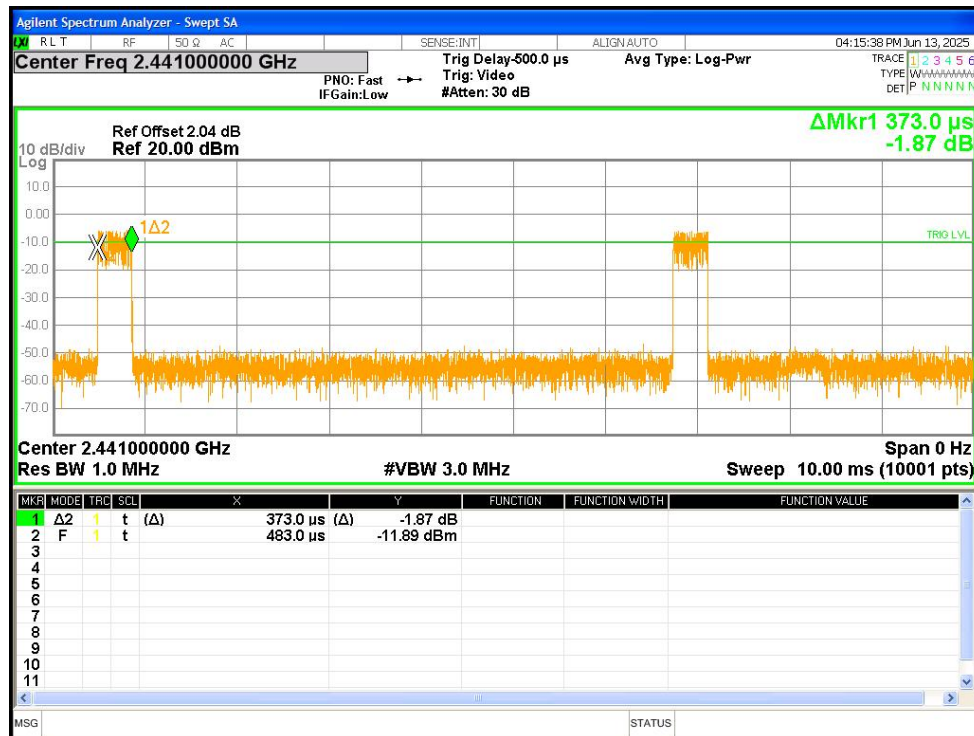
### Dwell NVNT 1-DH1 2441MHz Ant1 One Burst

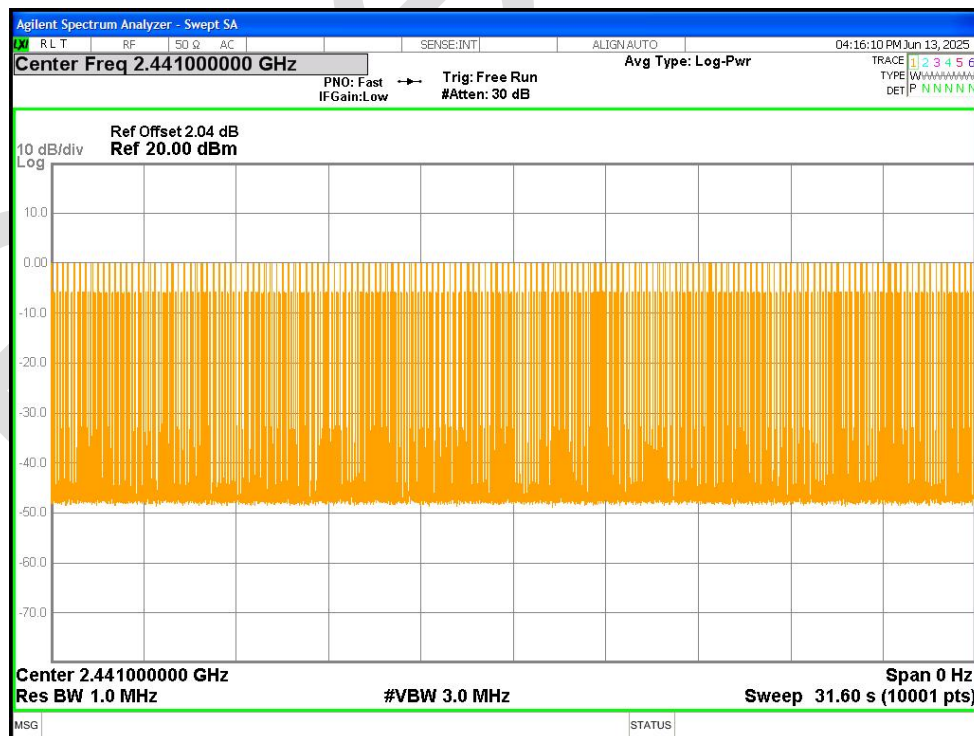
### Dwell NVNT 1-DH1 2441MHz Ant1 Accumulated

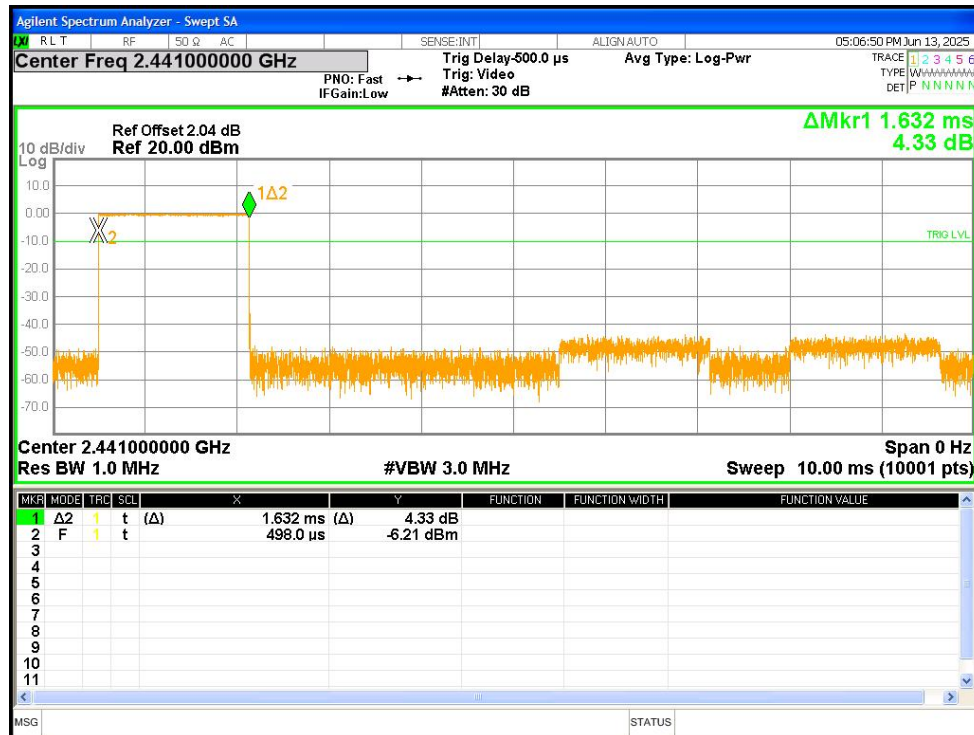
### Dwell NVNT 1-DH3 2441MHz Ant1 One Burst

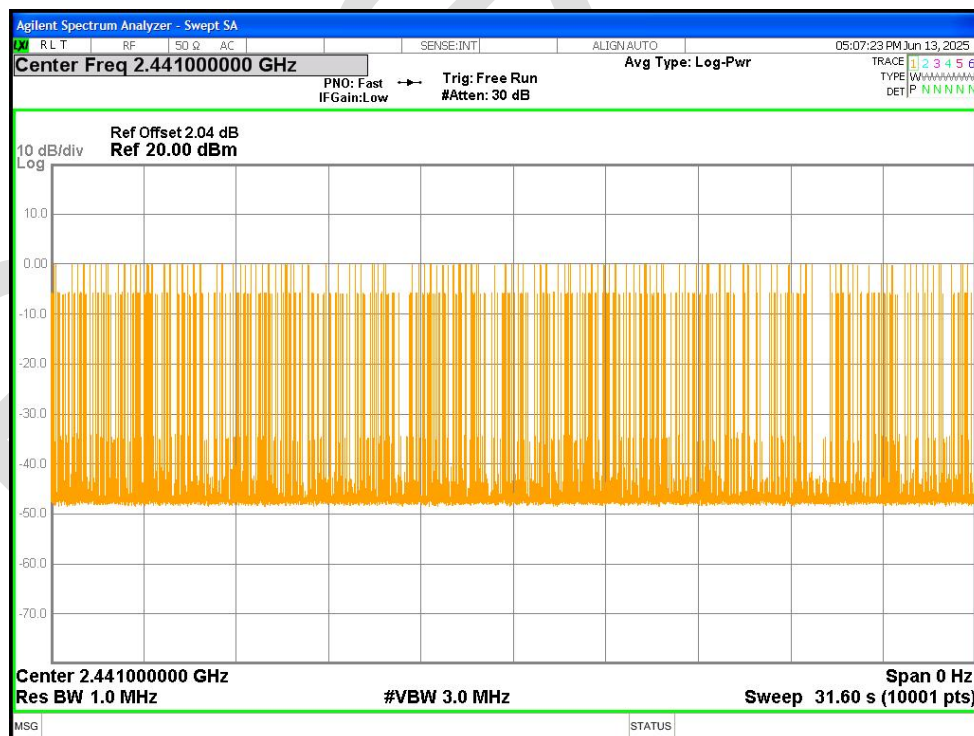
### Dwell NVNT 1-DH3 2441MHz Ant1 Accumulated

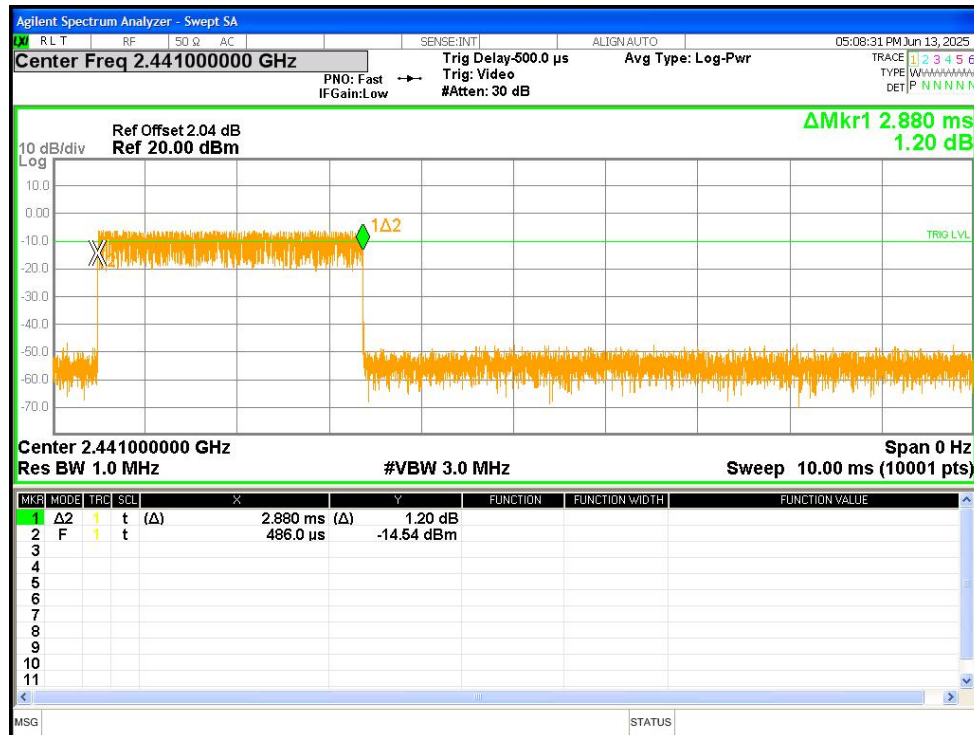
### Dwell NVNT 1-DH5 2441MHz Ant1 One Burst

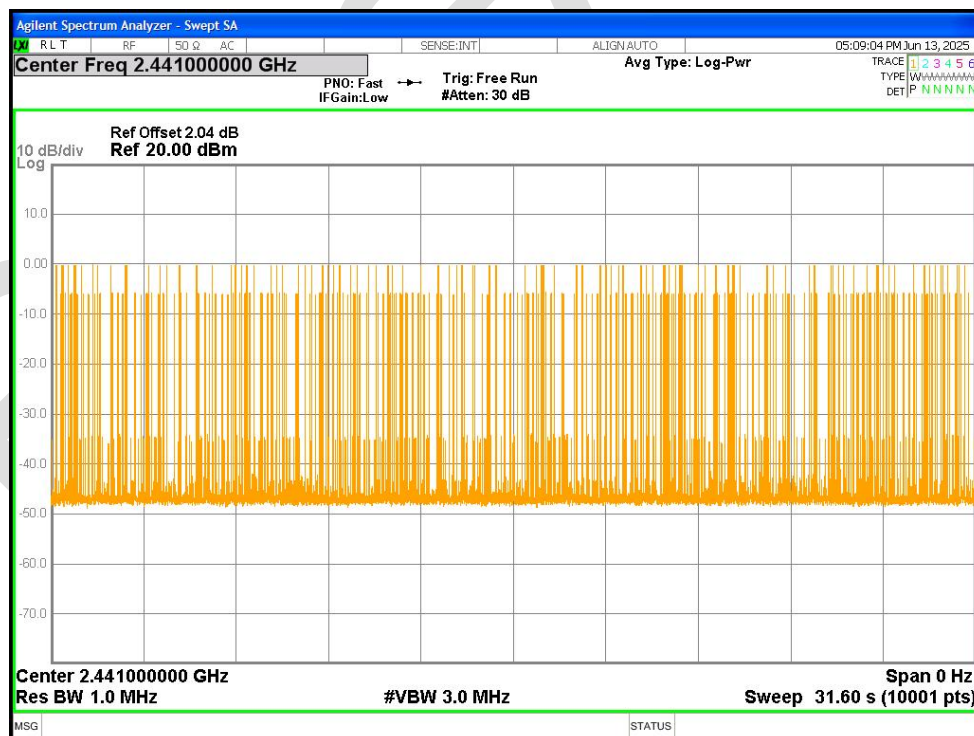
### Dwell NVNT 1-DH5 2441MHz Ant1 Accumulated

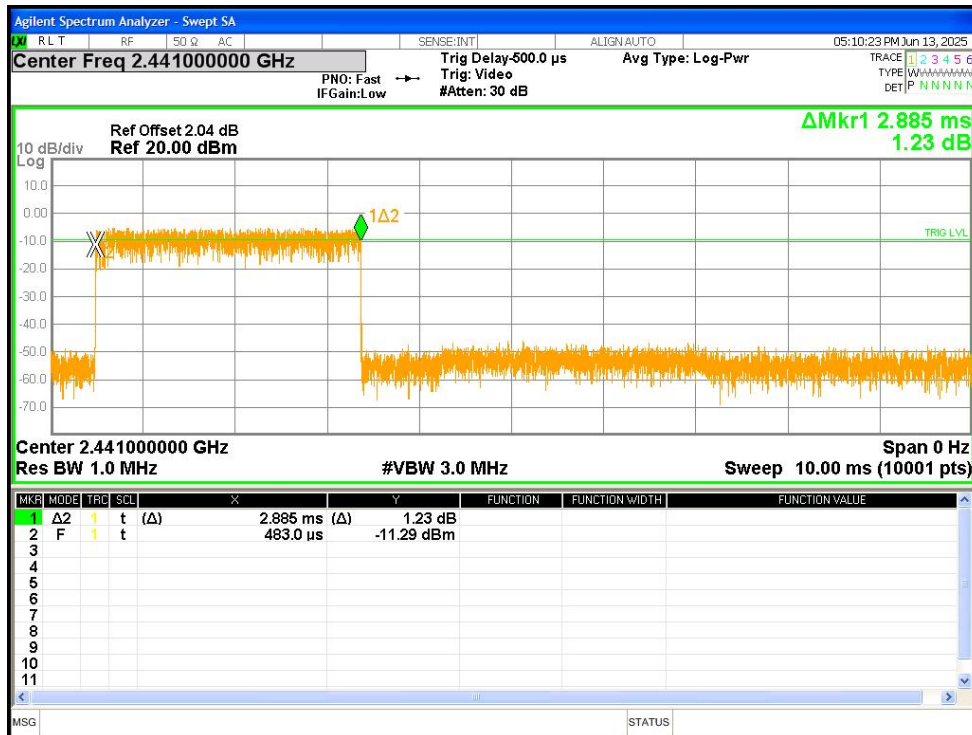
### Dwell NVNT 2-DH5 2441MHz Ant1 One Burst

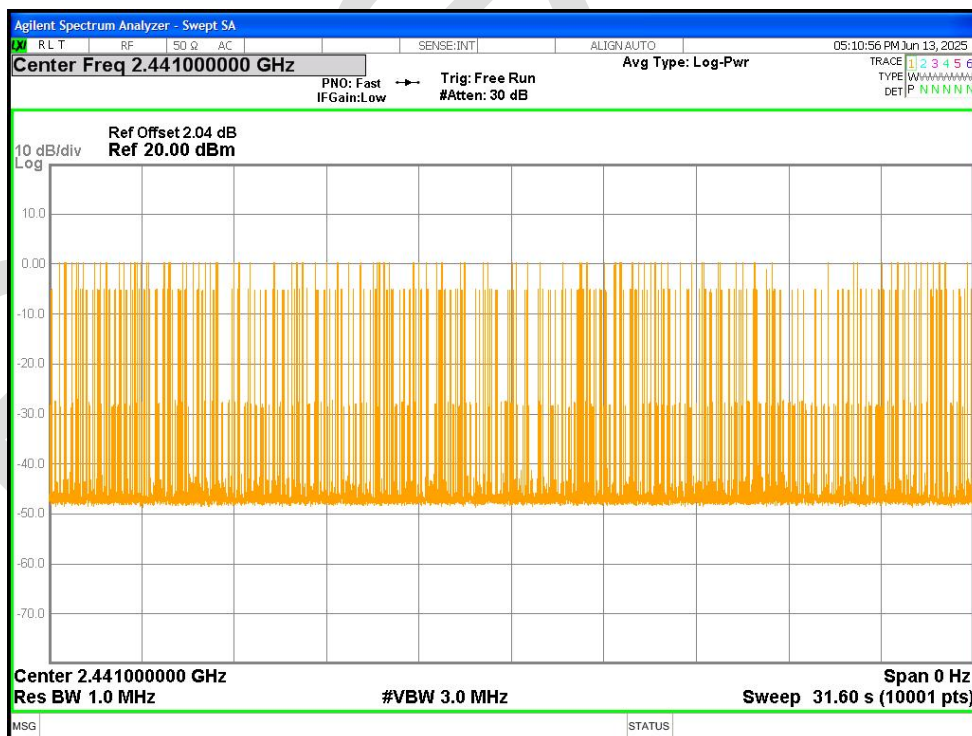
### Dwell NVNT 2-DH5 2441MHz Ant1 Accumulated

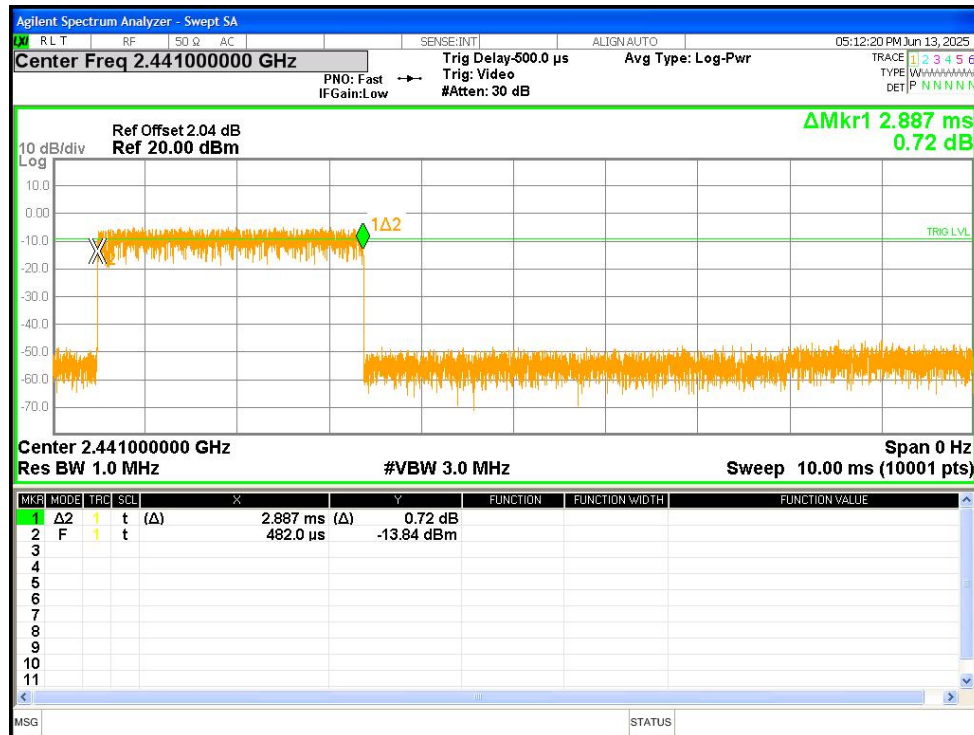
### Dwell NVNT 3-DH5 2441MHz Ant1 One Burst

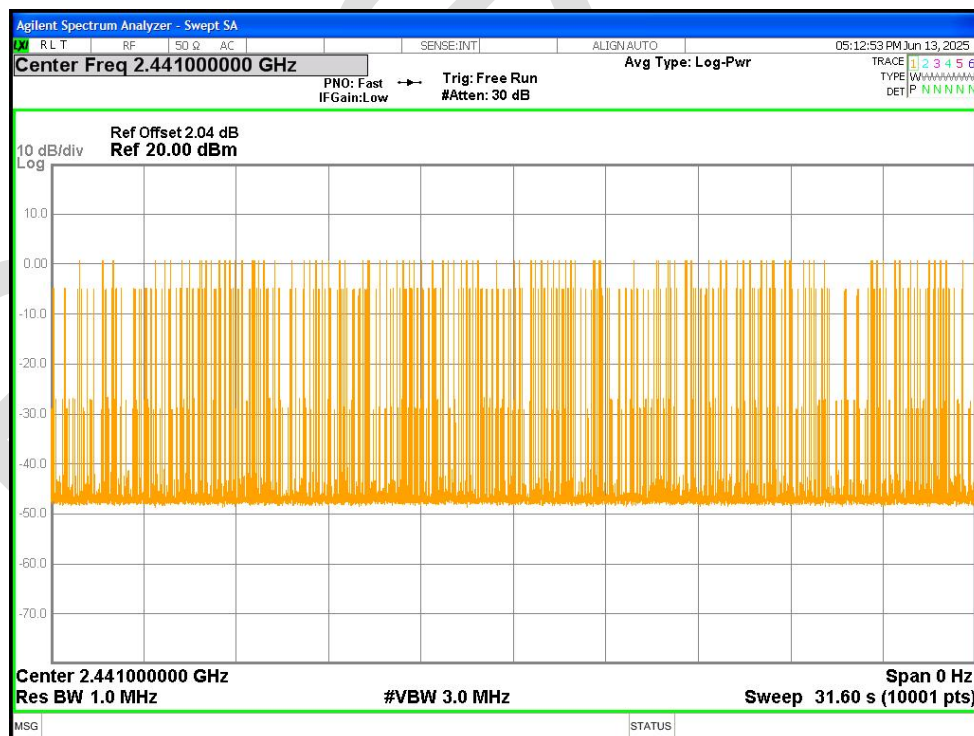
### Dwell NVNT 3-DH5 2441MHz Ant1 Accumulated

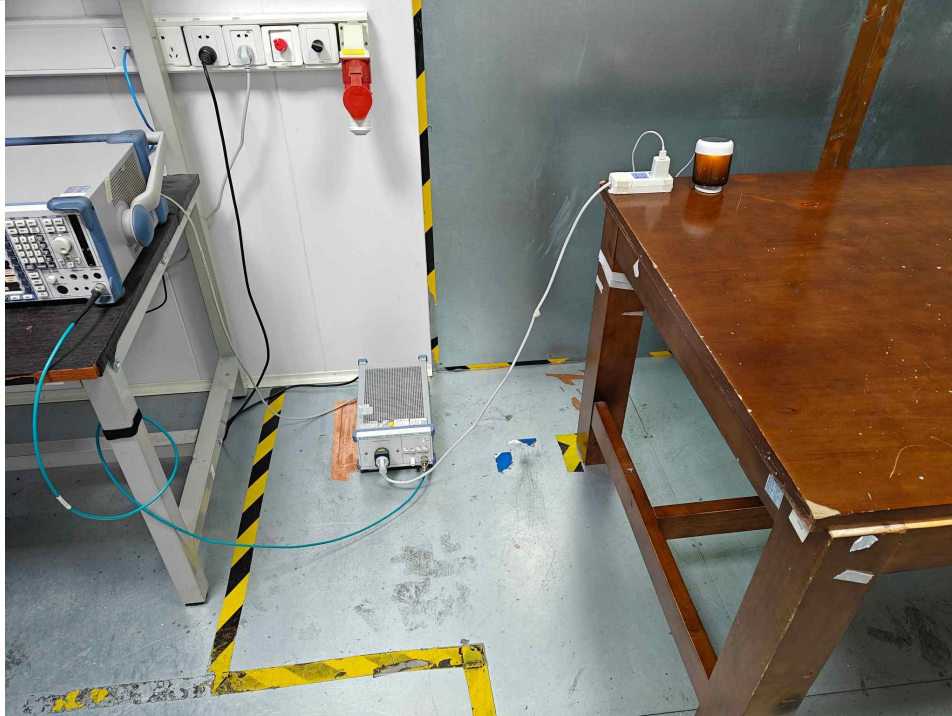
Conducted emissions at AC power line (150kHz-30MHz)

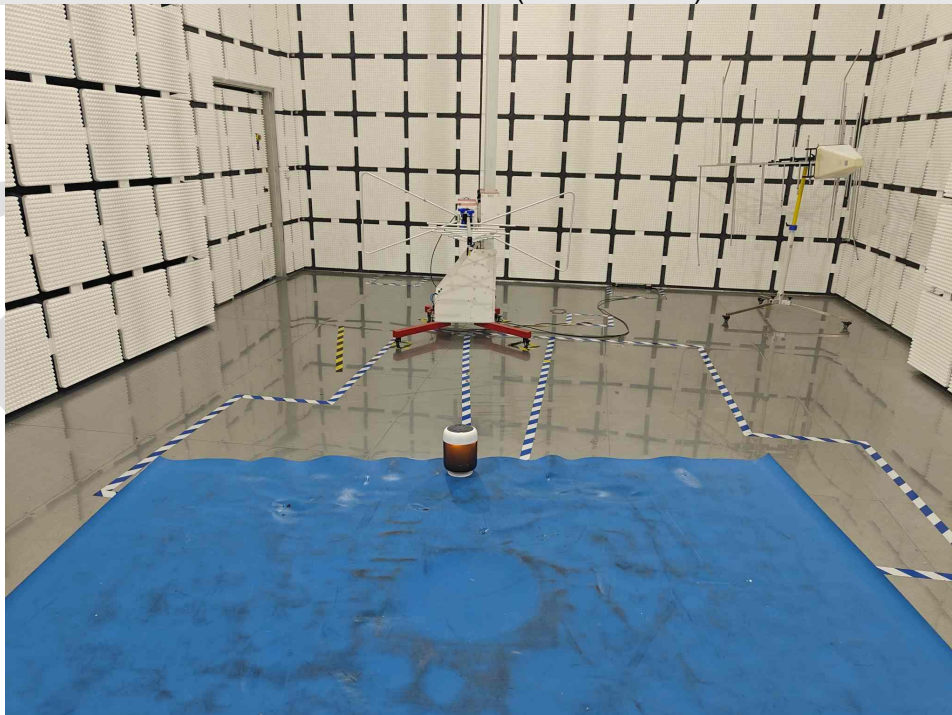
Radiated Emissions (30MHz-1GHz)

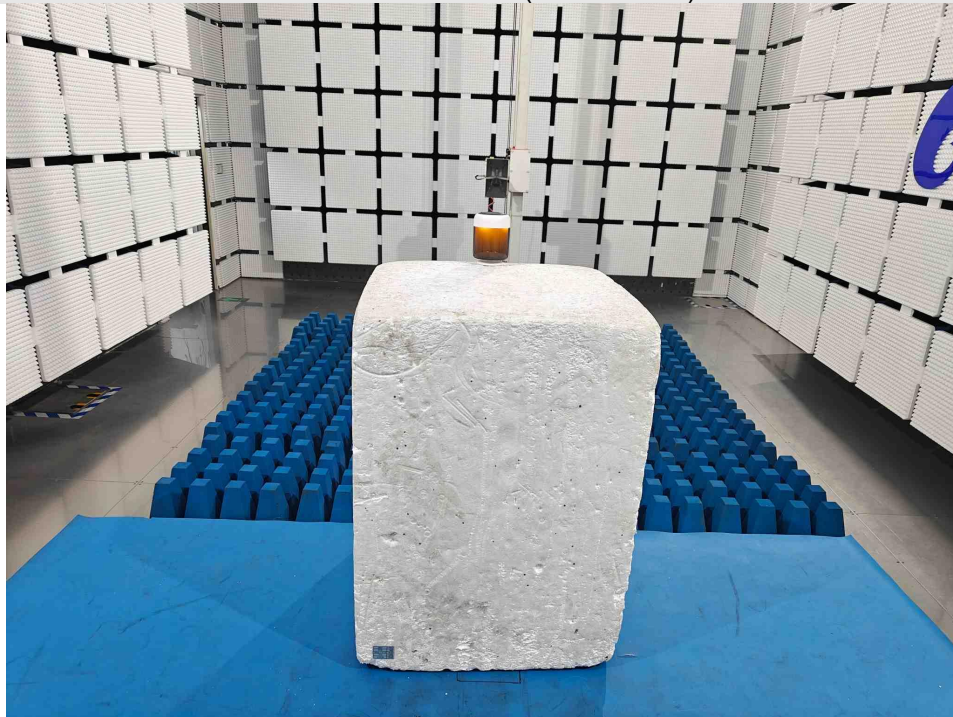
Radiated Emissions (above 1GHz)
