## Appendix B: photographs of test setup

## Appendix C: photographs of EUT

Reference to the test report no. BLA-EMC-202505-A0201

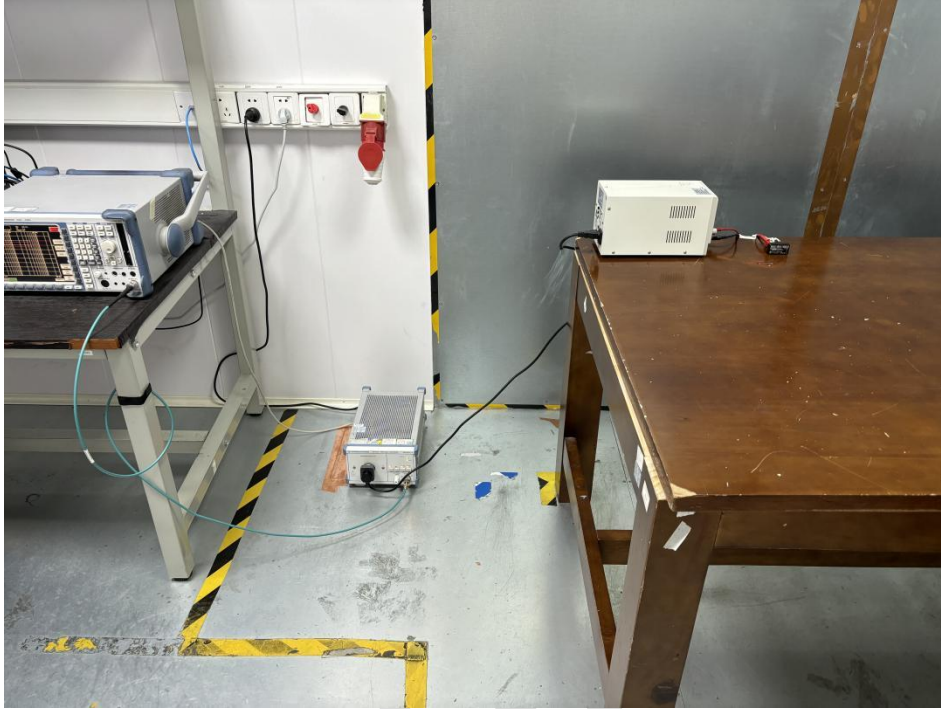
Conducted emissions at AC power line (150kHz-30MHz)

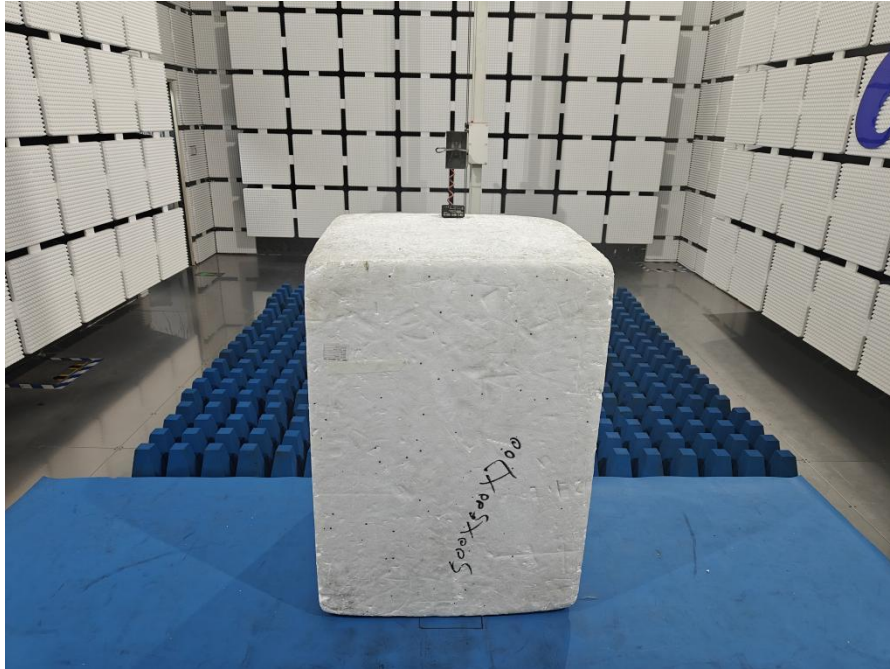
Radiated Emissions (above 1GHz)
