## 5. PHOTOGRAPHS

### 5.1. Photos of Powerline Conducted Measurement

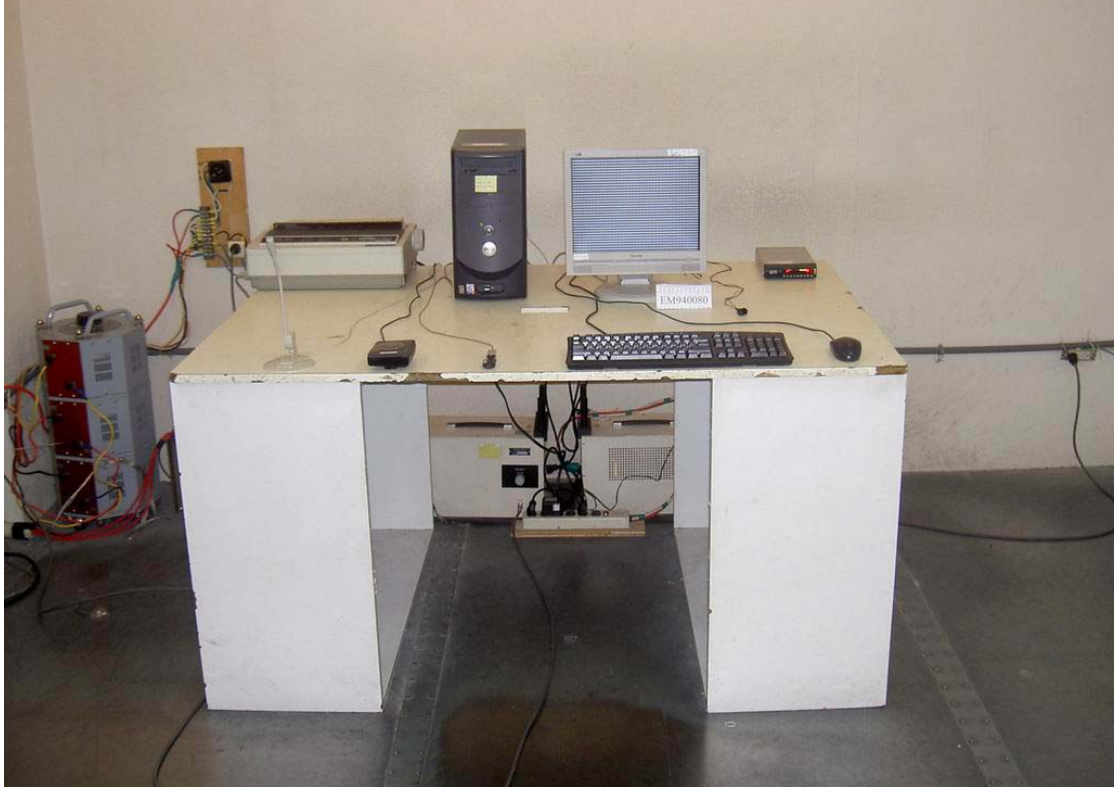
Test Model : 150B6

FRONT VIEW OF CONDUCTED TEST

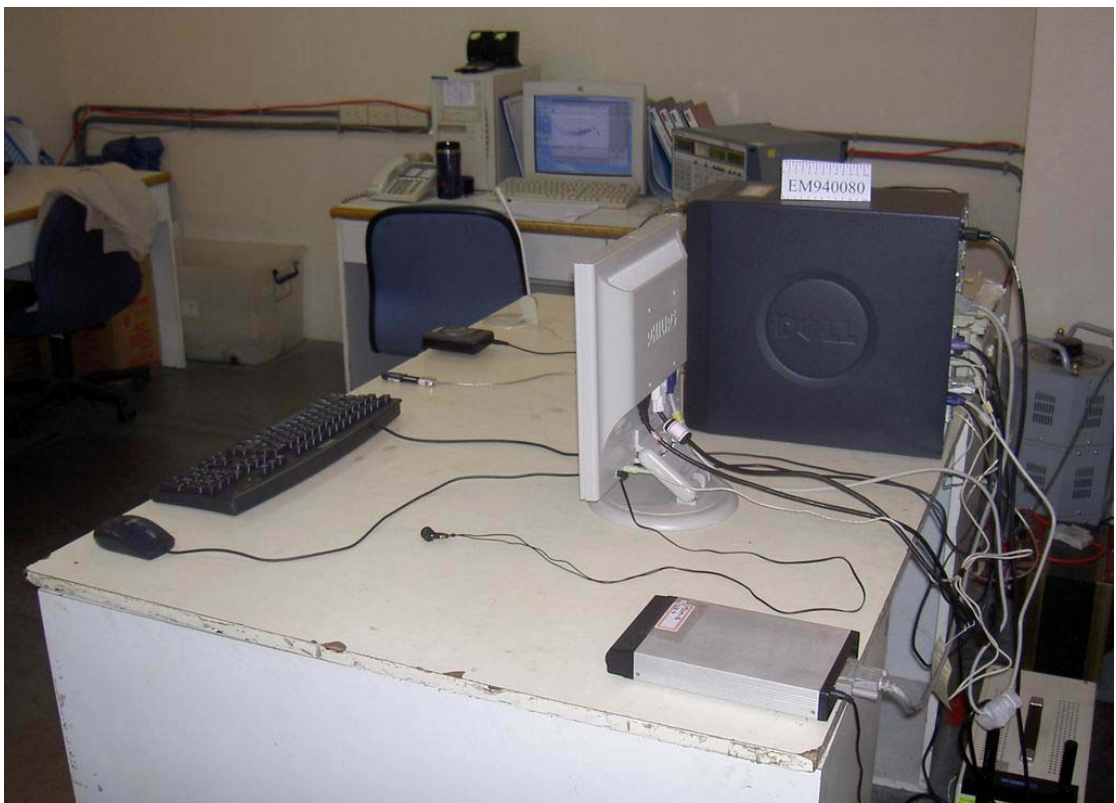
BACK VIEW OF CONDUCTED TEST

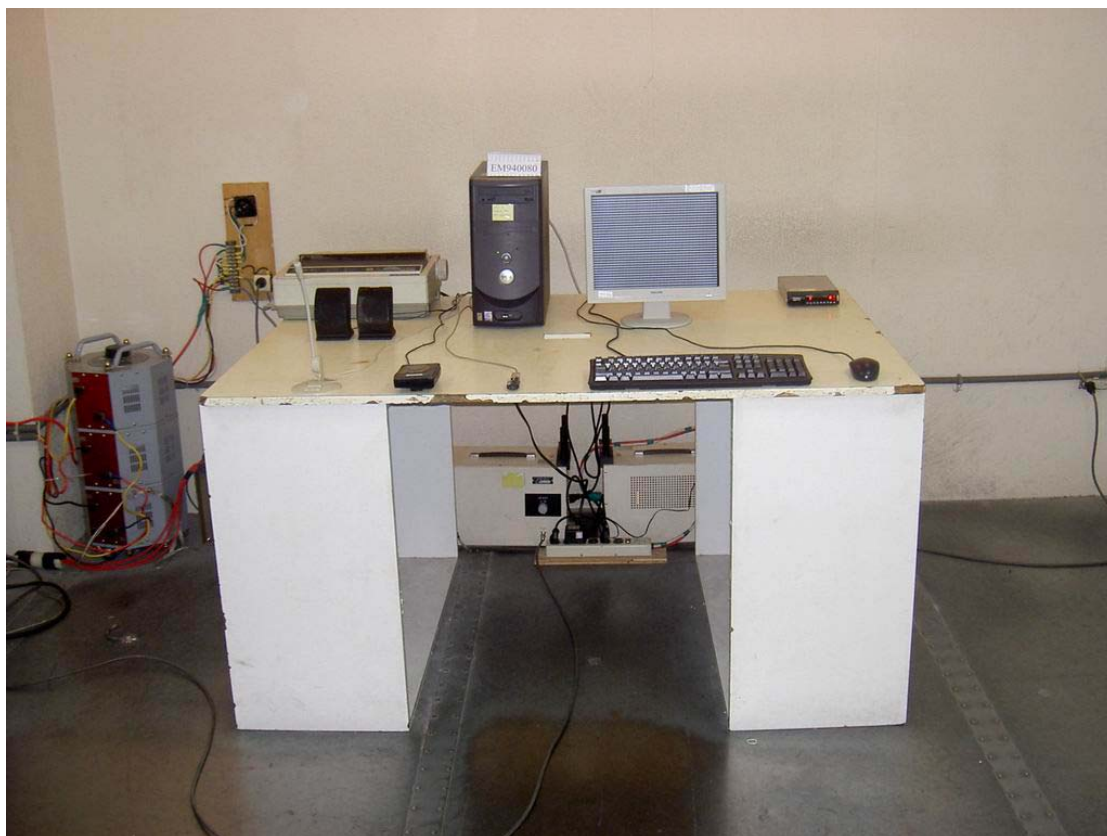
Test Model : 150S6

FRONT VIEW OF CONDUCTED TEST

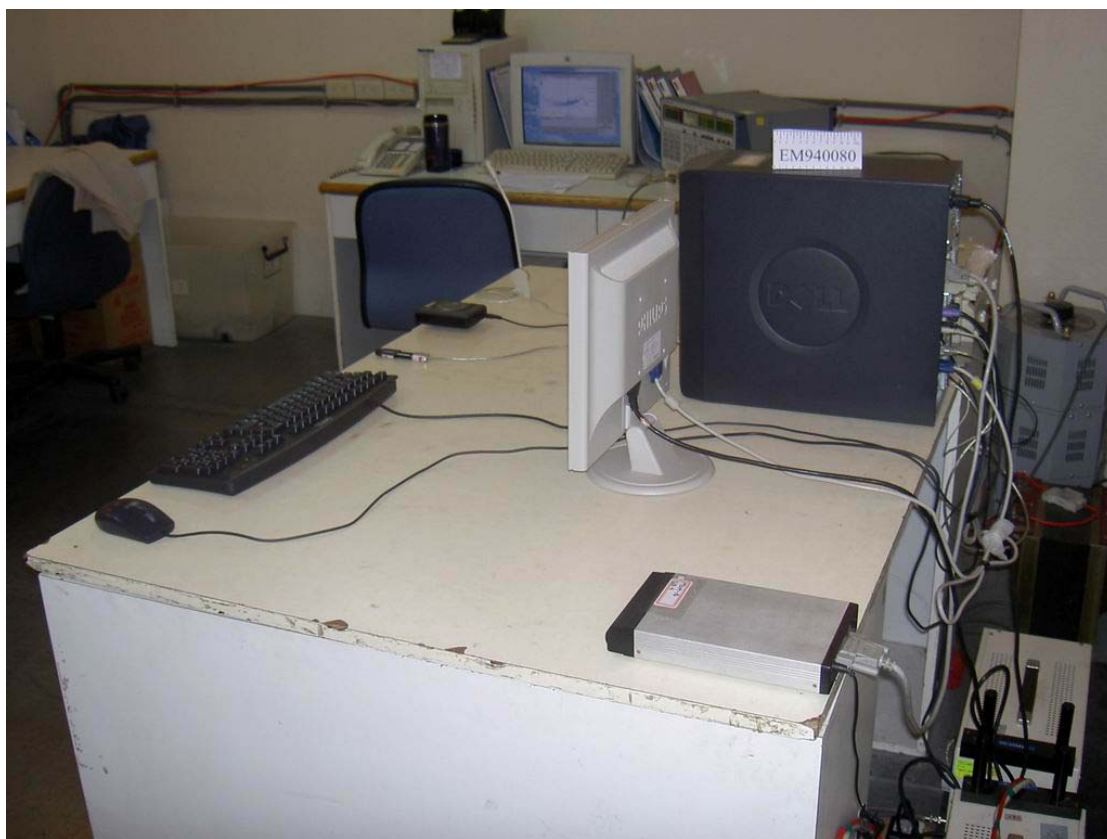
BACK VIEW OF CONDUCTED TEST

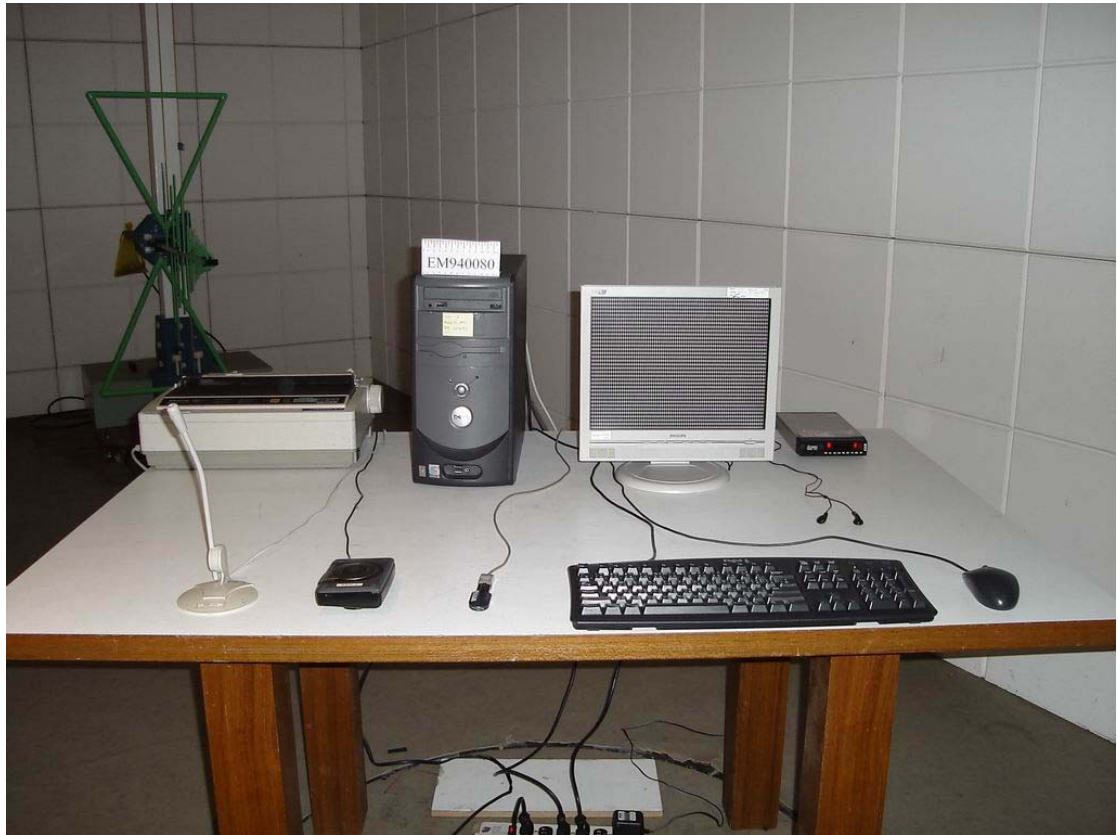
## 5.2. Photos of Radiated Measurement at Simple Anechoic Chamber (3m)

FRONT VIEW OF RADIATED TEST

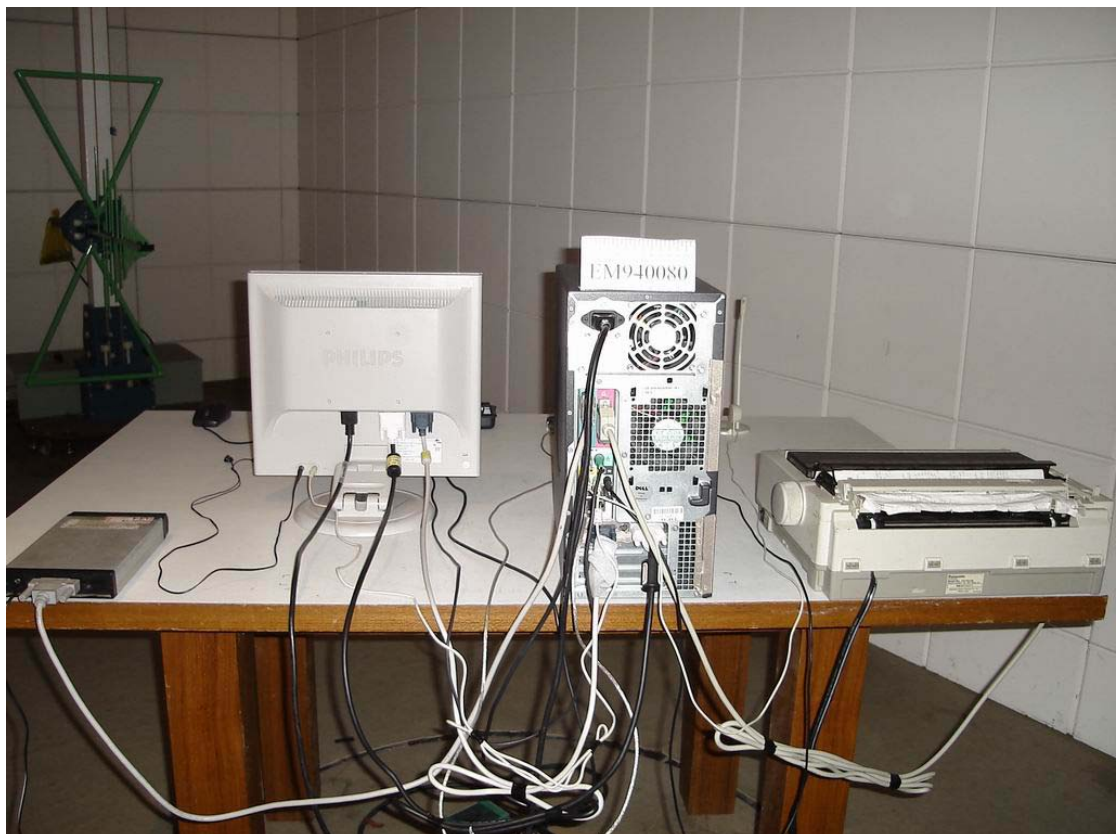
BACK VIEW OF RADIATED TEST

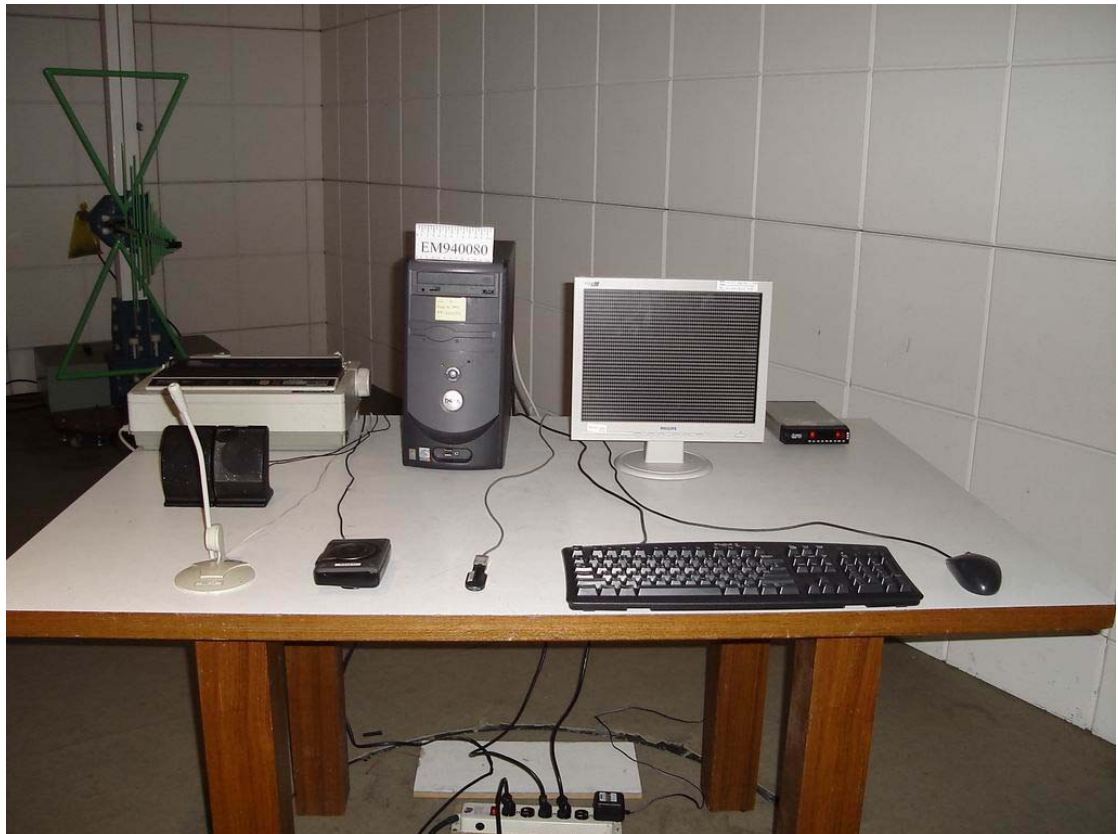
Test Model : 150S6

FRONT VIEW OF RADIATED TEST

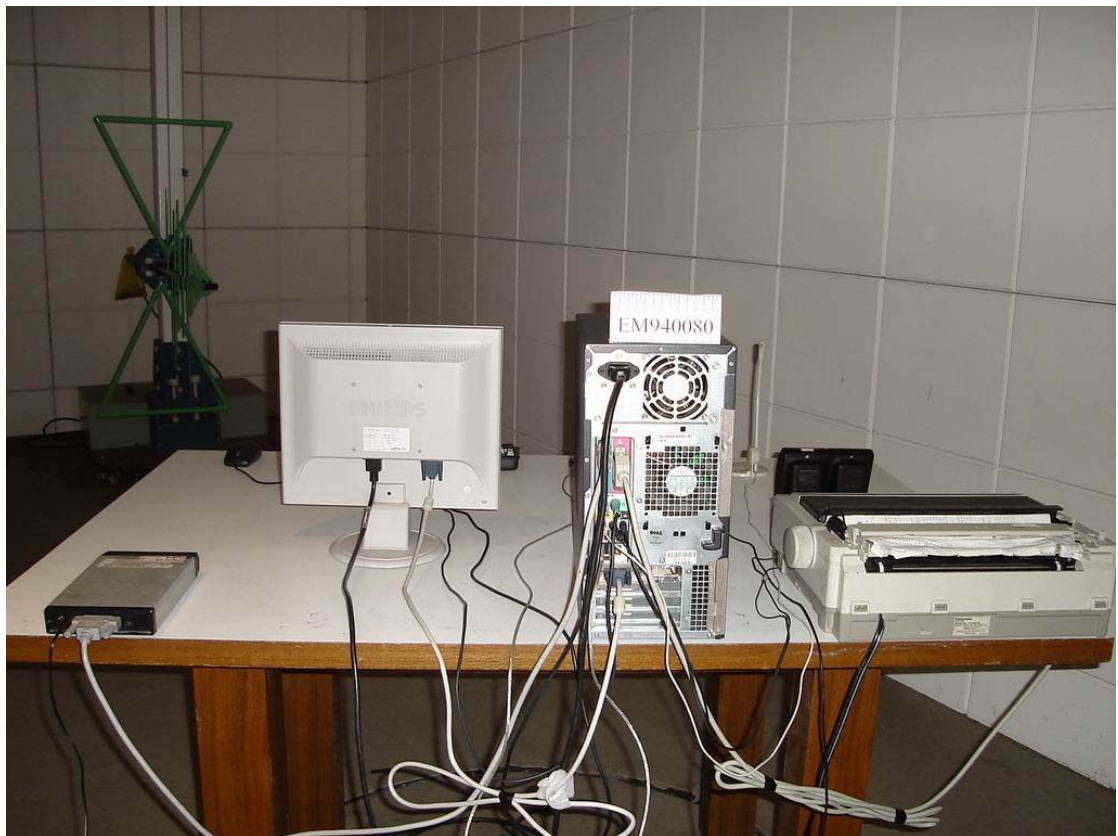
BACK VIEW OF RADIATED TEST

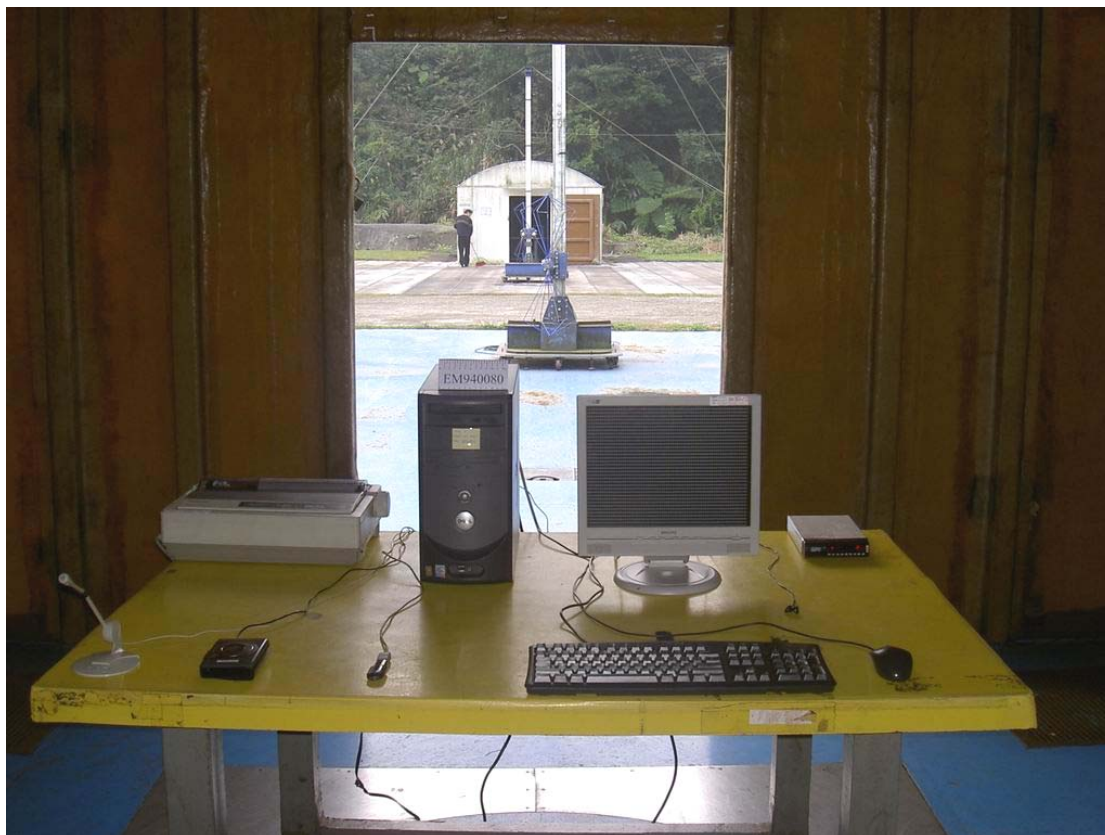
### 5.3. Photos of Radiated Measurement at Open Area Test Site (10m)

FRONT VIEW OF RADIATED TEST

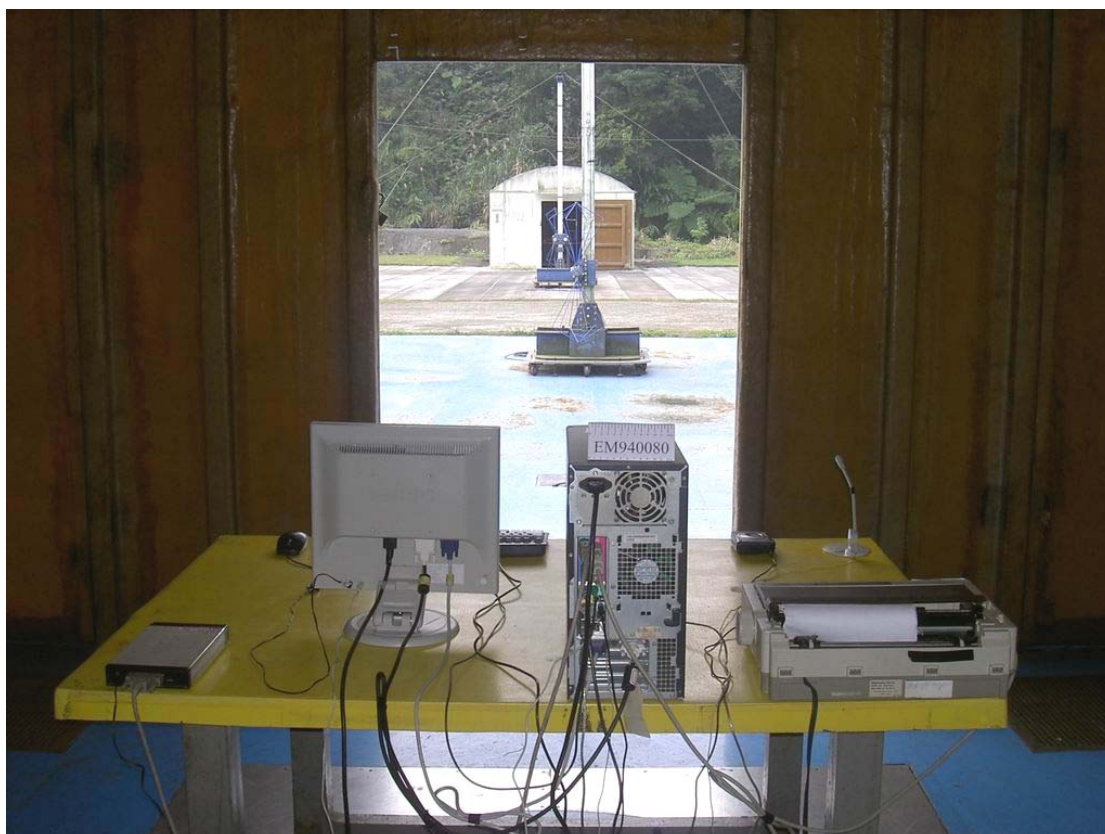
BACK VIEW OF RADIATED TEST

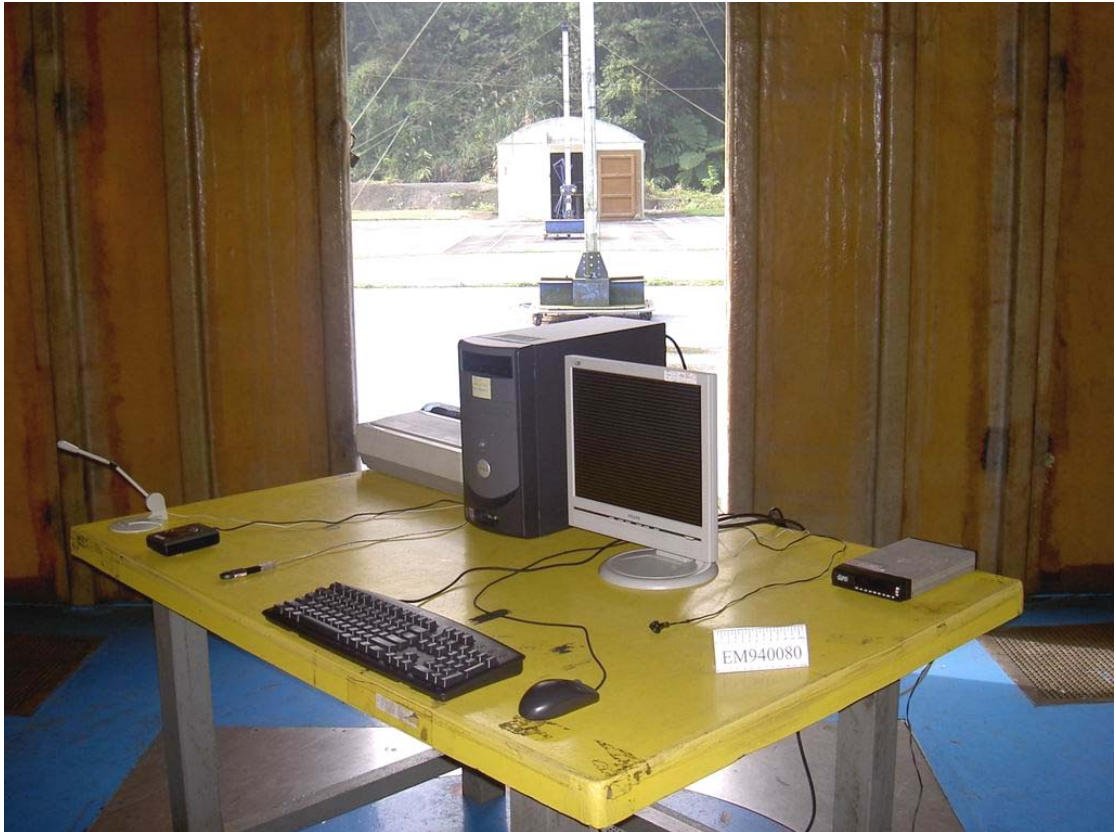
Test Mode : M/N 150B6, S/N TY0404779 (1024\*768/75Hz, 60kHz), DVI Cable

SETUP WITH MAXIMUM DETECTED EMISSION AT HORIZONTAL POLARIZATION

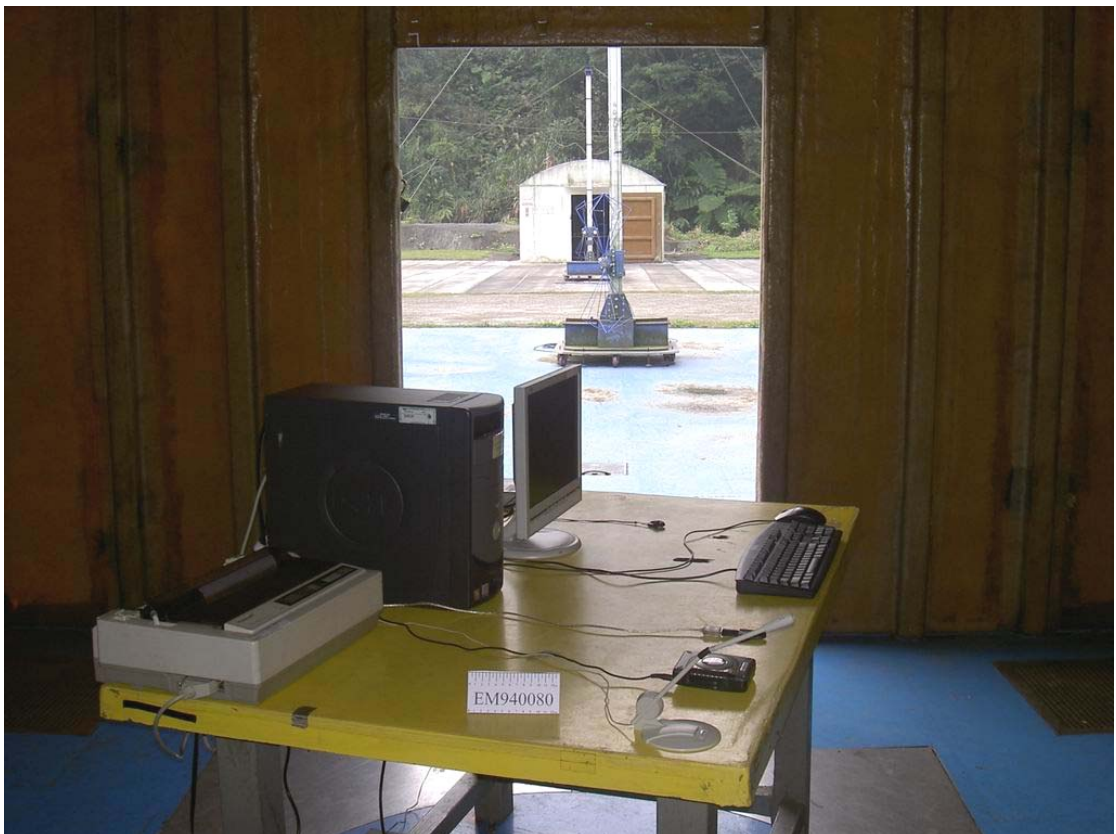
SETUP WITH MAXIMUM DETECTED EMISSION AT VERTICAL POLARIZATION

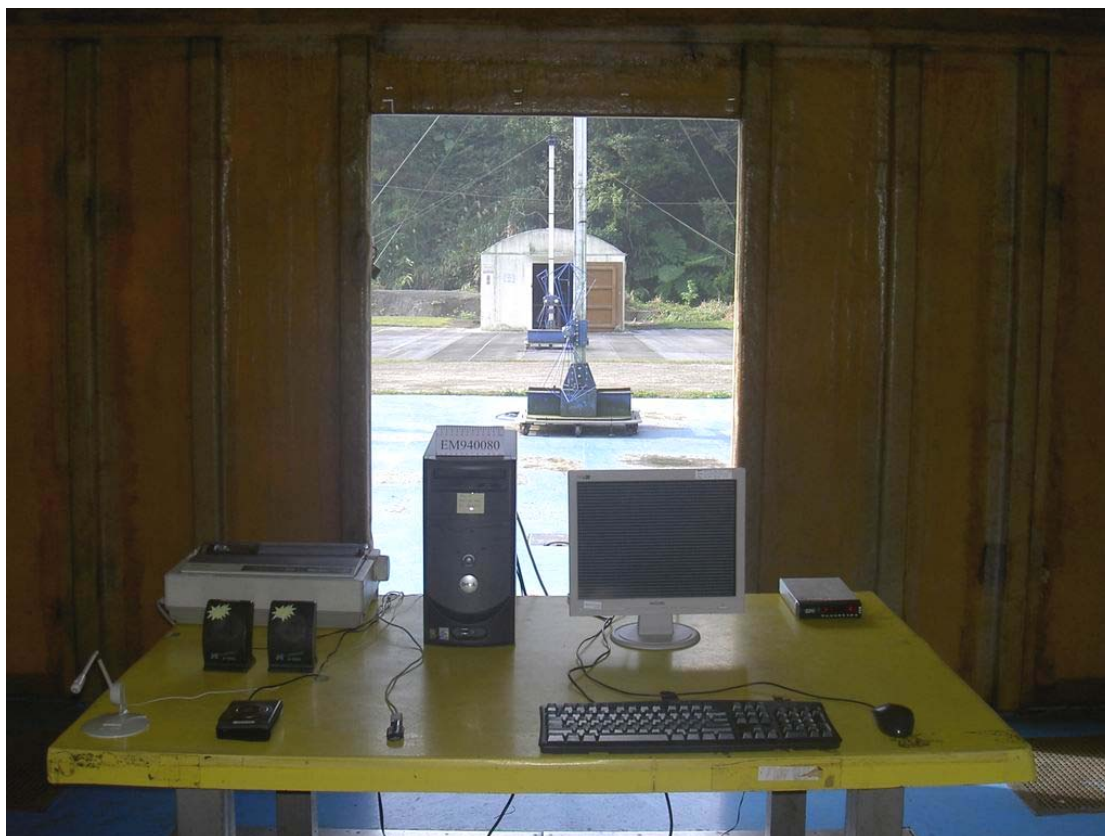
Test Model : 150S6

FRONT VIEW OF RADIATED TEST

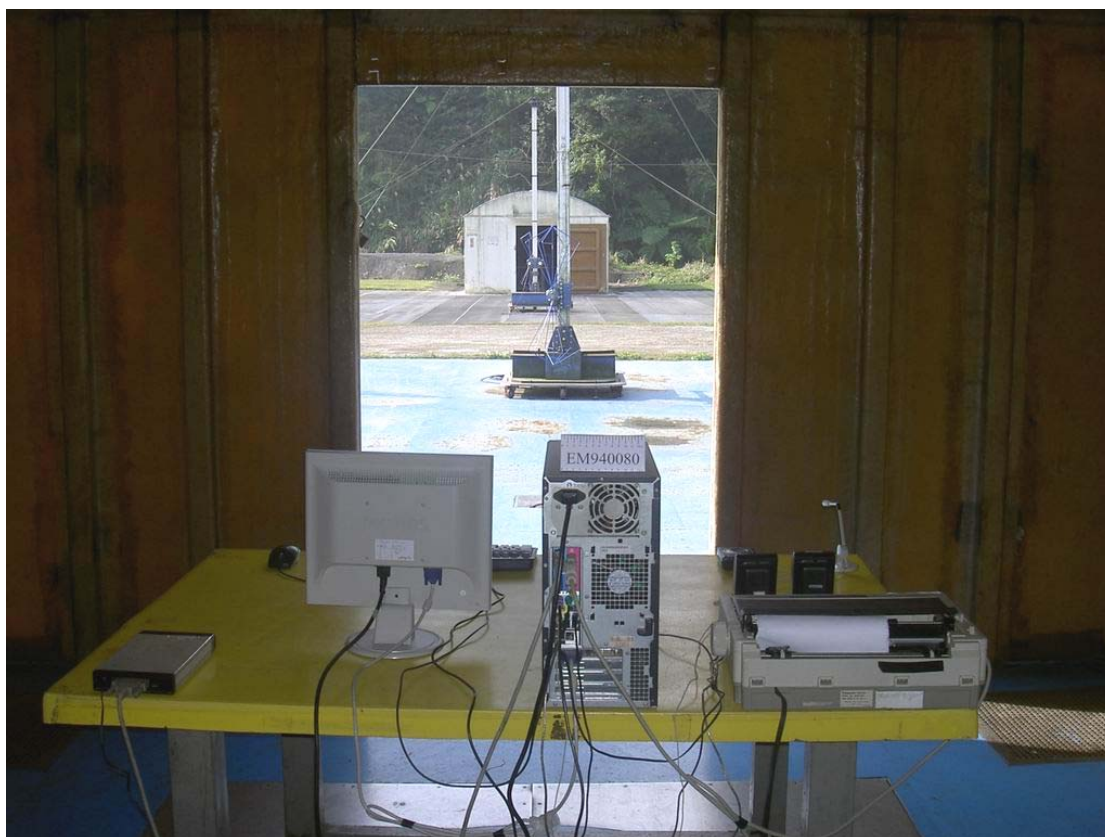
BACK VIEW OF RADIATED TEST

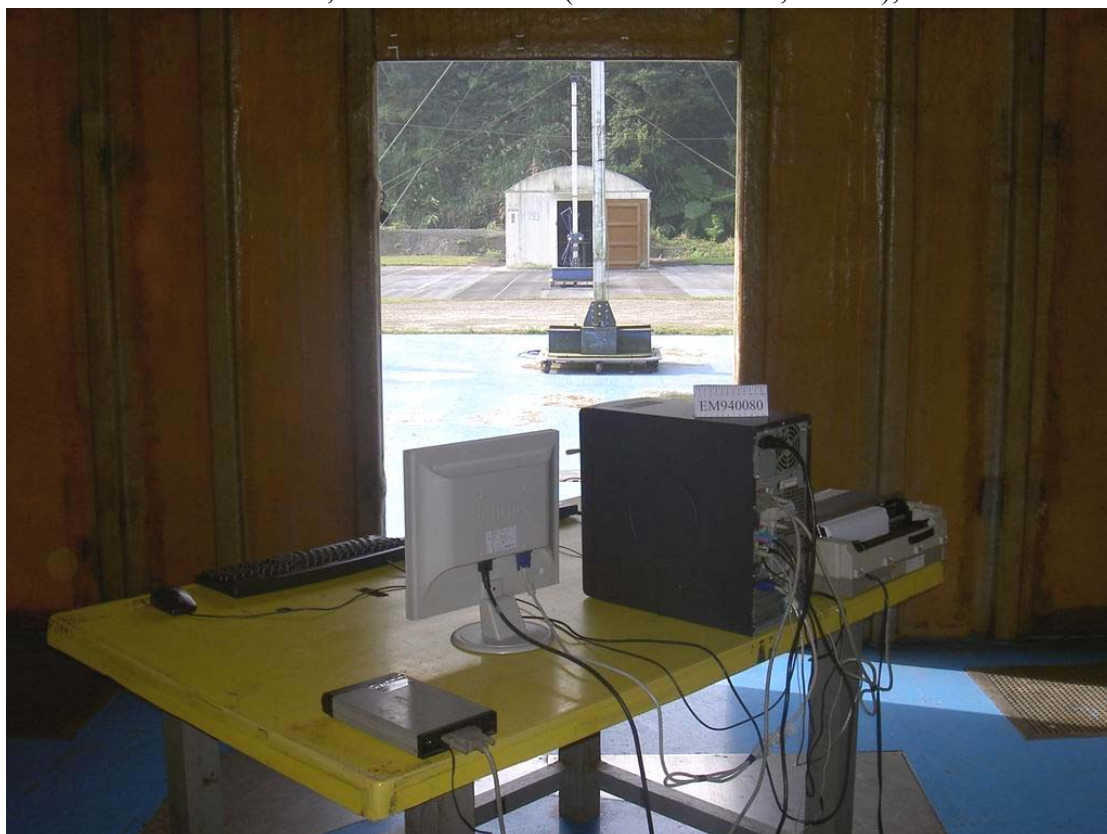
Test Mode : M/N 150S6, S/N TY0404742 (1024\*768/75Hz, 60kHz), D-Sub Cable

SETUP WITH MAXIMUM DETECTED EMISSION AT HORIZONTAL POLARIZATION

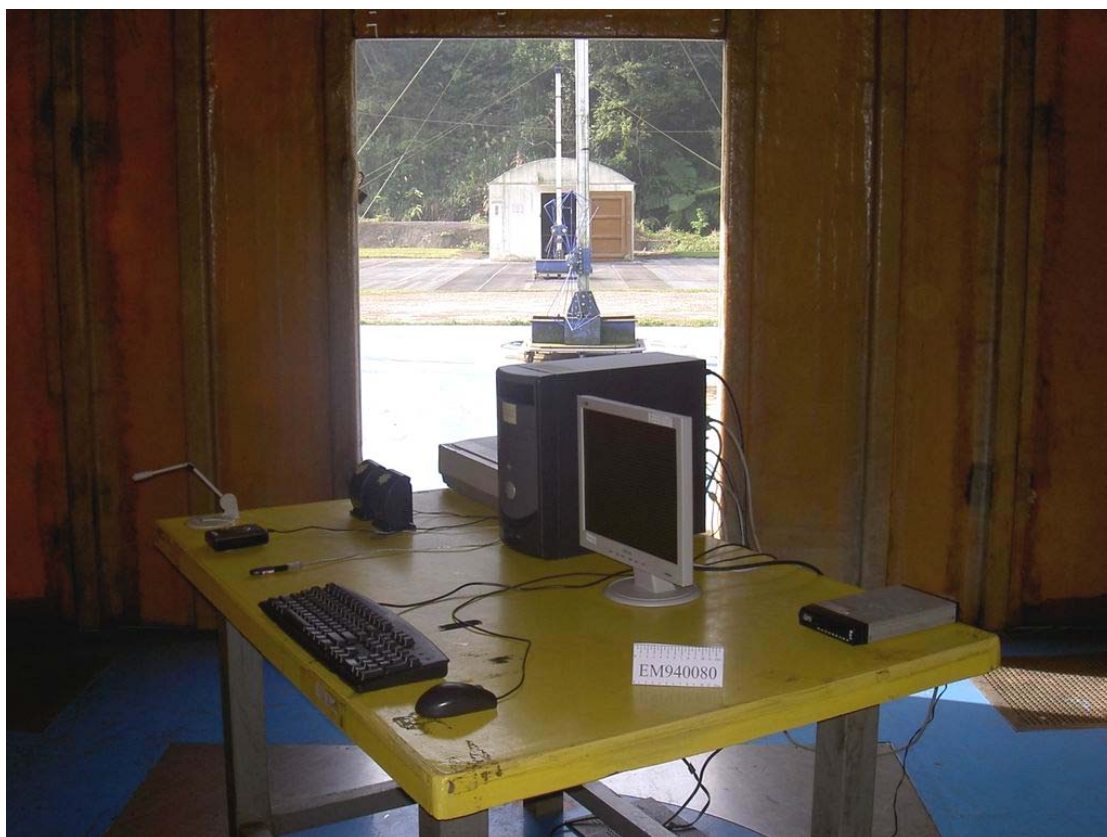
SETUP WITH MAXIMUM DETECTED EMISSION AT VERTICAL POLARIZATION
