## **APPENDIX 1: Photographs of test setup**

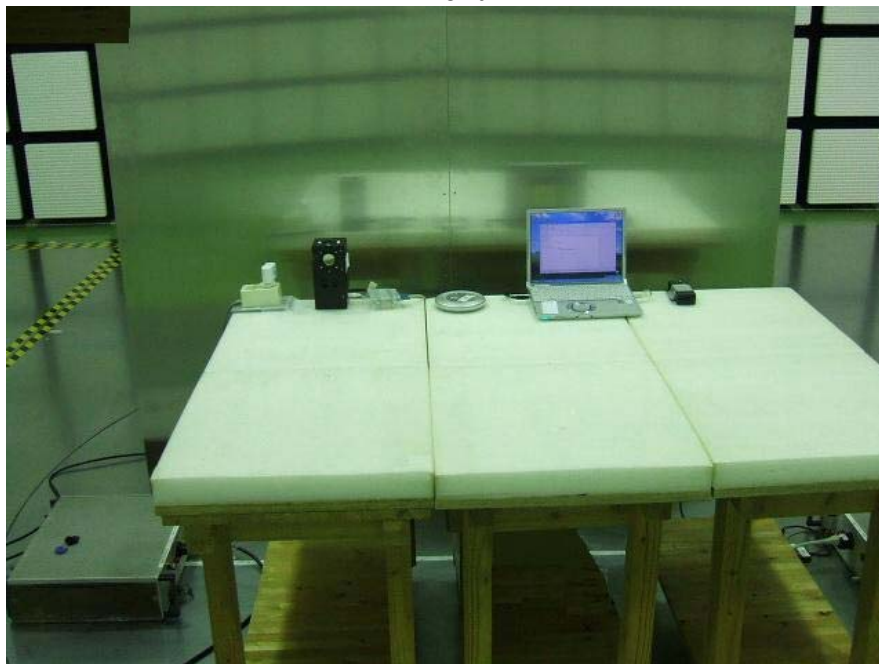
**Front**

### **Conducted Emission**

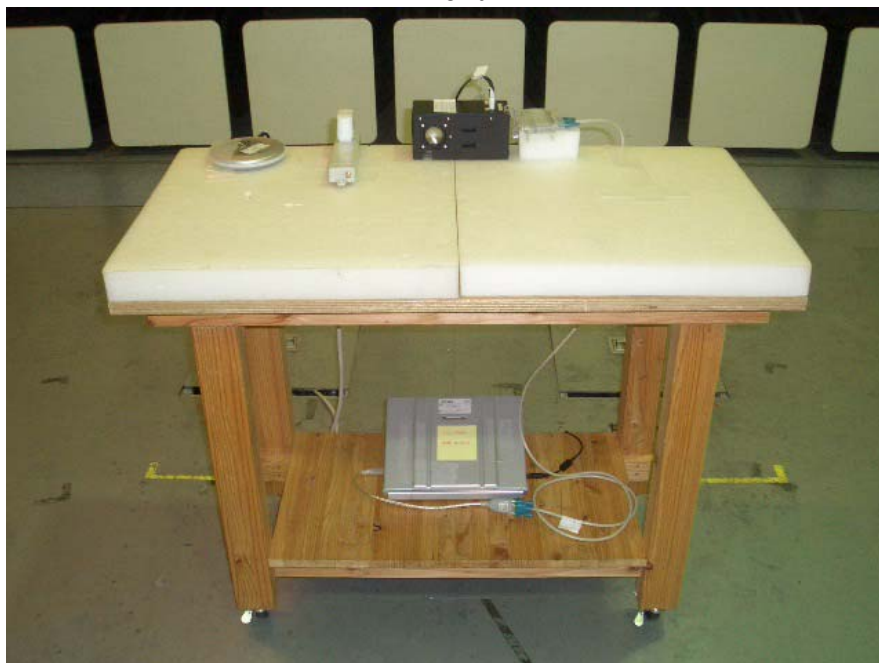
**Front**

### Spurious Emission (Radiated)

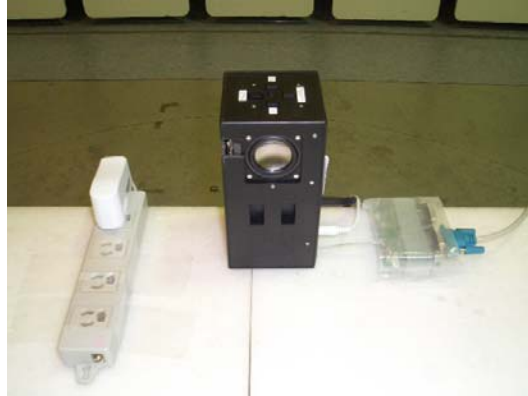
**X-axis**

**Worst Case Position (Horizontal: Z-axis/ Vertical:X-axis)**

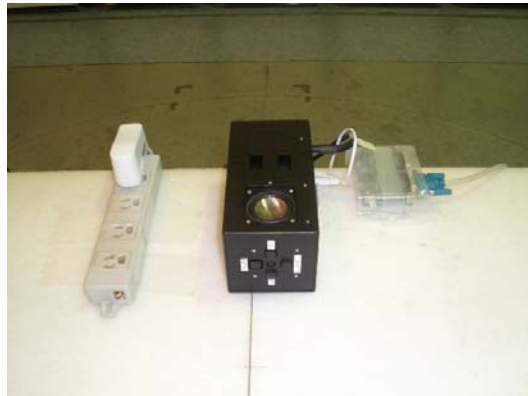
**Y-axis\***

\*The EUT is not used or set at the position of Y-axis, so the test was not performed at Y-axis.
