APPENDIX 3: Photographs of test setup

Radiated Emission

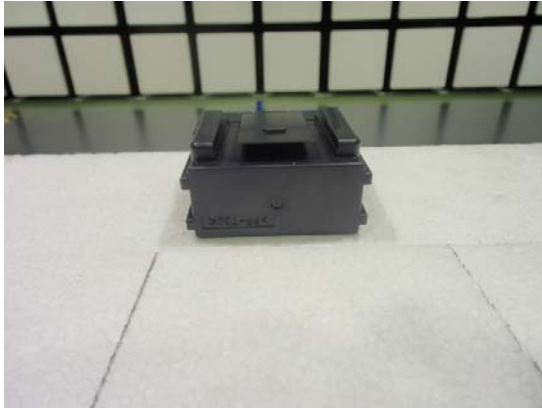
ECU
Below 30 MHz
X-axis
Above 30 MHz
Horizontal: X-axis / Vertical: X-axis
X-axis

Worst Case Position

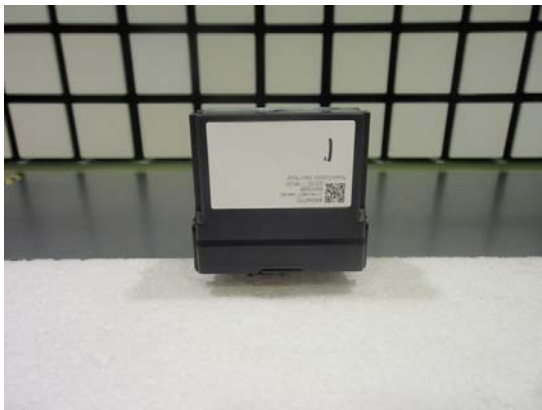
Y-axis

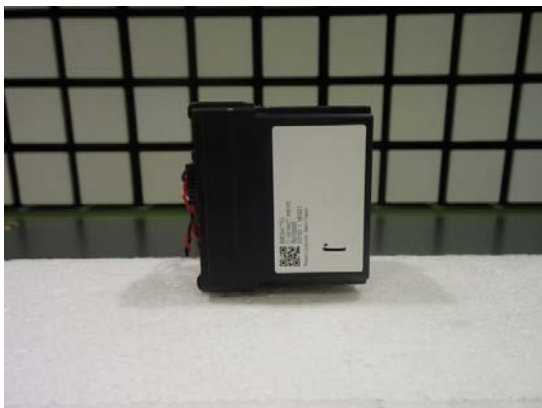
Z-axis

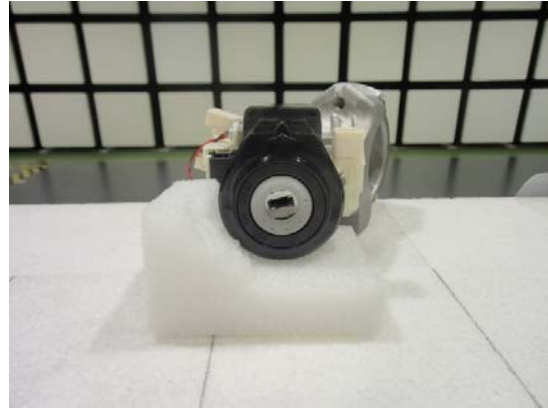
Immobilizer
Below 30 MHz
Zaxis
Above 30 MHz
Horizontal: X-axis / Vertical: X-axis
X-axis

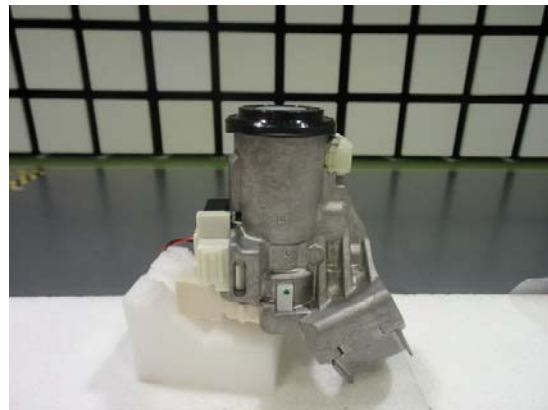
Y-axis
