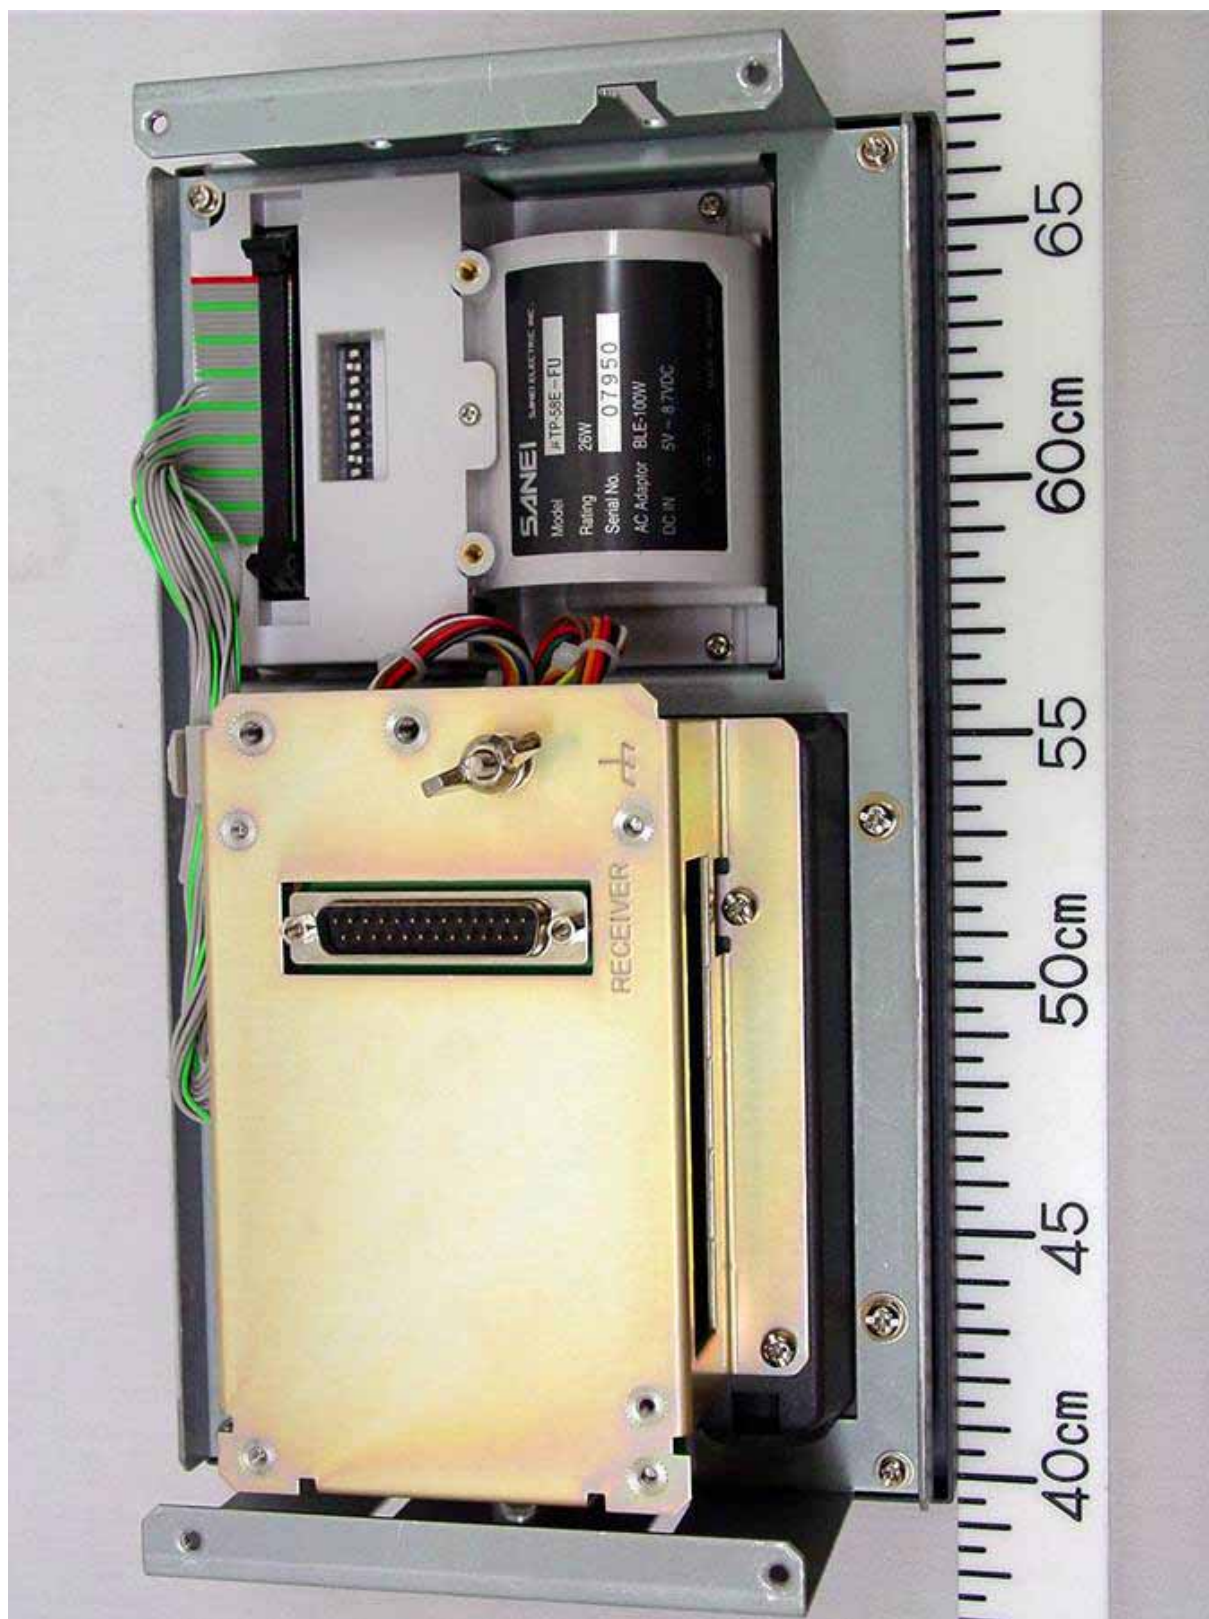
1.3 Inside view (with Rear Cover removed, showing Printer module  $\mu$ TP-58E-FU (upper))

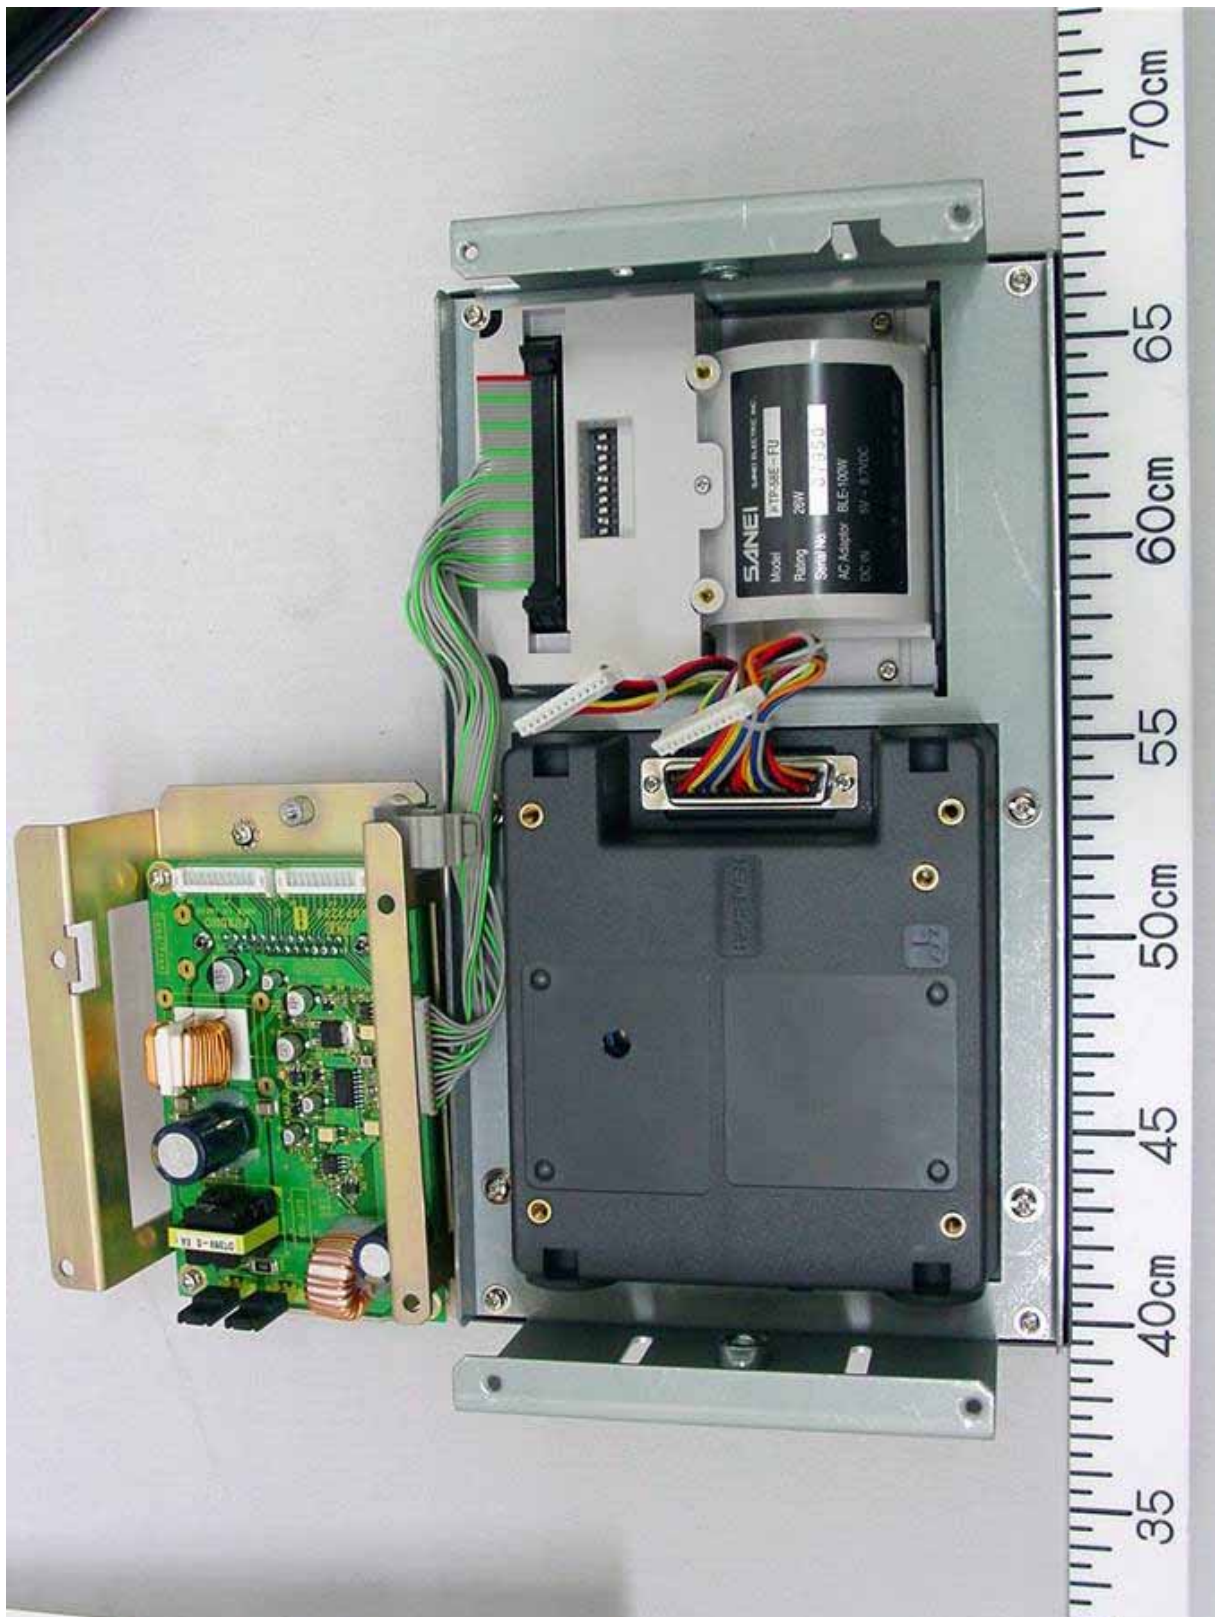
- 1.4 Inside view (with PWR Board chassis removed, showing PWR Board 08P3226 (lower left) and Display module (lower right)).

Note: The inner part of Display module (lower right) was identical with those of Display unit NX-700B. See Clause 2 Display unit NX-700B of this report for details.

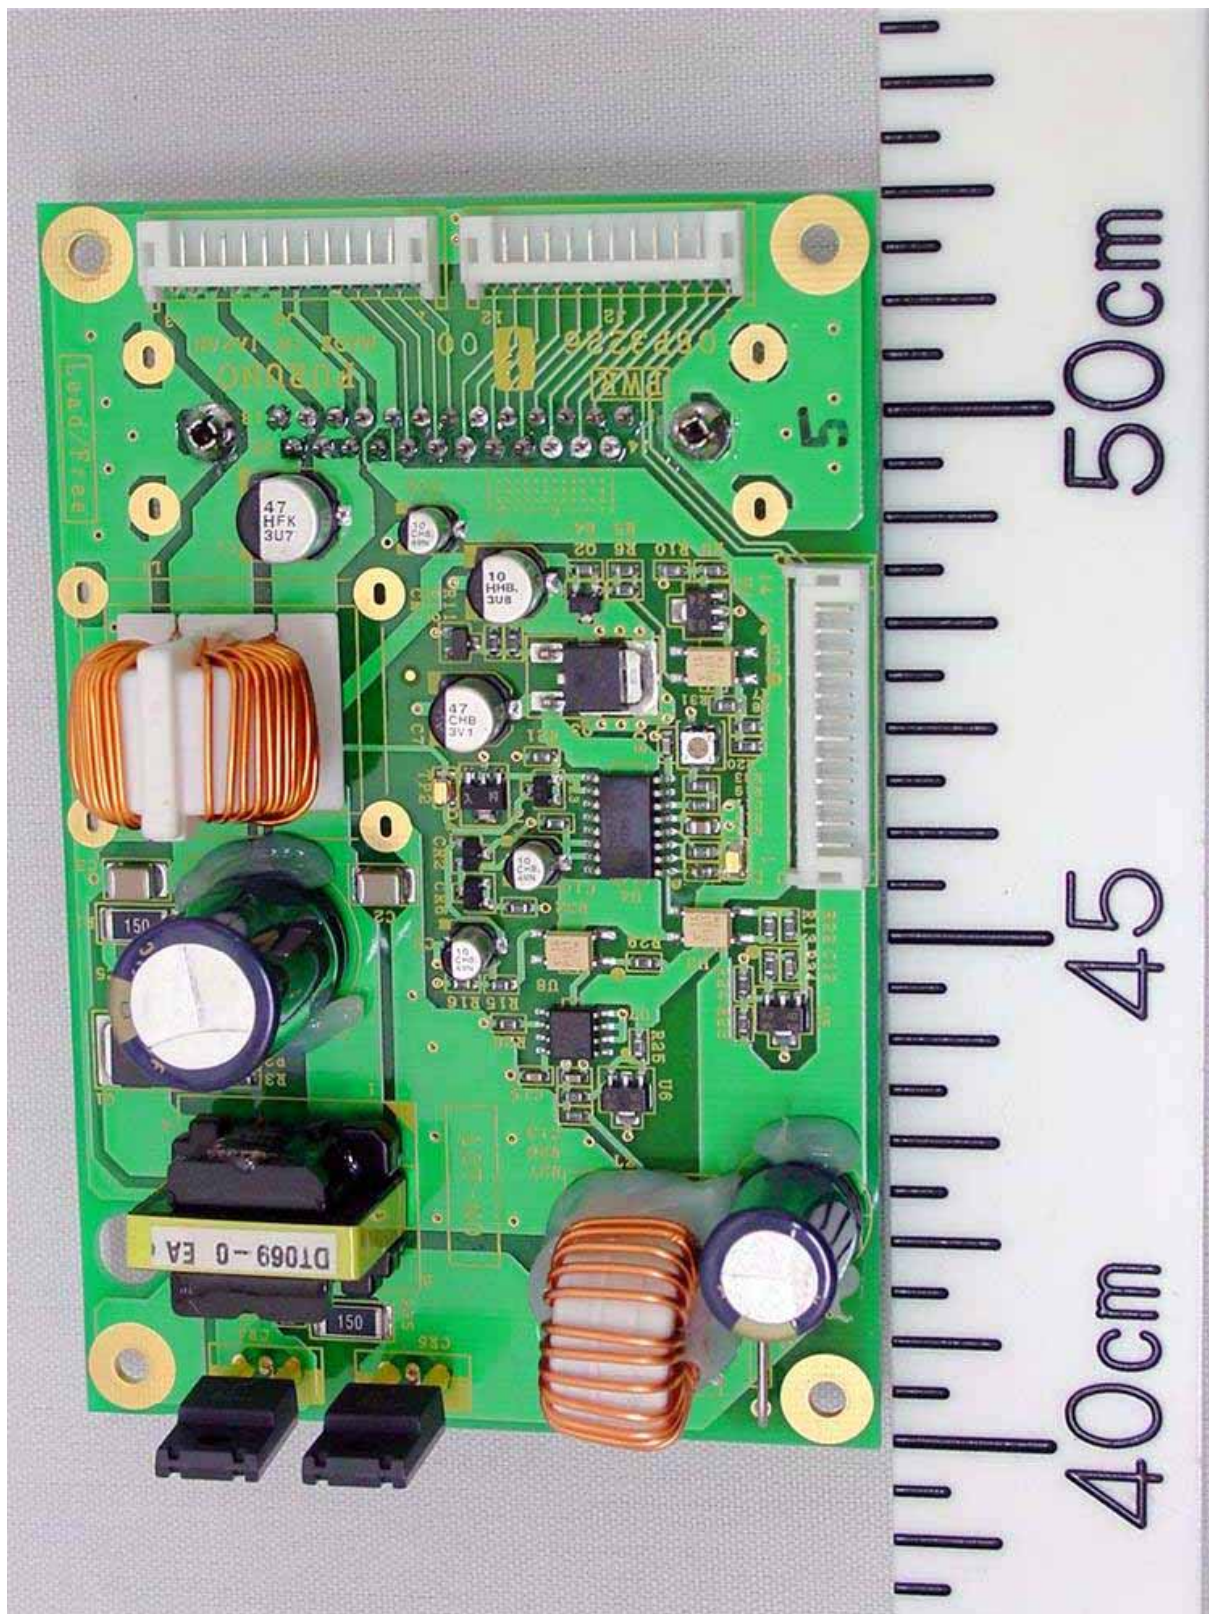
## 1.5 PWR Board 08P3226 Front side

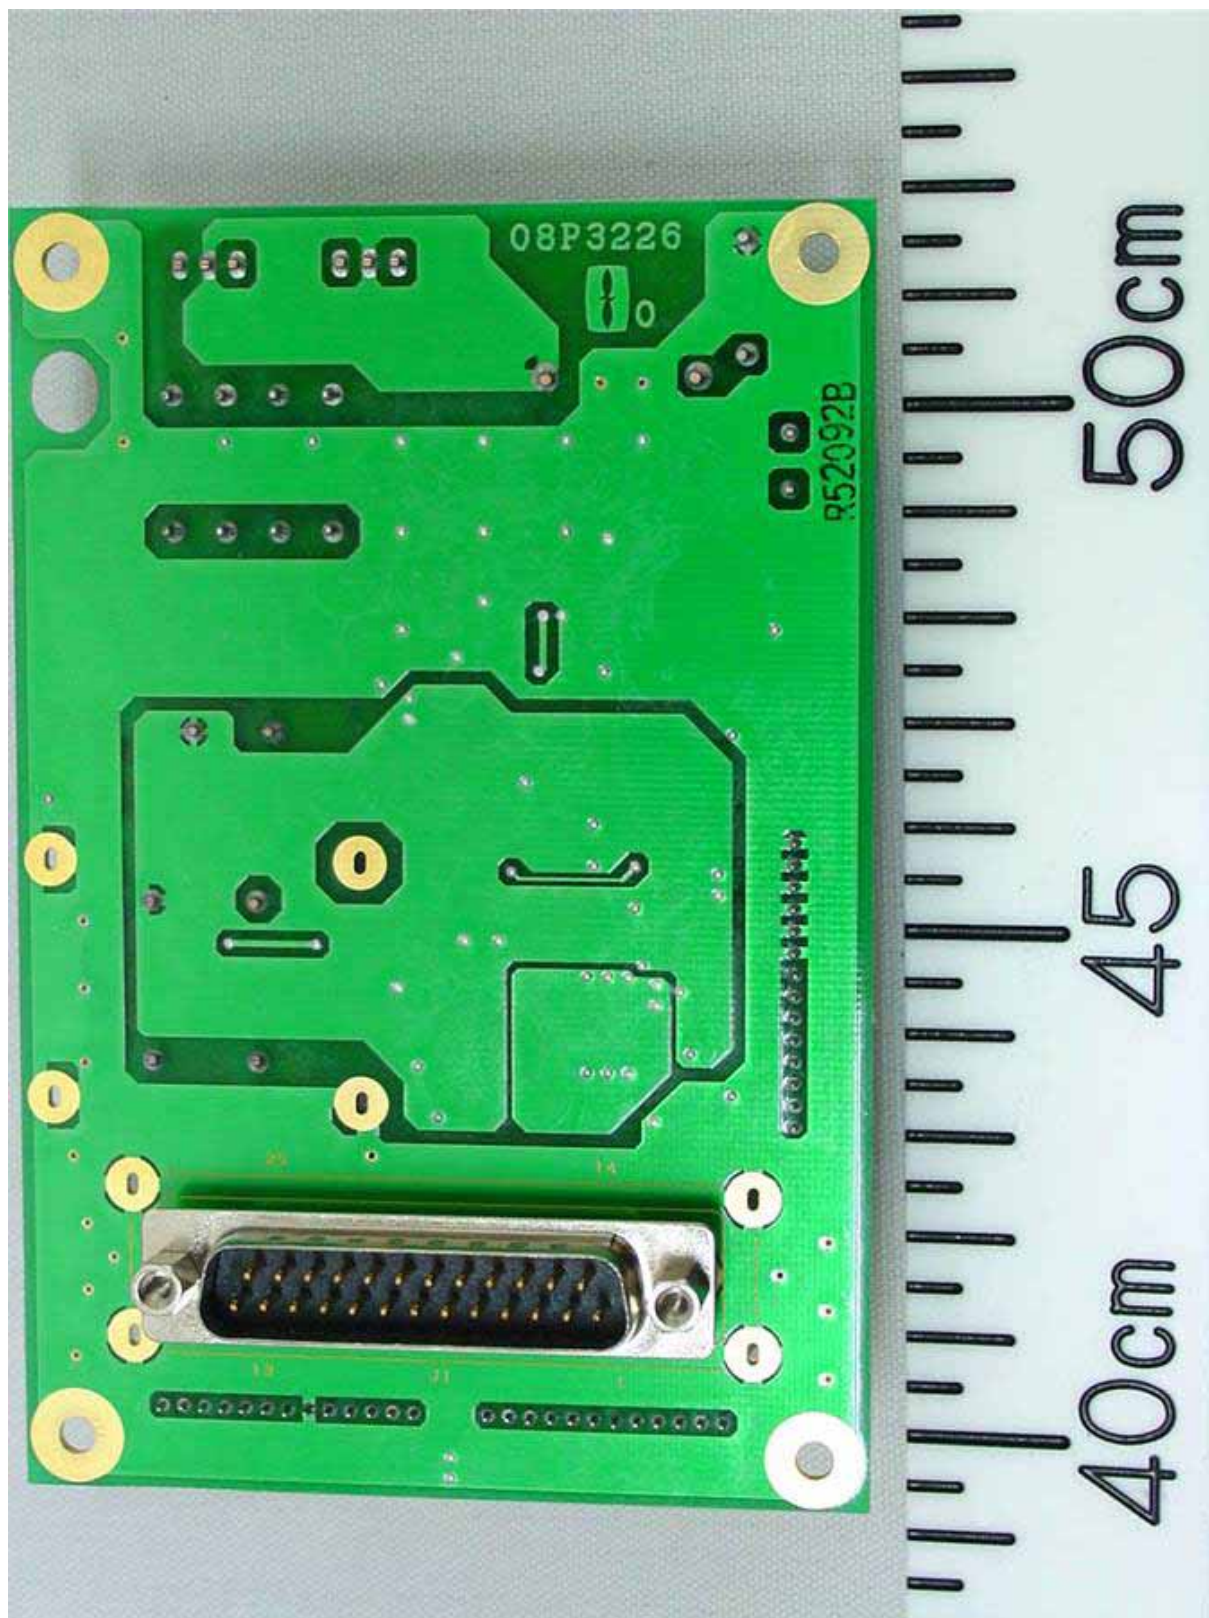
## 1.6 PWR Board 08P3226 Rear side

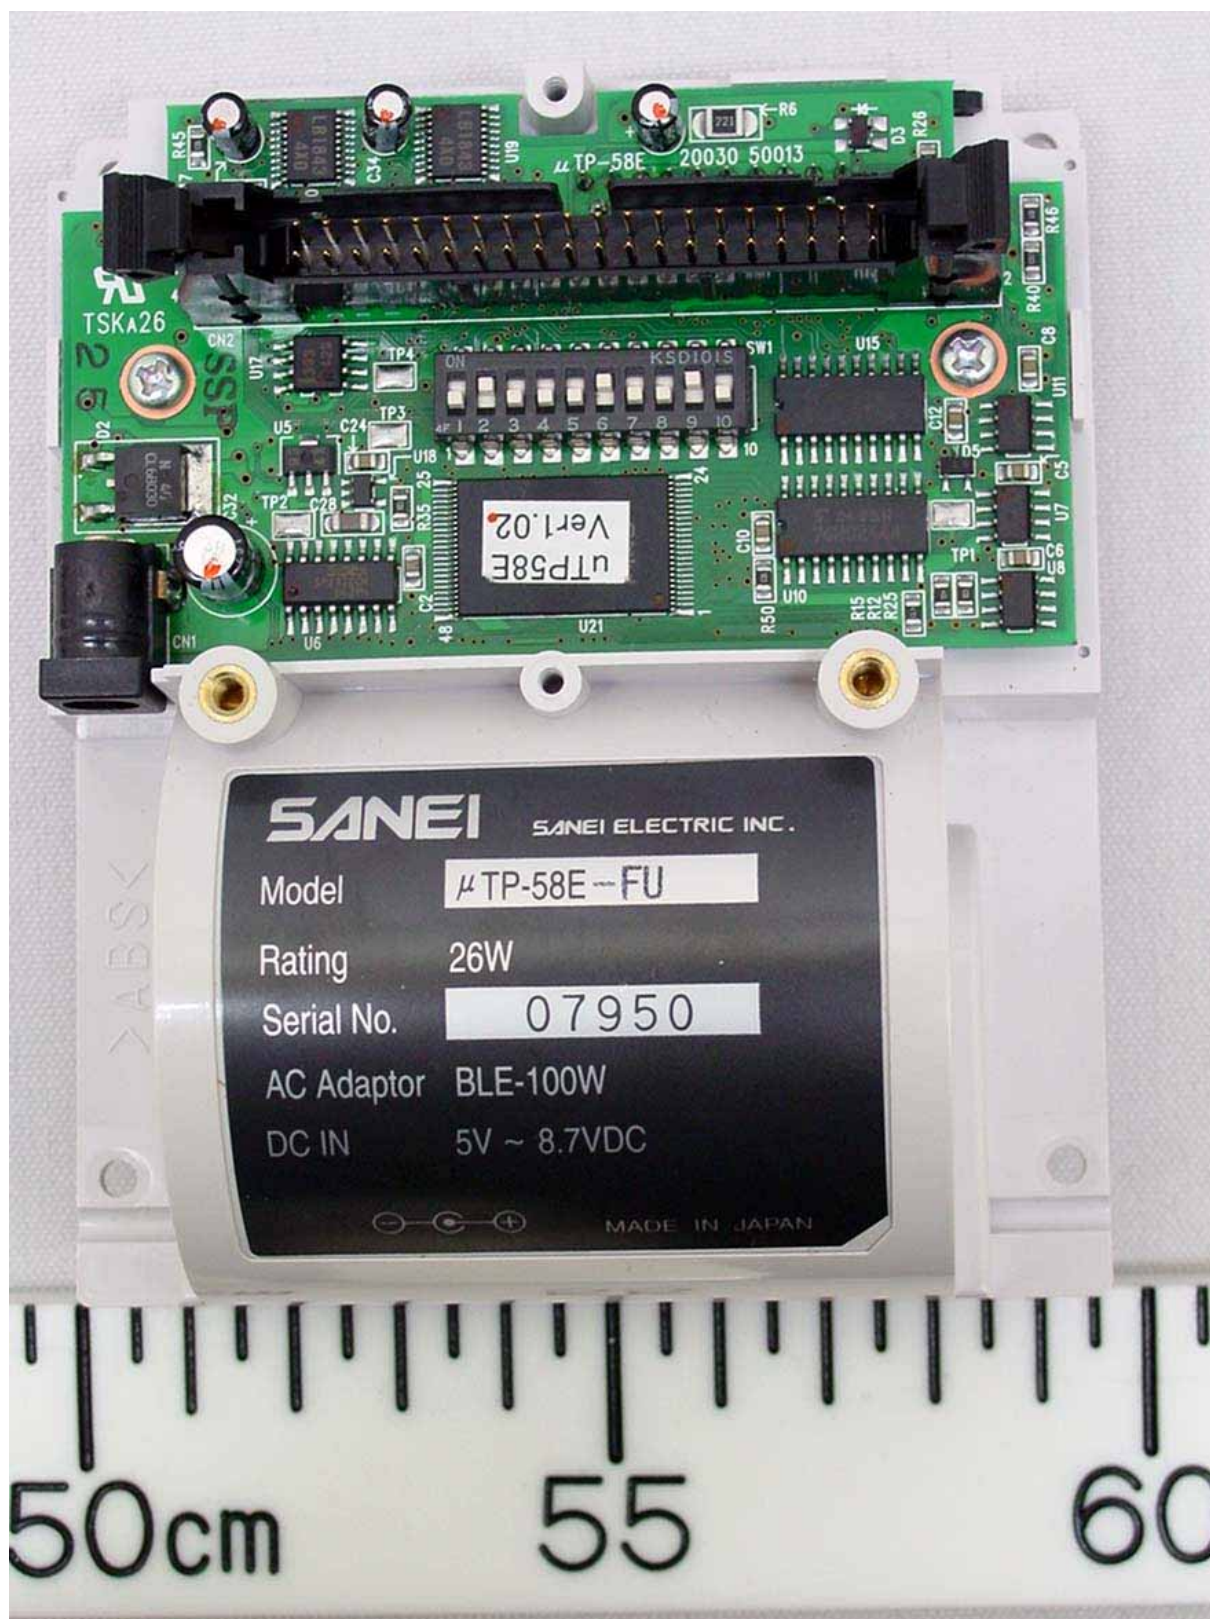
## 1.7 Printer module $\mu$ TP-58E-FU Rear side

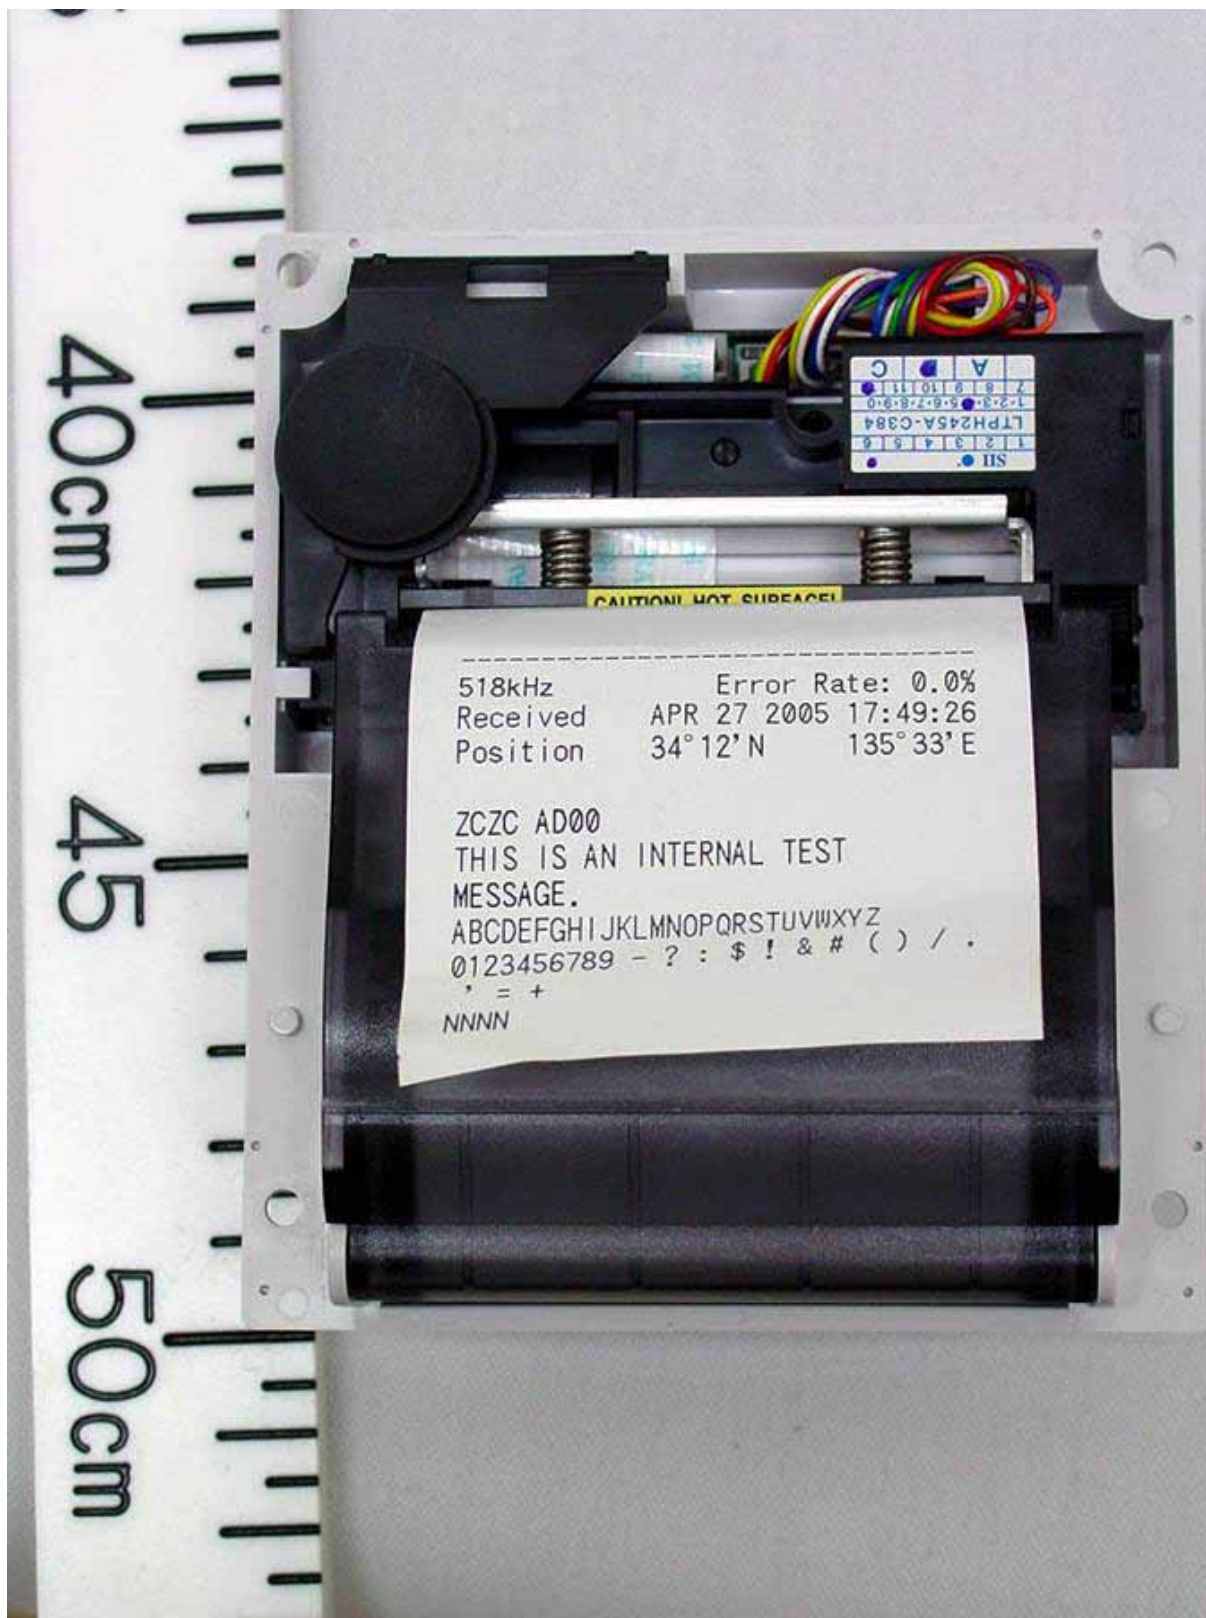
## 1.8 Printer module $\mu$ TP-58E-FU Front side
