### **APPENDIX 3: Photographs of test setup**

#### **Conducted Emission**

### Radiated Spurious Emission

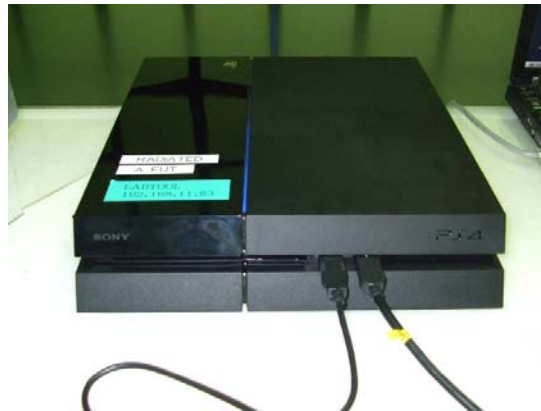
**X-axis**

**Worst Case Position (Horizontal: X-axis/ Vertical:Y-axis)**

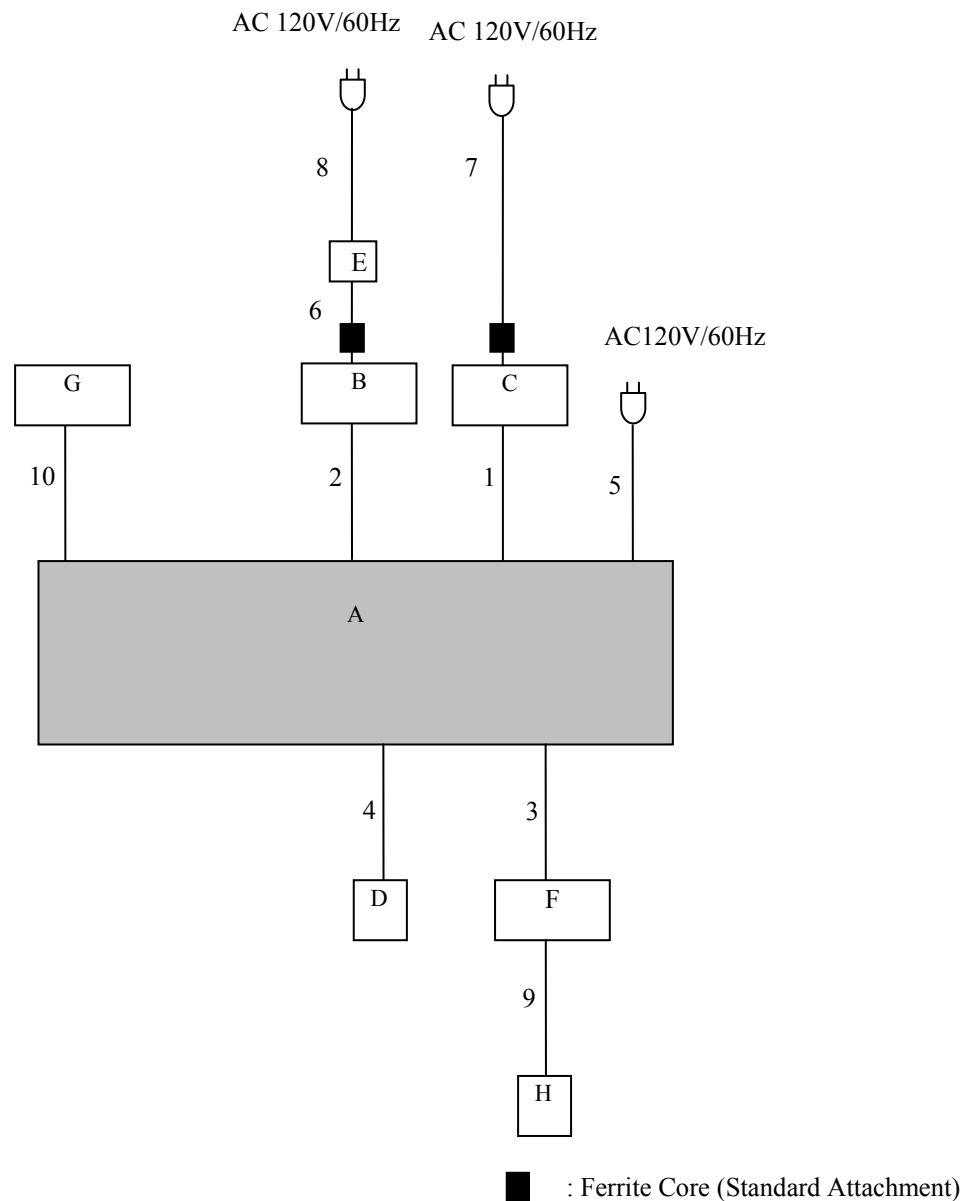
### Test Configuration and peripherals

\*Cabling and setup were taken into consideration and test data was taken under worse case conditions.
