**FCC TEST REPORT**

**THALES ATM, INC.**

**GLIDESLOPE**

**Model #: 098786-0001**

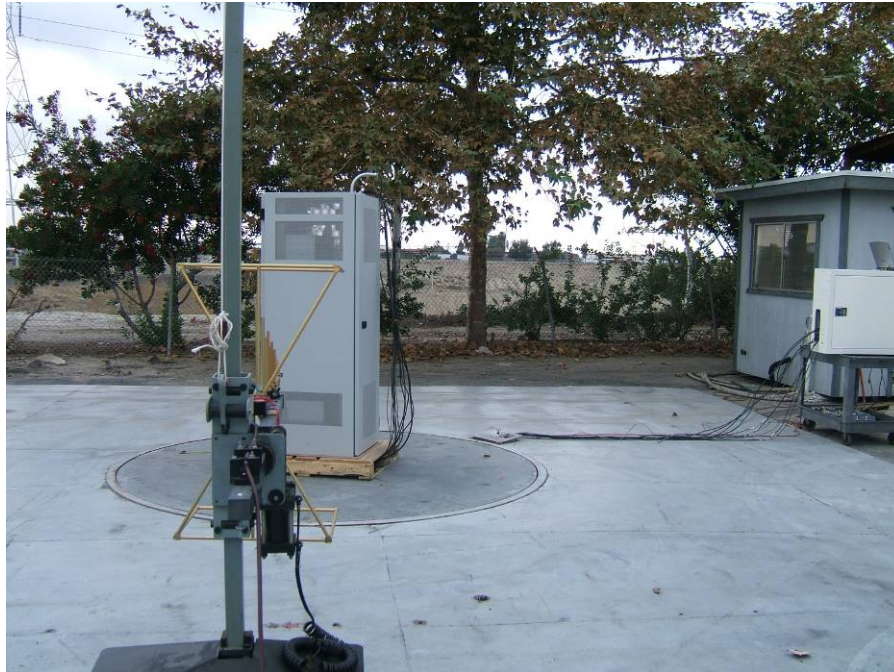
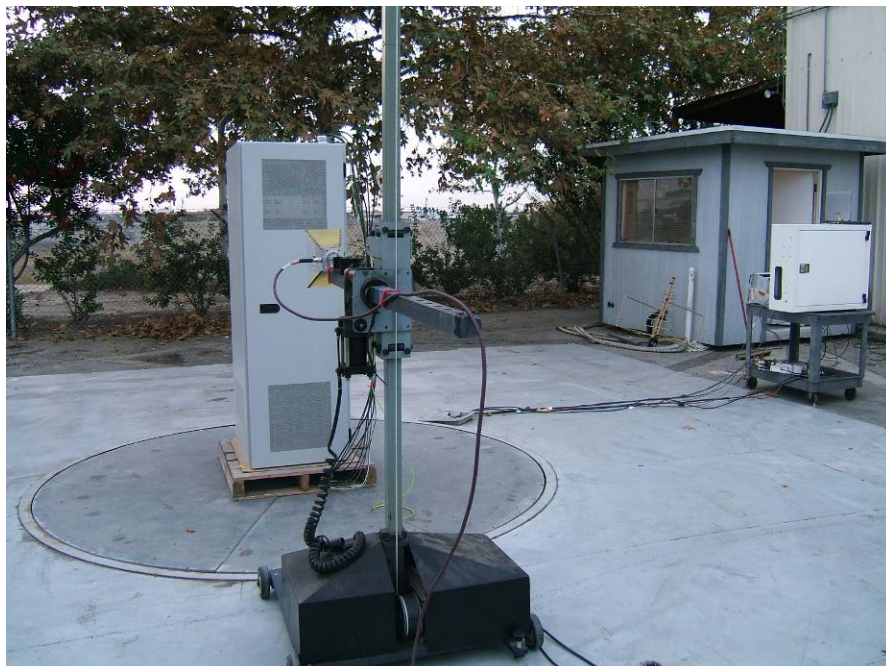
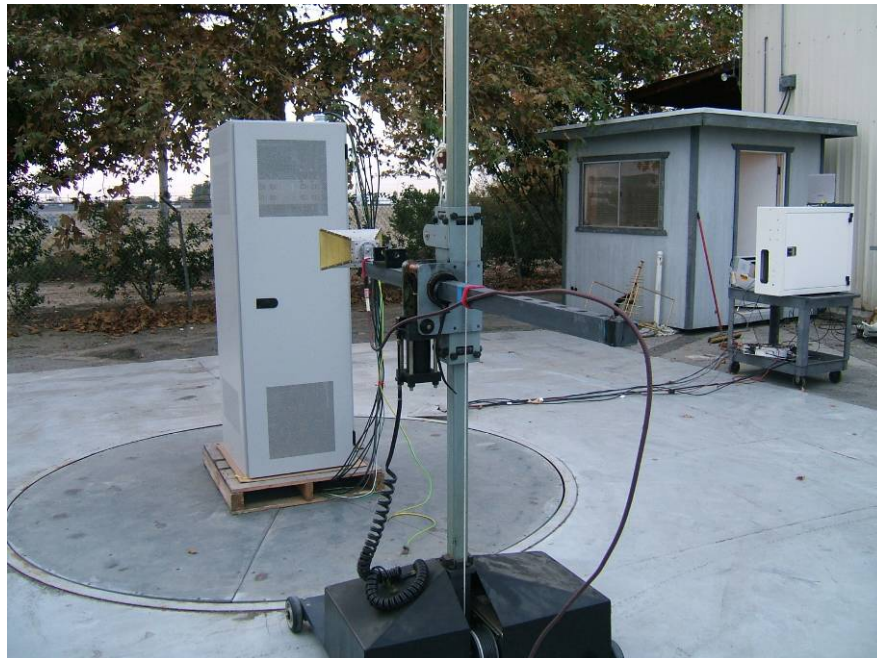
**Glideslope Test Setup Photo**

The transmitter was placed on a wooden turntable 0.1 meters above the ground plane and at a distance of 3 meters from the antenna. The transmitter was activated and the frequency spectrum of the fundamental was observed. The turntable was rotated through 360 degrees to locate the position registering the highest amplitude emission. The amplitude of the fundamental frequency was measured and recorded. The frequency spectrum was then searched for spurious emissions generated from the transmitter. The amplitude of each spurious emission was maximized by raising and lowering the FSM antenna and rotating the turntable before data was recorded. A log periodic antenna was used for frequencies of 200 MHz to 5 GHz and pyramidal horn antennas were used for frequencies of 5 GHz to 40 GHz. Emission levels were measured and recorded from the spectrum analyzer in dBμV.
