**FCC TEST REPORT**  
*for*  
**THALES ATM, INC.**  
**LOCALIZER**  
**Model #: 098783-0001**

## **EMC TEST REPORT**

**47 CFR Ch.1 (10-1-03 Edition)**  
**Parts 2, 15, & 87**

Report No: FR2900ASC

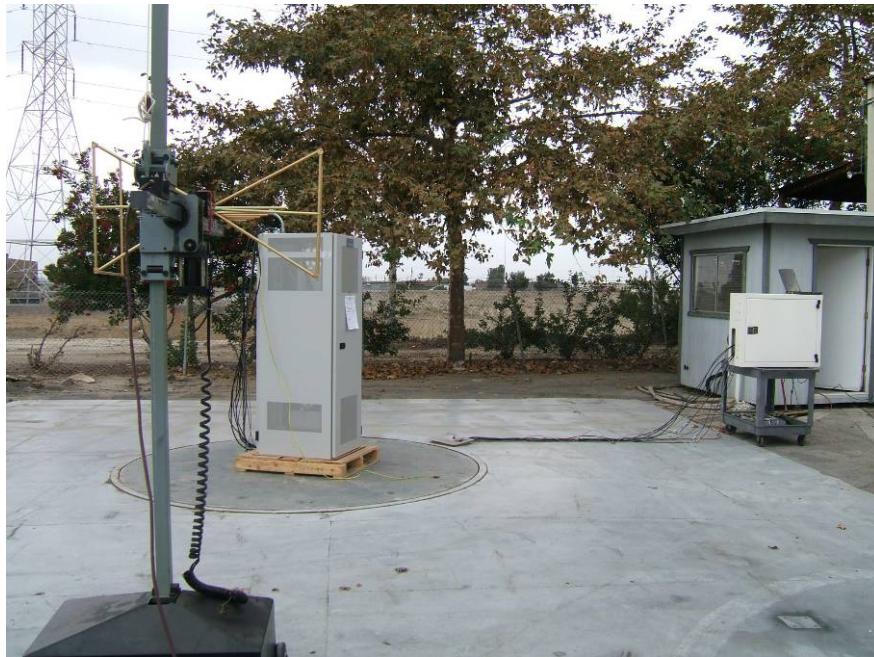
Localizer Test Setup Photo

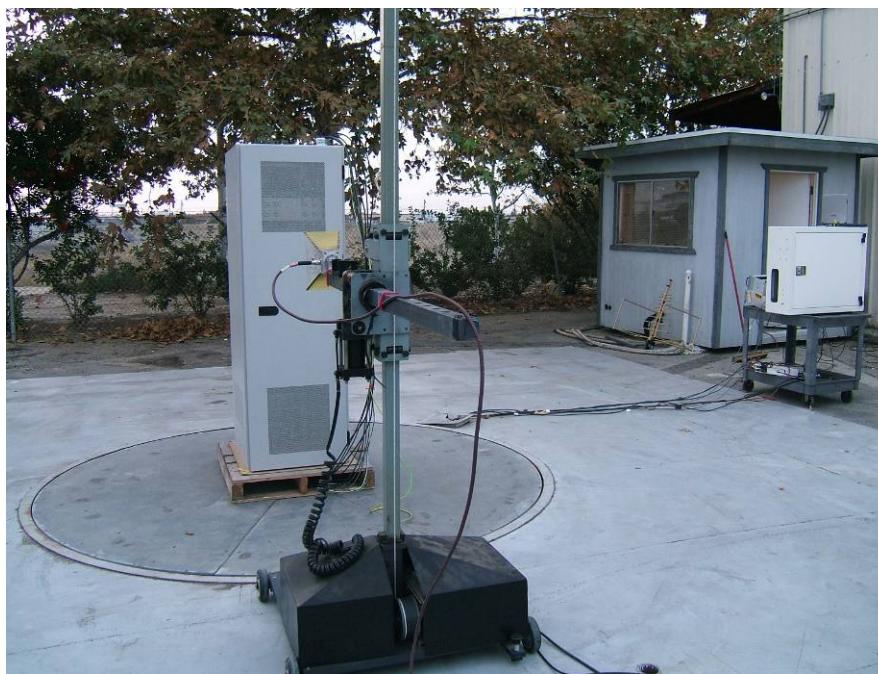
Localizer Test Setup Photo

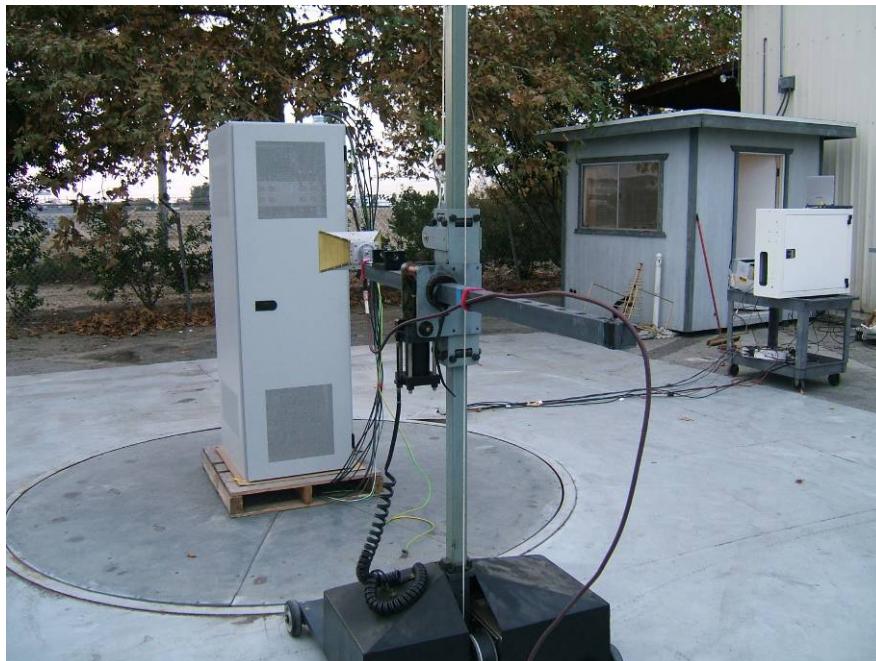
Localizer Test Setup Photo
