APPENDIX F: DUT ANTENNA DIAGRAM & SAR TEST SETUP PHOTOGRAPHS

FCC ID BV8BBPBM214

SAR EVALUATION REPORT

Reviewed by: Quality Manager
Test Dates: 03/14/16 – 07/25/16, 02/22/17 – 03/02/17	DUT Type: Module Integrated to PTT Device	APPENDIX F: Page 1 of 5

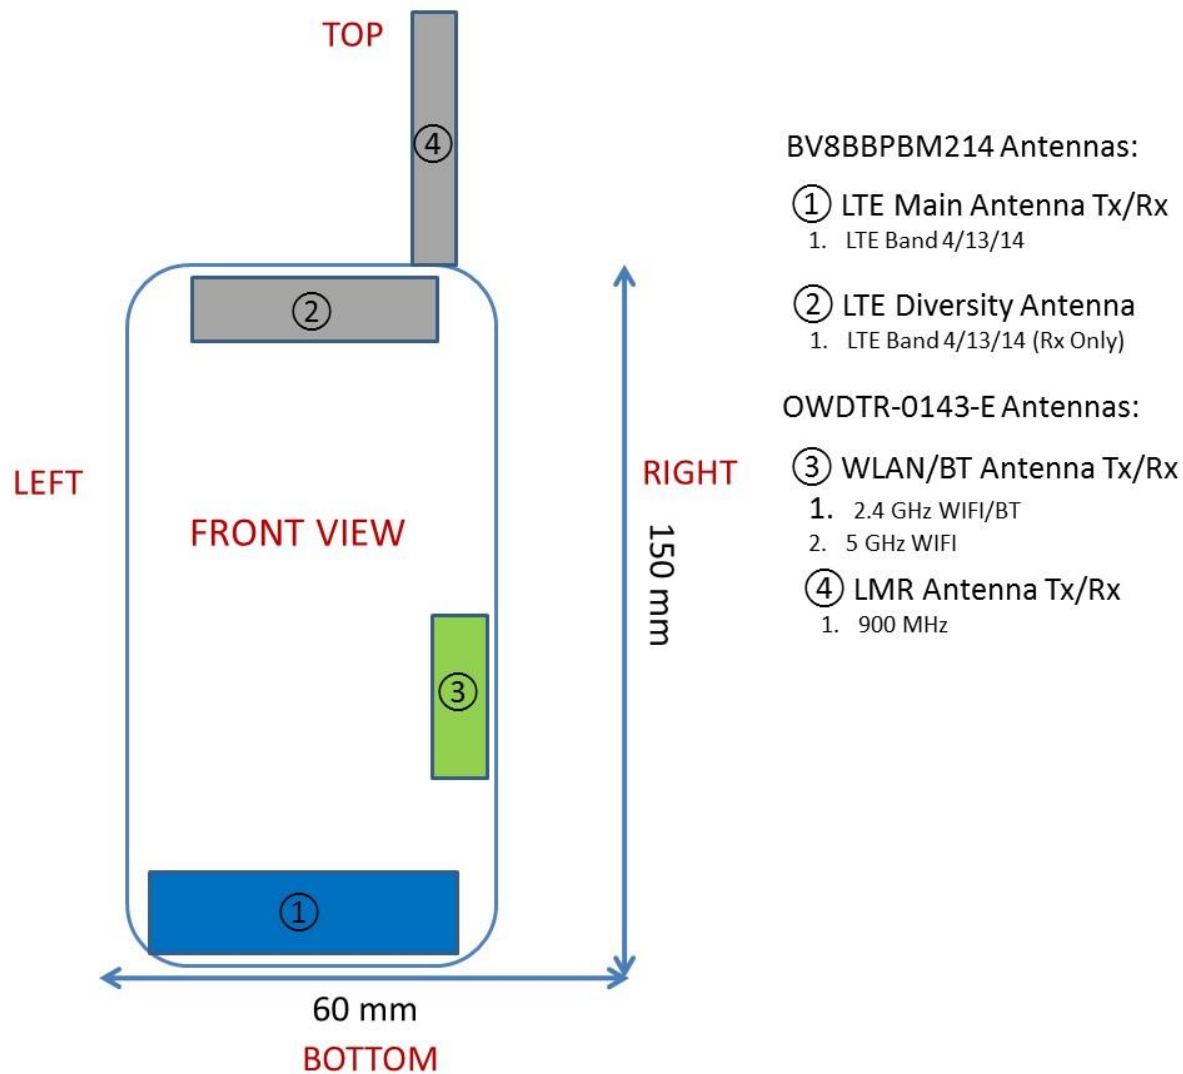
Figure F-1
DUT Antenna Locations

Note: Exact antenna dimensions and separation distances are shown in the Technical Descriptions in the FCC Filing.

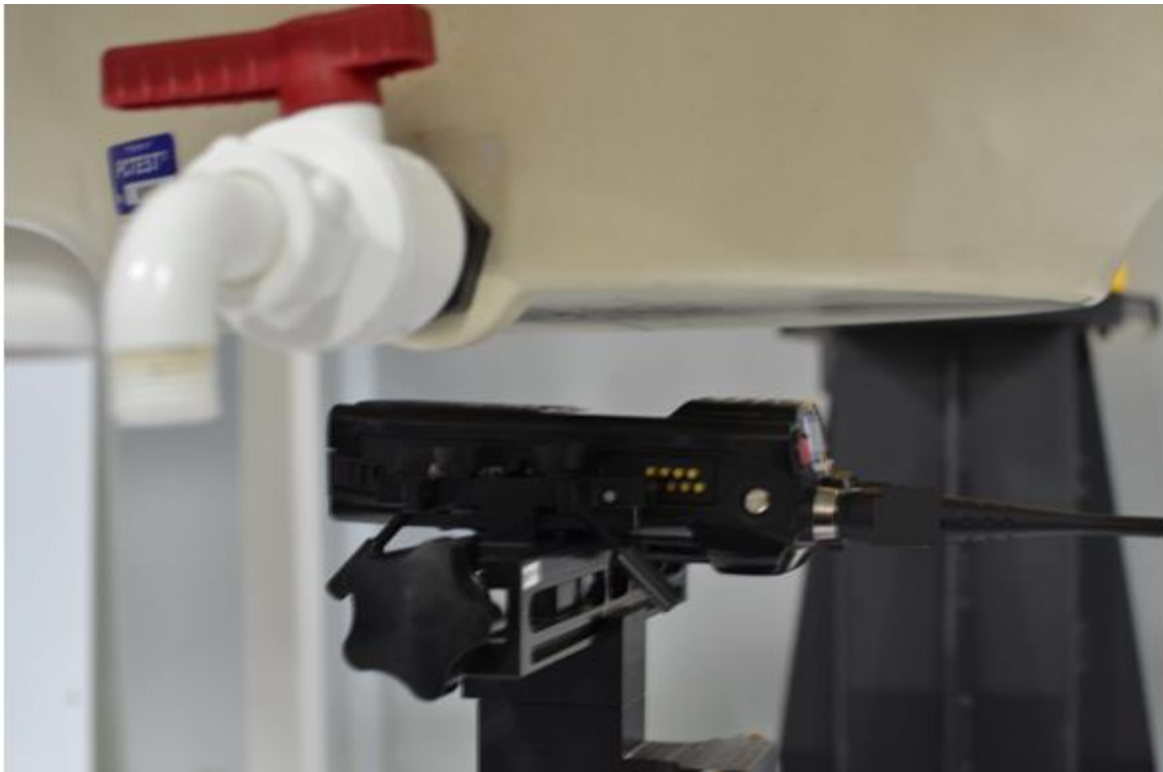
SAR Test Setup Photo 1 – Head Testing at 2.5 cm

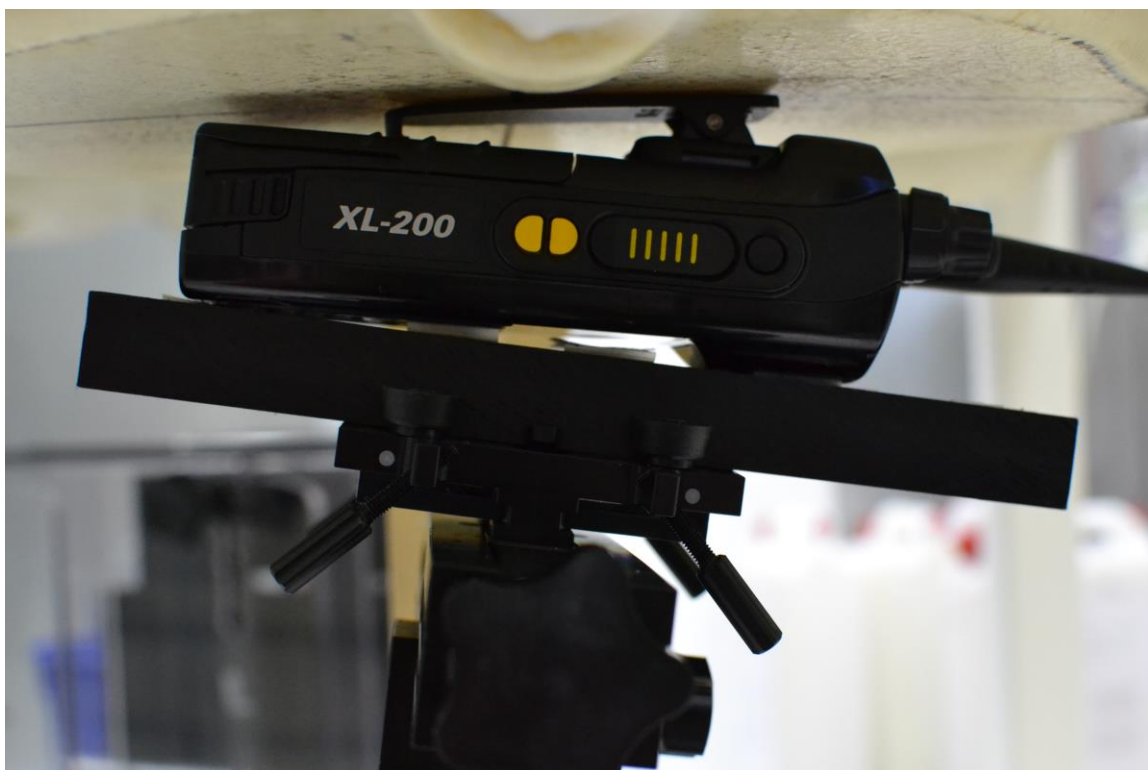
SAR Test Setup Photo 2 – BW Grouping 1 Test Distance

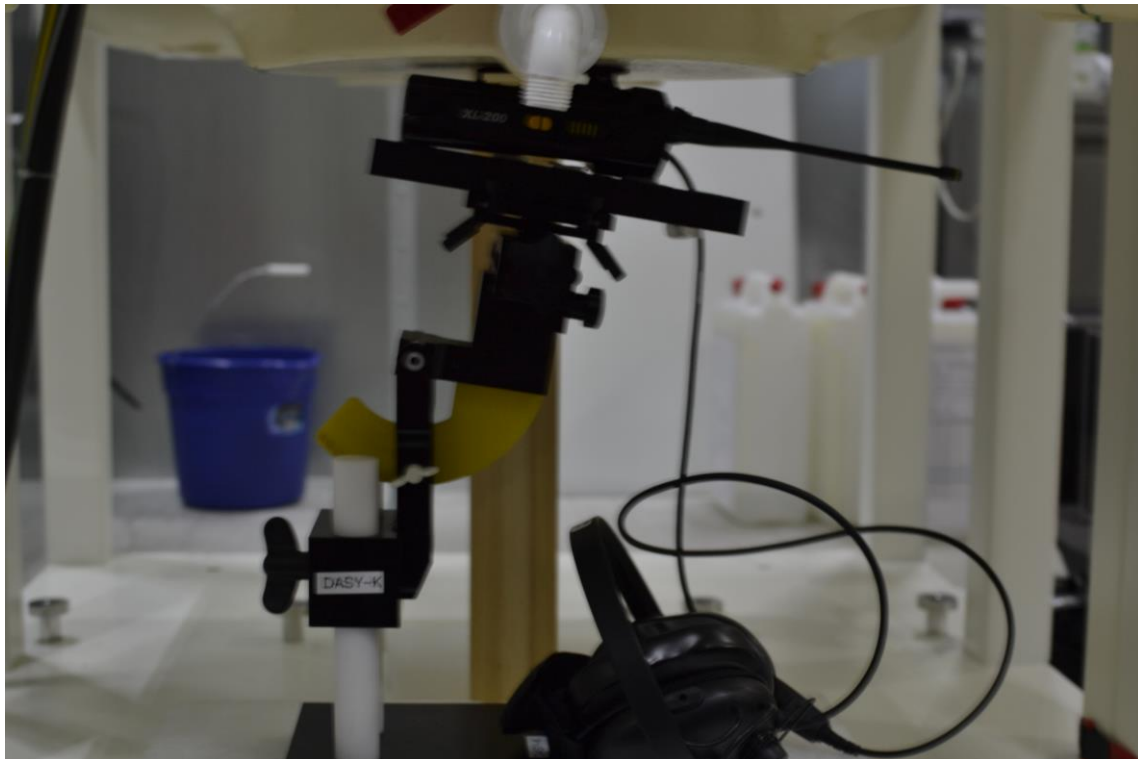
SAR Test Setup Photo 3 – Back Side at 0.0 cm with BW Grouping 1, Audio Accessory I

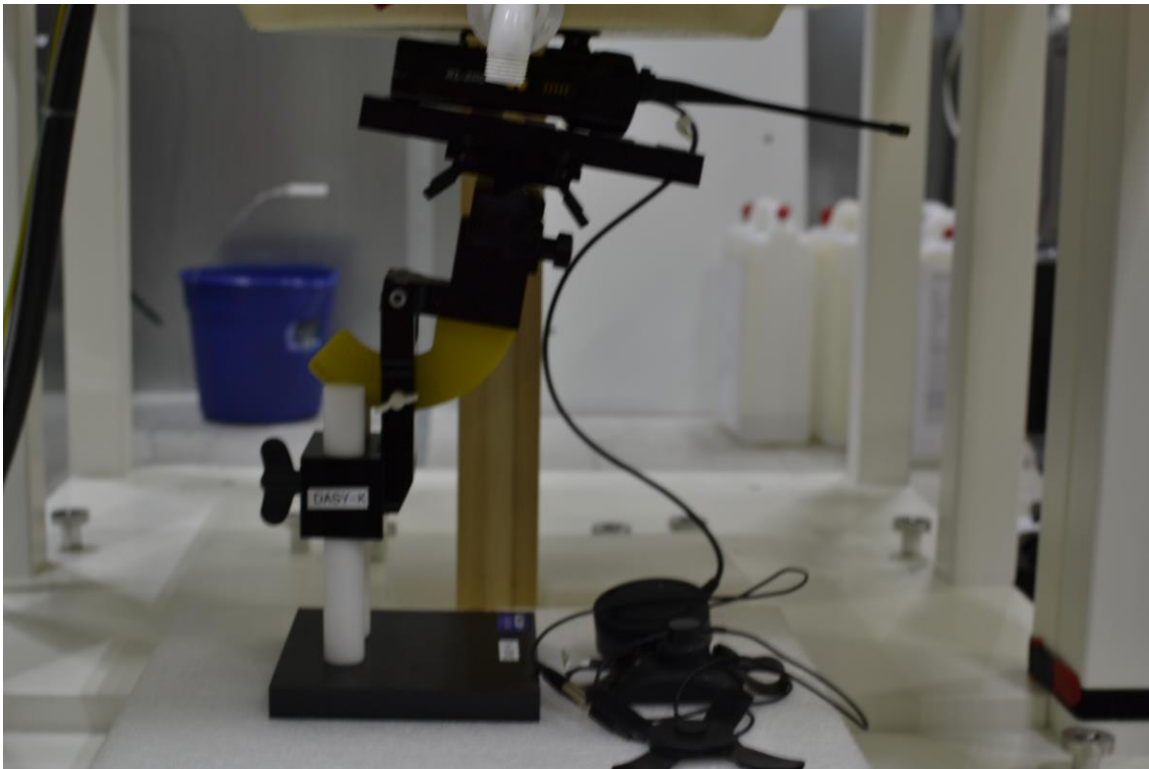
SAR Test Setup Photo 4 – Back Side at 0.0 cm with BW Grouping 1, Audio Accessory II

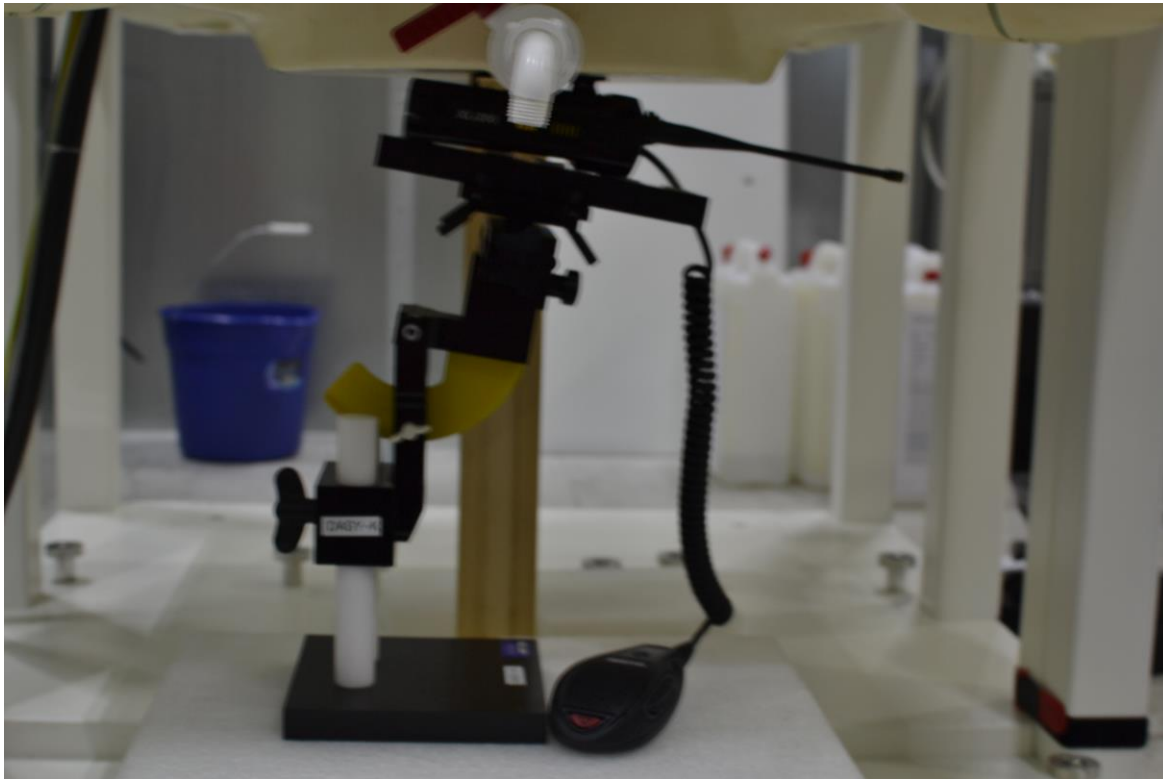
SAR Test Setup Photo 5 – Back Side at 0.0 cm with BW Grouping 1, Audio Accessory IV
