# **CERTIFICATION TEST REPORT**

**Report Number. :** R12886350-EP1

**Model :** SiXMINICTA / SiXMINICT

**EUT Description :** Remote Control

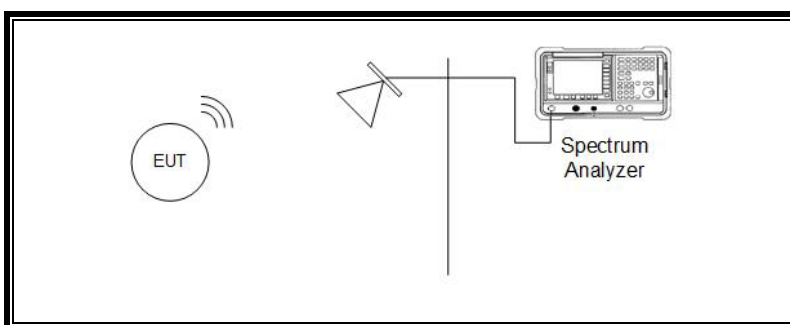
### SETUP DIAGRAMS

| I/O Cable List | | | | | | |
|---|---|---|---|---|---|---|
| 1 | N/A | N/A | N/A | DC | 1 | The EUT is battery powered and operates at a low duty cycle. To facilitate testing using a continuous transmit mode the battery was replaced with an external DC power supply that was connected to the battery terminals. |

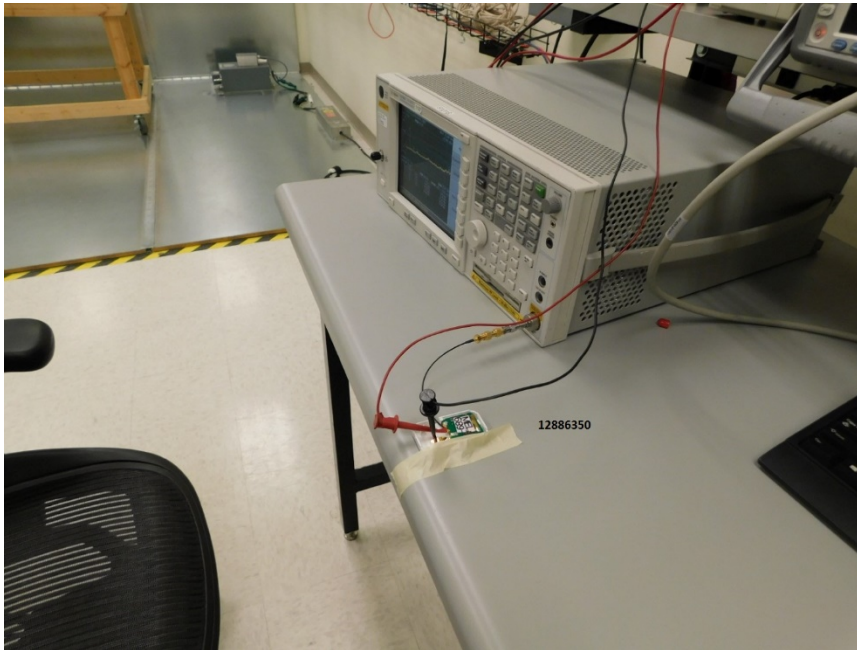
ANTENNA PORT CONDUCTED PHOTO

### ANTENNA PORT CONDUCTED RF MEASUREMENT SETUP

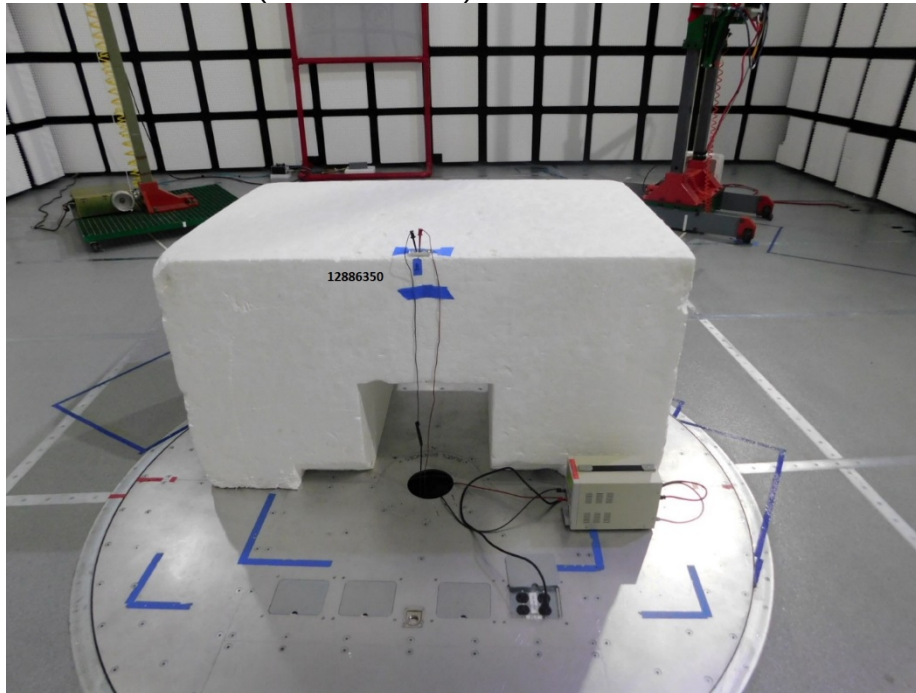
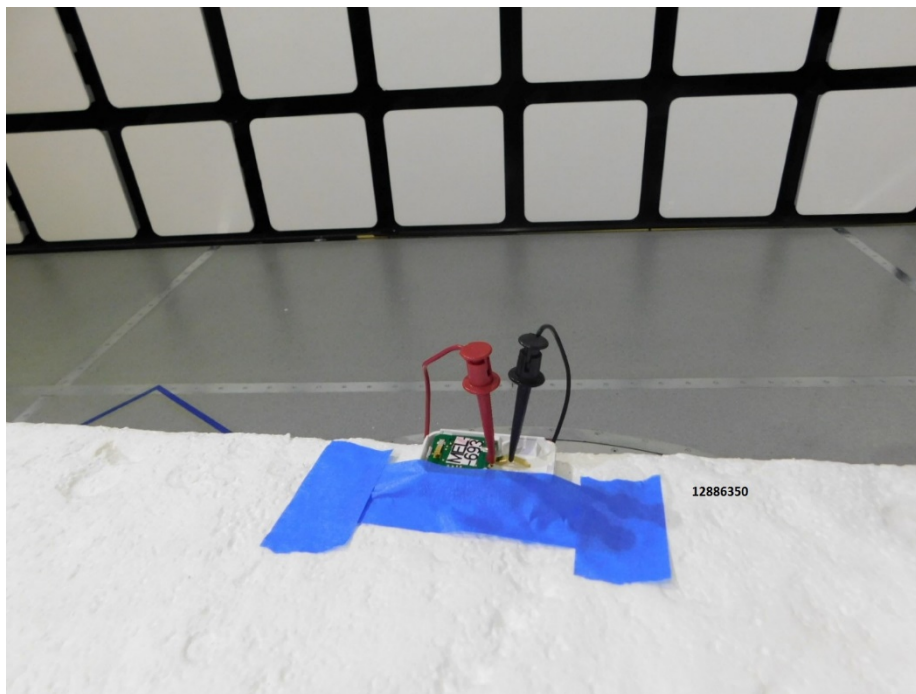
RADIATED PHOTO (BELOW 1 GHz)

**RADIATED RF MEASUREMENT SETUP (BELOW 1 GHz)**

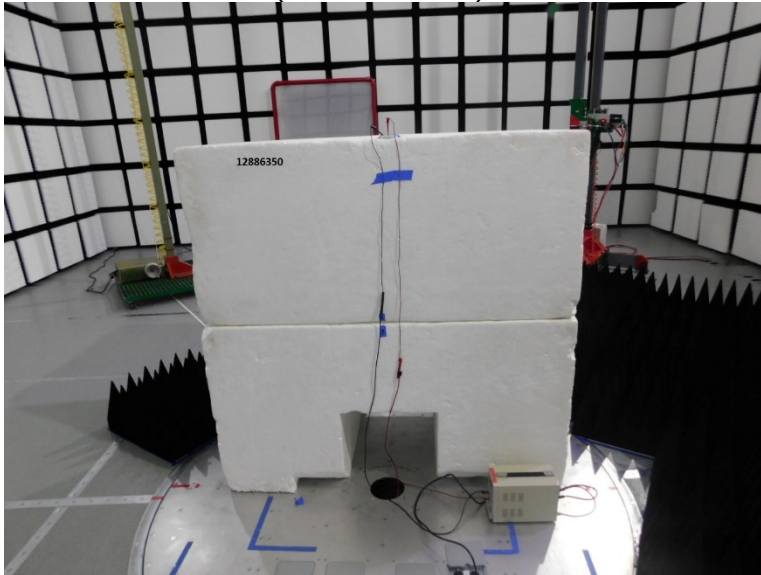
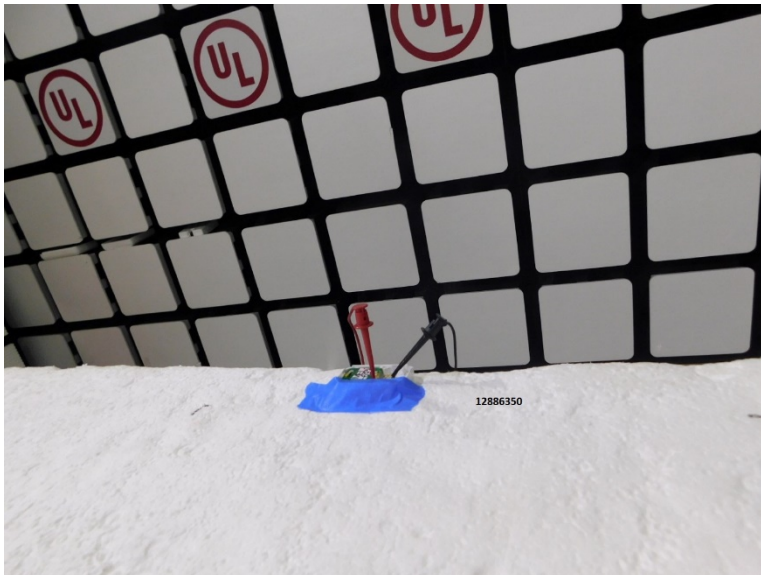
RADIATED PHOTO (ABOVE 1 GHz)

**RADIATED RF MEASUREMENT SETUP (ABOVE 1 GHz)**
