## 5 Photographs of the Test Set-Up

**Prüfbericht - Nr.: 15048276 001**  
Test Report No.:

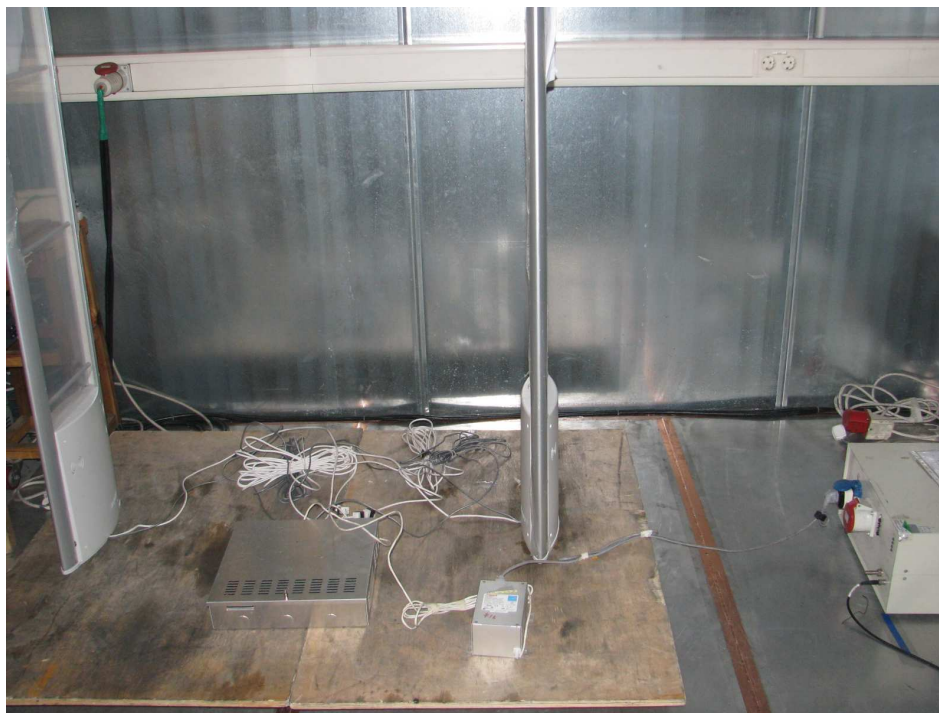
**Photograph 1: Set-up for conducted emission**

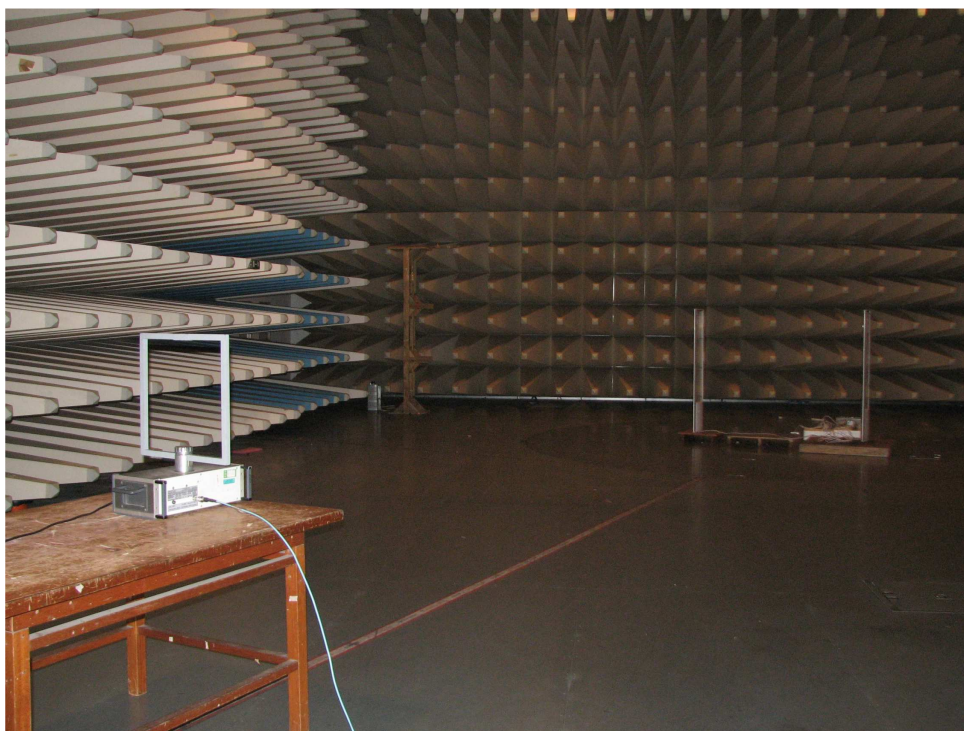
**Photograph 2: Set-up for radiated emission (9kHz - 30MHz)**

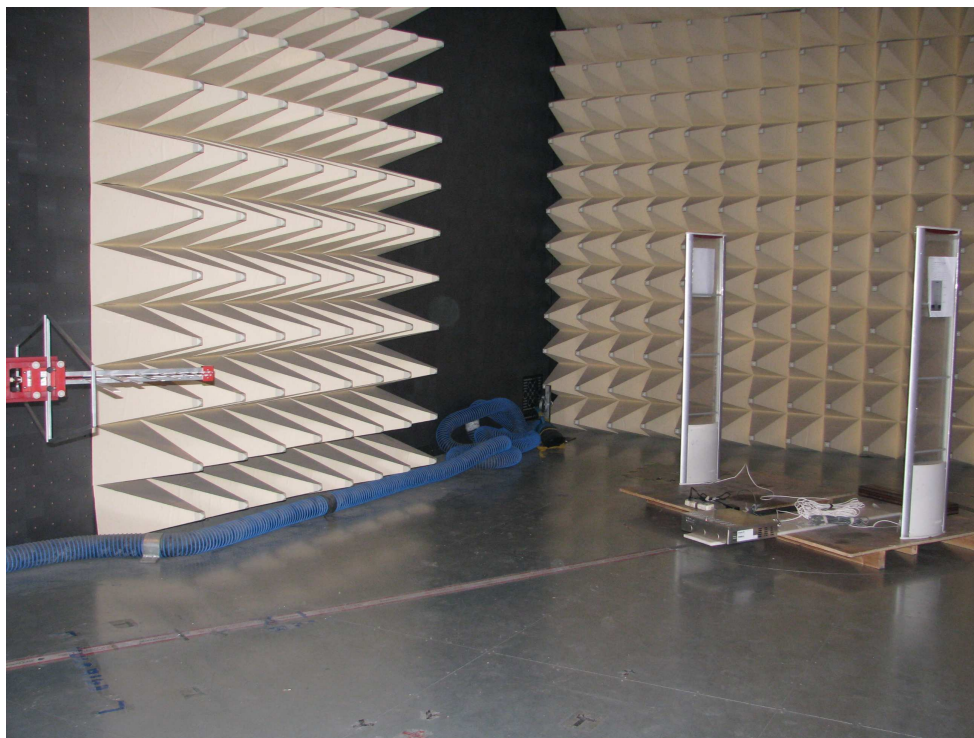
**Photograph 3: Set-up for radiated emission (30 - 1000MHz)**

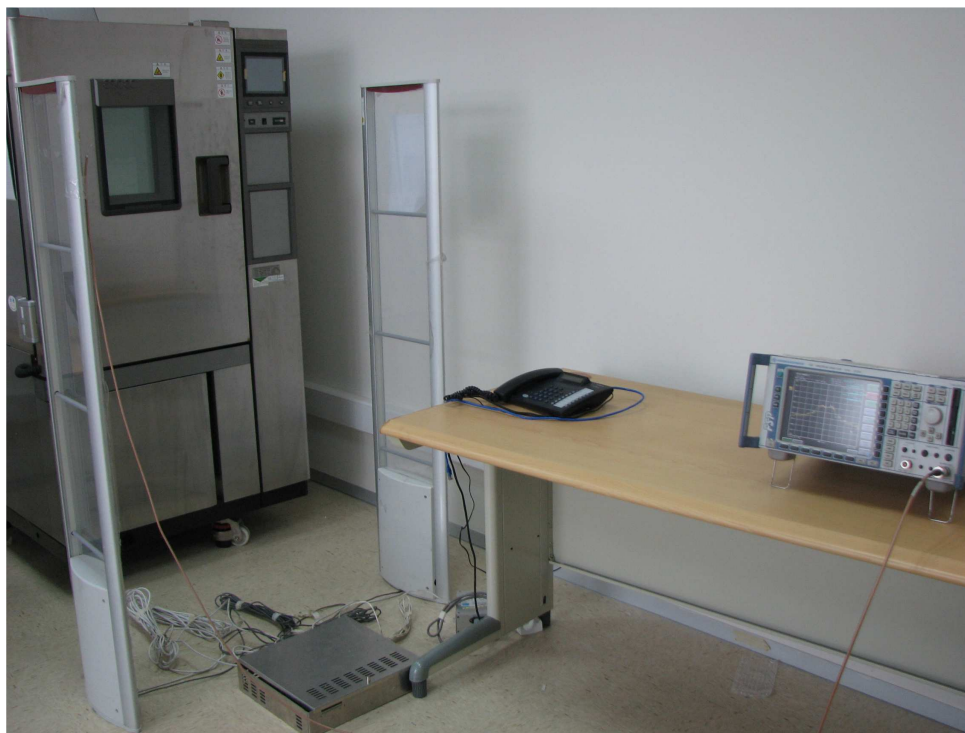
**Photograph 4: Set-up for emission bandwidth & duty cycle**
