## **APPENDIX B2**

### **Test Setup Photograph**

**FCC Part 15 class B test set up photos**

**Photos extracted from report FG08\_070EAL**

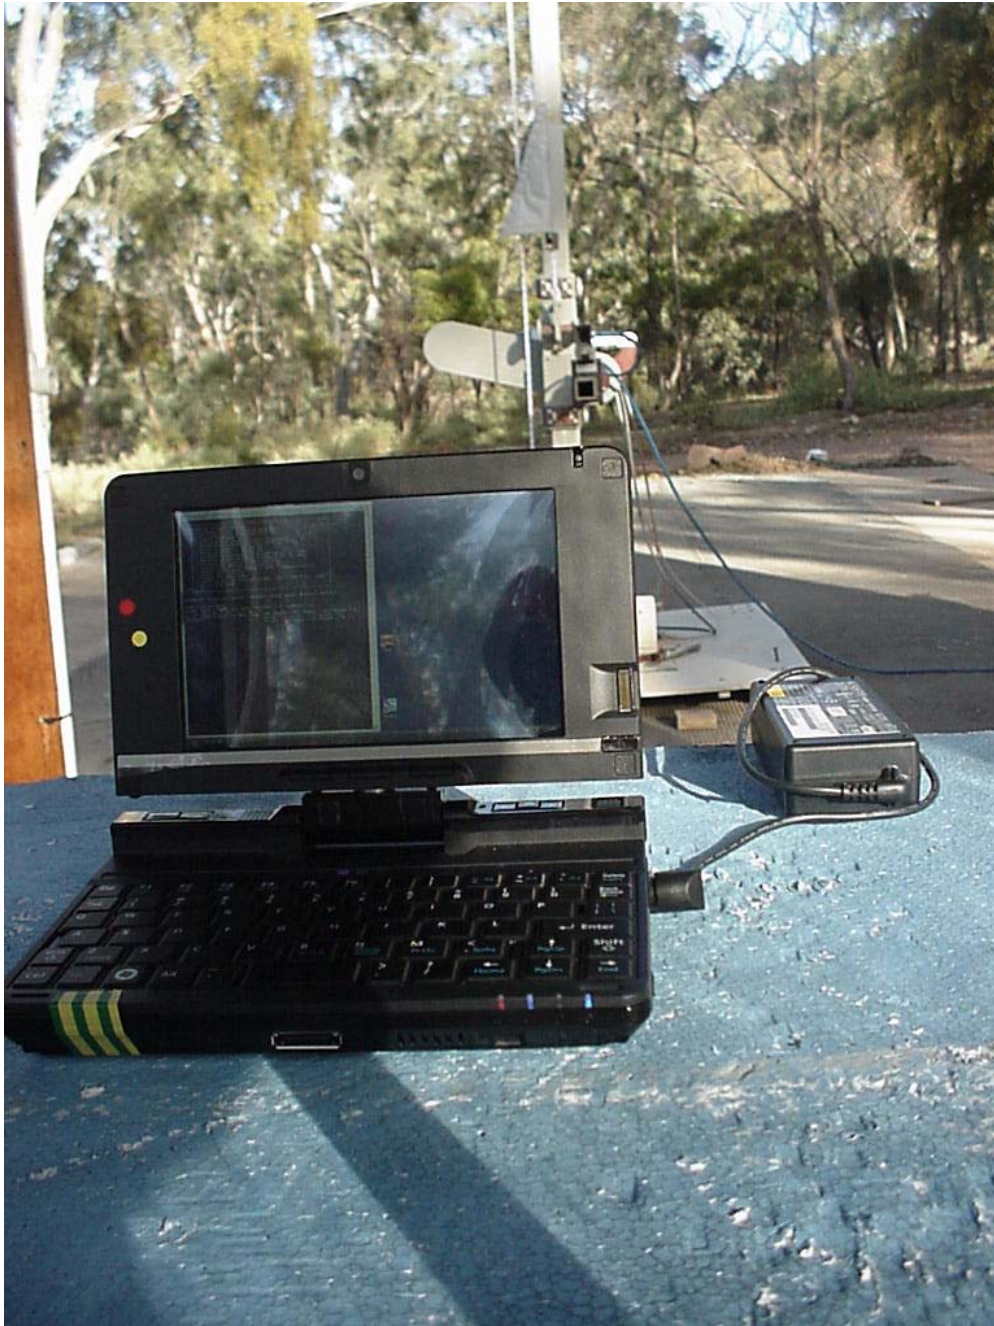
### Radiated Spurious Emissions Test Setup

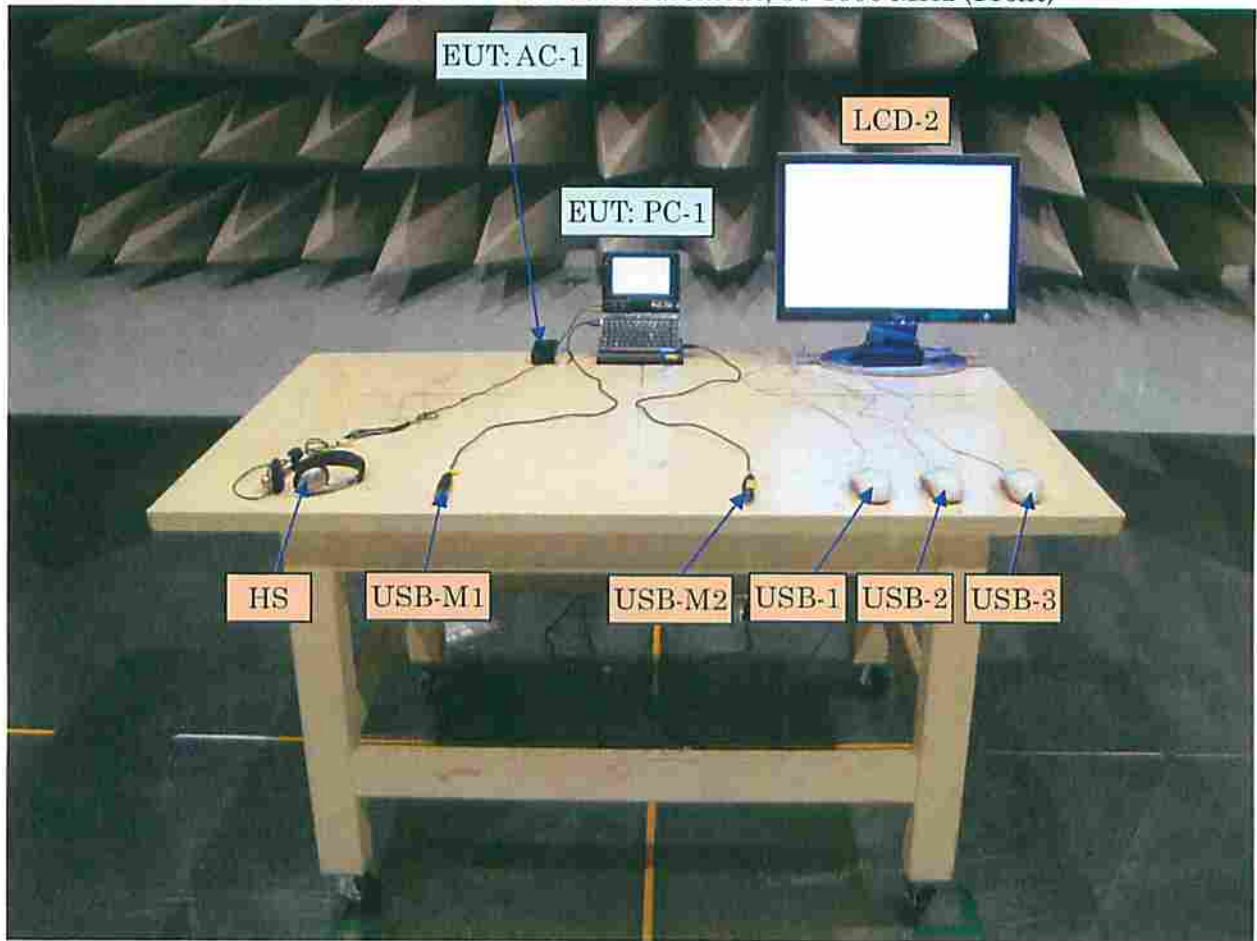
Photo-1.1 Radiated emission measurement; 30-1000 MHz (Front)

- HUB and PC-2 were set at outside of the chamber.

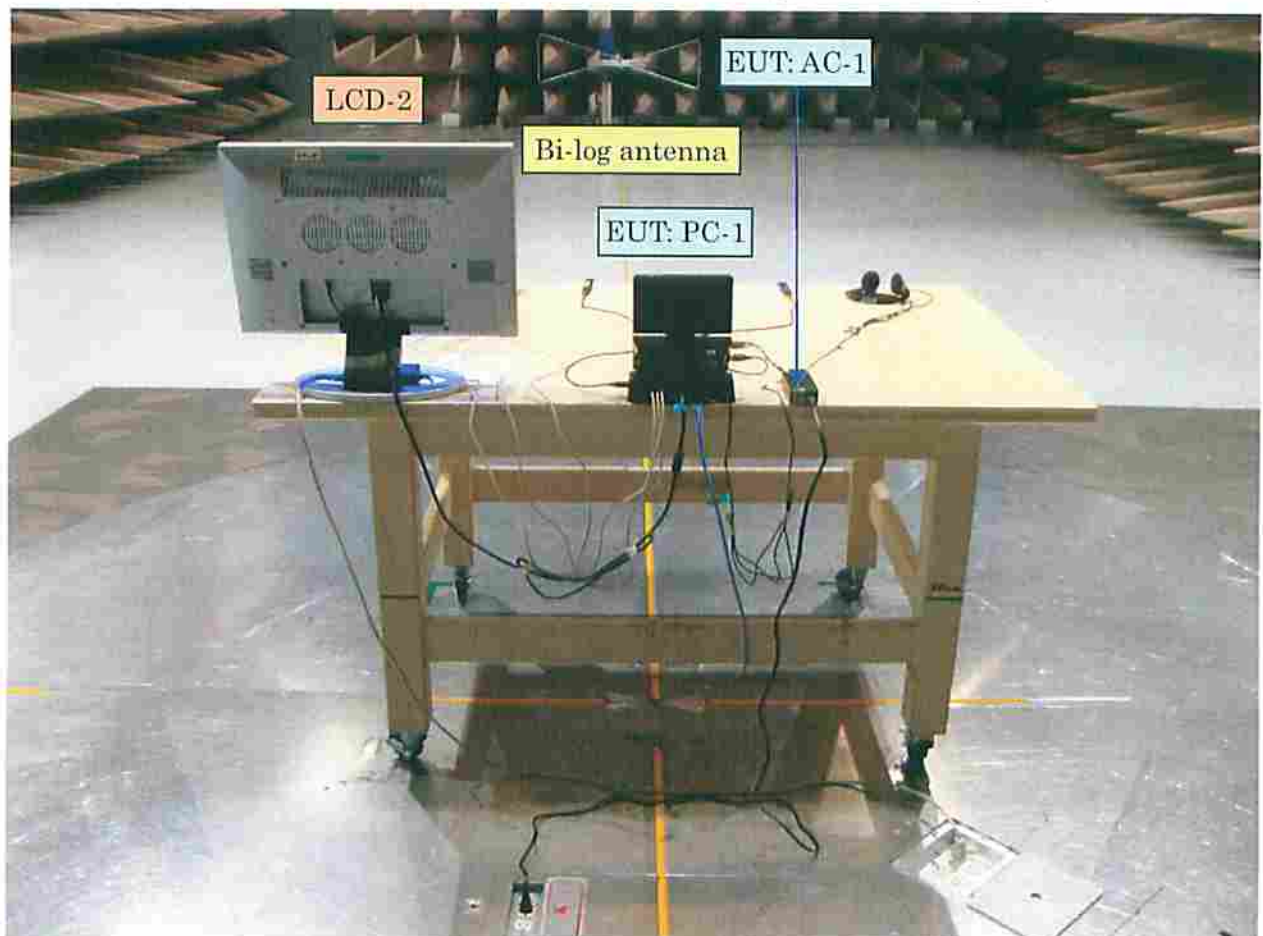
Photo-1.2 Radiated emission measurement; 30-1000 MHz (Back)

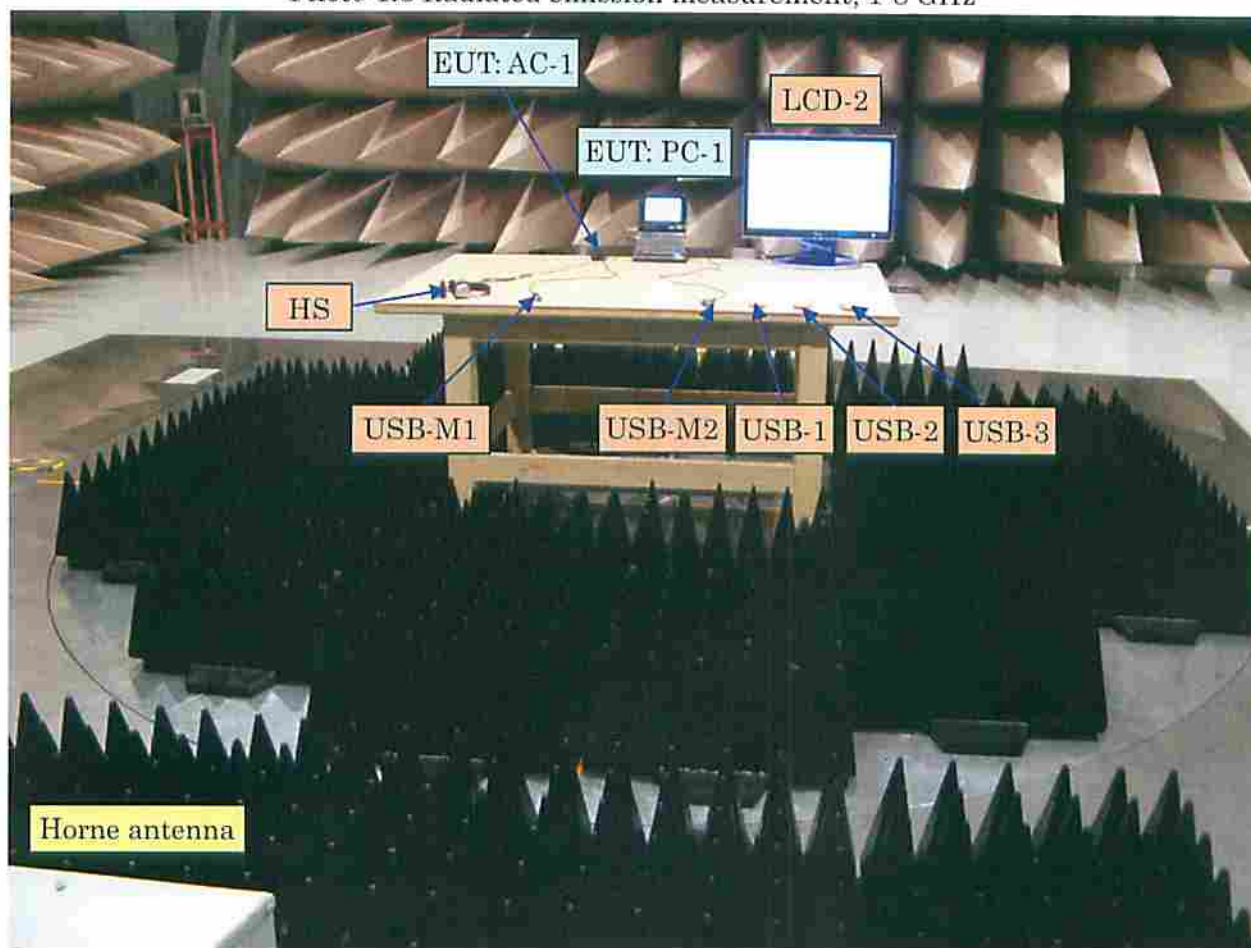
Photo-1.3 Radiated emission measurement; 1-8 GHz

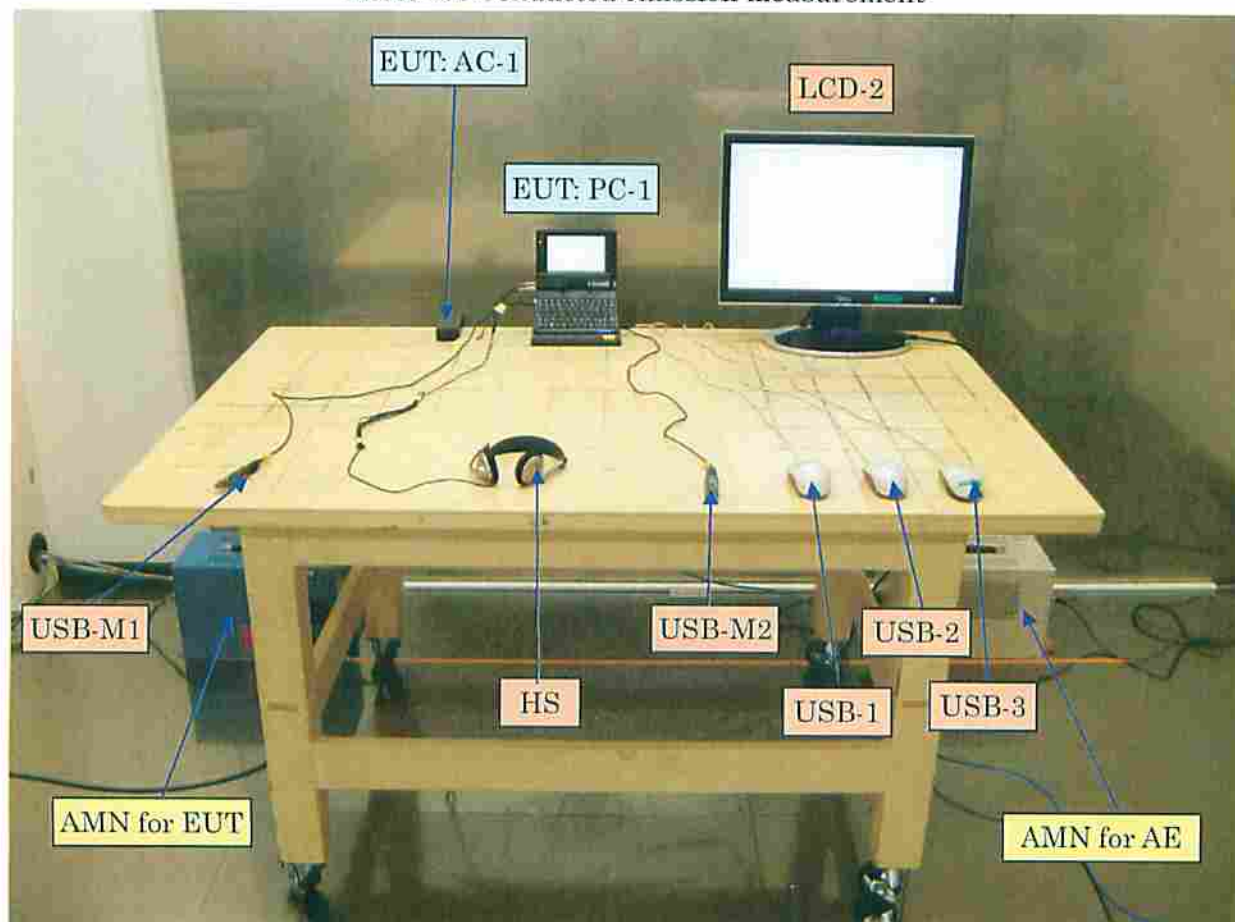
Photo-2.1 Conducted emission measurement
