Compliance Testing, LLC
Testing since 1963

Annex C

Conducted Spurious Emissions

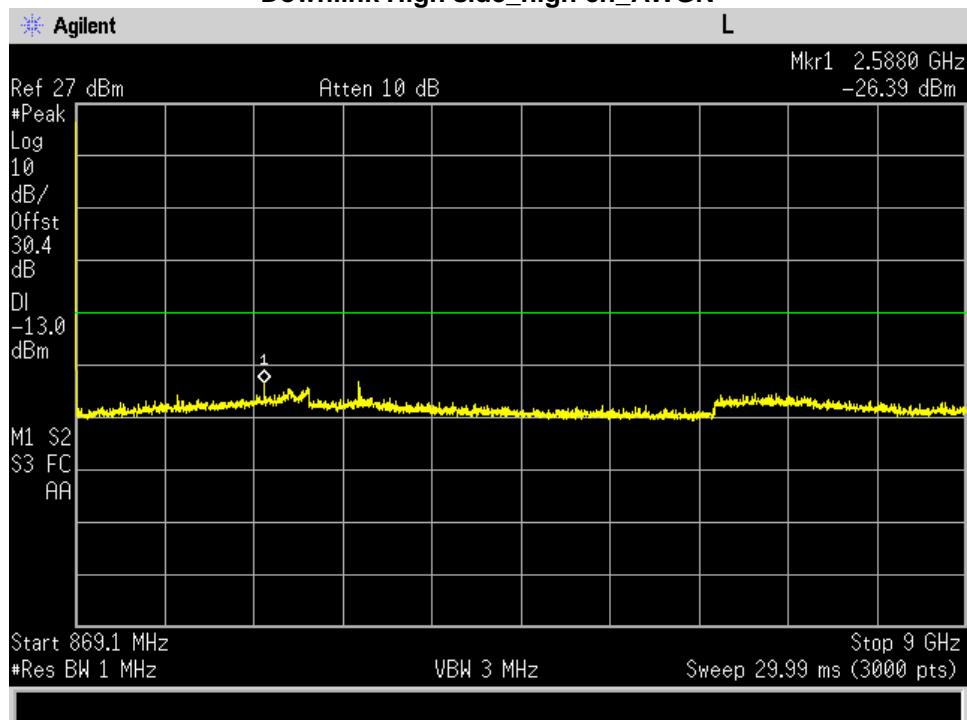
Downlink High side_high ch_AWGN

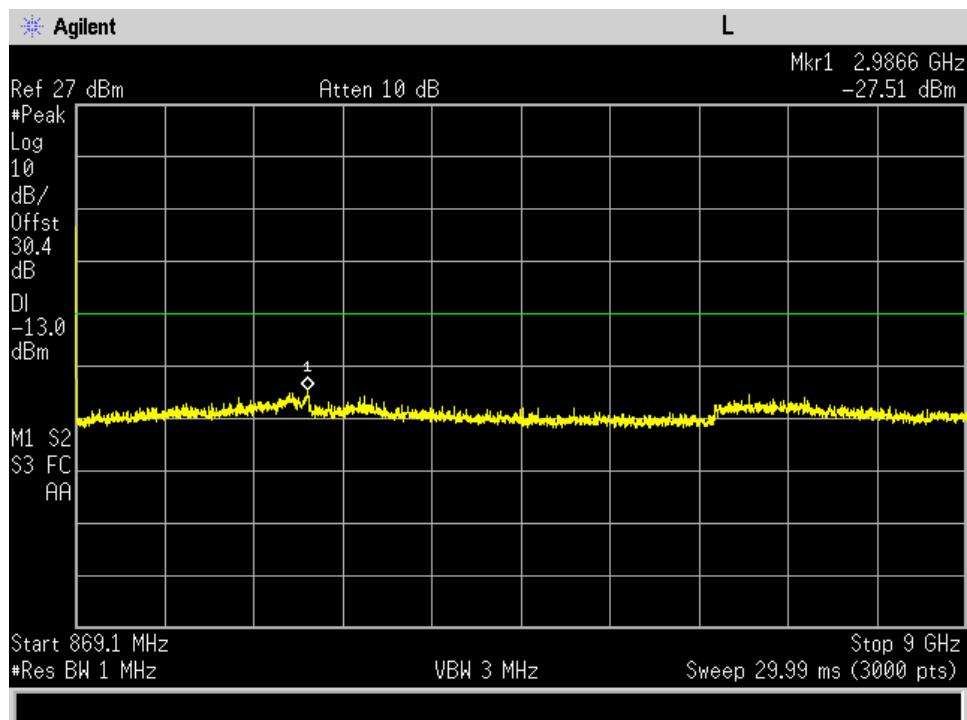
Downlink High side_high ch_GSM

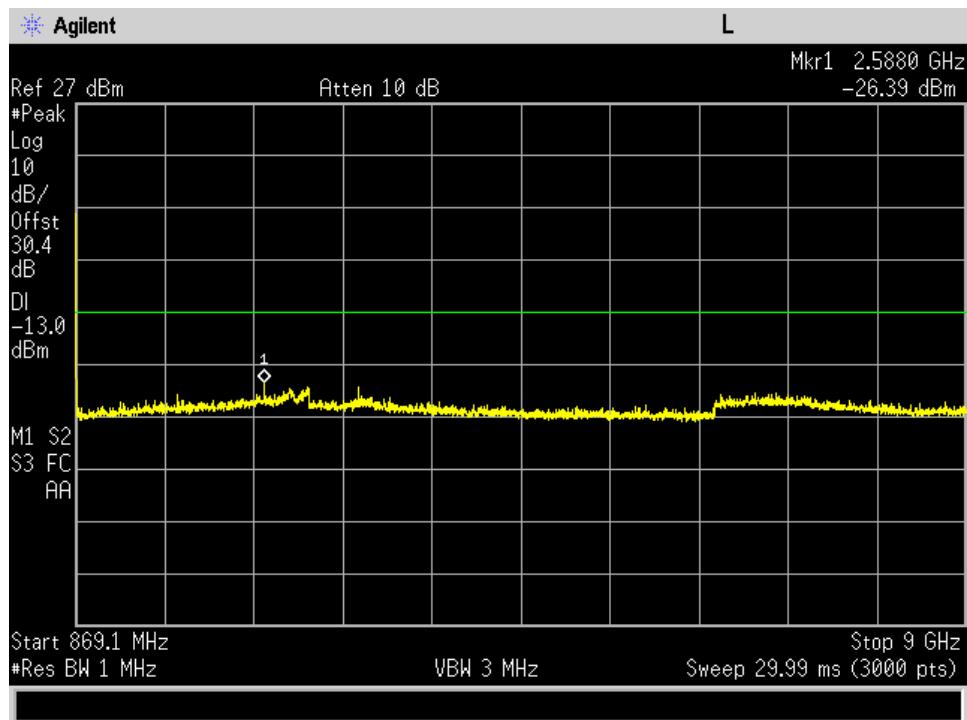
Downlink High side_low ch_AWGN

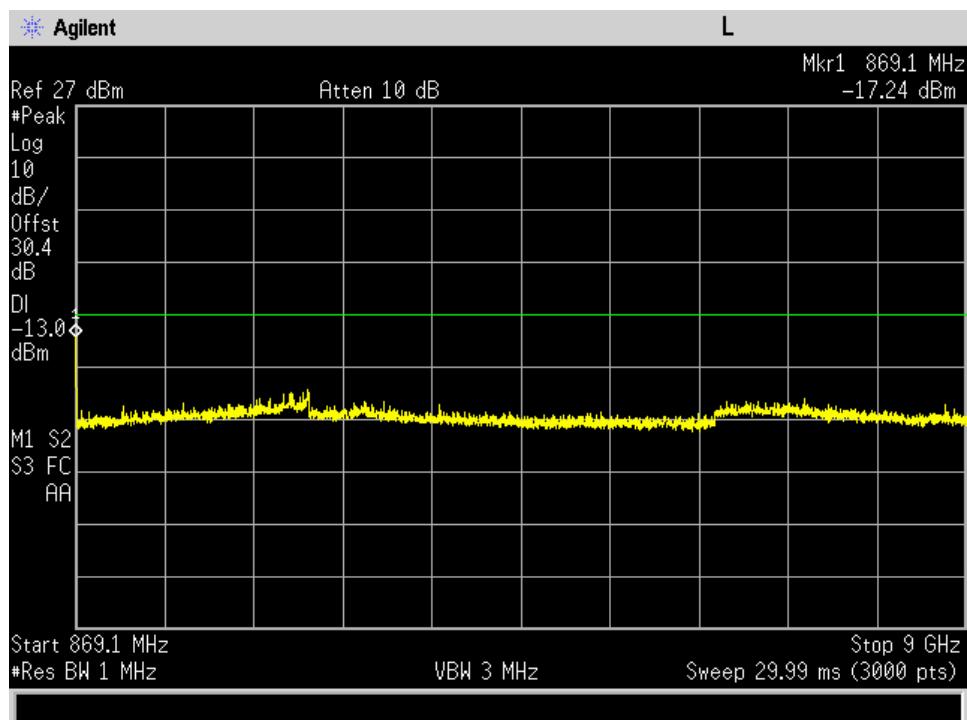
Downlink High side_low ch_GSM

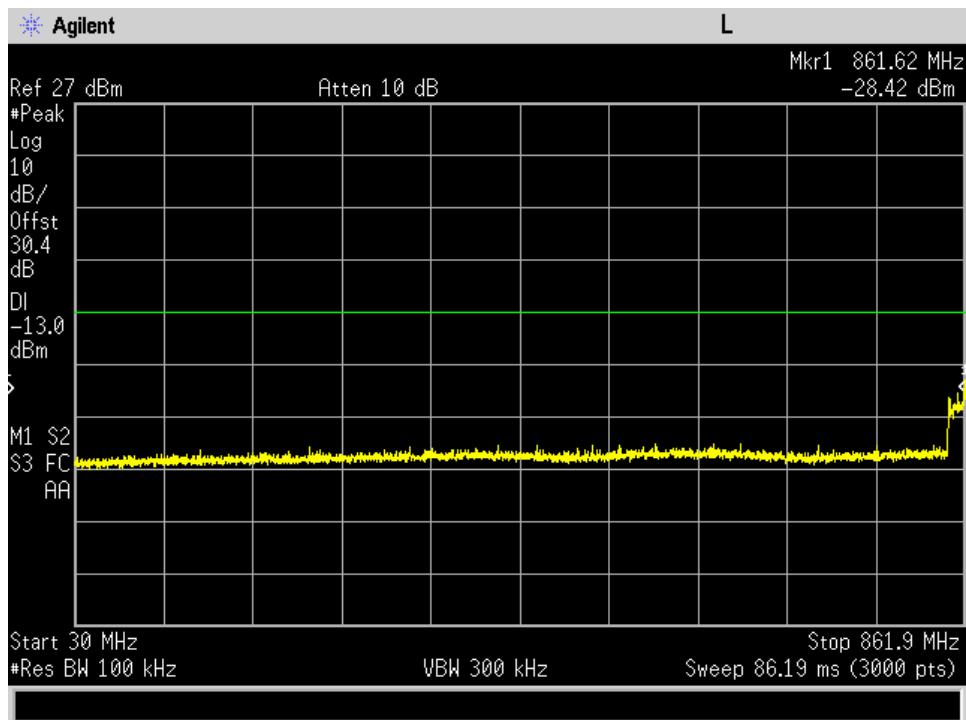
Downlink Low side_high ch_AWGN

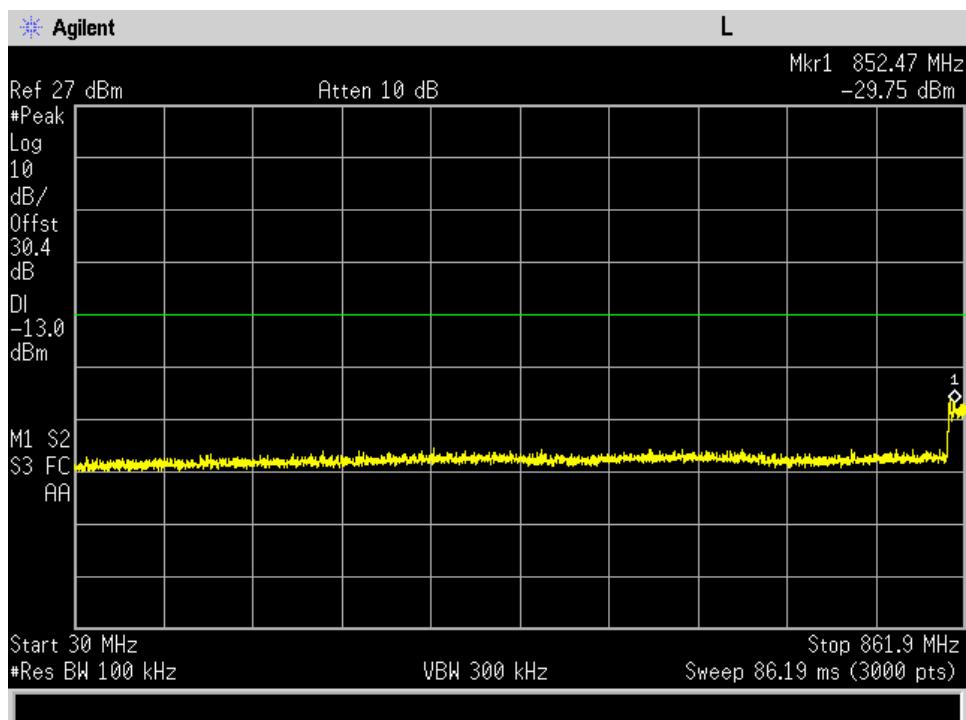
Downlink Low side_high ch_GSM

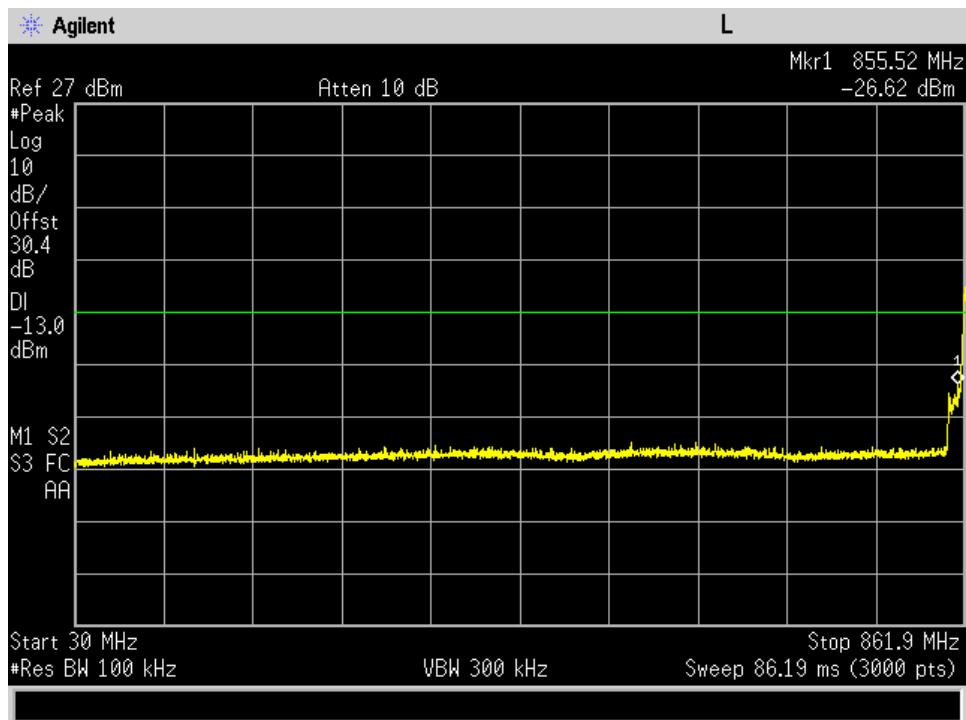
Downlink Low side_low ch_AWGN

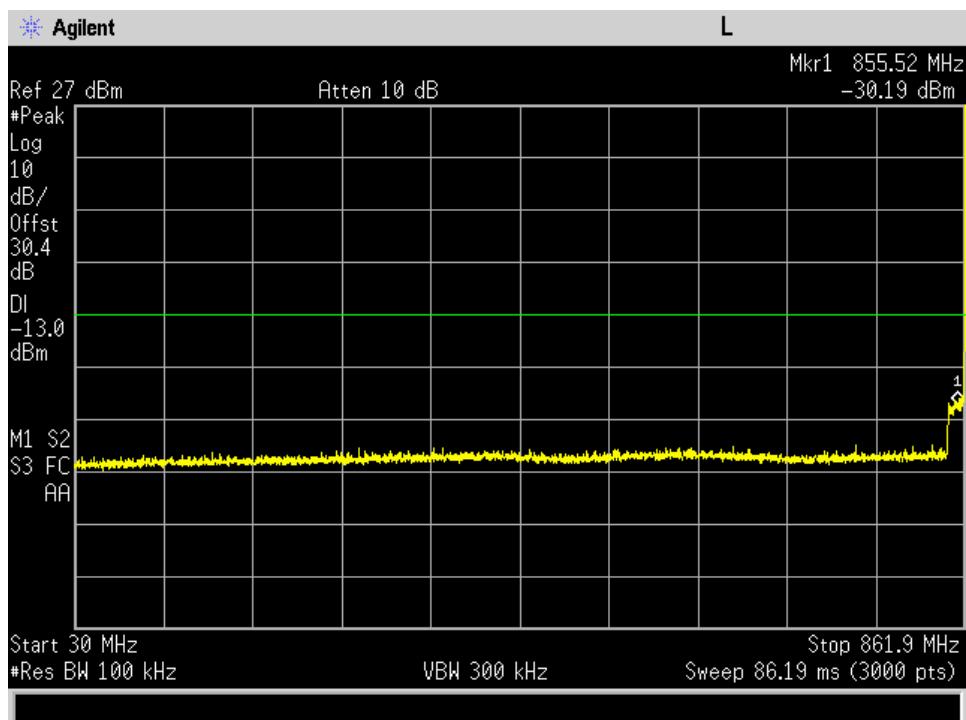
Downlink Low side_low ch_GSM

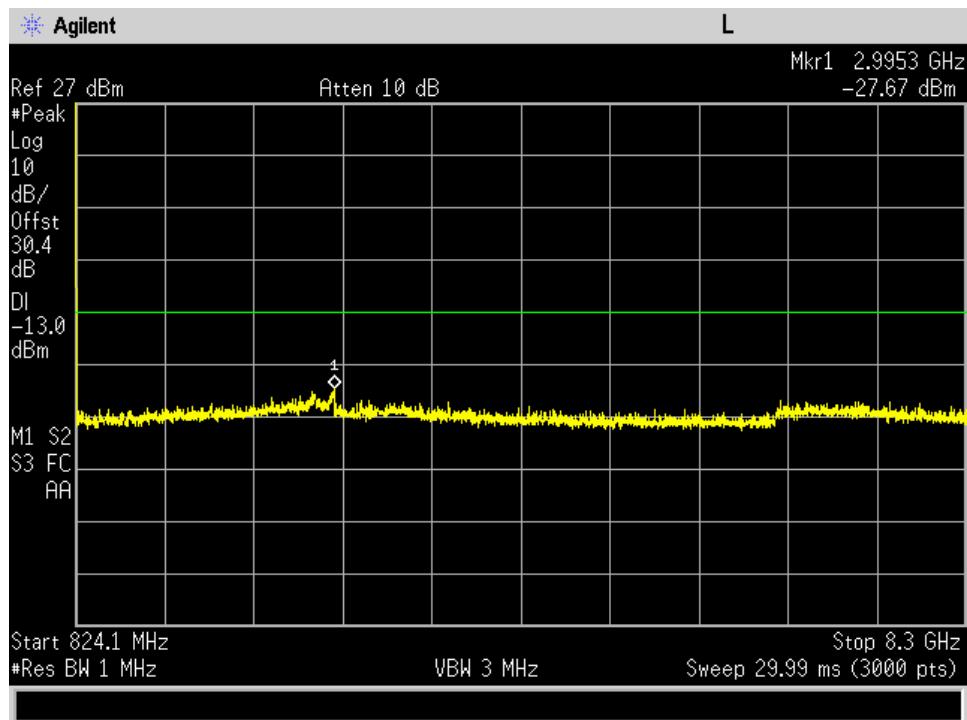
Uplink High side_high ch_AWGN

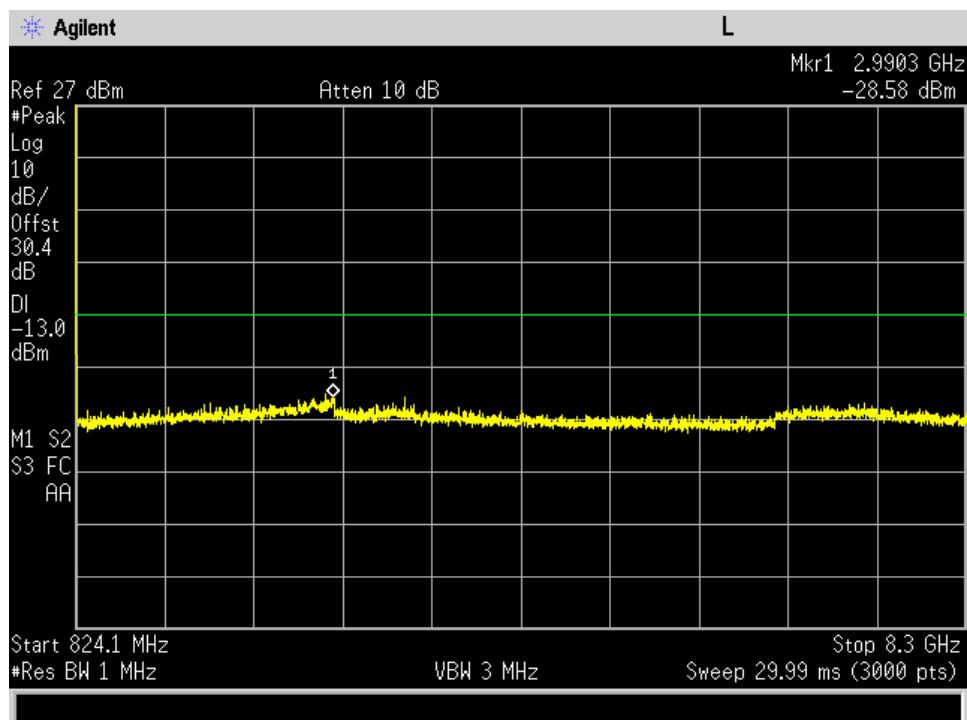
Uplink High side_high ch_GSM

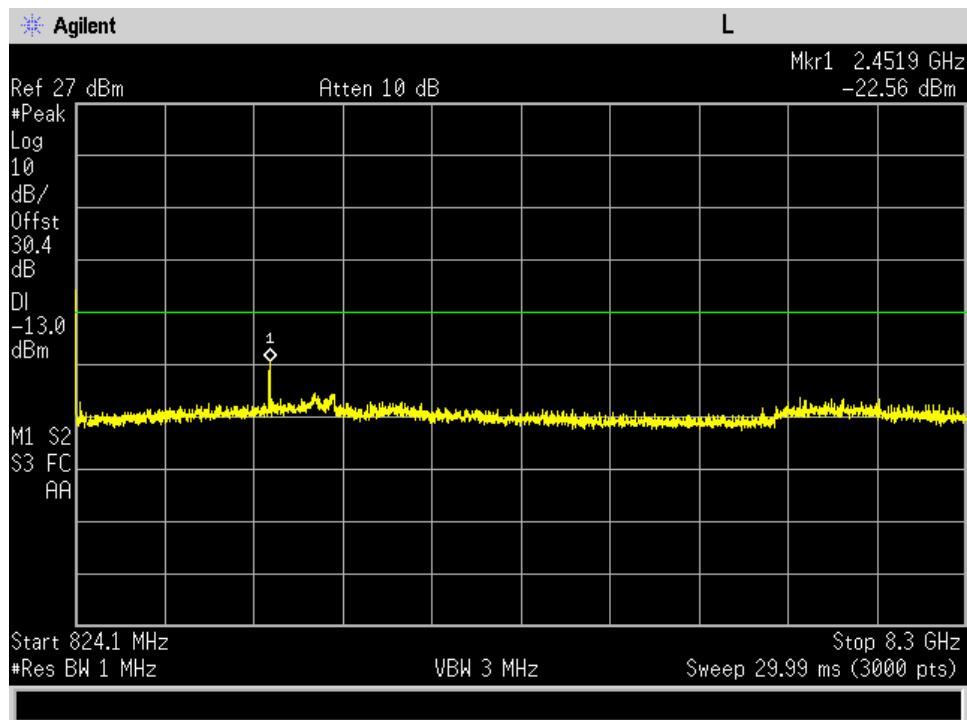
Uplink High side_low ch_AWGN

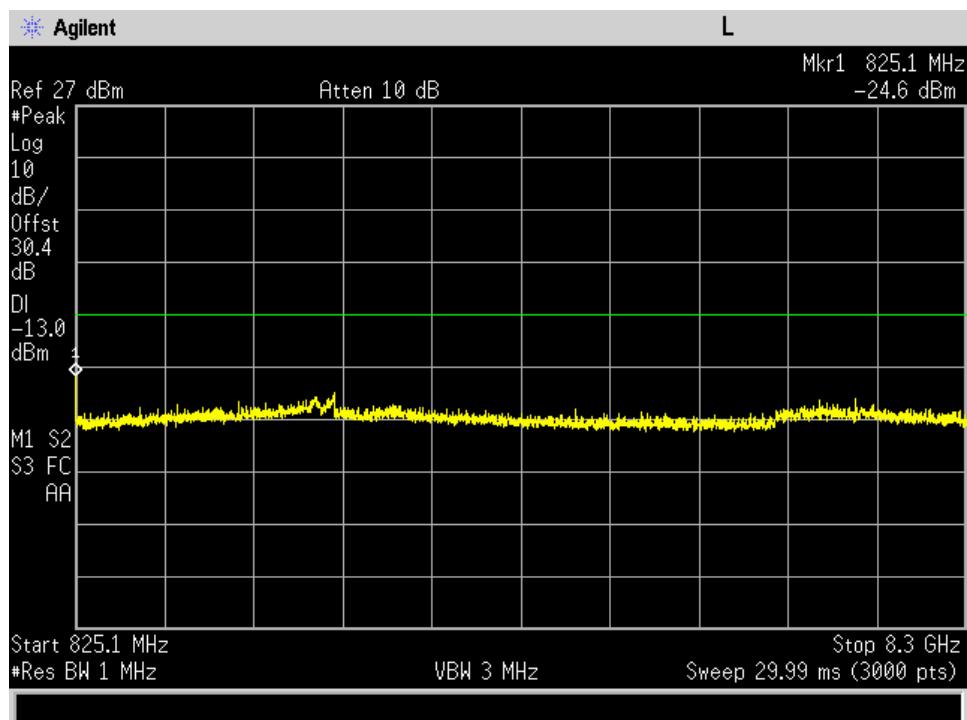
Uplink High side_low ch_GSM

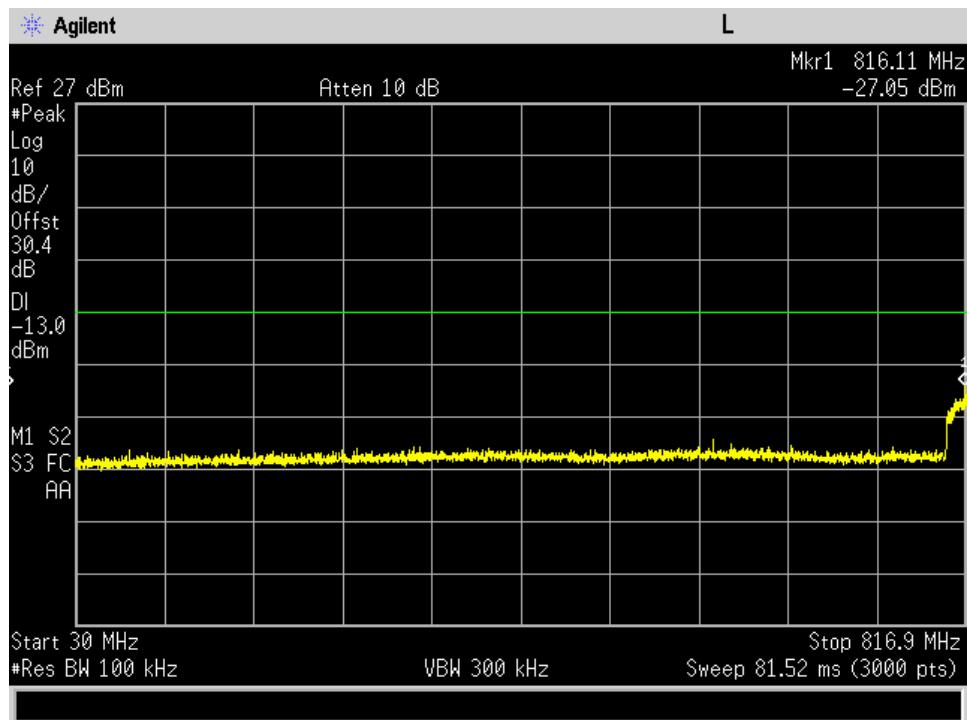
Uplink Low side_high ch_AWGN

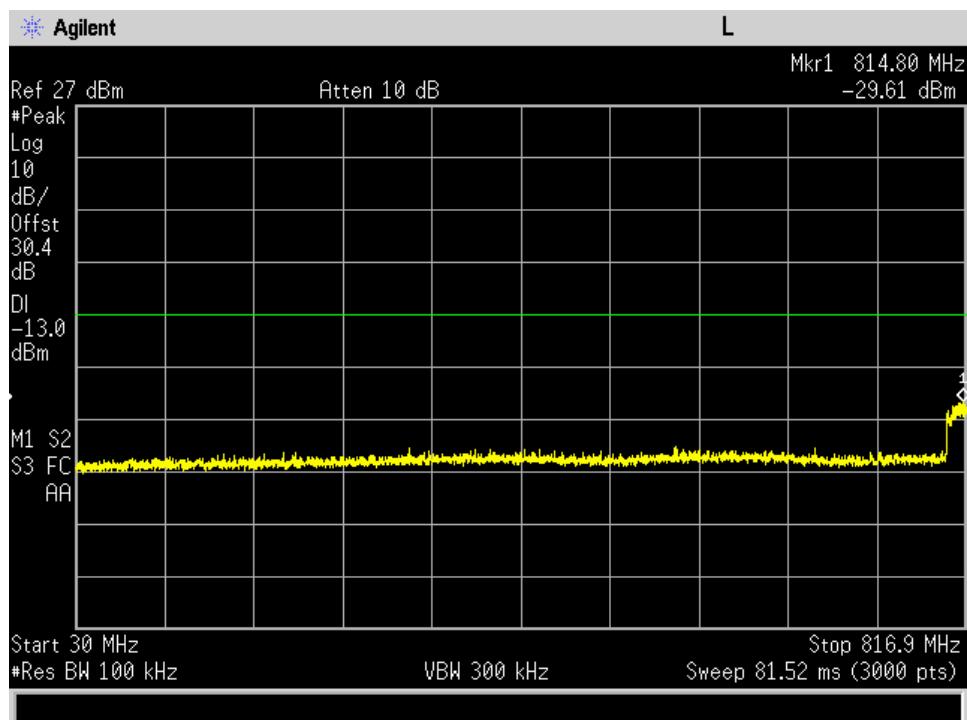
Uplink Low side_high ch_GSM

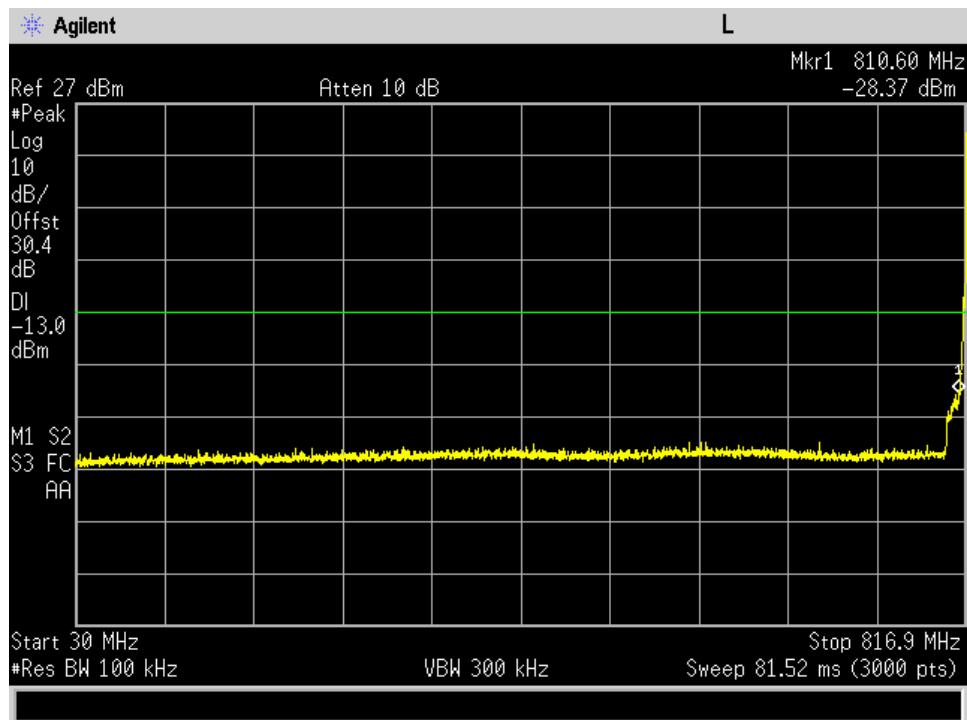
Uplink Low side_low ch_AWGN

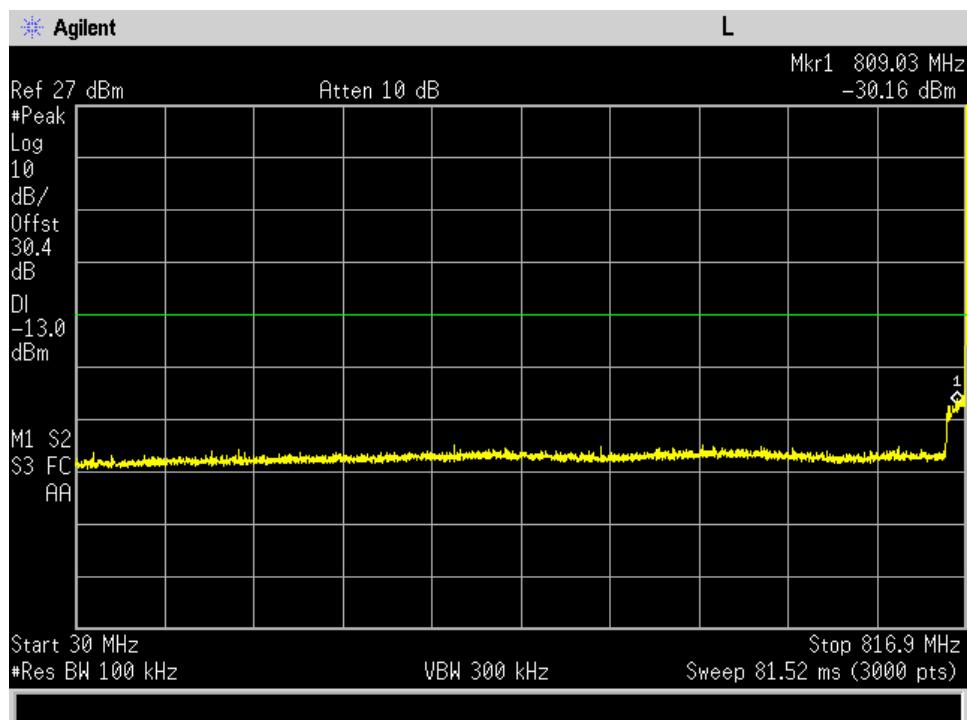
Uplink Low side_low ch_GSM
