# Antenna TEST REPORT

Test Report No.....: RF230627008-01-001

Product(s) Name.....: Remote Work Light TX PCB Antenna

Model(s).....: TX PCB Antenna

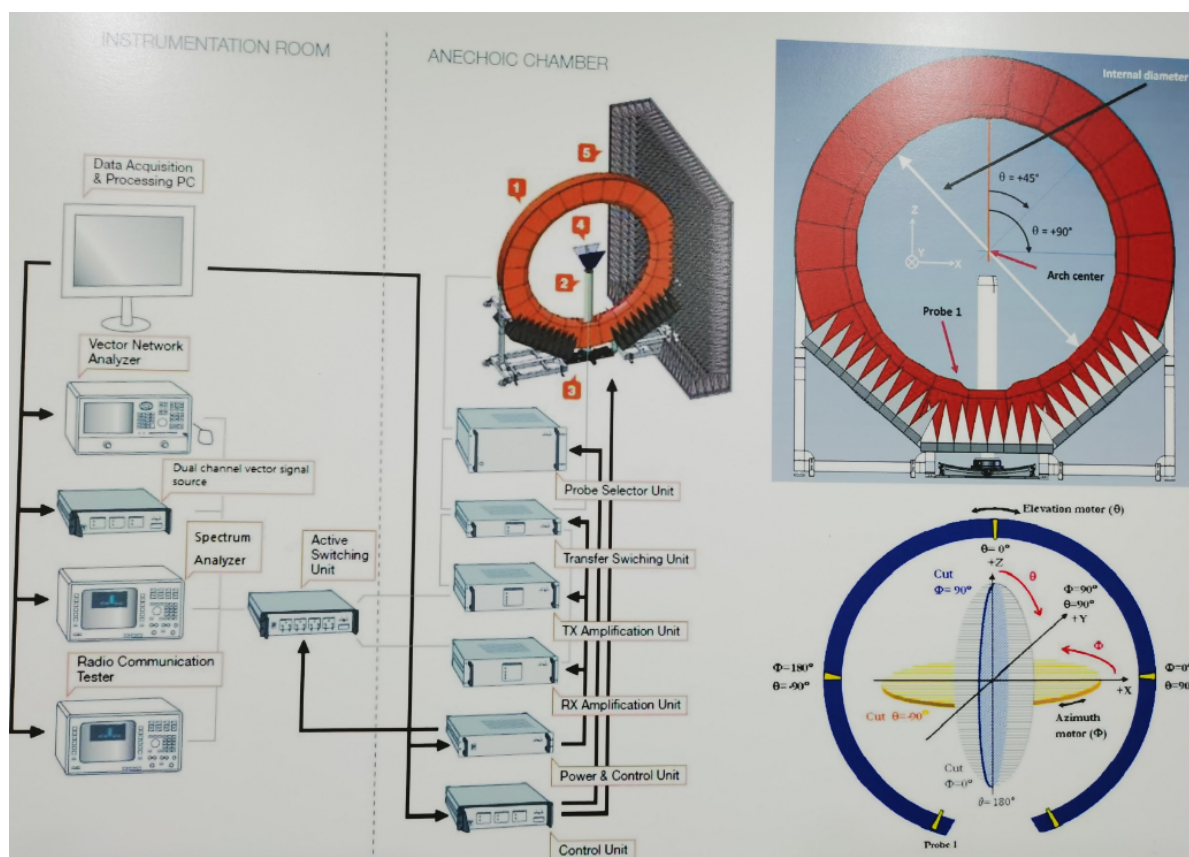
Test system configuration diagram

Test configuration: Reference to CITA OTA distributed-axes system configuration.

Chamber: Fully Anechoic Chamber.

Turntable: Phi angle; Multiple antenna loop: Theta angle

Port 1 of Network analyzer connect to antenna of EUT. Record S21 value every 15 degree from 0 to 345 degree on Theta angle and 0 to 180 on Phi angle . Repeat process to each antenna of EUT.

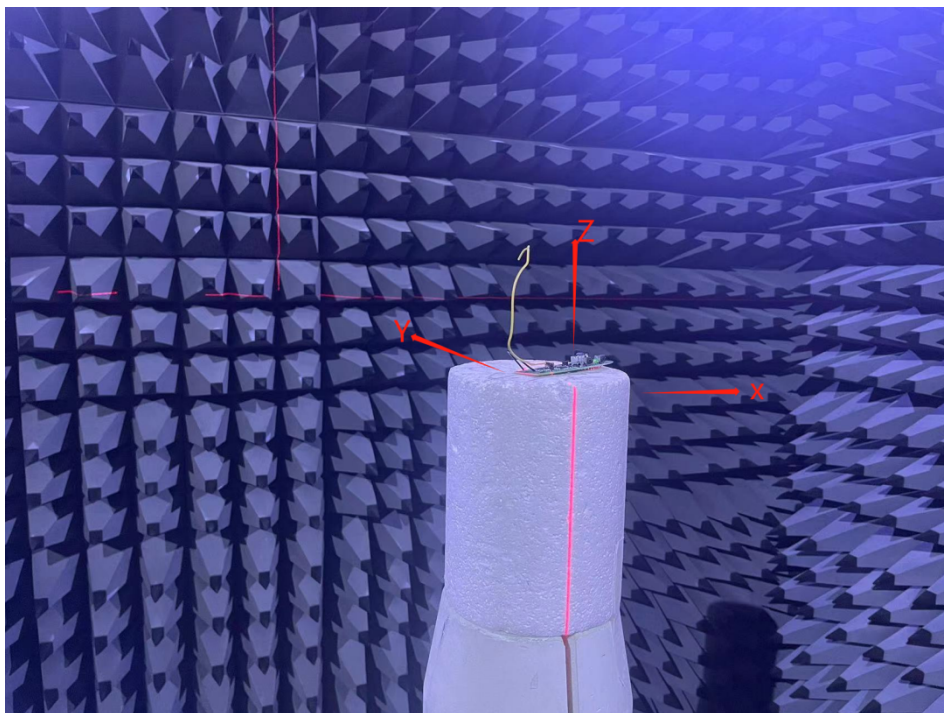
Microwave anechoic chamber

- Test Condition: the network analyzer(E5071C) and SATIMO microwave anechoic chamber
- Passive measurement results are presented

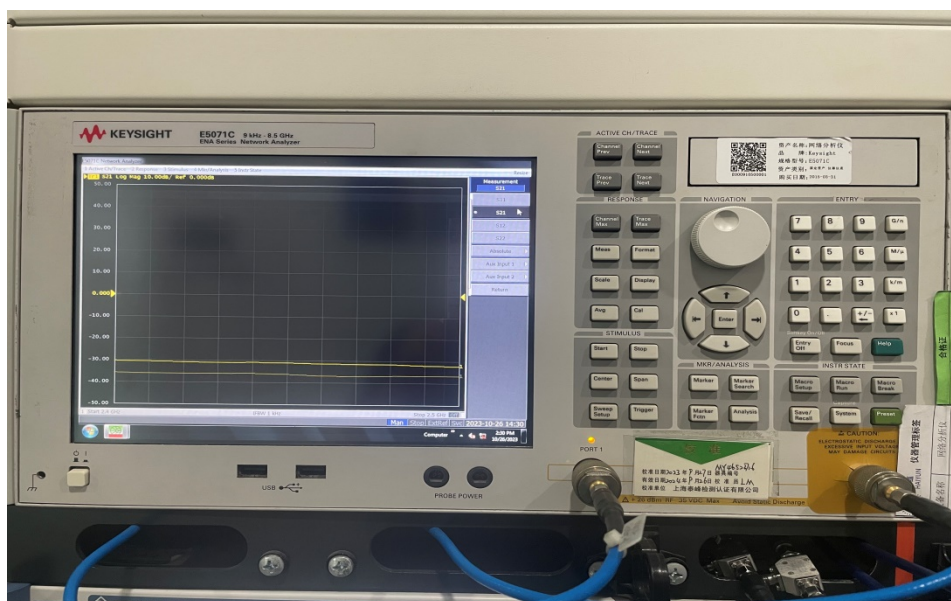
The network Analyzer

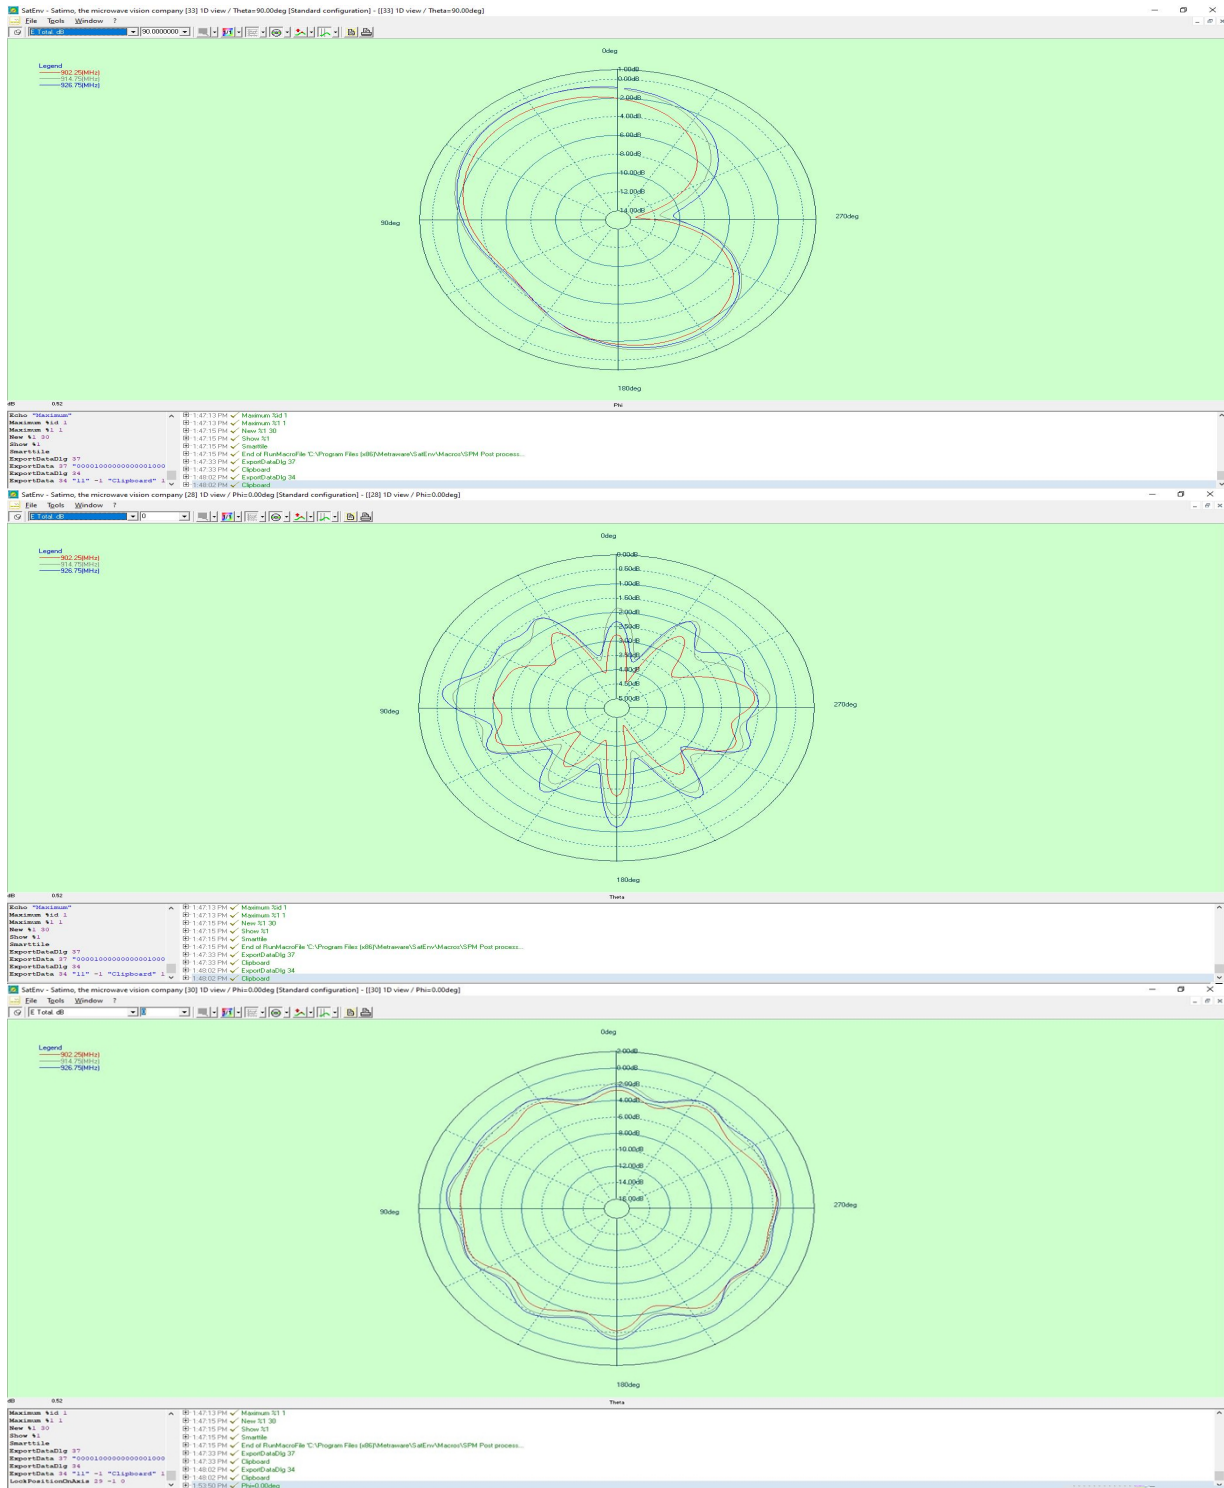
Antenna\_2D

### 4.1 2D Radiation pattern test results
