## Appendix A: 20dB Occupied bandwidth

Test Report No.: EFGX20080028-01-E01

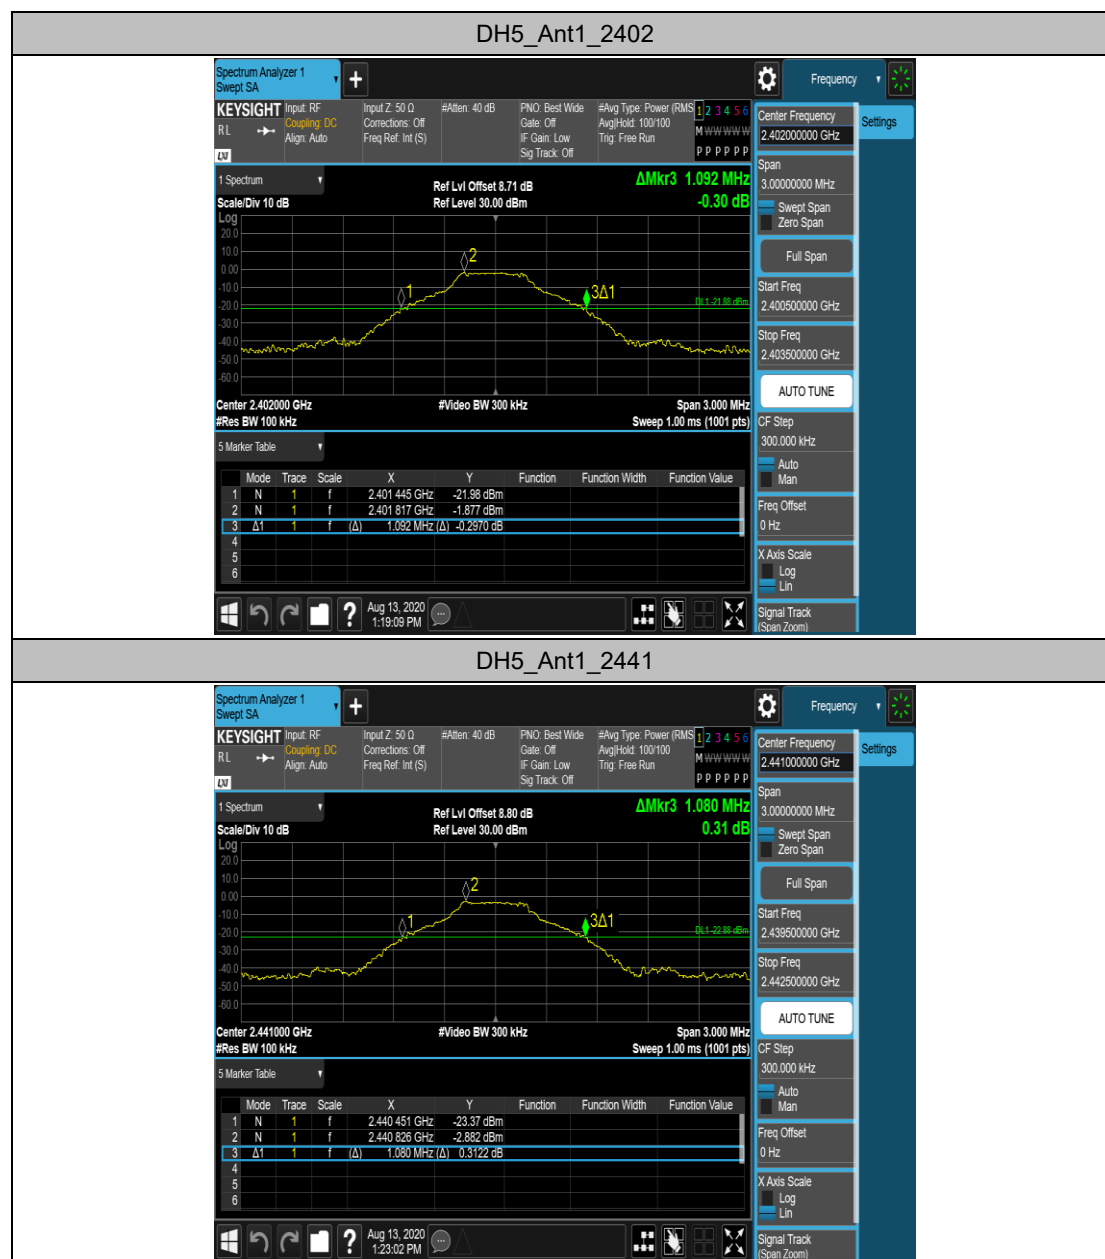
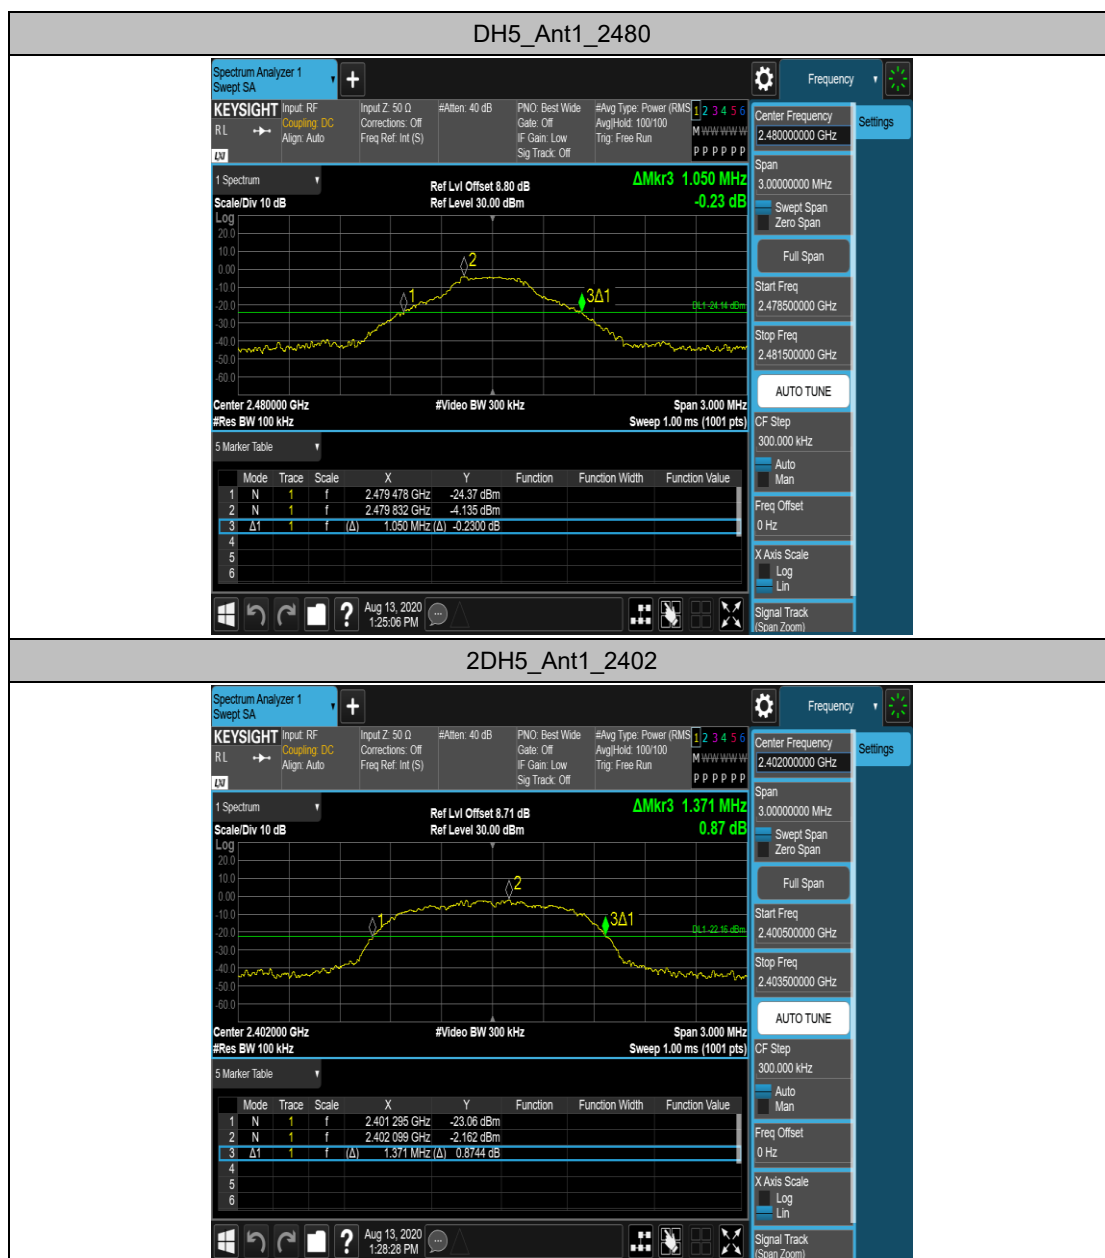
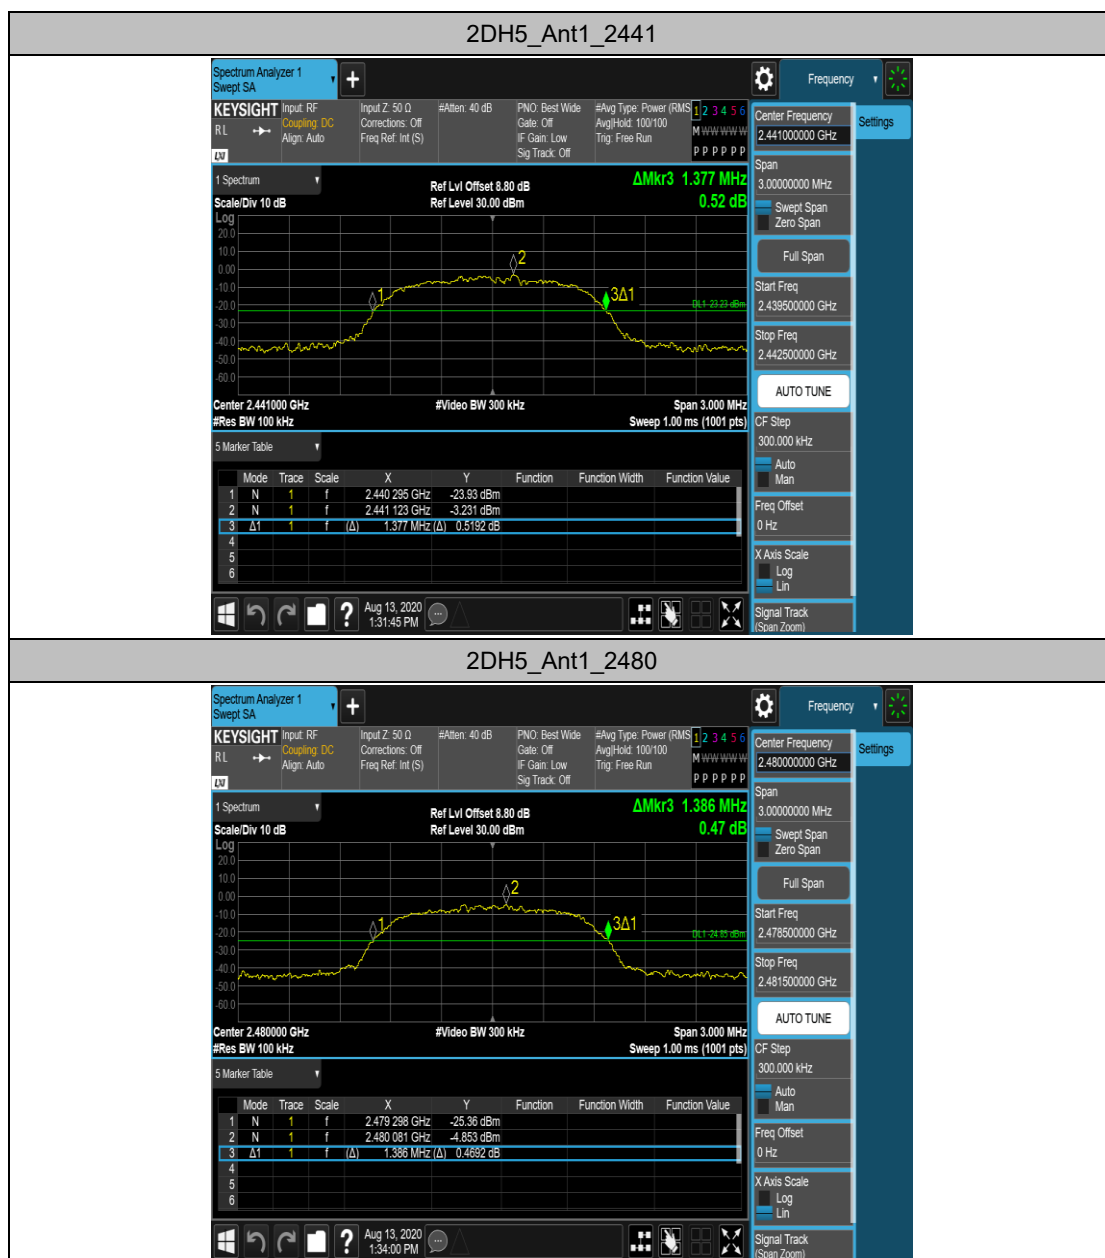
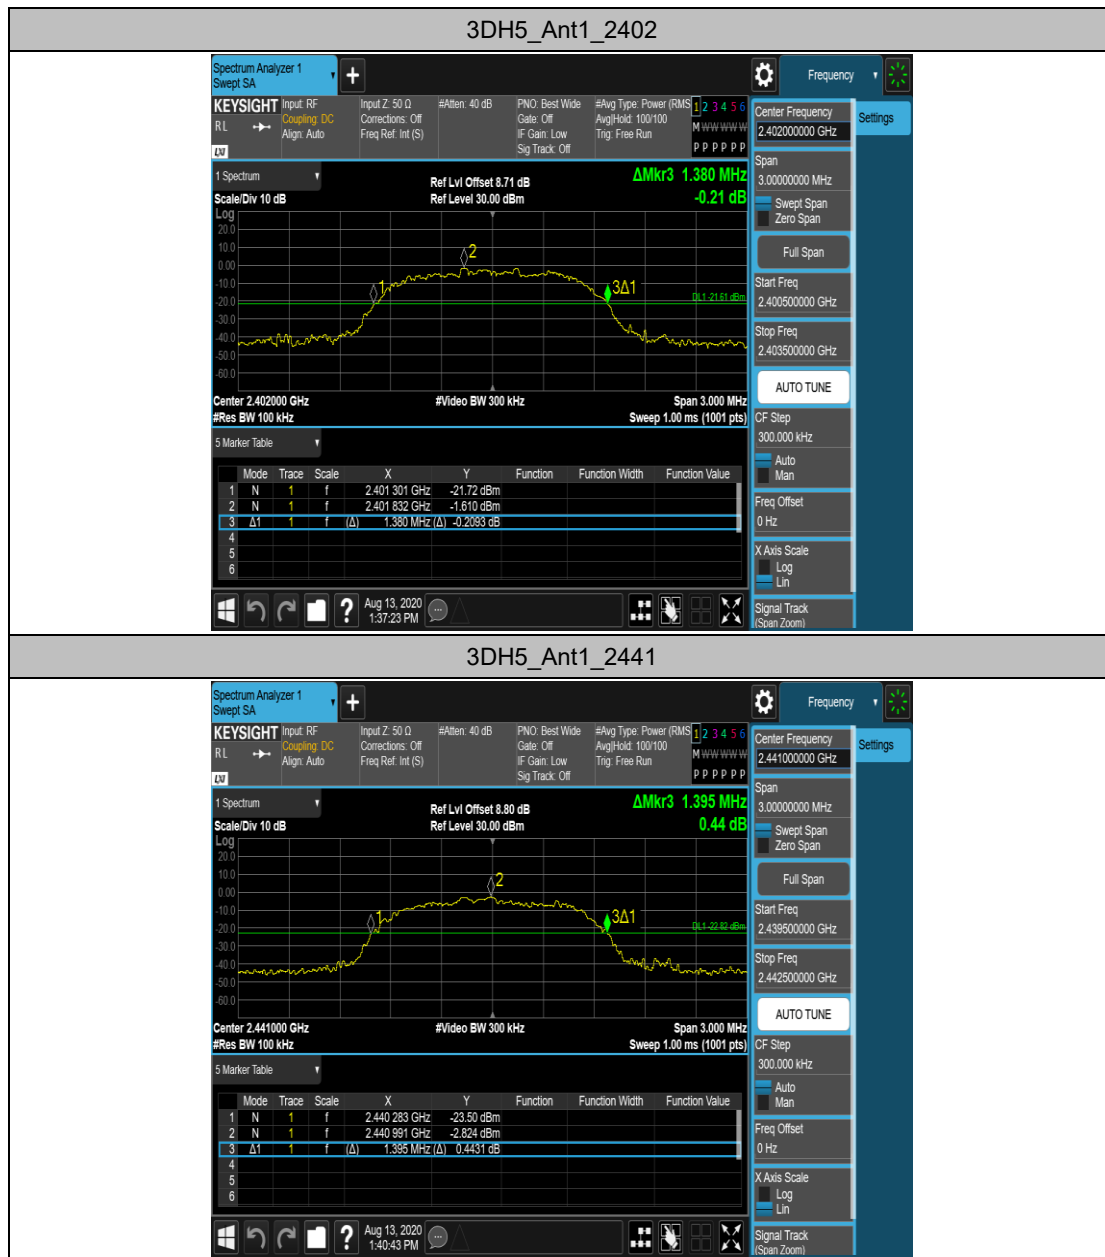
## Test Graphs

### Test Result

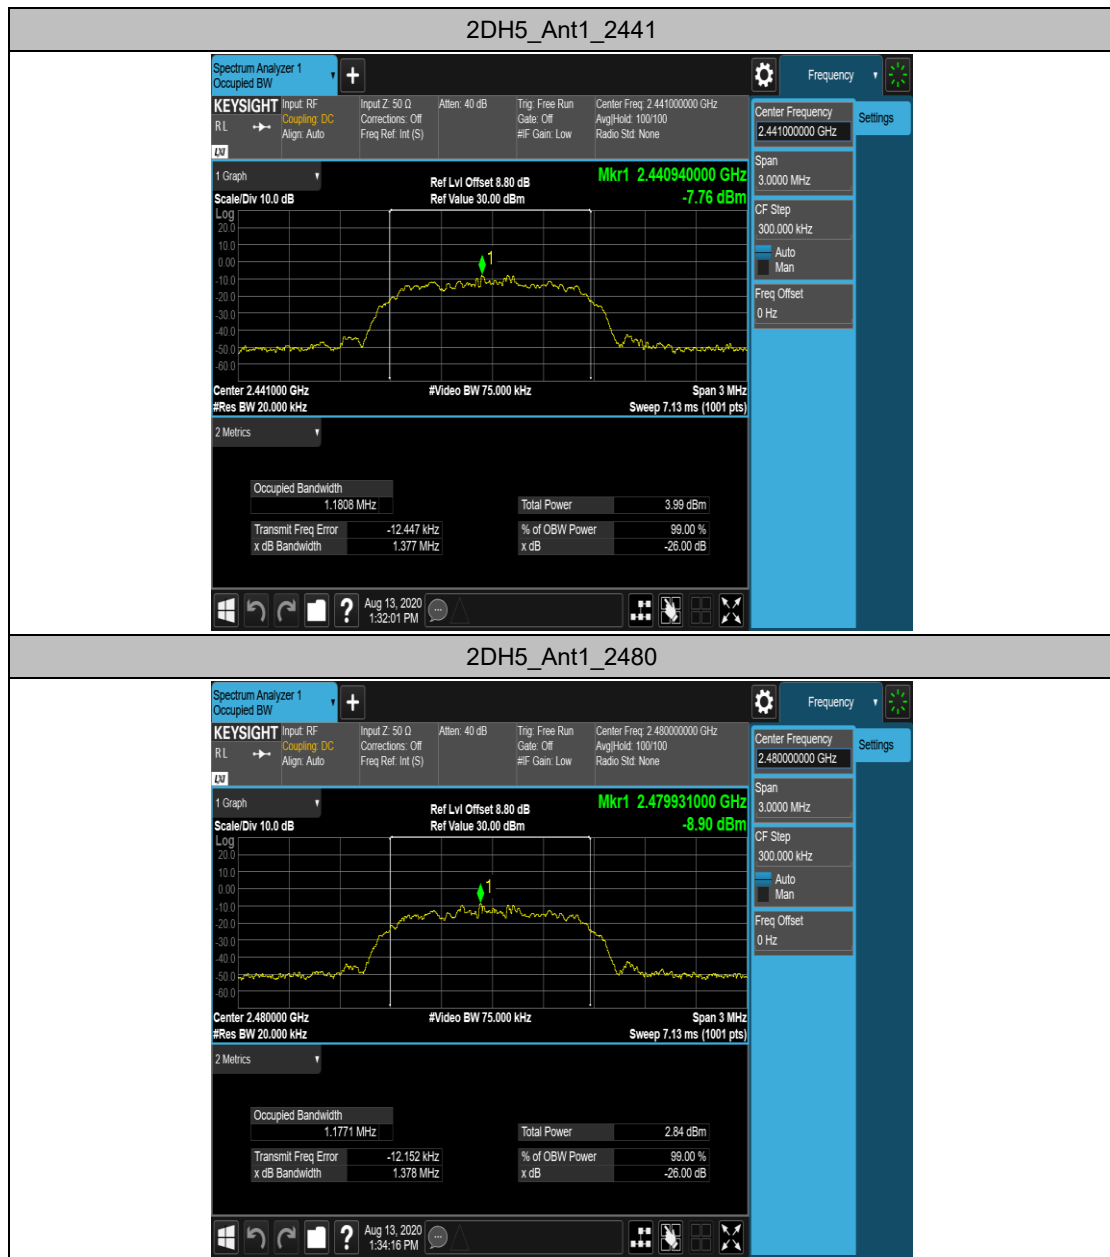
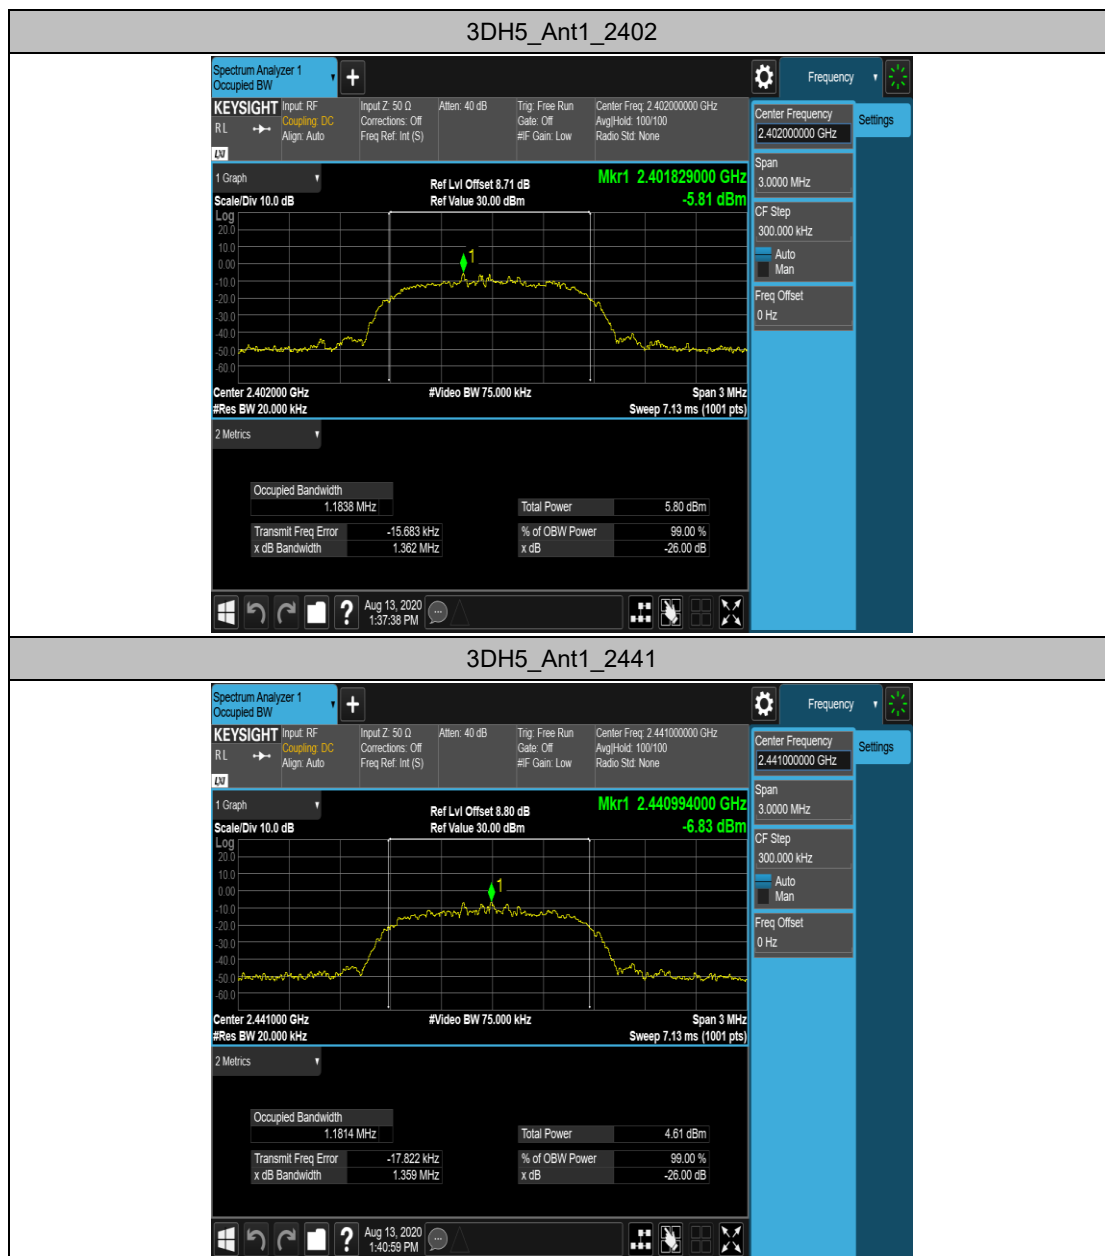
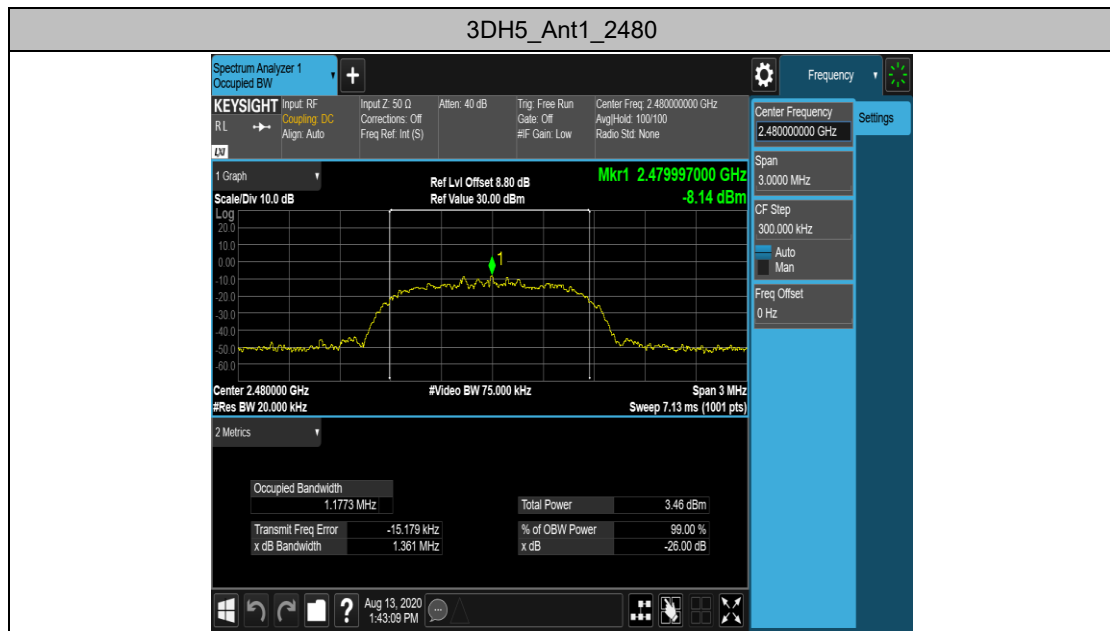
## Test Graphs

## Appendix B: 99% Occupied Bandwidth

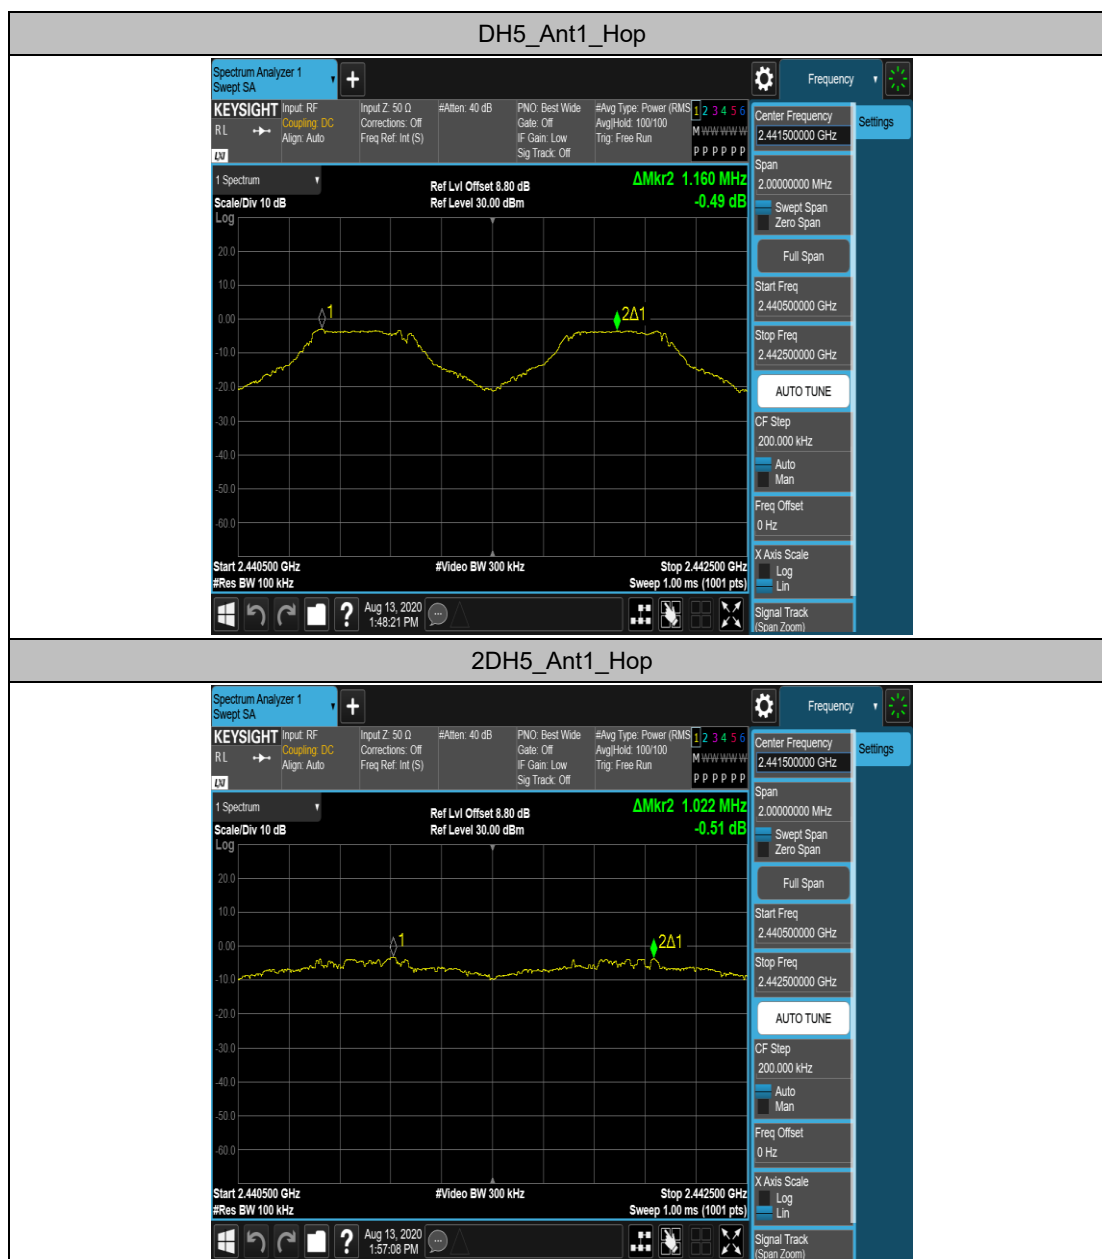
## Test Graphs

## Appendix D: Carrier frequency separation

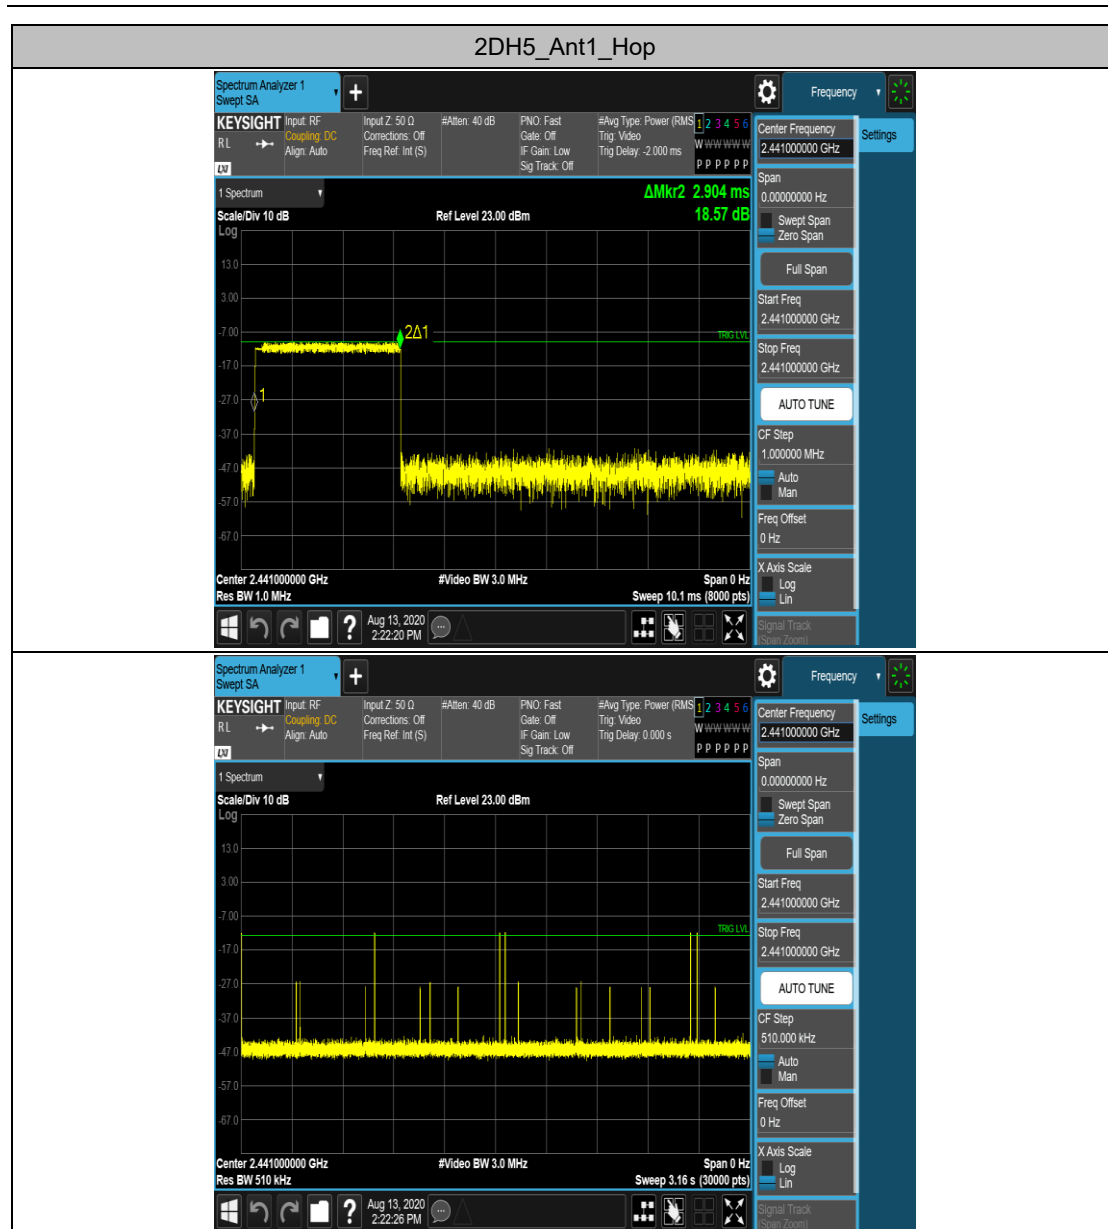
## Test Graphs

## Appendix E: Time of occupancy
