**MOTOROLA**

HAC Test Report for T-coil IHDP56JS1

**Pictures of Test Setup**

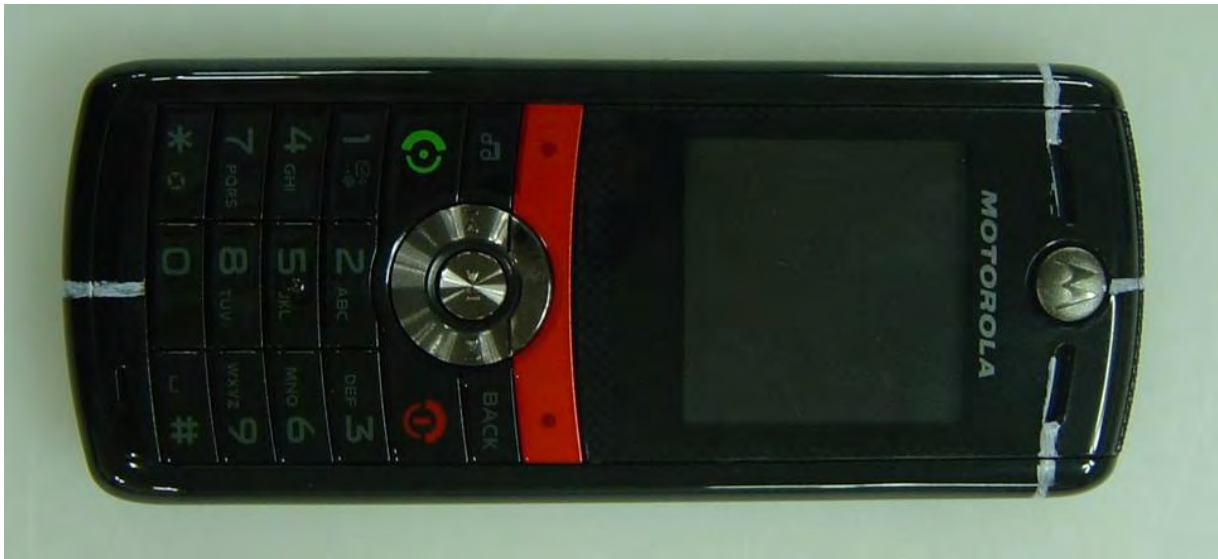
Figure 1. Phone Front

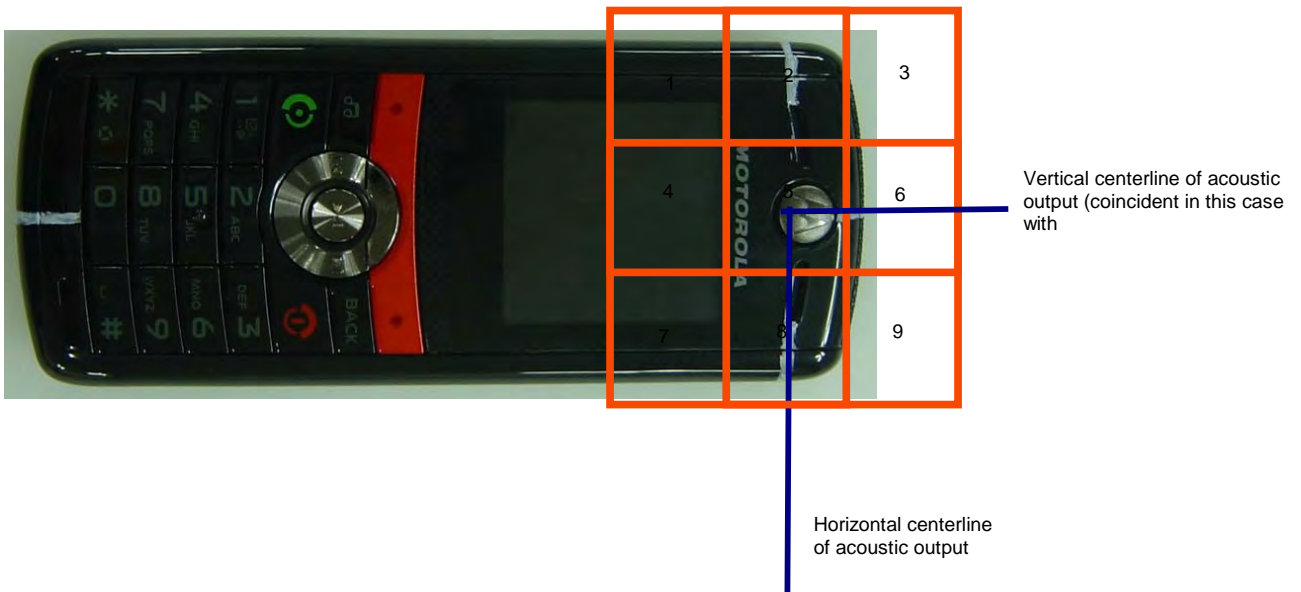
Figure 2. Phone Open - Orientation and Measurement Plane for RF Emissions Testing

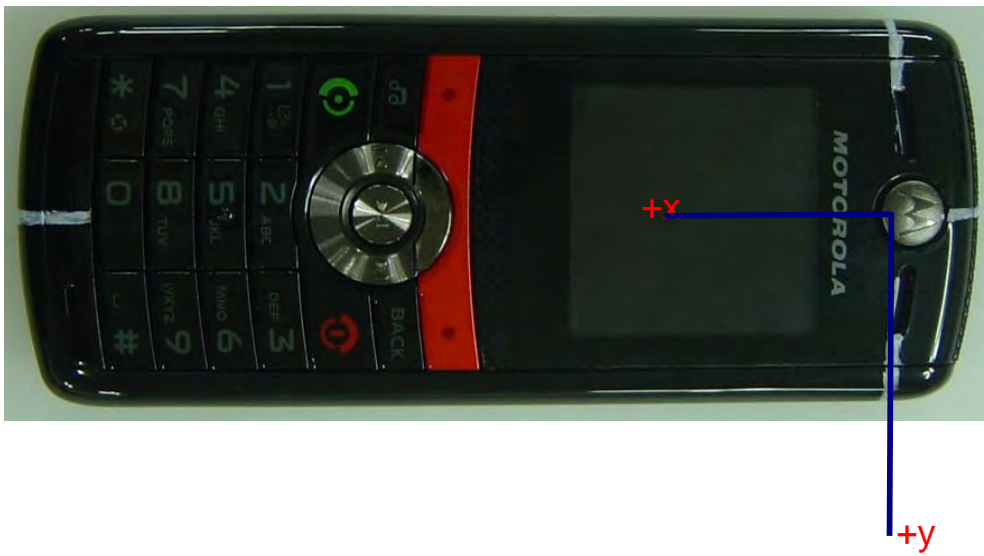
Figure 3. Coordinate Axis for T-coil Measurements

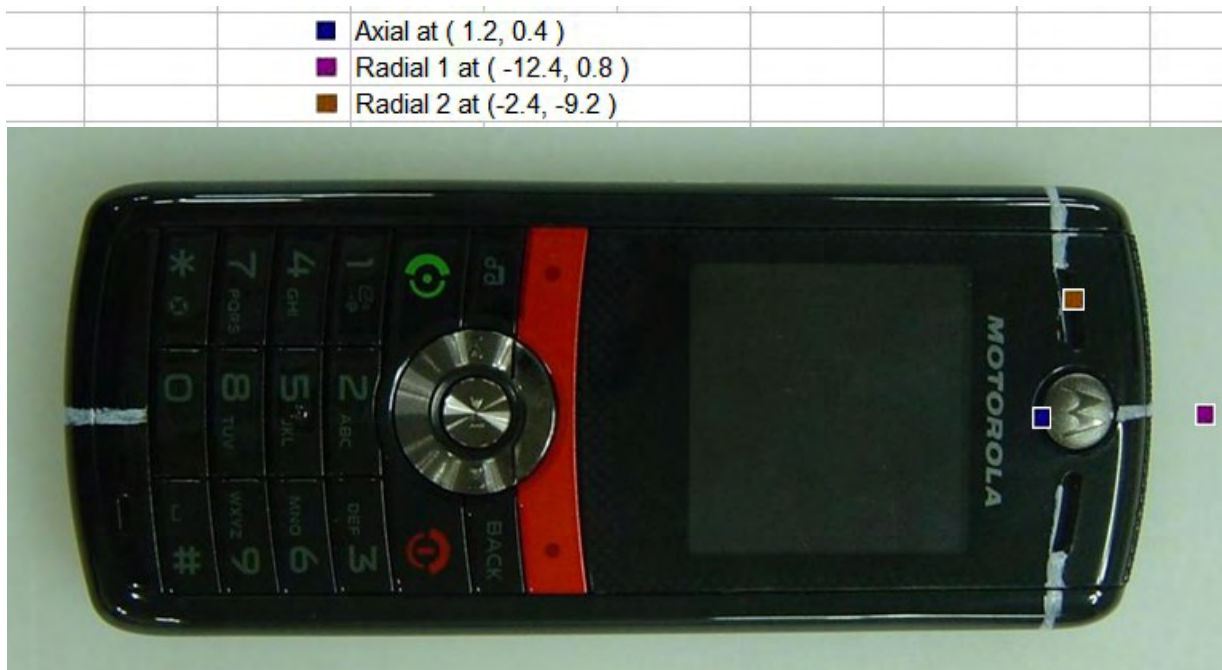
Figure 4. Location of Measured Points for T-coil measurements

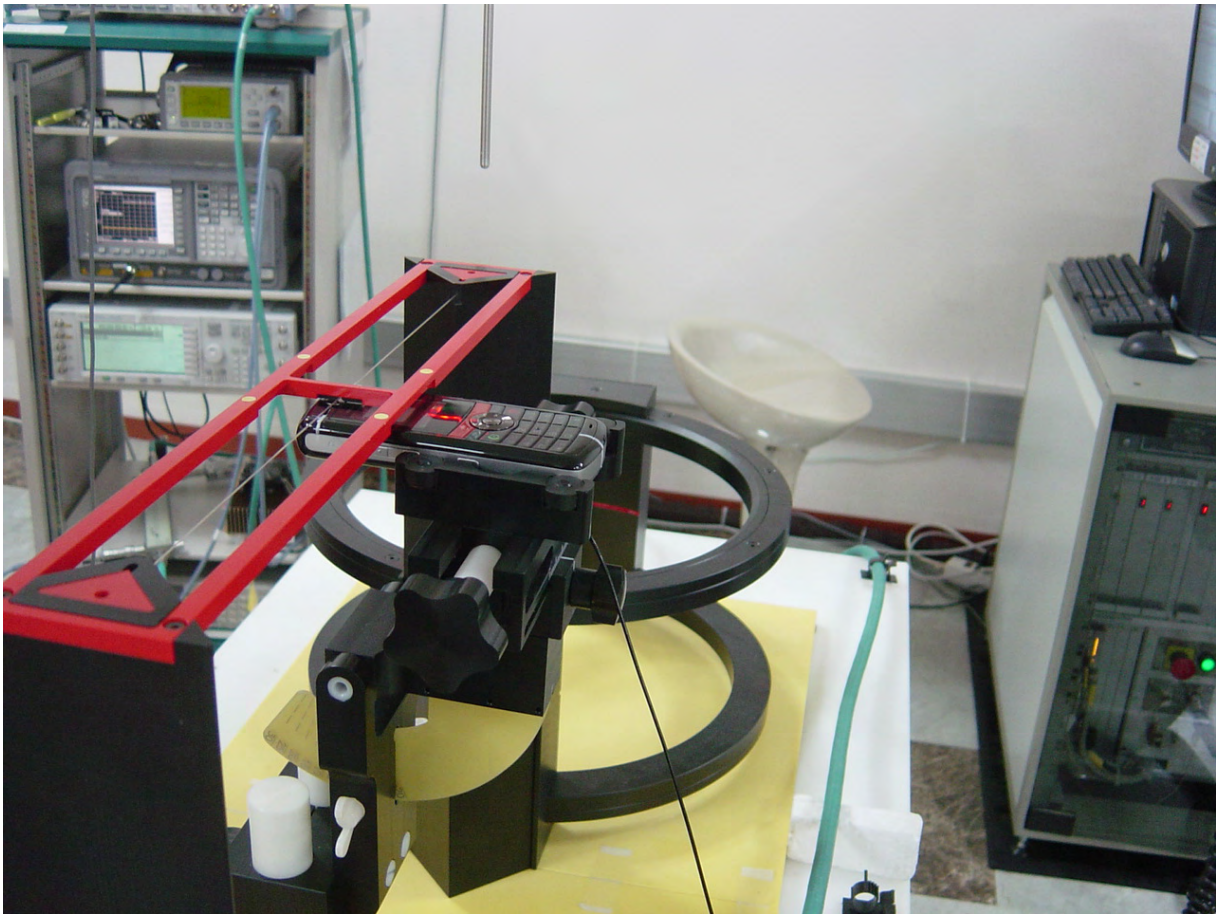
**Figure 5. Positioning and Measurement for T-coil**
