## 10. Photographs of Test Setup

## 10.2 Photographs of the EUT

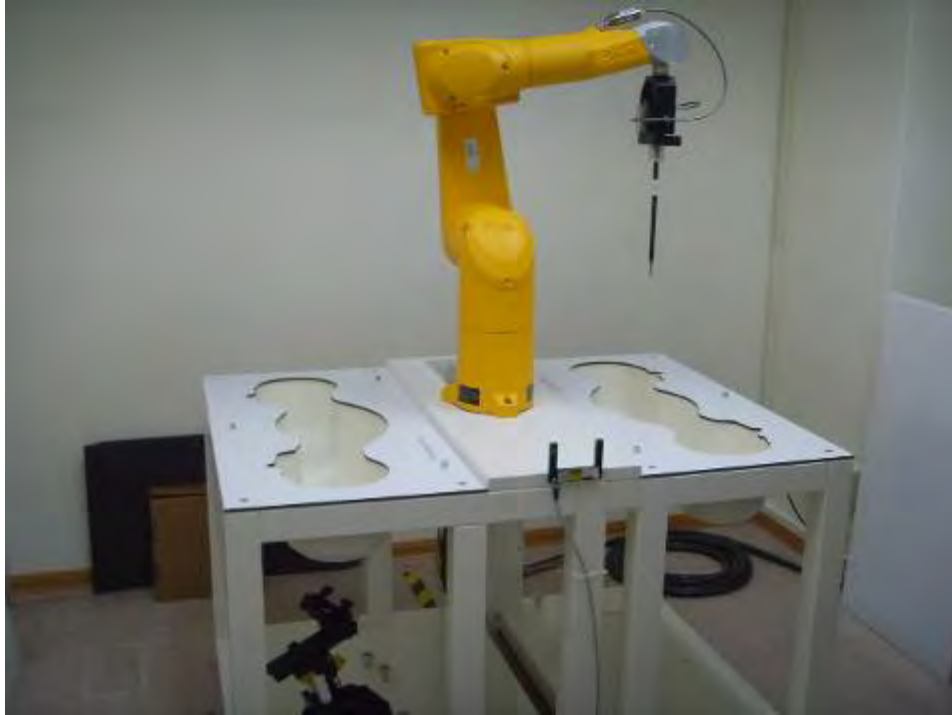
Fig.1 Photograph of the SAR measurement System

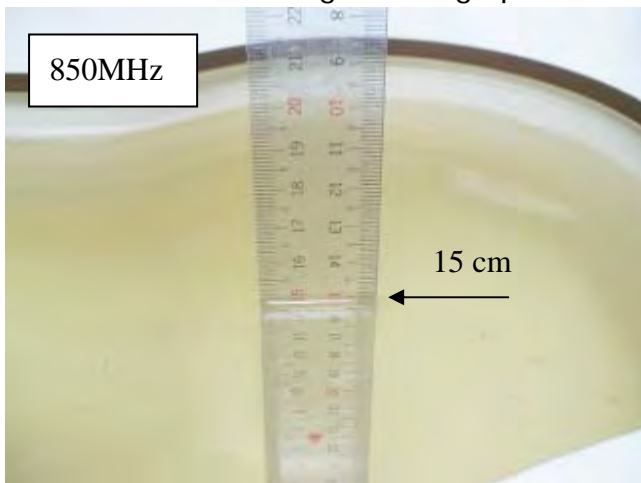
Fig.2.1 Photograph of the Tissue Simulant Fluid liquid depth 15cm for Left-head Side

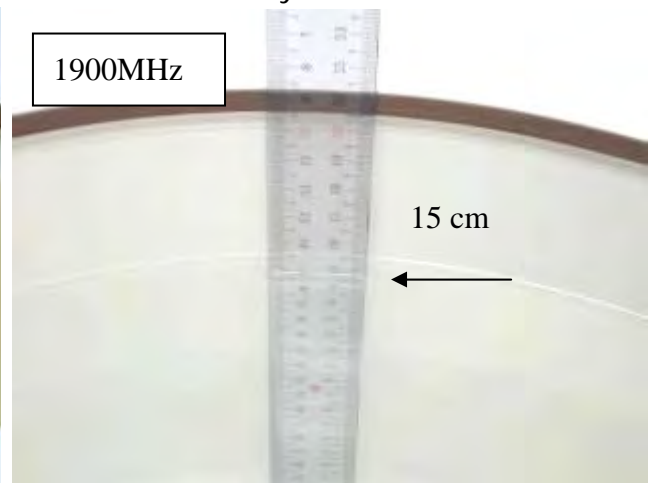
Fig.2.2 Photograph of the Tissue Simulant Fluid liquid depth 15cm for Right-head Side

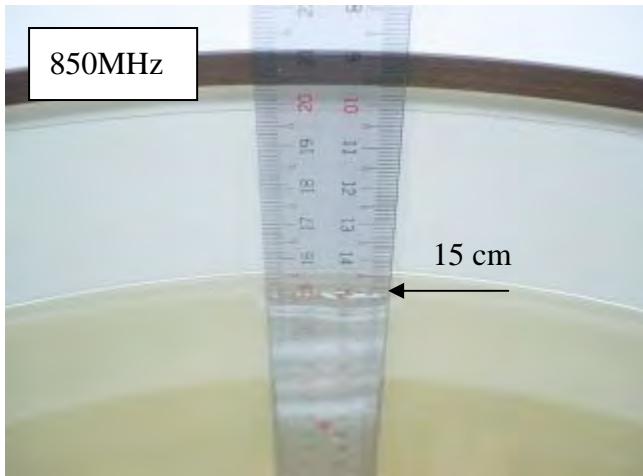
850MHz

15 cm

Fig.2.3 Photograph of the Tissue Simulant Fluid liquid depth 15cm for Flat (Body)

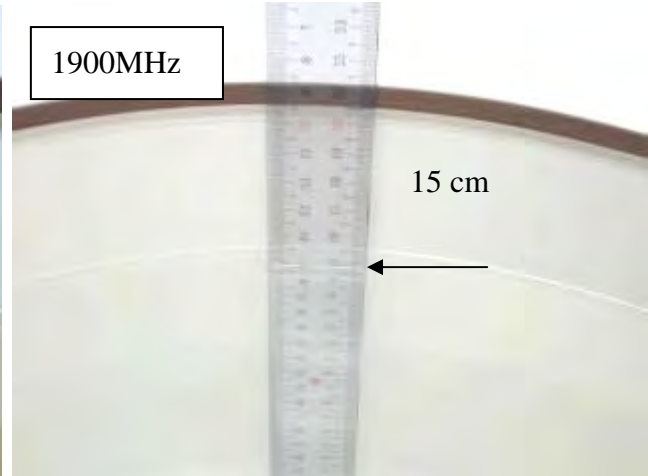
1900MHz

15 cm

Fig.2.4 Photograph of the Tissue Simulant Fluid liquid depth 15cm for Flat (Body)

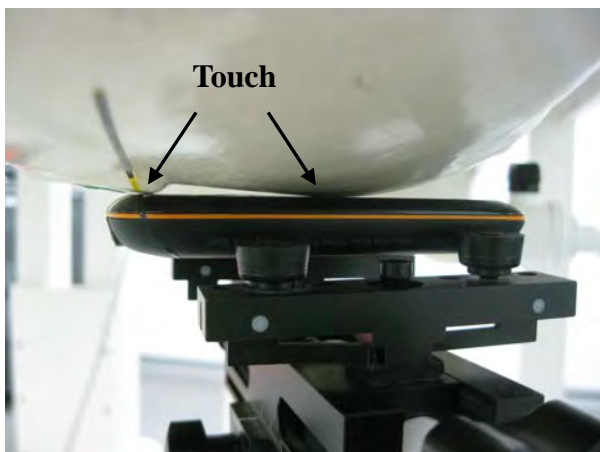
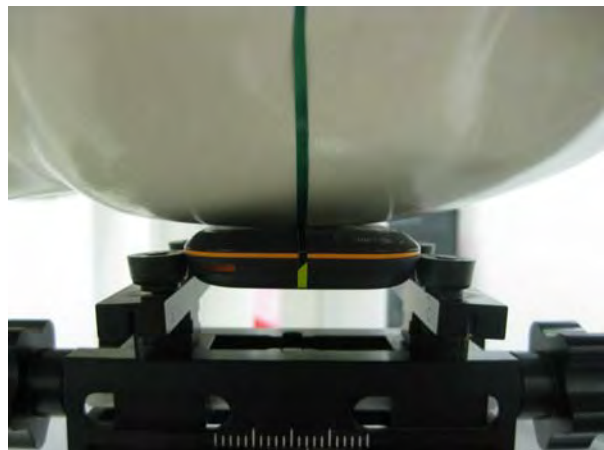
Fig.3 Right Head Section / Cheek-Touch Position

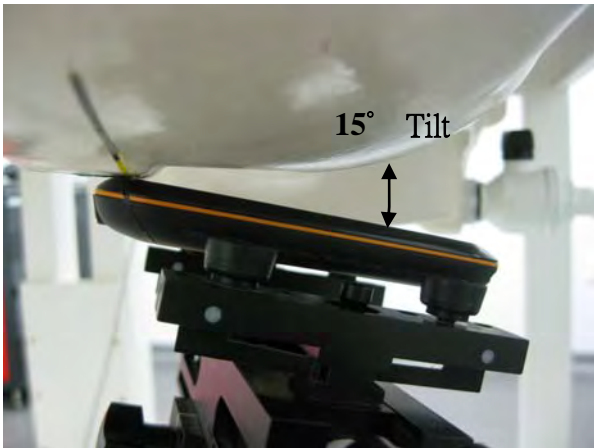
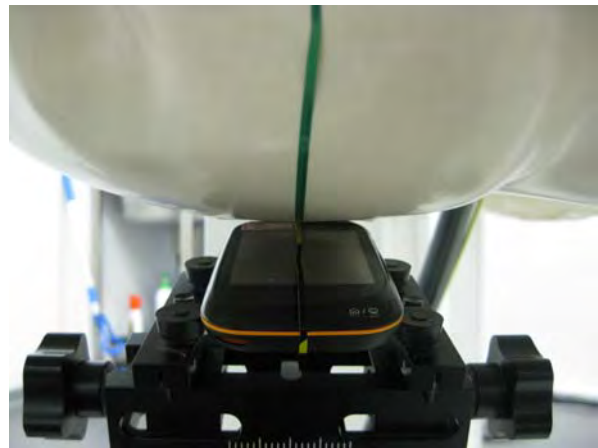
Fig.4 Right Head Section / Ear-Tilt Position(15°)

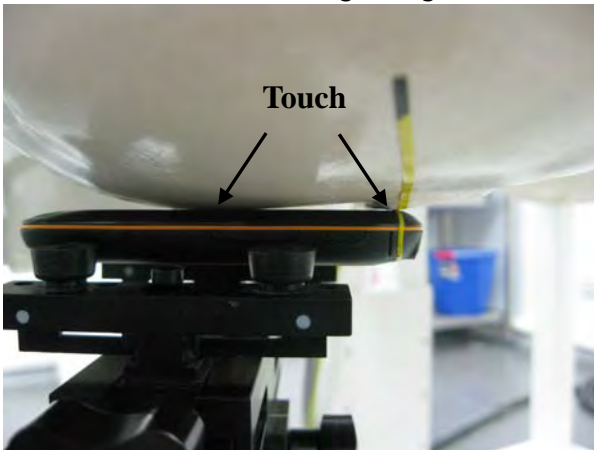
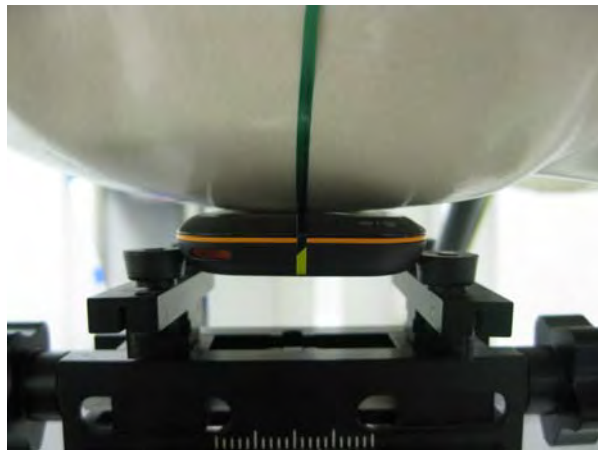
Fig.5 Left Head Section / Cheek-Touch Position

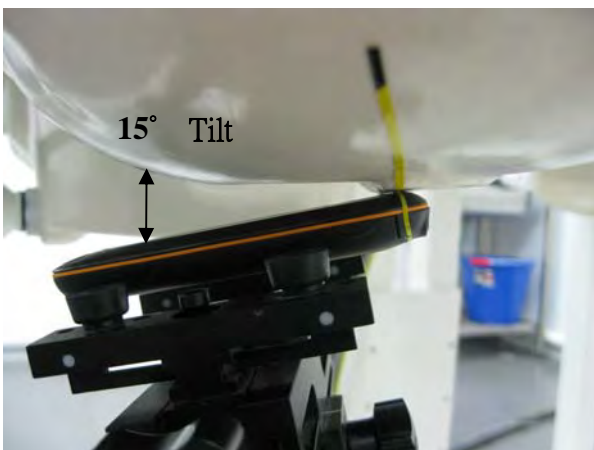
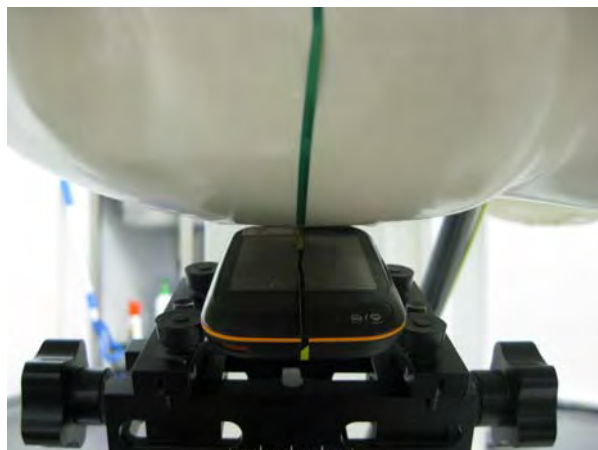
Fig.6 Left Head Section / Ear-Tilt Position(15°)

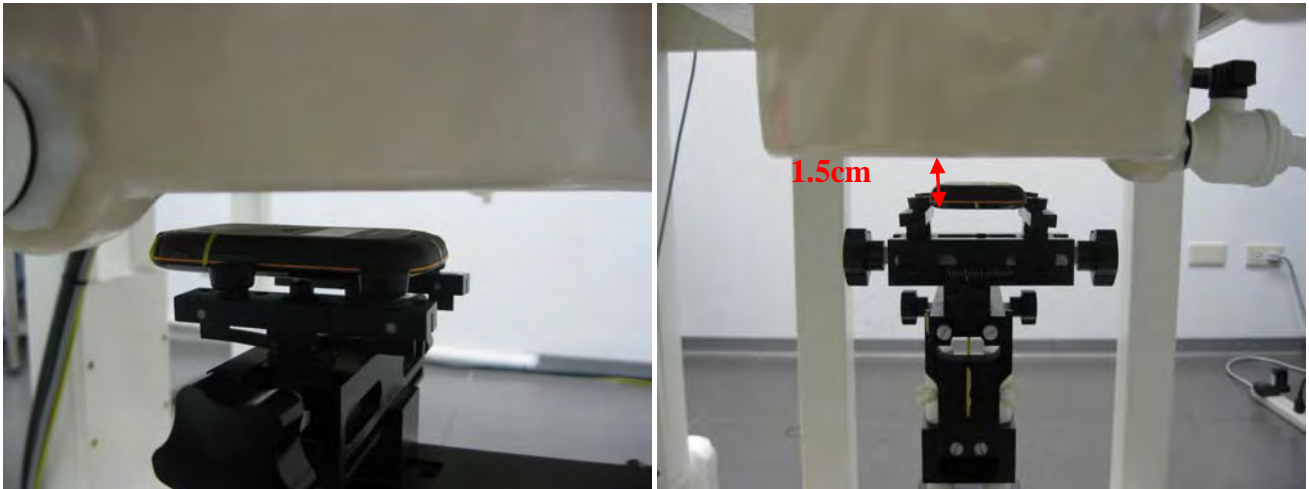
Fig.7 Body worn- EUT to flat phantom and distance between flat phantom and mobile phone is 1.5 cm.

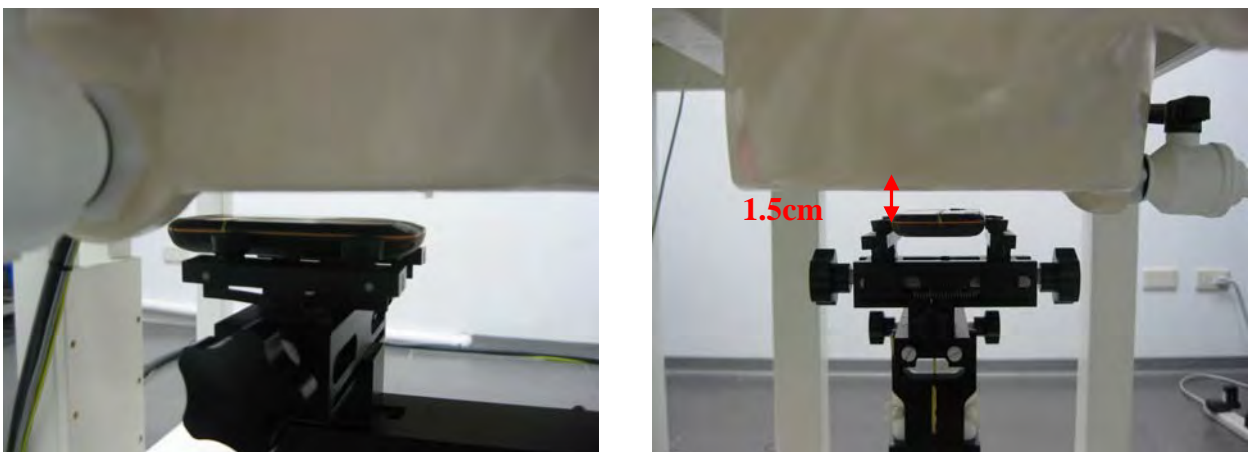
Fig.8 Body worn- EUT Front to flat phantom and distance between flat phantom and mobile phone is 1.5 cm.

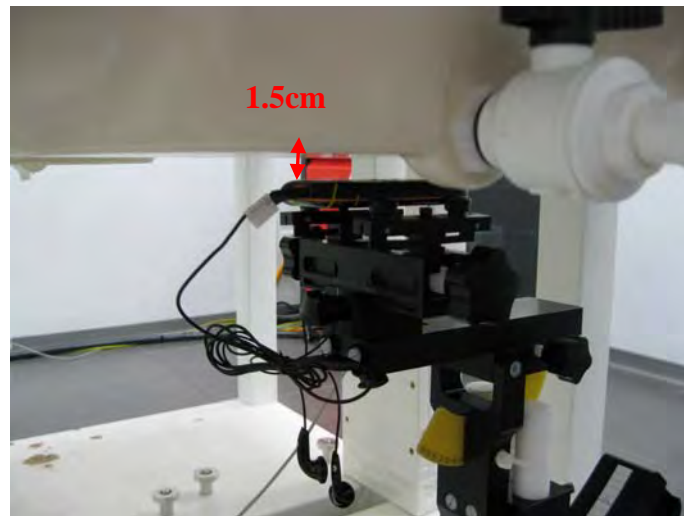
Fig.9 Body worn- EUT Back to flat phantom and distance between flat phantom and mobile phone is 1.5 cm. (with headset)

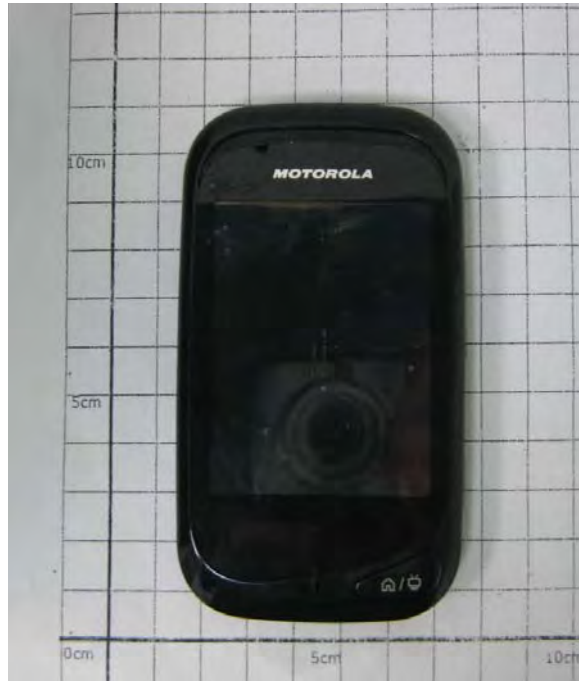
Fig.10 Front view of device

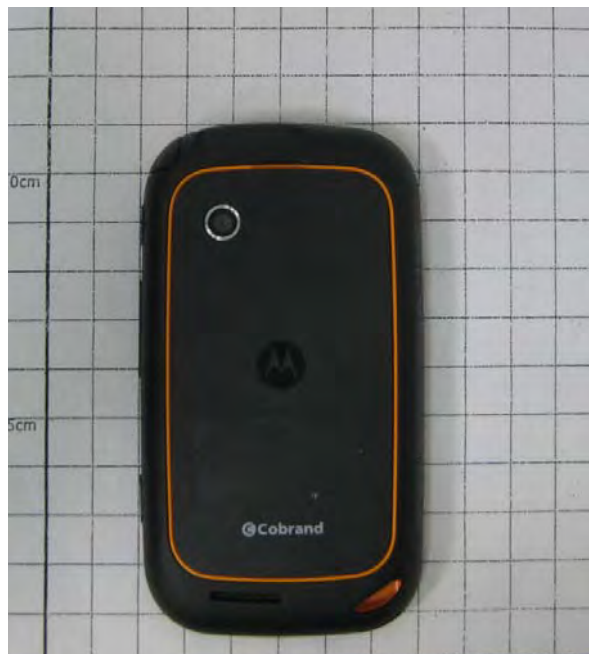
Fig.11 Back view of device

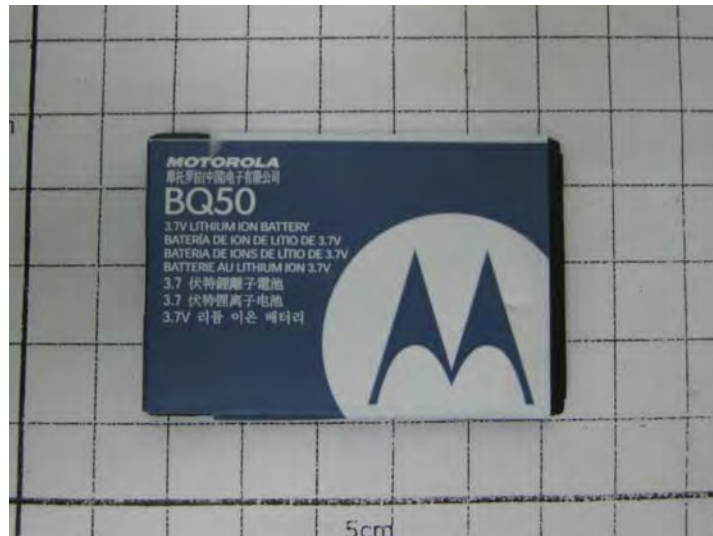
Fig.12 Front view of Battery

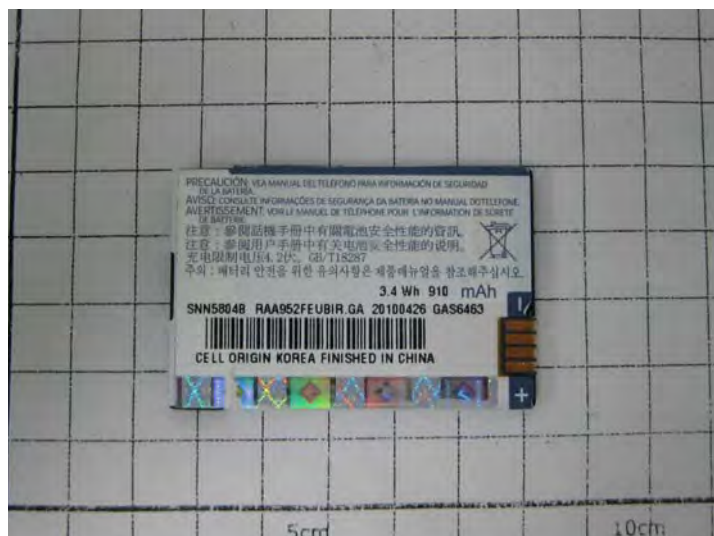
Fig.13 Back view of Battery

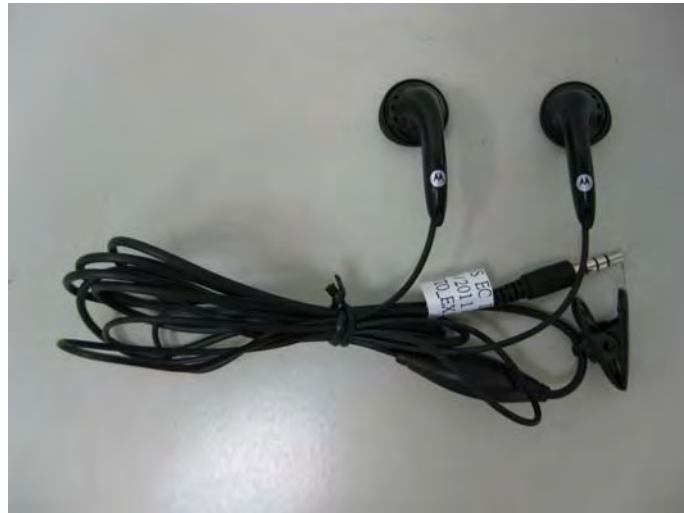
Fig.14 Headset

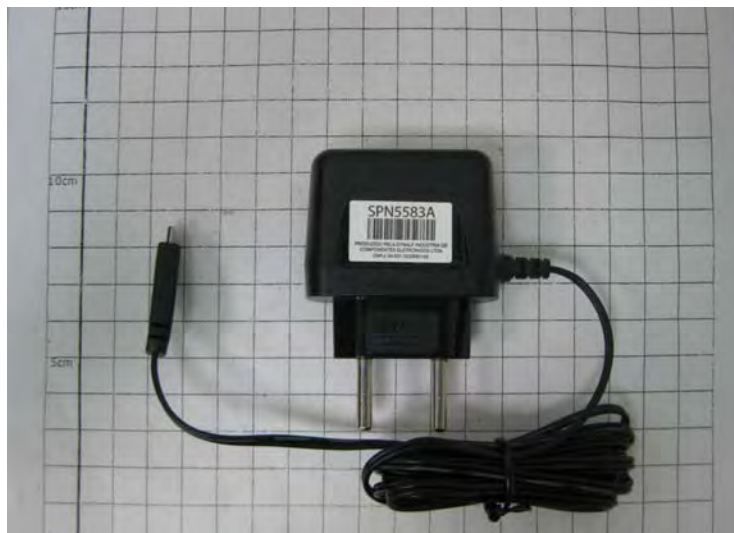
Fig.15 US Adapter
