## APPENDIX

### 10. Photographs of Test Setup

## 11. Photographs of the EUT

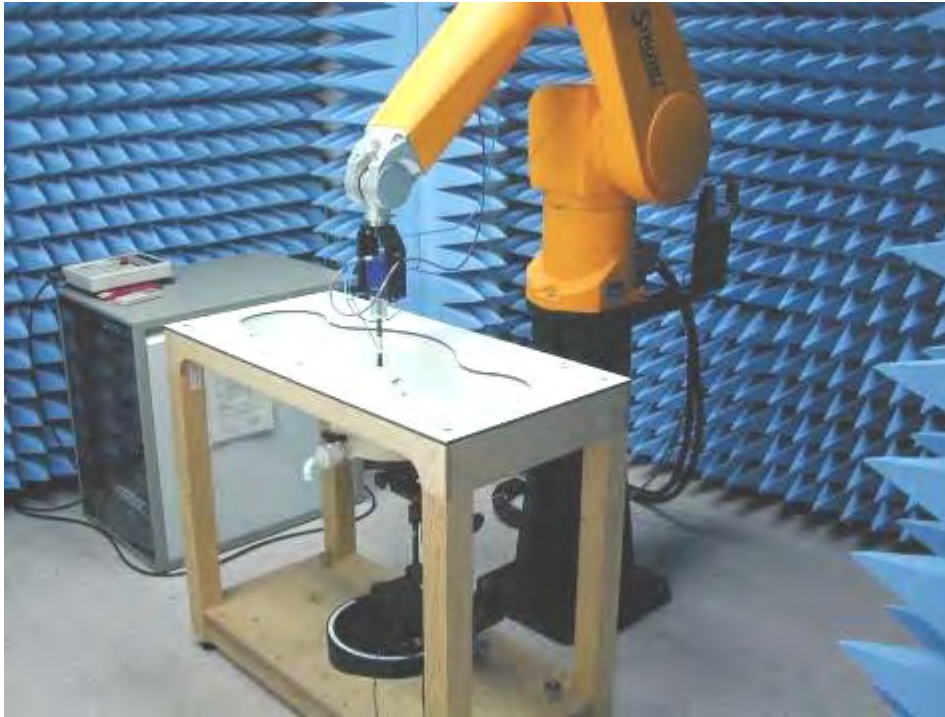
Fig.1 Photograph of the SAR measurement System

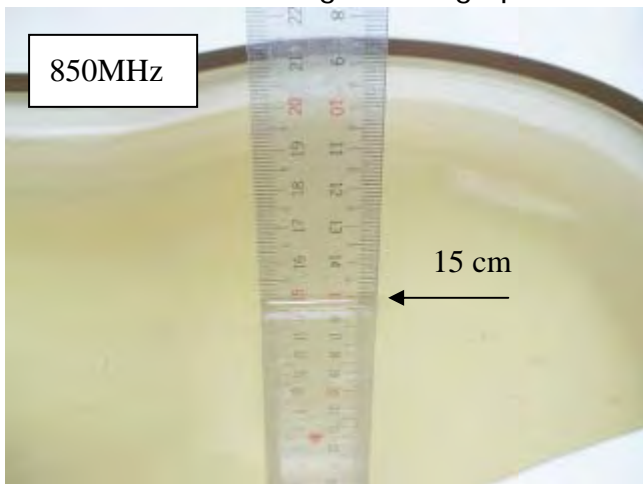
Fig.2.1 Photograph of the Tissue Simulant Fluid liquid depth 15cm for Left-head Side

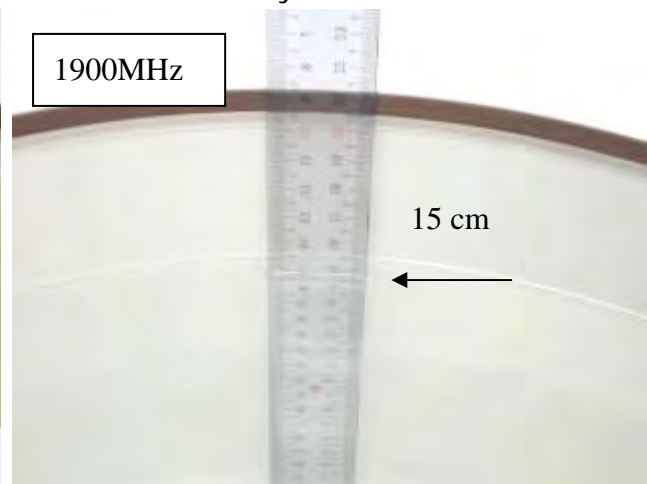
Fig.2.2 Photograph of the Tissue Simulant Fluid liquid depth 15cm for Right-head Side

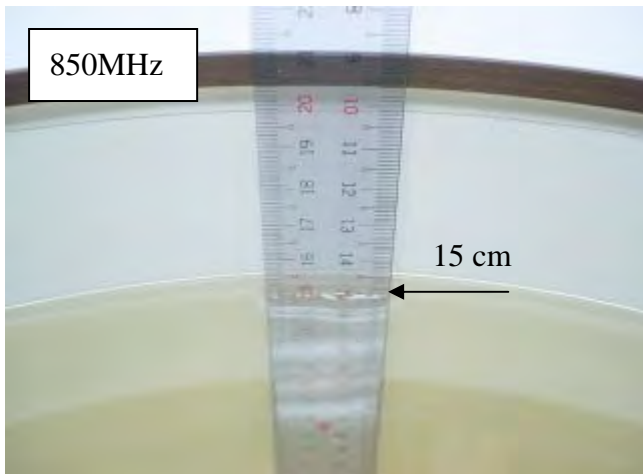
Fig.2.3 Photograph of the Tissue Simulant Fluid liquid depth 15cm for Flat (Body)

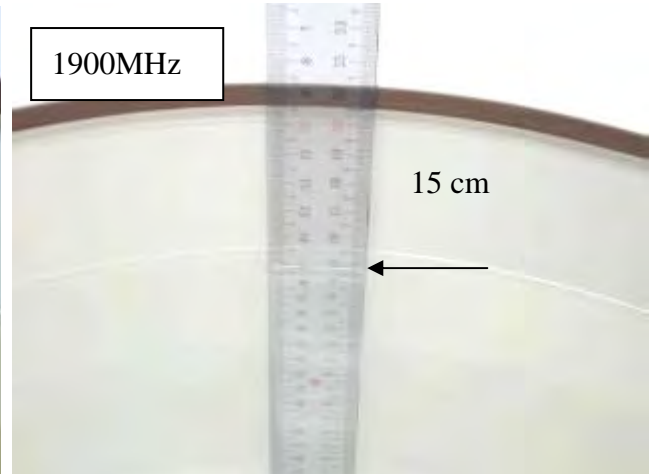
Fig.2.4 Photograph of the Tissue Simulant Fluid liquid depth 15cm for Flat (Body)

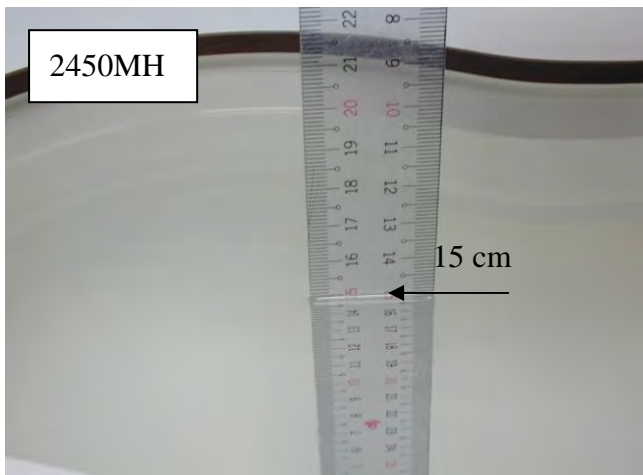
Fig.2.5 Photograph of the Tissue Simulant Fluid liquid depth 15cm for Left-head Side

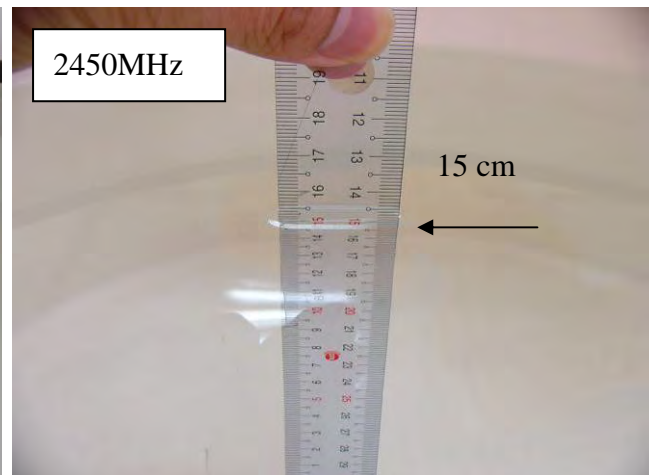
Fig.2.6 Photograph of the Tissue Simulant Fluid liquid depth 15cm for Flat (Body)

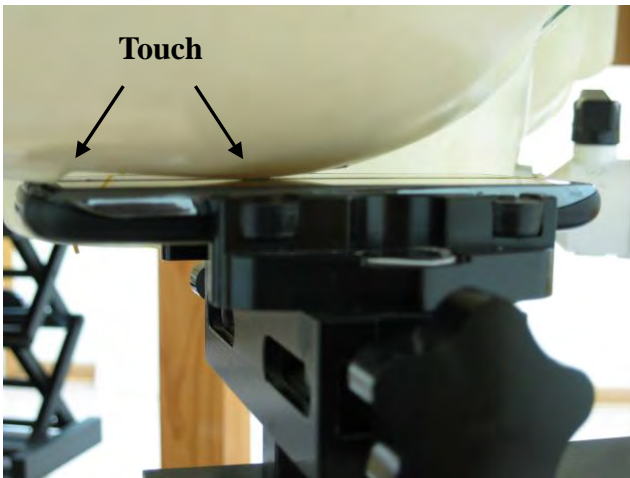
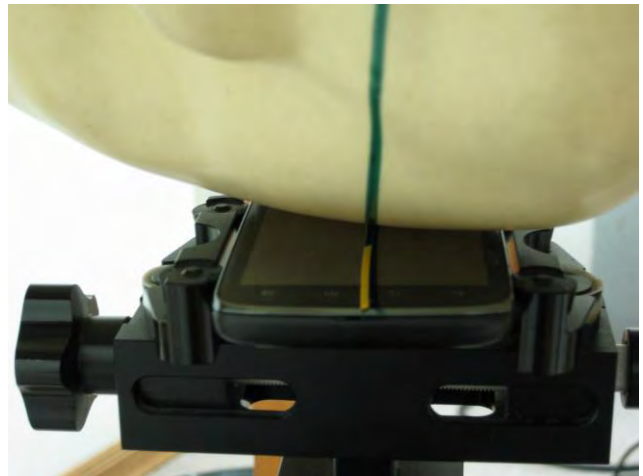
Fig.3 Right Head Section / Cheek-Touch Position

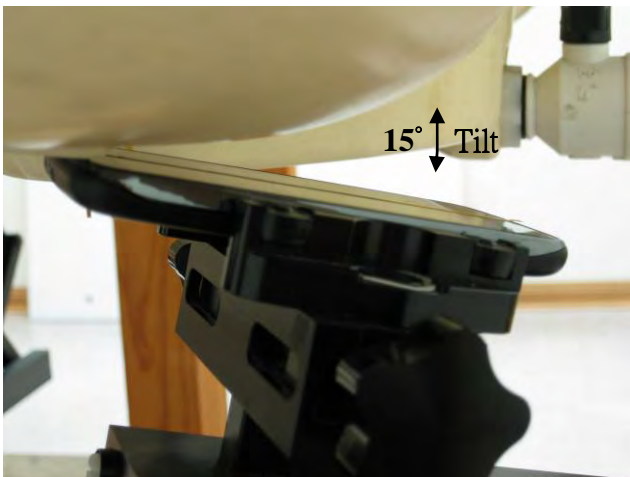
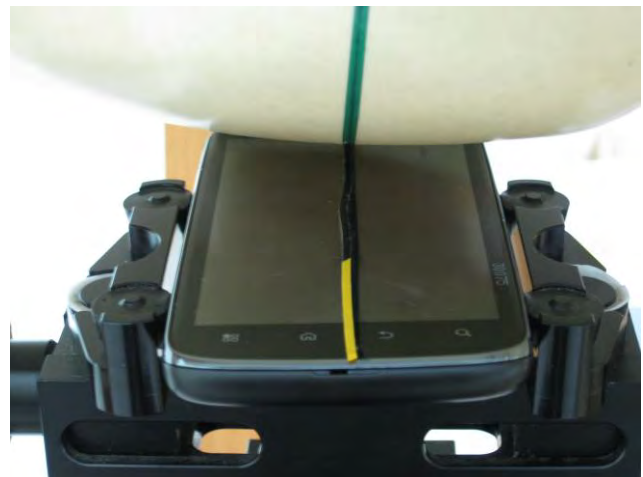
Fig.4 Right Head Section / Ear-Tilt Position(15°)

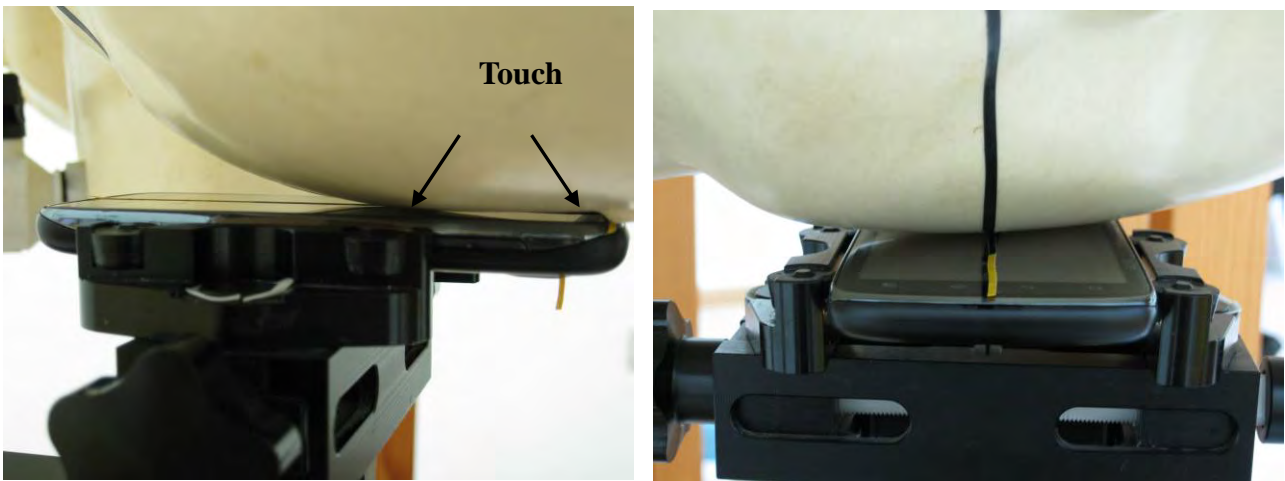
Fig.5 Left Head Section / Cheek-Touch Position

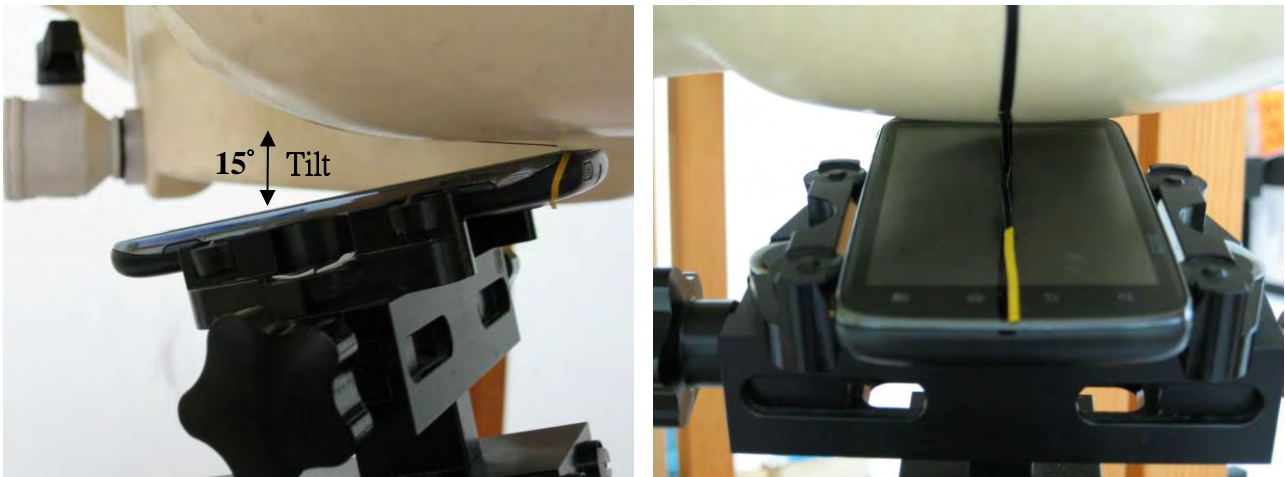
Fig.6 Left Head Section / Ear-Tilt Position(15°)

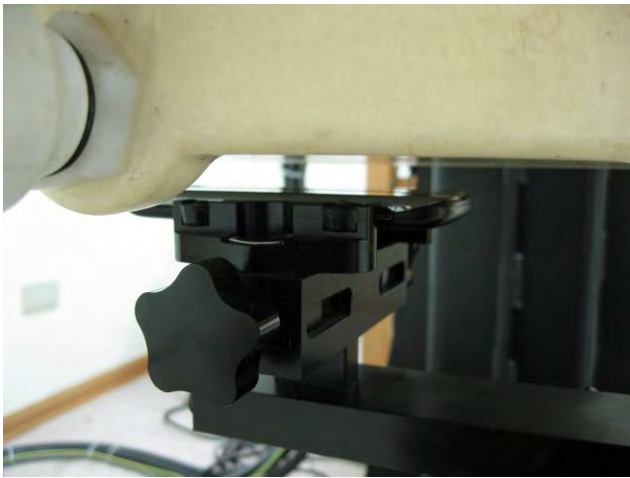
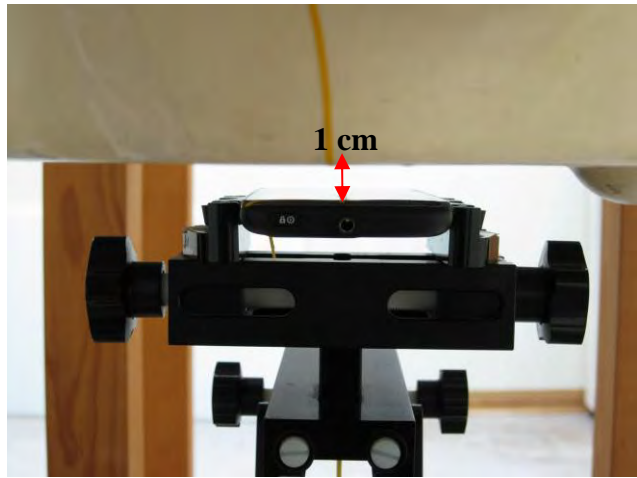
Fig.7 Hotspot mode- EUT front to flat phantom and distance between flat phantom and mobile phone is 1 cm.

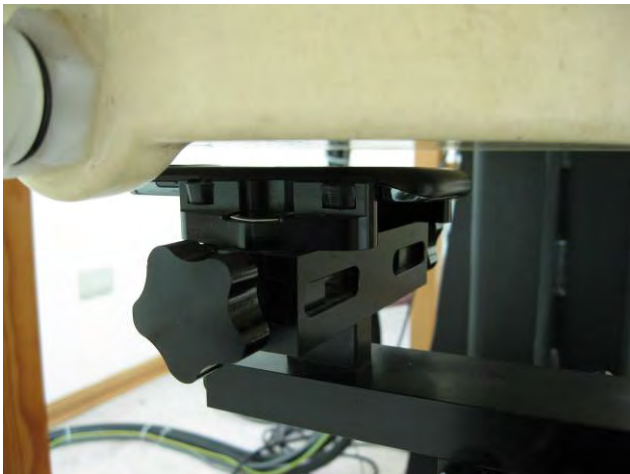
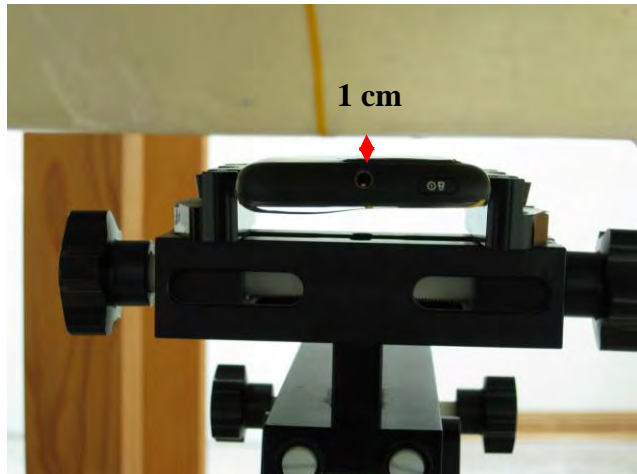
Fig.8 Hotspot mode- EUT back to flat phantom and distance between flat phantom and mobile phone is 1 cm.

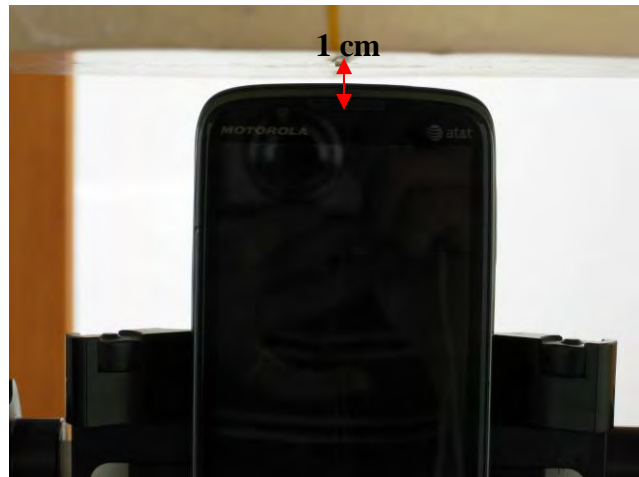
Fig.9 Hotsopt mode- EUT Top to flat phantom and distance between flat phantom and mobile phone is 1 cm.

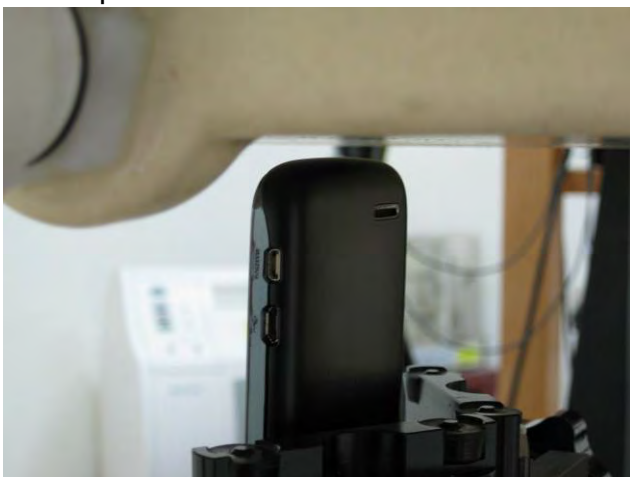
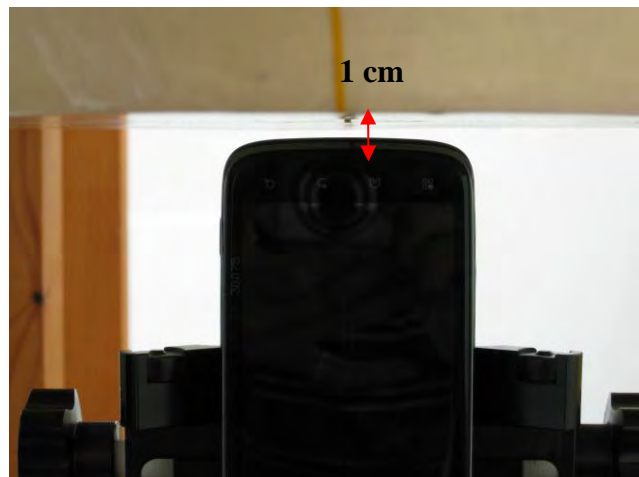
Fig.10 Hotsopt mode- EUT Bottom to flat phantom and distance between flat phantom and mobile phone is 1 cm.

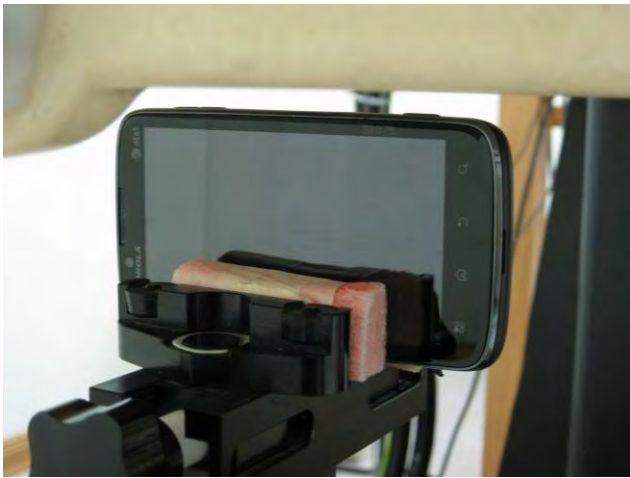
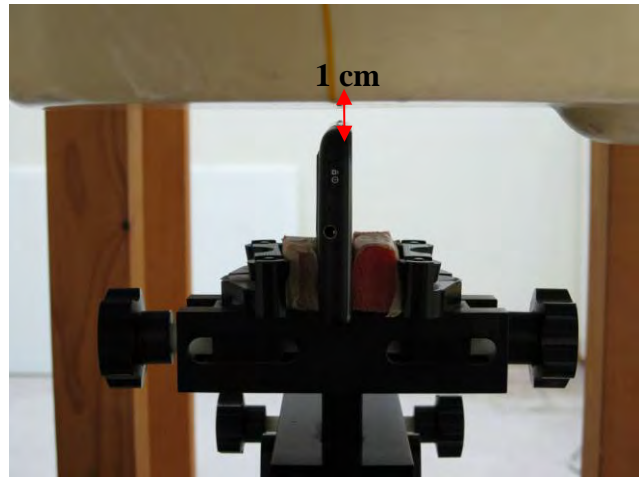
Fig.11 Hotspot mode- EUT Right to flat phantom and distance between flat phantom and mobile phone is 1 cm.

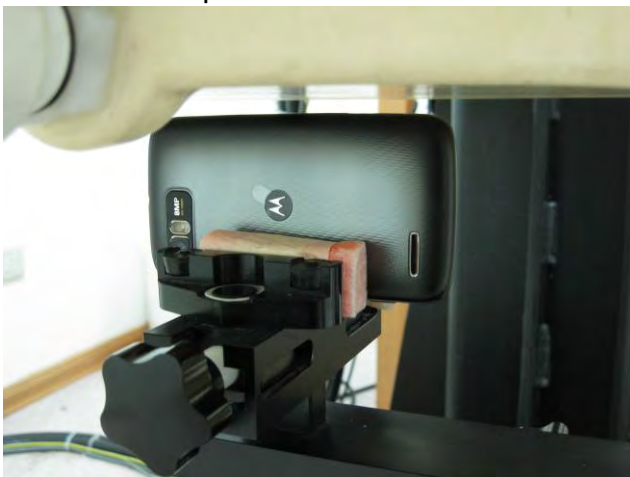
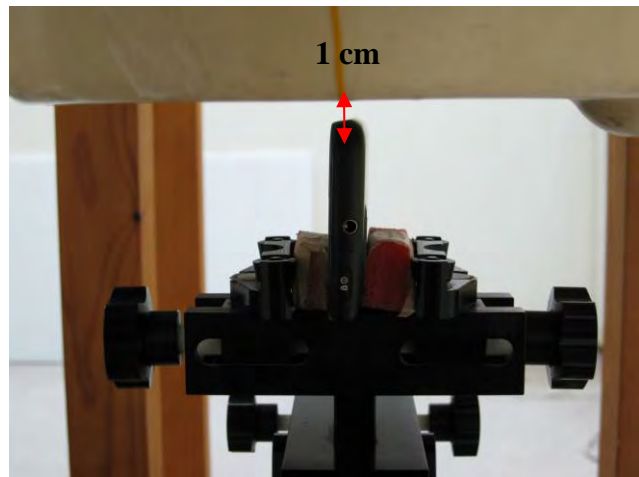
Fig.12 Hotspot mode- EUT Left to flat phantom and distance between flat phantom and mobile phone is 1 cm.

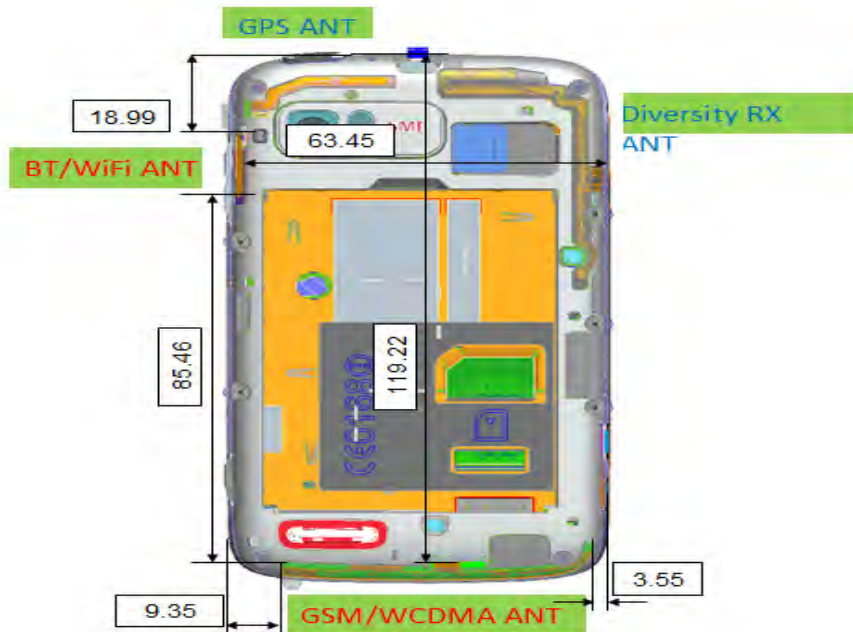
Fig.18 Antenna position of EUT
