APPENDIX

10. Photographs of Test Setup

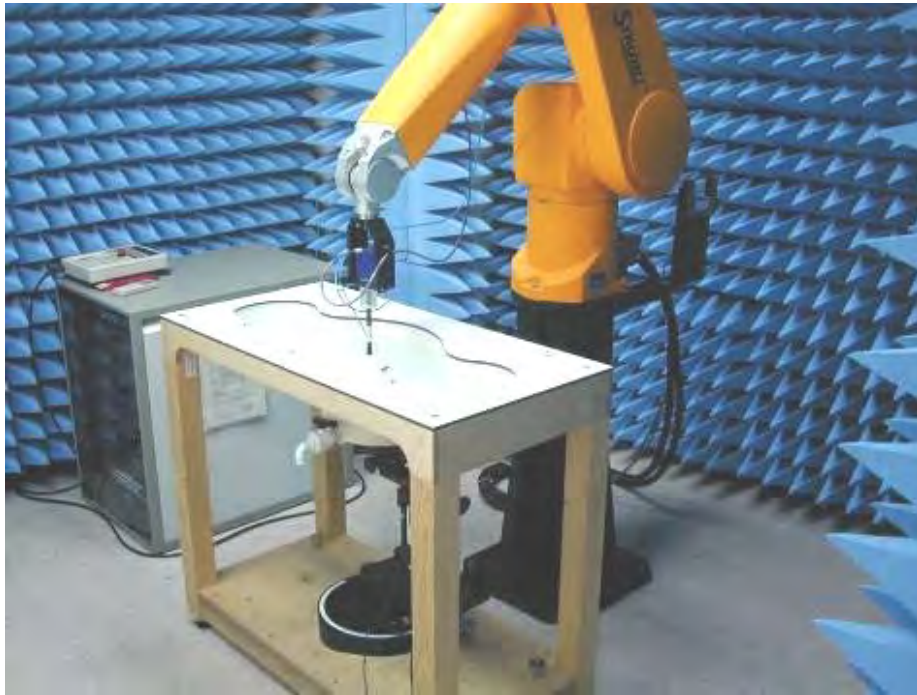
Fig.1 Photograph of the SAR measurement System

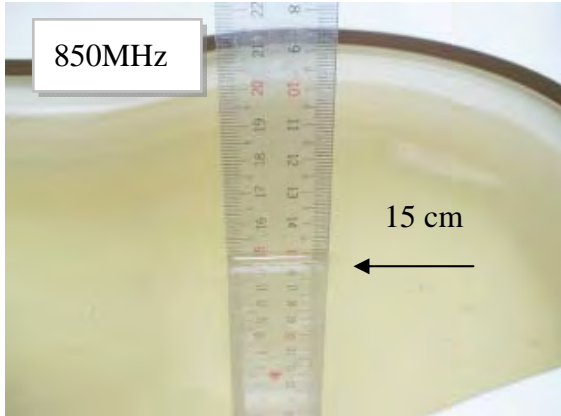
Photograph of the Tissue Simulant Fluid liquid depth 15cm

Fig.2.1 Left-head Side

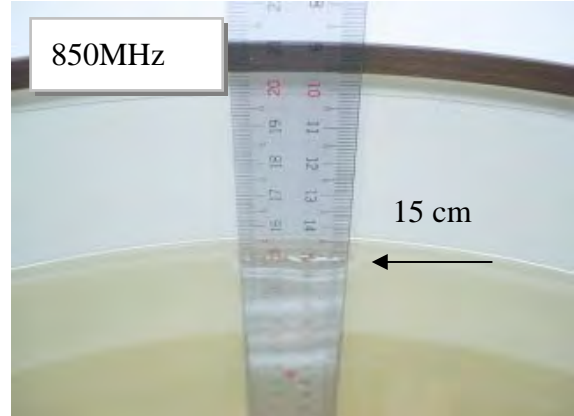
Fig.2.2 Flat (Body)

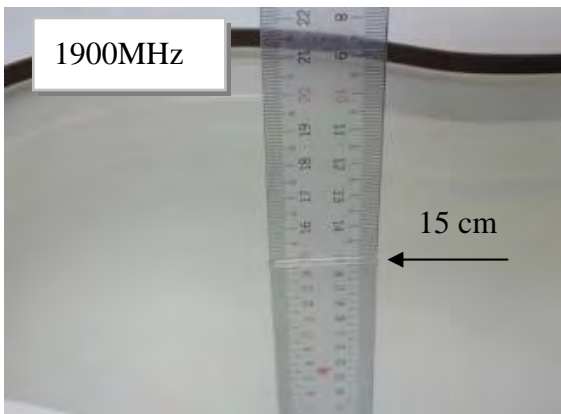
Fig.2.3 Flat (Body)

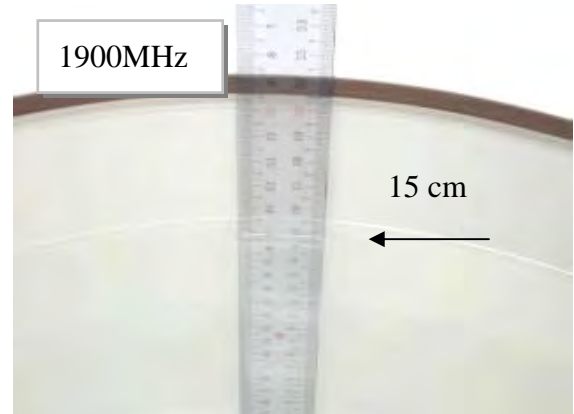
Fig.2.4 Flat (Body)

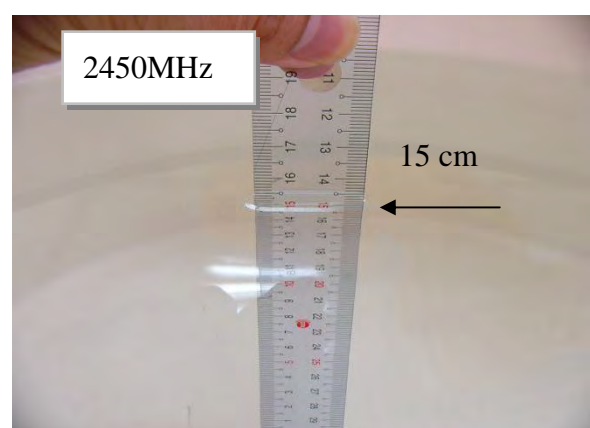
Fig.2.6 Flat (Body)

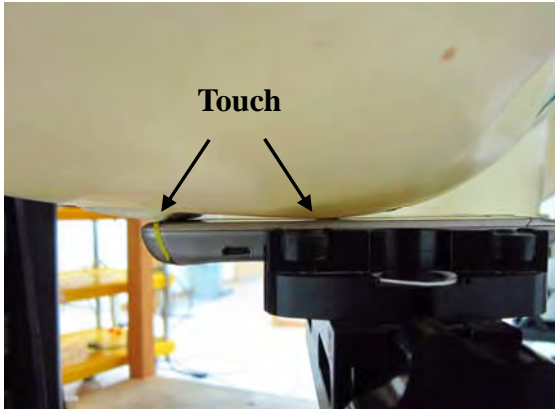
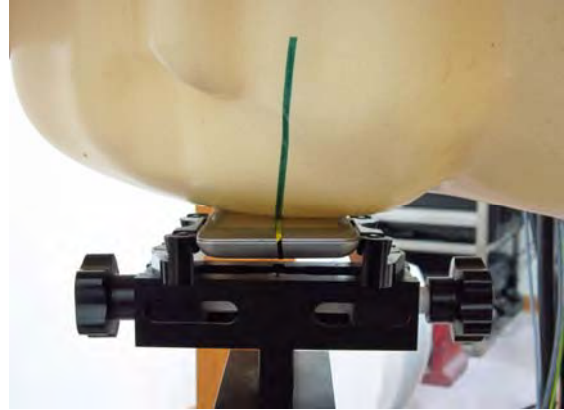
Fig.3 Right Head Section / Cheek-Touch Position

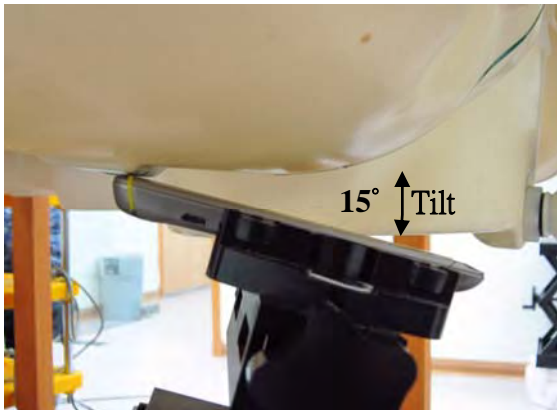
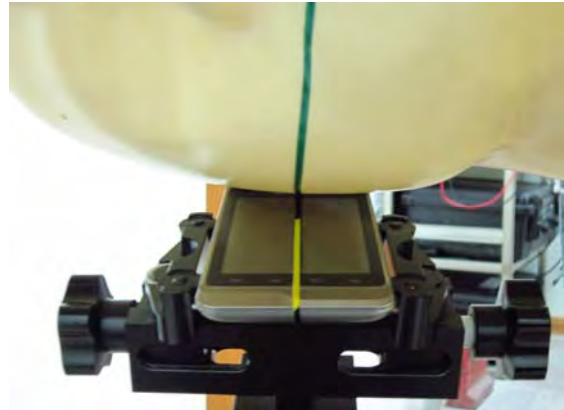
Fig.4 Right Head Section / Ear-Tilt Position(15°)

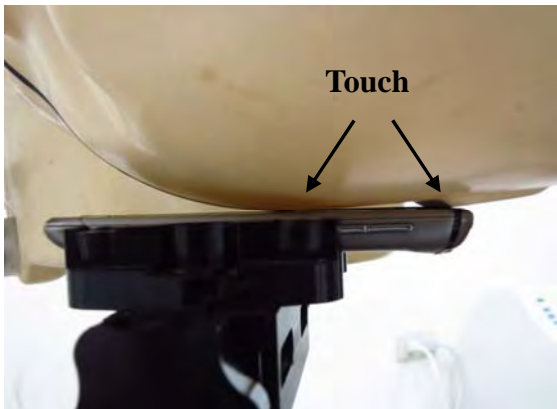
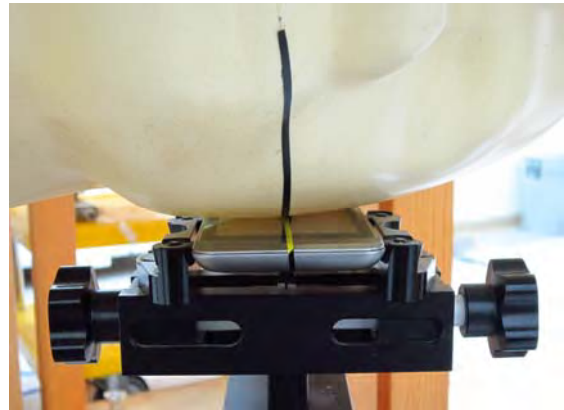
Fig.5 Left Head Section / Cheek-Touch Position

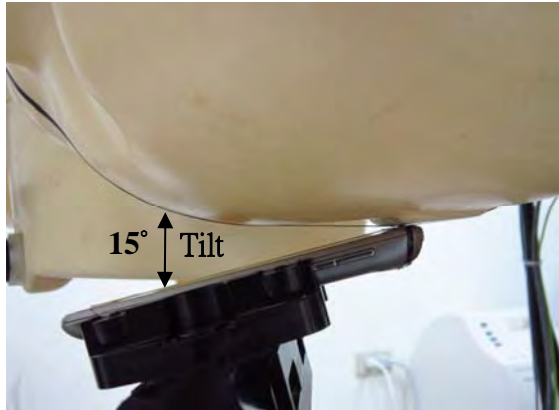
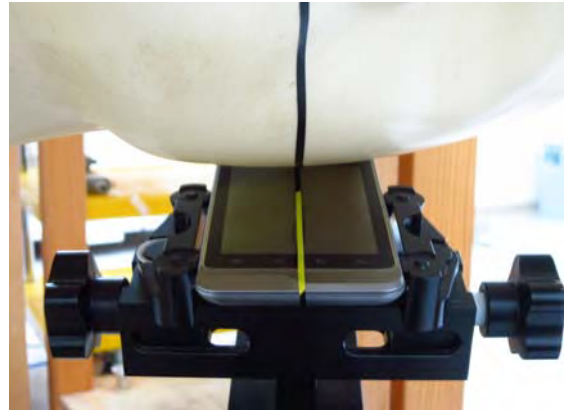
Fig.6 Left Head Section / Ear-Tilt Position(15°)

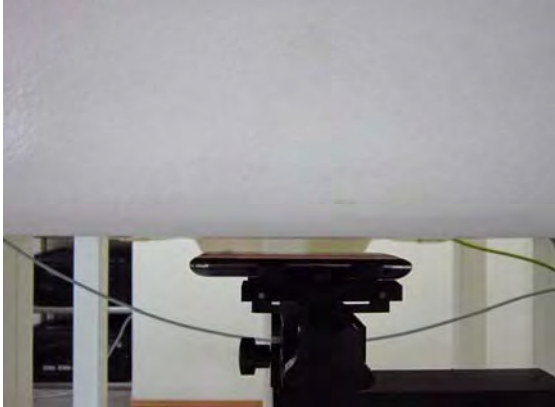
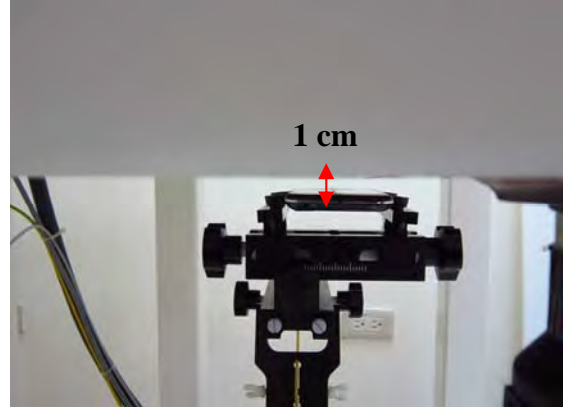
Hotspotmode - distance between flat phantom and mobile phone is 1 cm

Fig.7 EUT front to flat phantom

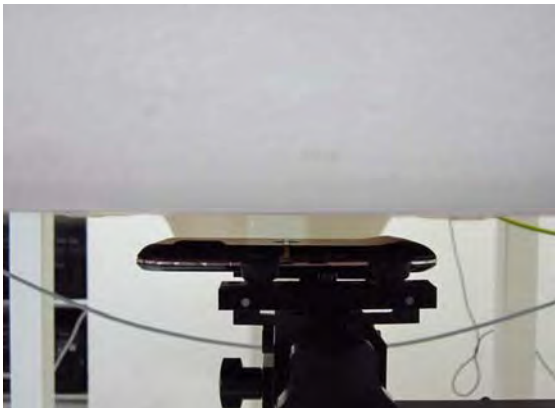
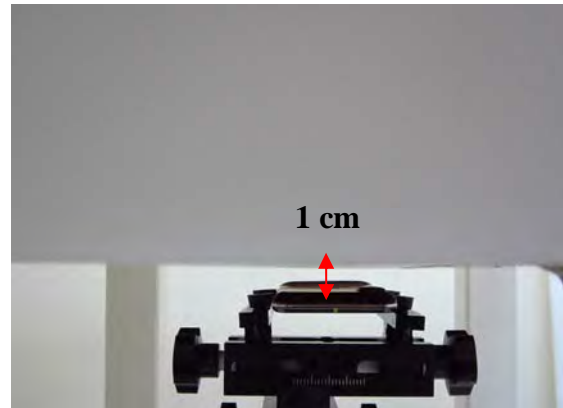
Fig.8 EUT back to flat phantom

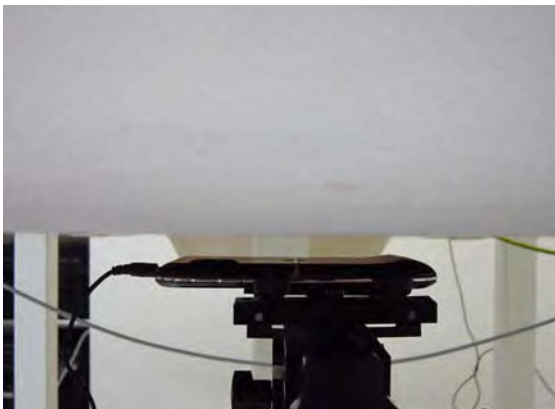
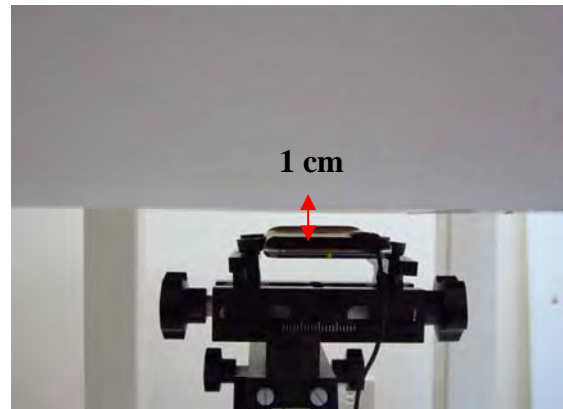
Fig.9 EUT back side with Headset to flat phantom

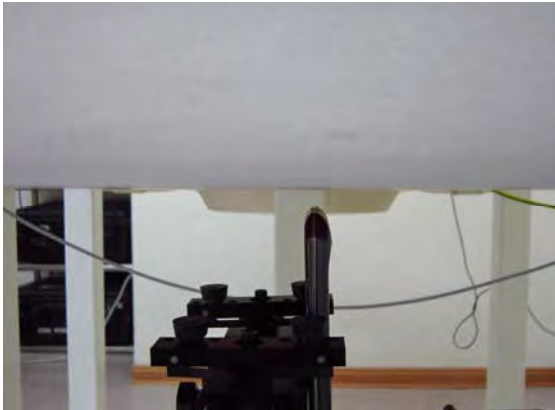
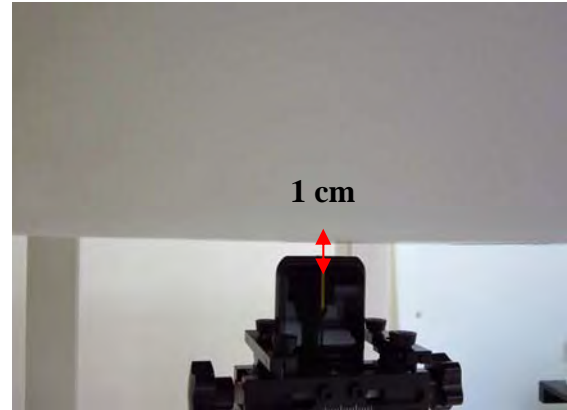
Fig.10 EUT Bottom to flat phantom

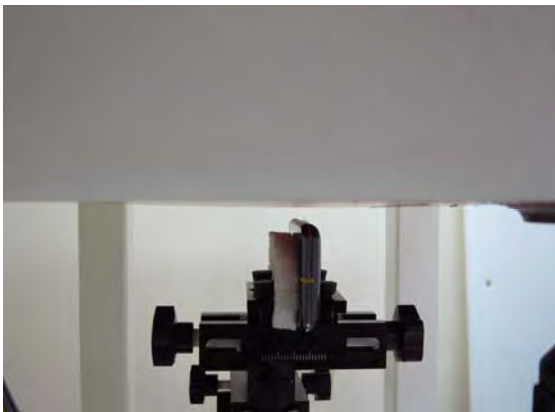
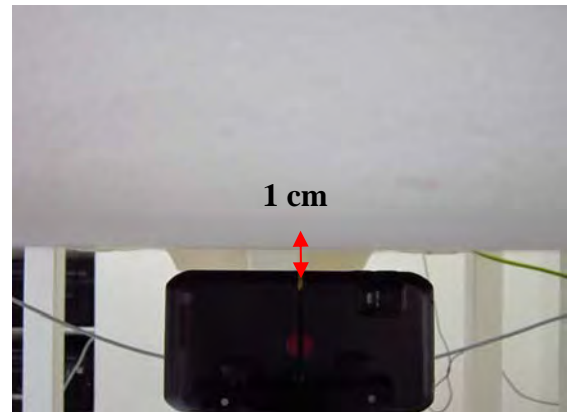
Fig.11 EUT Right to flat phantom

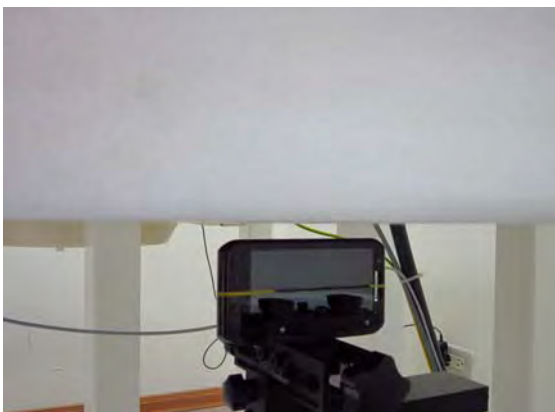
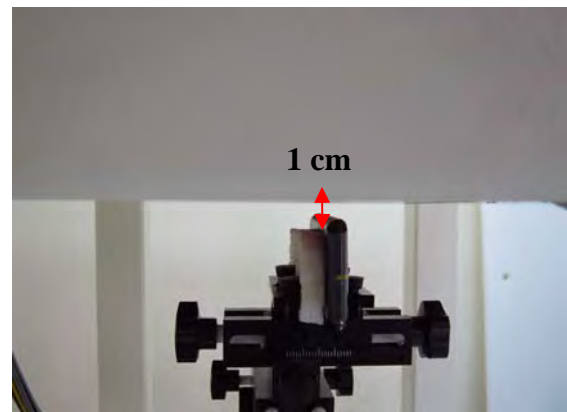
Fig.12 EUT Left to flat phantom

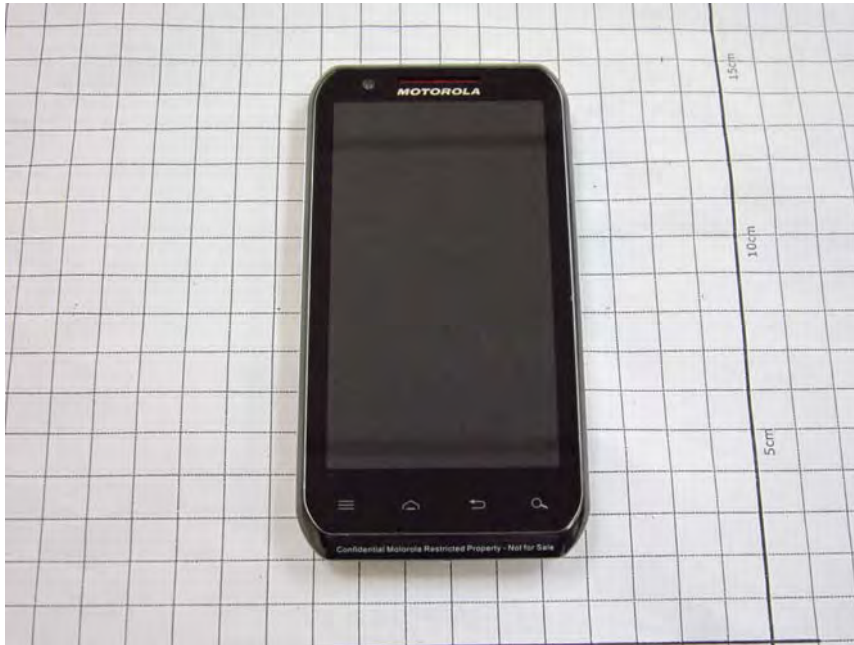
Fig.13 Front view of EUT device

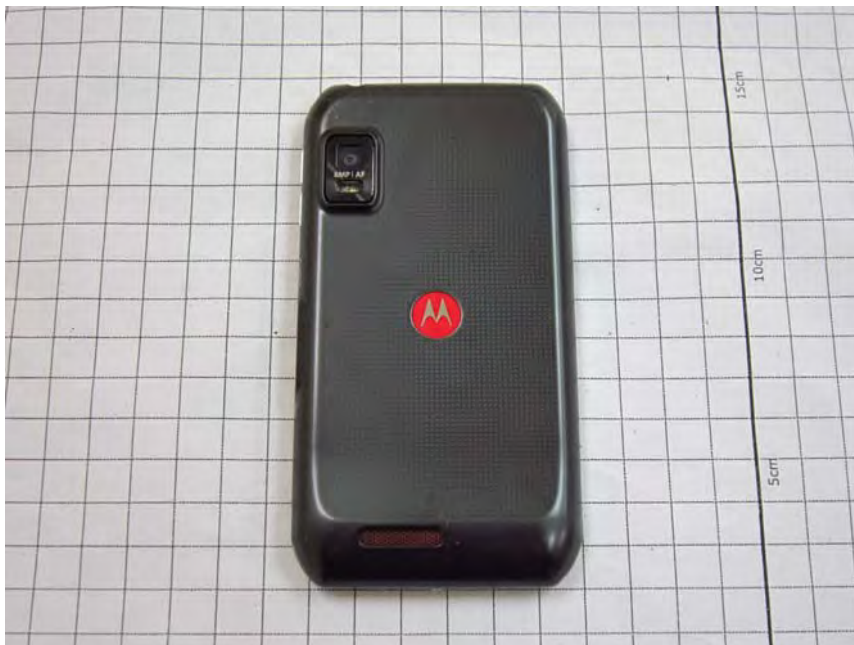
Fig.14 Back view of EUT device

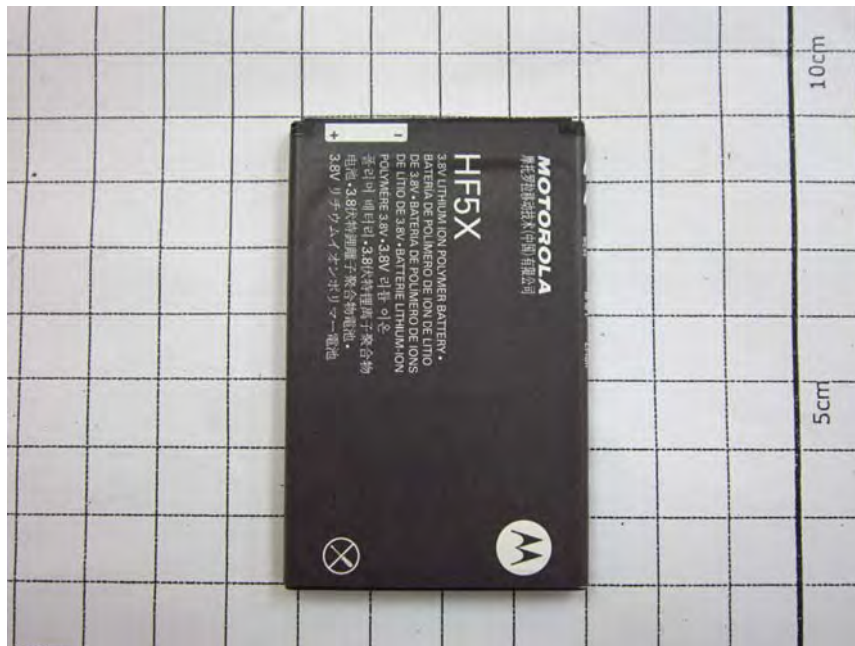
Fig.15 Front view of Battery

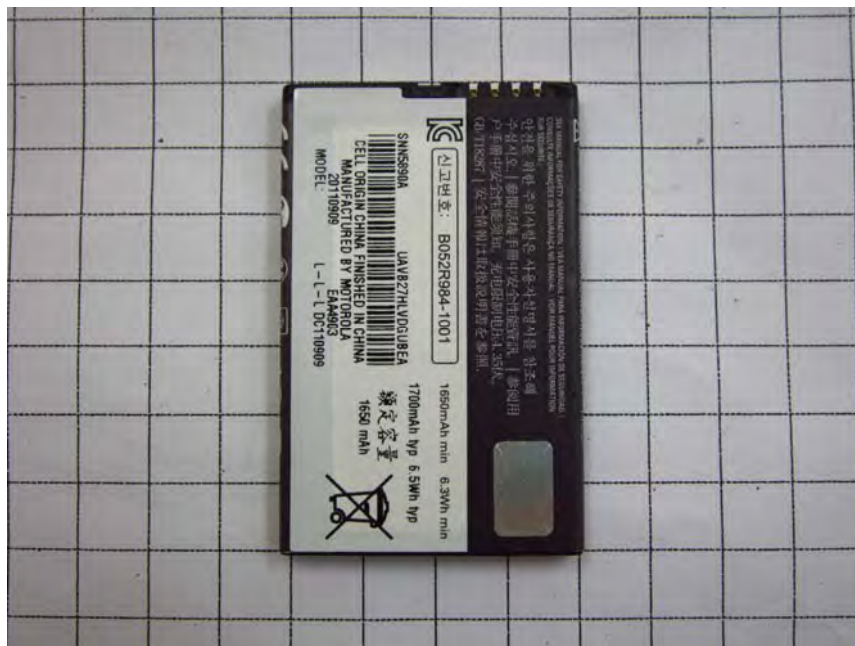
Fig.16 Back view of Battery

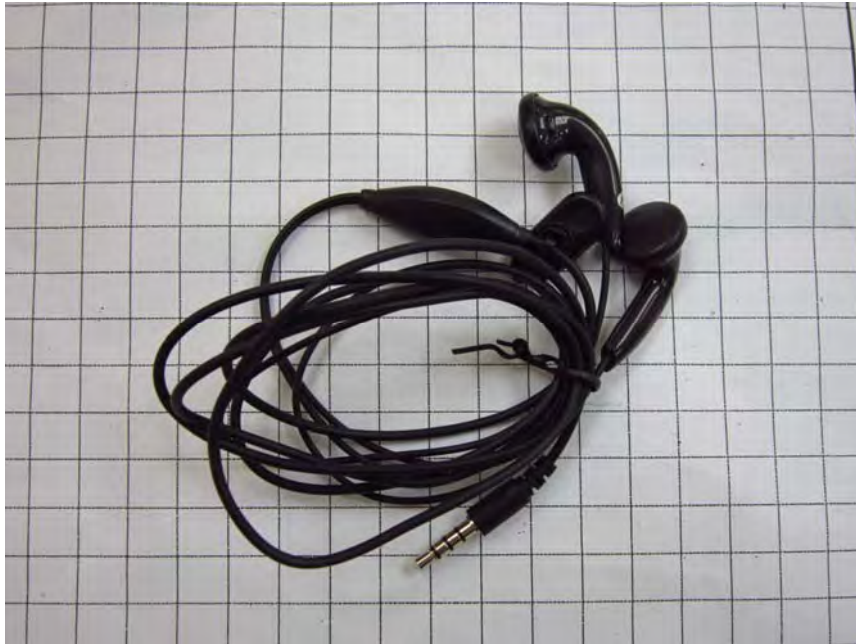
Fig.17 Headset

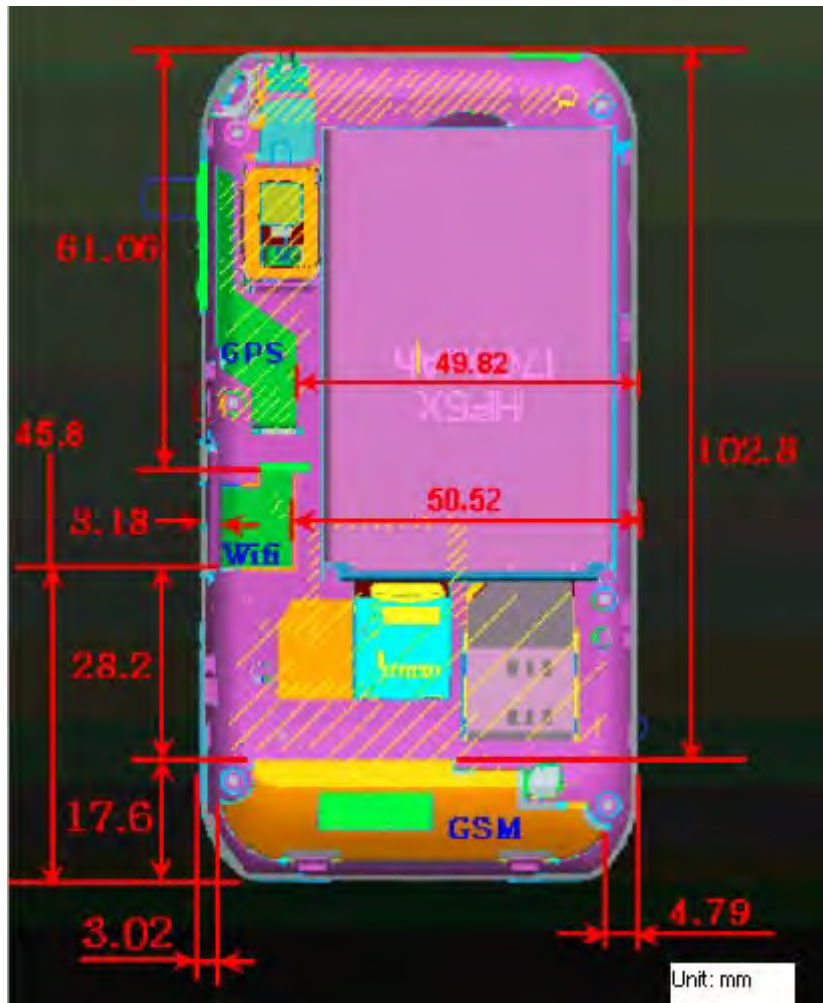
Fig.18 Antenna
