Radiated Emission Measurement

Condition : FCC\_part 15 RE-Class B\_Above 1GHz\_PK

EUT : W6M21910-19416

Test Mode : RX 802.11b CH7

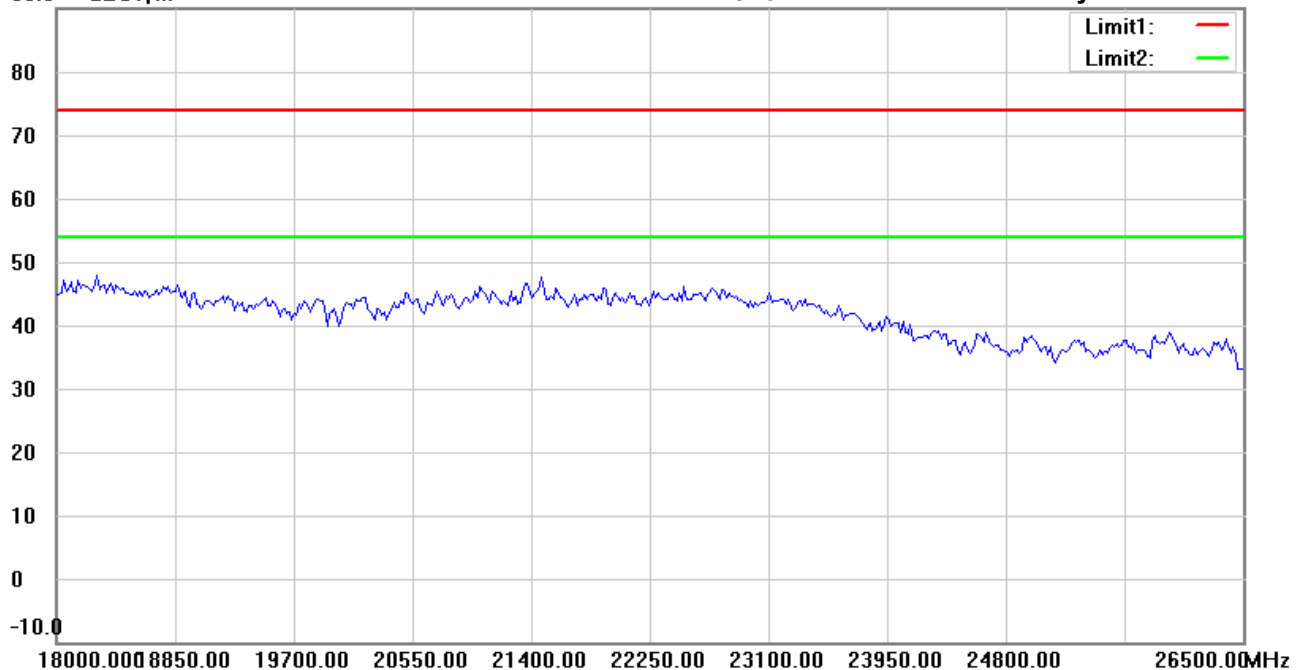
Site : Chamber

Condition : FCC\_part 15 RE-Class B\_Above 1GHz\_PK
