## Radiated Emission Measurement

File : 1\_WiFi 5G\_ant1\_TX 802 Data : #1

Condition : FCC\_part 15 RE-Class C\_30-1000MHz

EUT : W6M21910-19416

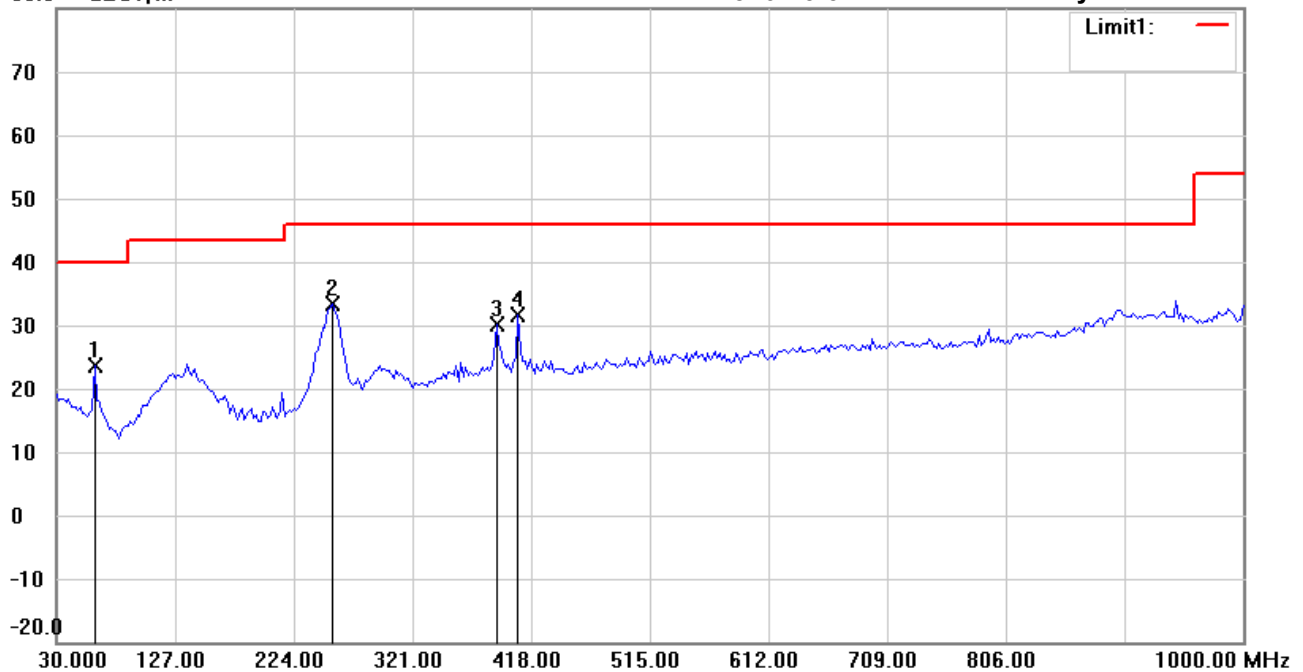
Test Mode : TX 802.11a CH36

Polarization: *Horizontal*

Distance: 3m

| Mk. | Frequency (MHz) | Reading (dBuV) | Detector | Corr. factor (dB/m) | Result (dBuV/m) | Limit (dBuV/m) | Ant.Pos (cm) | Tab.Pos (deg.) | Margin (dB) | Comment |
| | 61.1022 | 35.77 | peak | -12.03 | 23.74 | 40.00 | 100 | 50 | -16.26 | |
| * | 255.4910 | 41.11 | peak | -7.70 | 33.41 | 46.00 | 100 | 63 | -12.59 | |
| | 389.6191 | 34.31 | peak | -4.07 | 30.24 | 46.00 | 100 | 279 | -15.76 | |
| | 407.1141 | 35.60 | peak | -3.88 | 31.72 | 46.00 | 100 | 176 | -14.28 | |
