# Worldwide Testing Services(Taiwan) Co., Ltd.

Registration number: W6M22409-23739-C-3  
FCC ID: IR5ML15

## **Appendix**

### **Measurement diagrams**

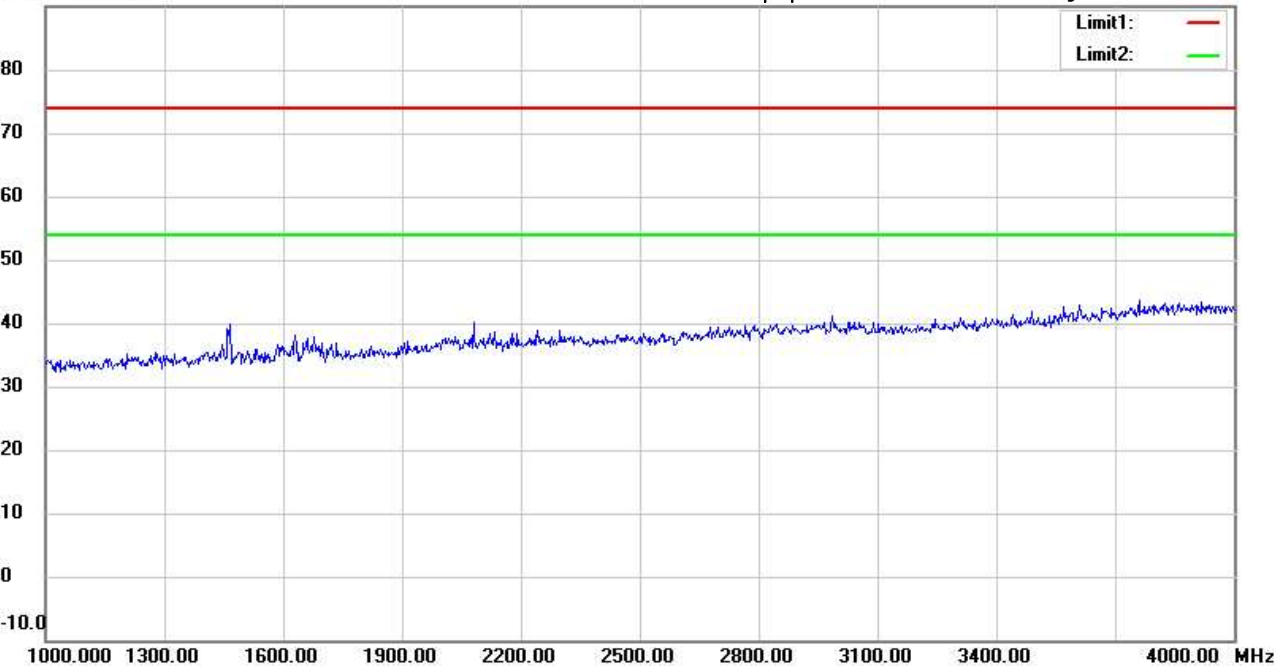
Site : 966A Chamber

Condition : FCC\_part 15E RE\_Above 1GHz\_PK

Test Mode : TX 802.11a CH1

Polarization: **Horizontal**

Distance: 3m

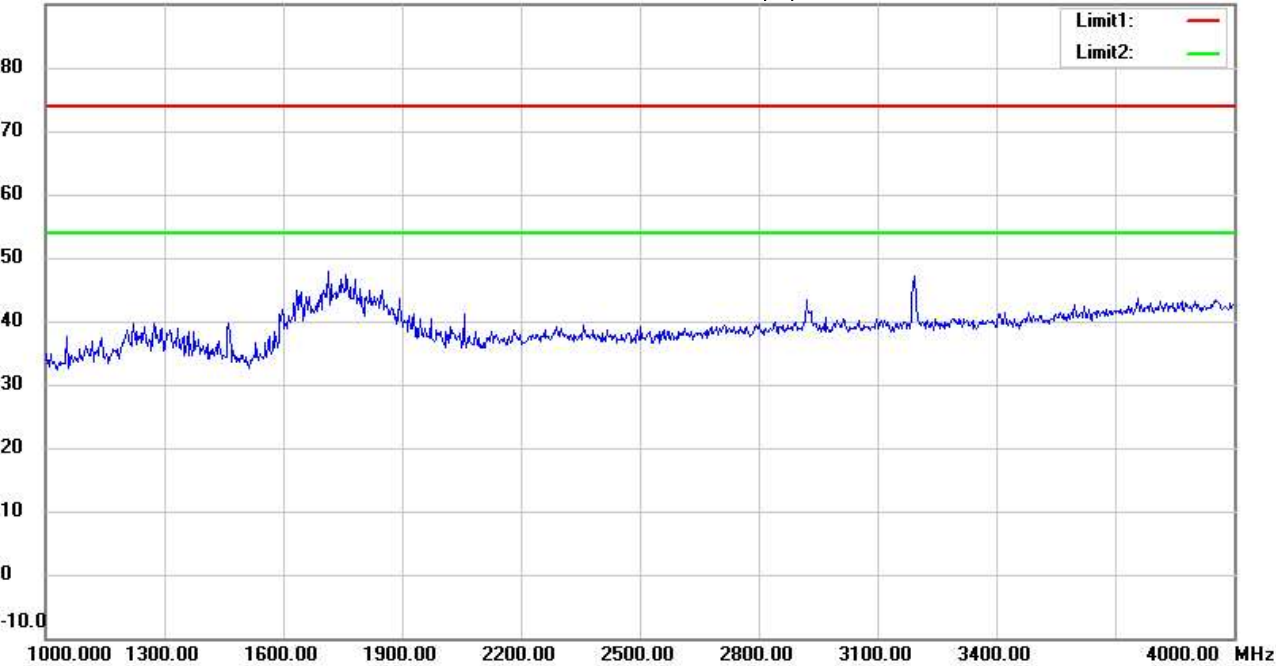
Site : 966A Chamber

Condition : FCC\_part 15E RE\_Above 1GHz\_PK

Test Mode : TX 802.11a CH1

Polarization: Vertical

Distance: 3m

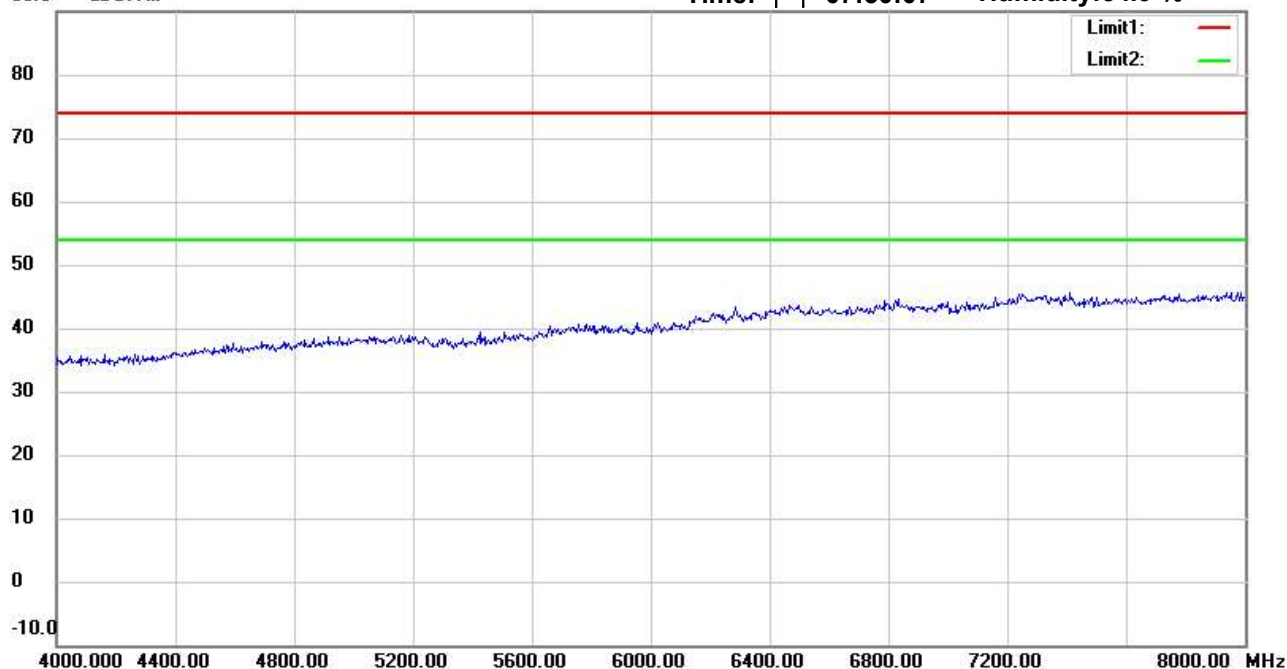
Site : 966A Chamber

Condition : FCC\_part 15E RE\_Above 1GHz\_PK

Test Mode : TX 802.11a CH1

Polarization: **Horizontal**

Distance: 3m

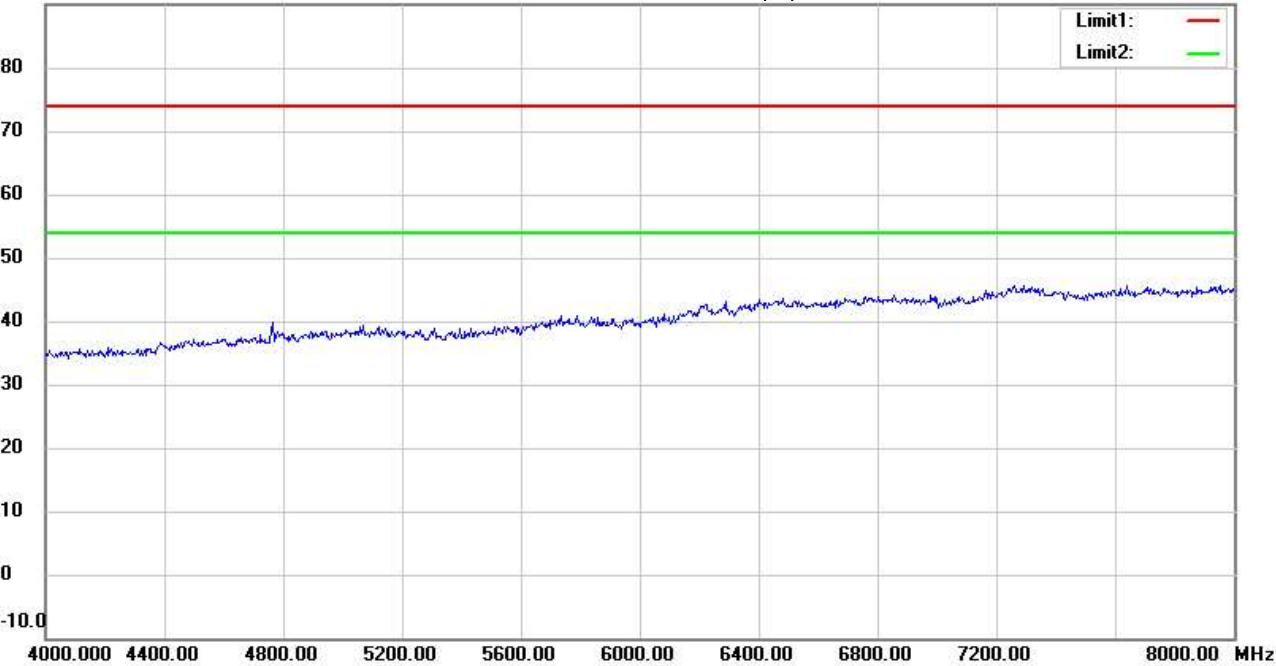
Site : 966A Chamber  
Condition : FCC\_part 15E RE\_Above 1GHz\_PK  
EUT : W6M22409-23739  
M/N:  
Test Mode : TX 802.11a CH1  
Note :

Polarization: Vertical  
Power : 120 Va.c.  
Distance: 3m

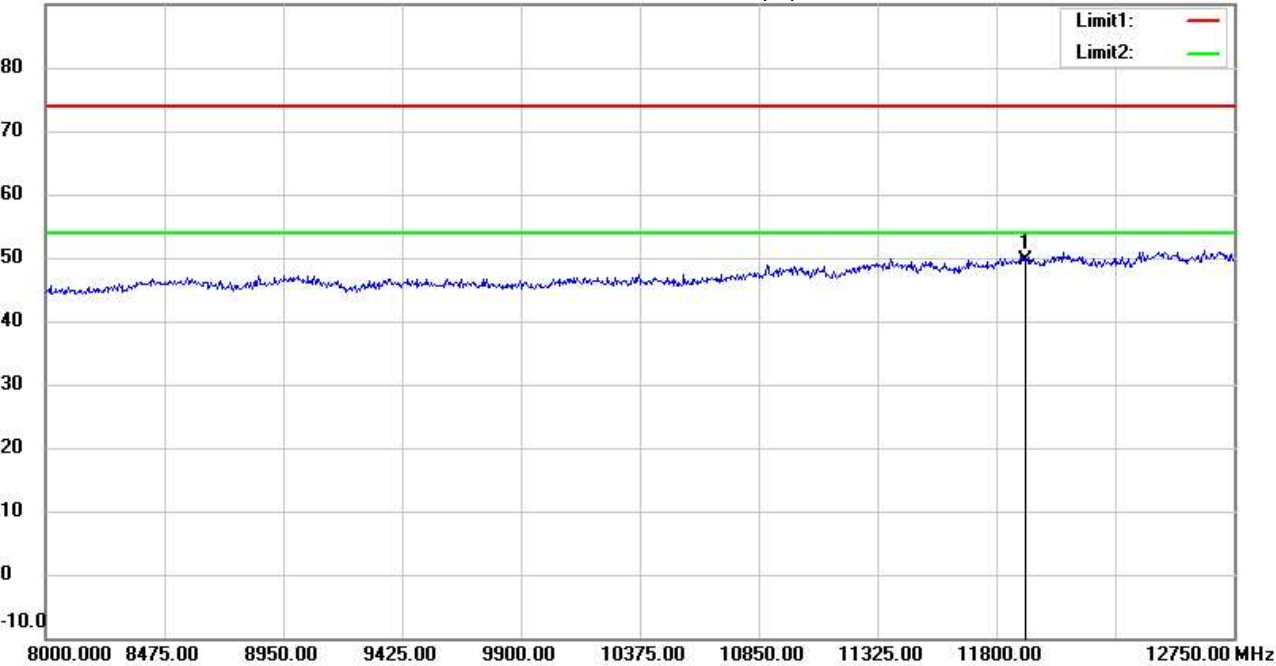
Data :#3

Site : 966A Chamber  
Condition : FCC\_part 15E RE\_Above 1GHz\_PK  
EUT : W6M22409-23739  
M/N:  
Test Mode : TX 802.11a CH1  
Note :

Polarization: **Horizontal**  
Power : 120 V.a.c.  
Distance: 3m

| Mk. | Frequency (MHz) | Reading (dBuV) | Detector | Corr. factor (dB/m) | Result (dBuV/m) | Limit (dBuV/m) | Ant.Pos (cm) | Tab.Pos (deg.) | Margin (dB) | Comment |
|---|---|---|---|---|---|---|---|---|---|---|
| * | 11910.000 | 33.51 | peak | 16.09 | 49.60 | 74.00 | 150 | 28 | -24.40 | |

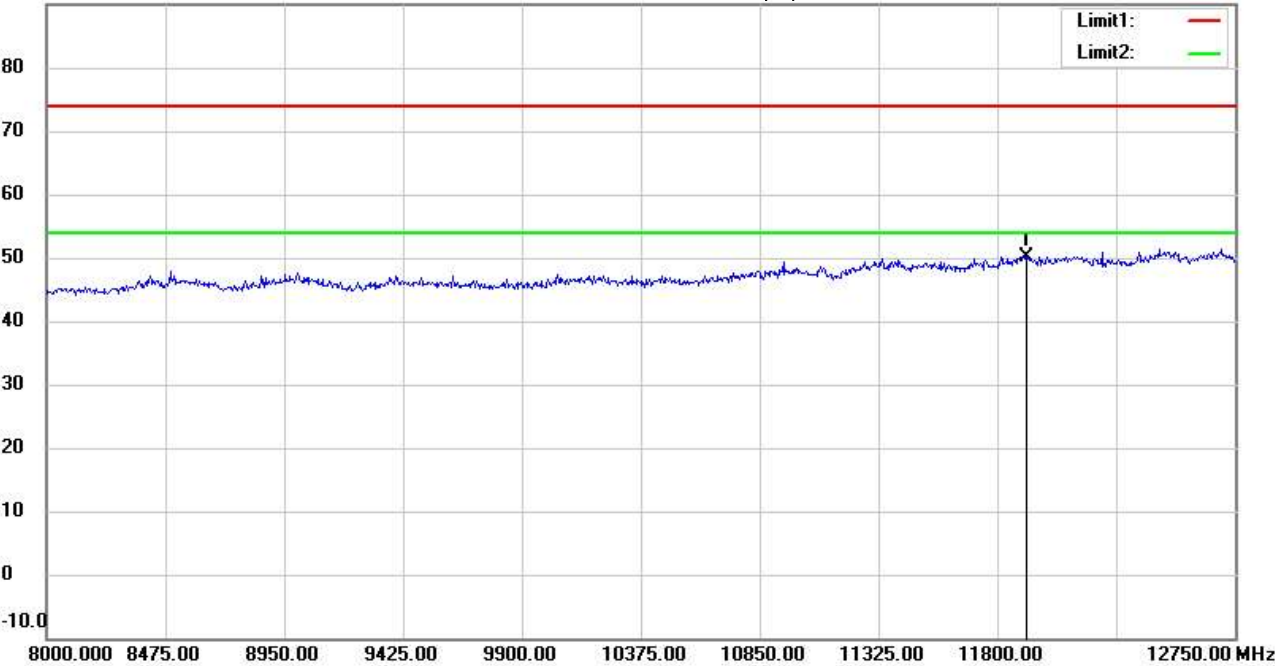
Data :#9

Site : 966A Chamber  
Condition : FCC\_part 15E RE\_Above 1GHz\_PK  
EUT : W6M22409-23739  
M/N:  
Test Mode : TX 802.11a CH1  
Note :

Polarization: Vertical  
Power : 120 V.a.c.  
Distance: 3m

| Mk. | Frequency (MHz) | Reading (dBuV) | Detector | Corr. factor (dB/m) | Result (dBuV/m) | Limit (dBuV/m) | Ant.Pos (cm) | Tab.Pos (deg.) | Margin (dB) | Comment |
|---|---|---|---|---|---|---|---|---|---|---|
| * | 11910.000 | 34.07 | peak | 16.09 | 50.16 | 74.00 | 150 | 331 | -23.84 | |

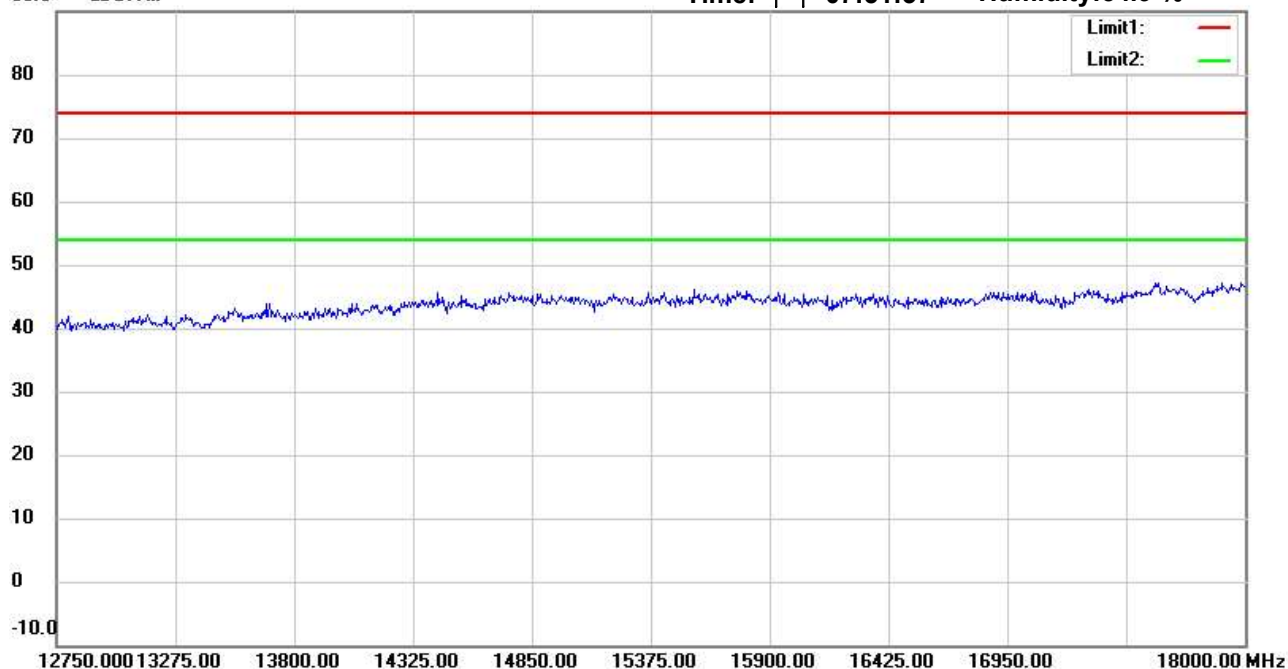
Site : 966A Chamber

Condition : FCC\_part 15E RE\_Above 1GHz\_PK

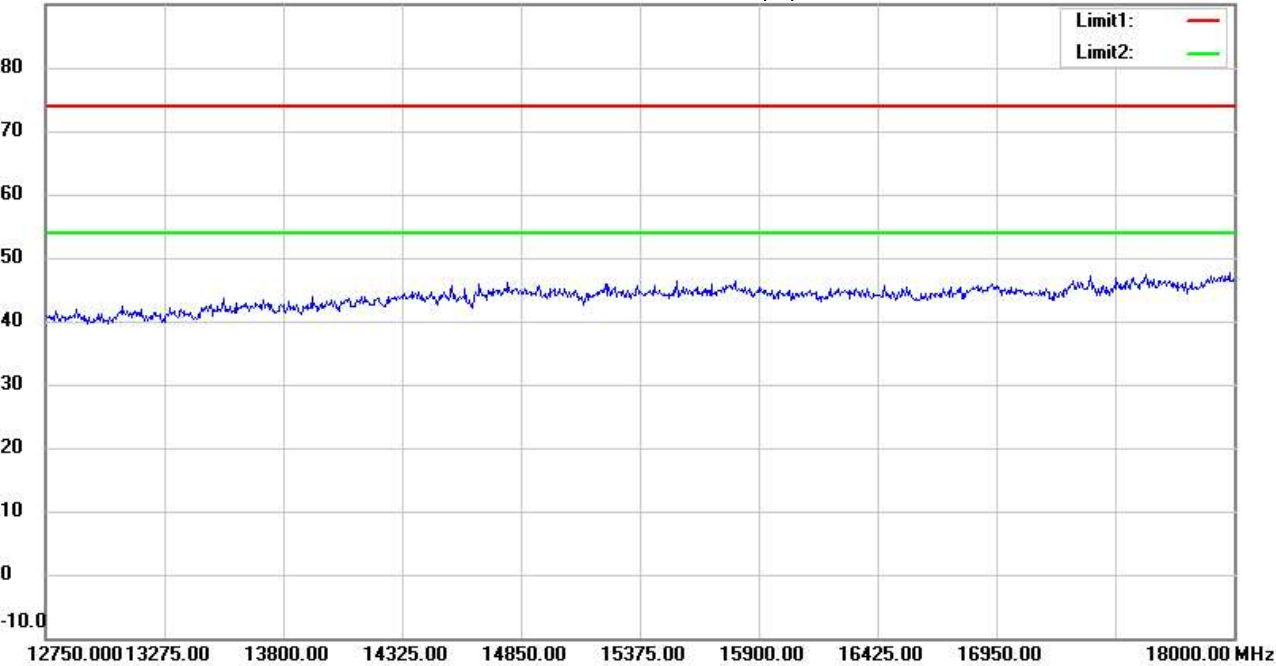
Site : 966A Chamber  
Condition : FCC\_part 15E RE\_Above 1GHz\_PK  
EUT : W6M22409-23739  
M/N:  
Test Mode : TX 802.11a CH1  
Note :

Polarization: Vertical  
Power : 120 Va.c.  
Distance: 3m

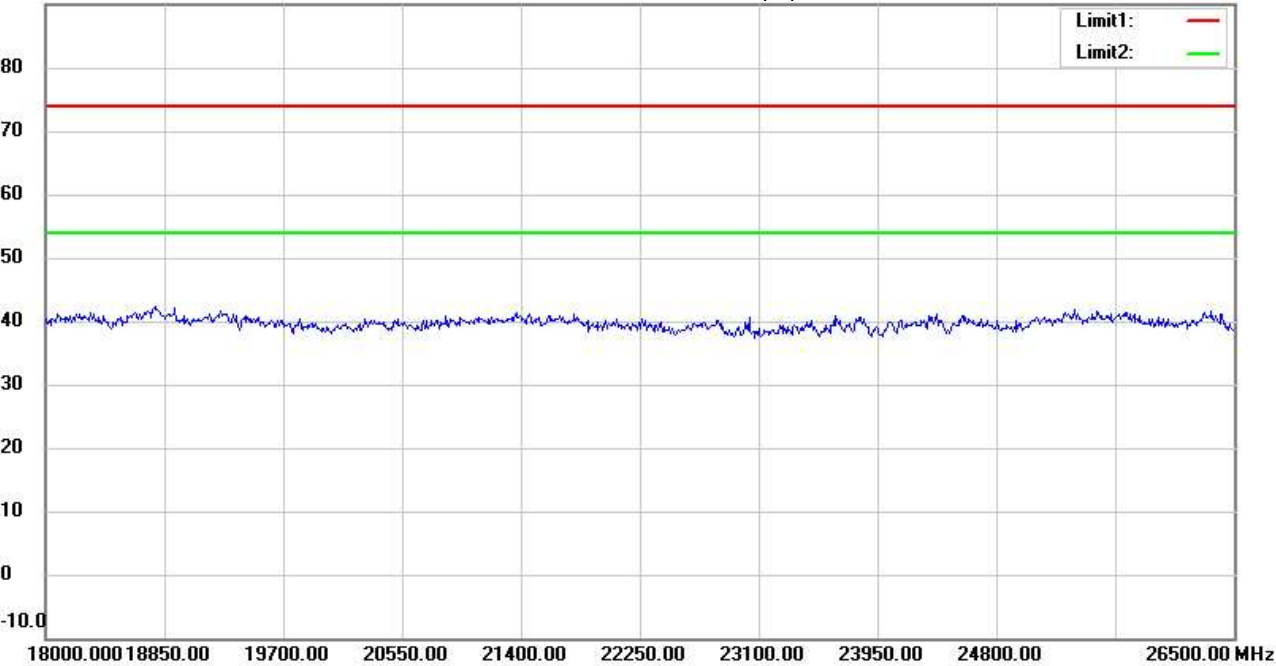
Site : 966A Chamber  
Condition : FCC\_part 15E RE\_Above 1GHz\_PK  
EUT : W6M22409-23739  
M/N:  
Test Mode : TX 802.11a CH1  
Note :

Polarization: *Horizontal*  
Power : 120 Va.c.  
Distance: 3m

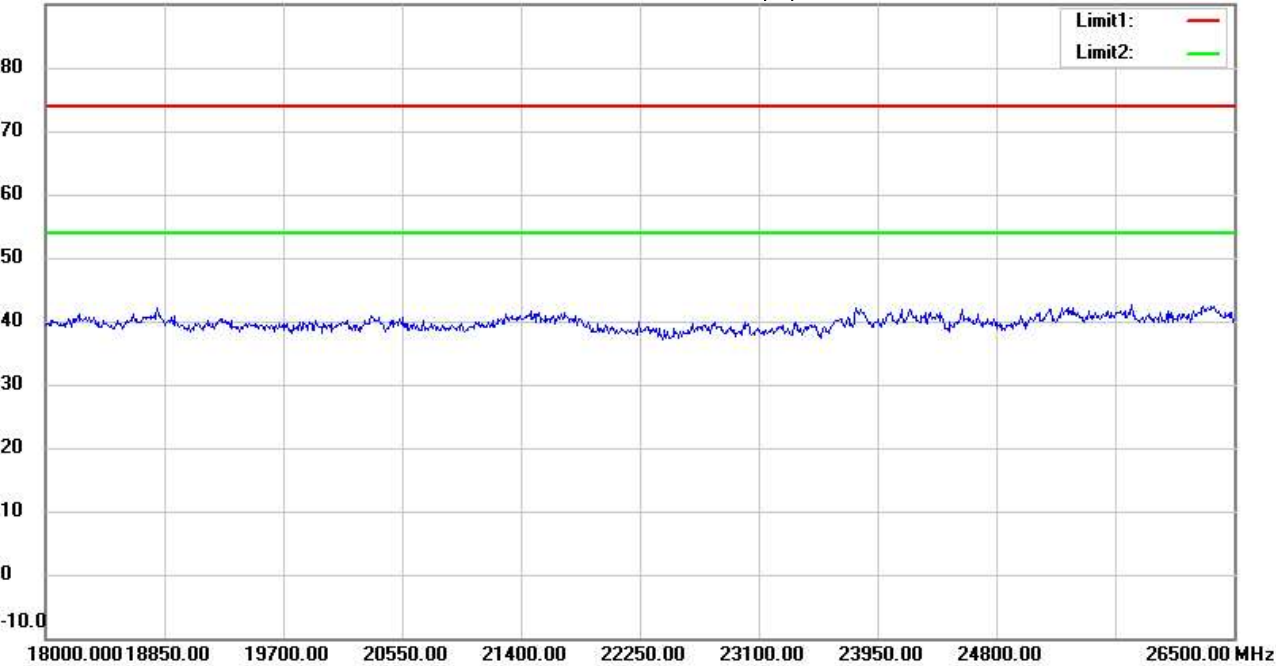
Site : 966A Chamber  
Condition : FCC\_part 15E RE\_Above 1GHz\_PK  
EUT : W6M22409-23739  
M/N:  
Test Mode : TX 802.11a CH1  
Note :

Polarization: Vertical  
Power : 120 Va.c.  
Distance: 3m

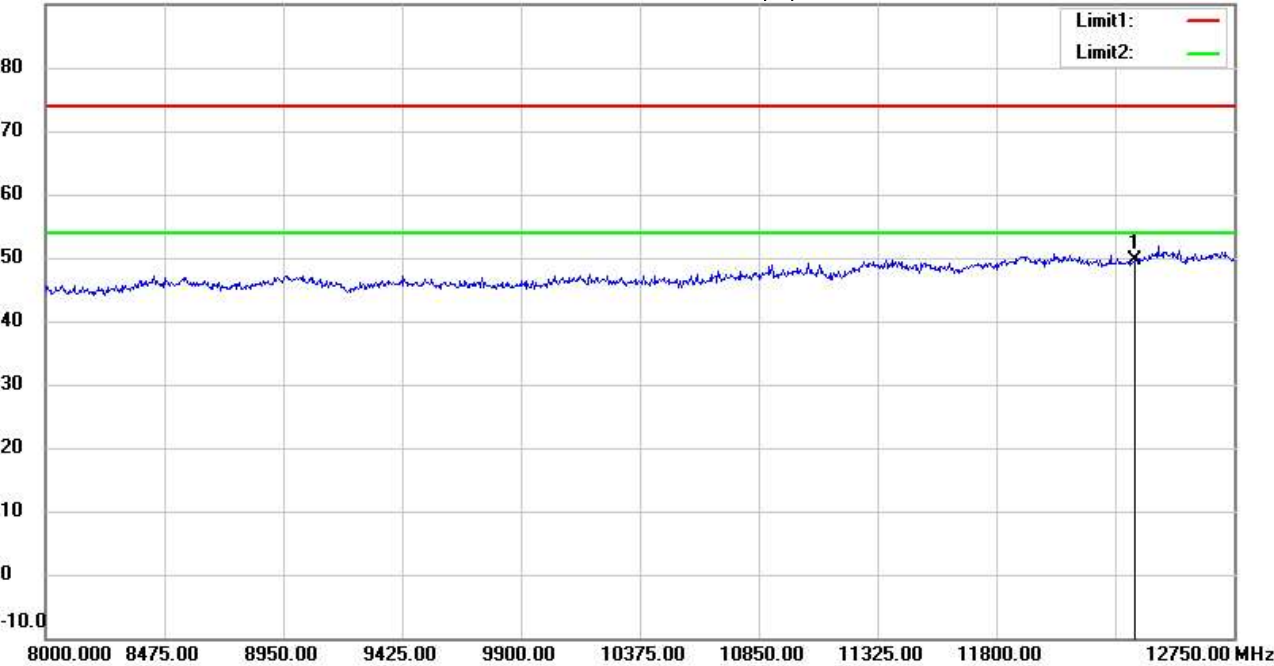
Data :#3

Site : 966A Chamber  
Condition : FCC\_part 15E RE\_Above 1GHz\_PK  
EUT : W6M22409-23739  
M/N:  
Test Mode : TX 802.11a CH45  
Note :

Polarization: **Horizontal**  
Power : 120 Va.c.  
Distance: 3m

| Mk. | Frequency (MHz) | Reading (dBuV) | Detector | Corr. factor (dB/m) | Result (dBuV/m) | Limit (dBuV/m) | Ant.Pos (cm) | Tab.Pos (deg.) | Margin (dB) | Comment |
|---|---|---|---|---|---|---|---|---|---|---|
| * | 12350.000 | 33.12 | peak | 16.43 | 49.55 | 74.00 | 150 | 29 | -24.45 | |

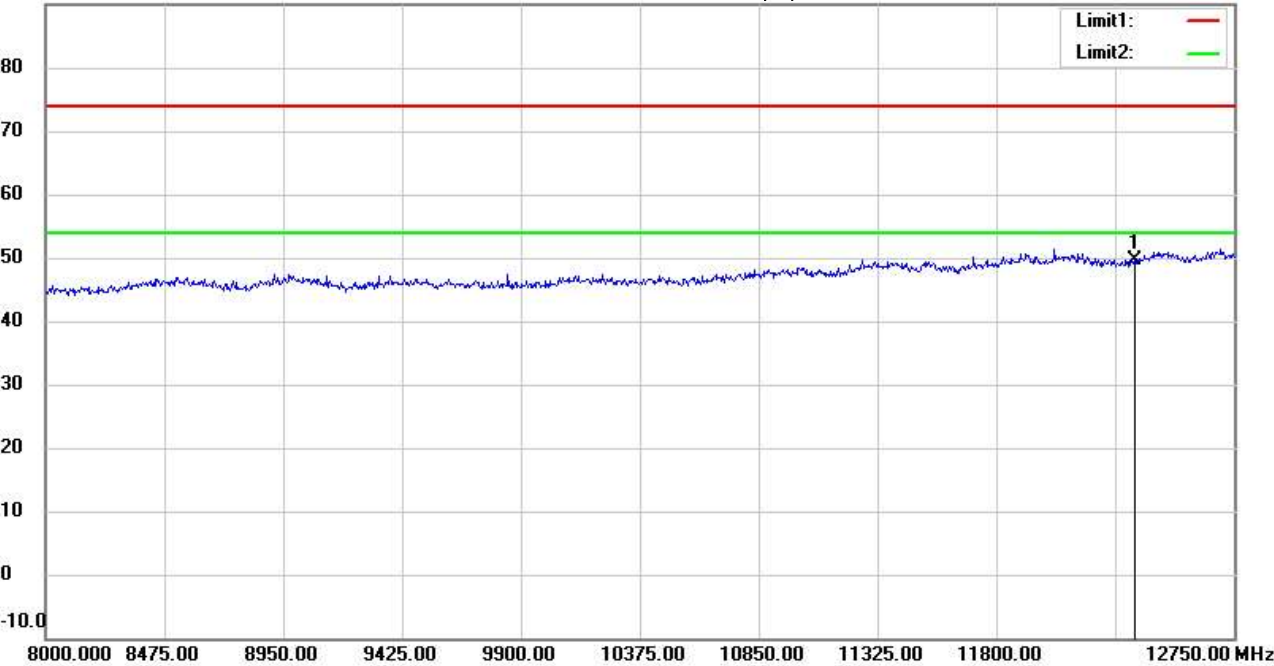
Data :#9

Site : 966A Chamber  
Condition : FCC\_part 15E RE\_Above 1GHz\_PK  
EUT : W6M22409-23739  
M/N:  
Test Mode : TX 802.11a CH45  
Note :

Polarization: Vertical  
Power : 120 Va.c.  
Distance: 3m

| Mk. | Frequency (MHz) | Reading (dBuV) | Detector | Corr. factor (dB/m) | Result (dBuV/m) | Limit (dBuV/m) | Ant.Pos (cm) | Tab.Pos (deg.) | Margin (dB) | Comment |
|---|---|---|---|---|---|---|---|---|---|---|
| * | 12350.000 | 33.17 | peak | 16.43 | 49.60 | 74.00 | 150 | 178 | -24.40 | |

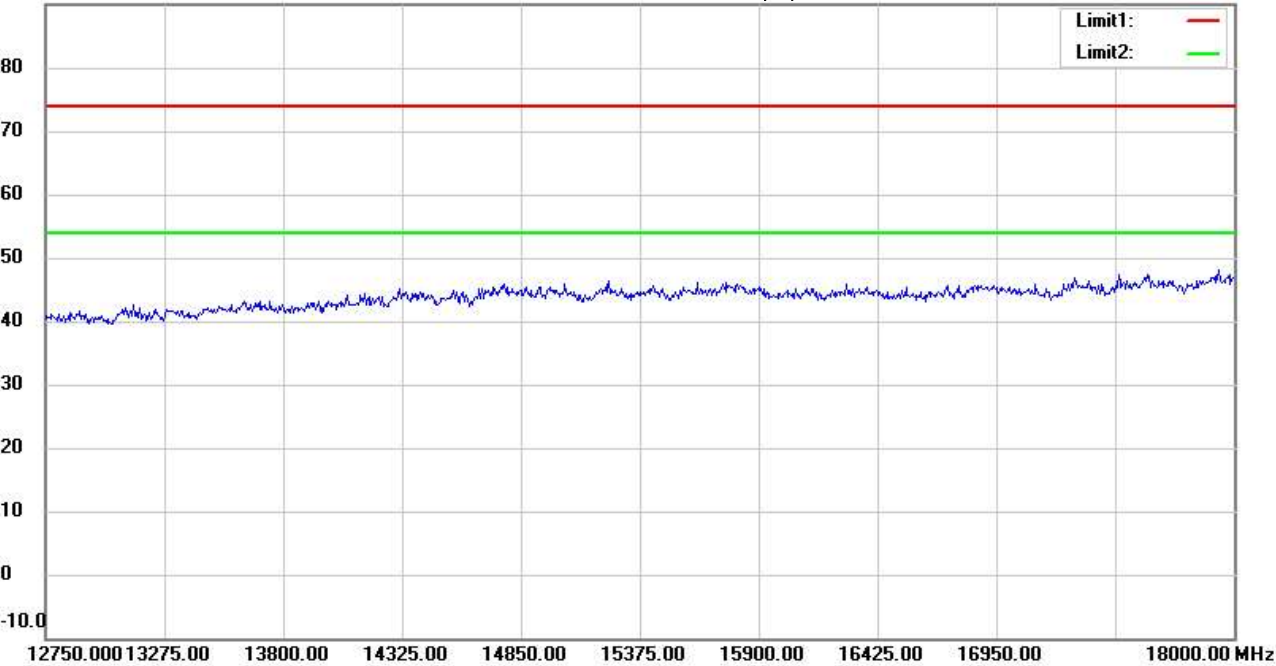
Site : 966A Chamber  
Condition : FCC\_part 15E RE\_Above 1GHz\_PK  
EUT : W6M22409-23739  
M/N:  
Test Mode : TX 802.11a CH45  
Note :

Polarization: Vertical  
Power : 120 Va.c.  
Distance: 3m

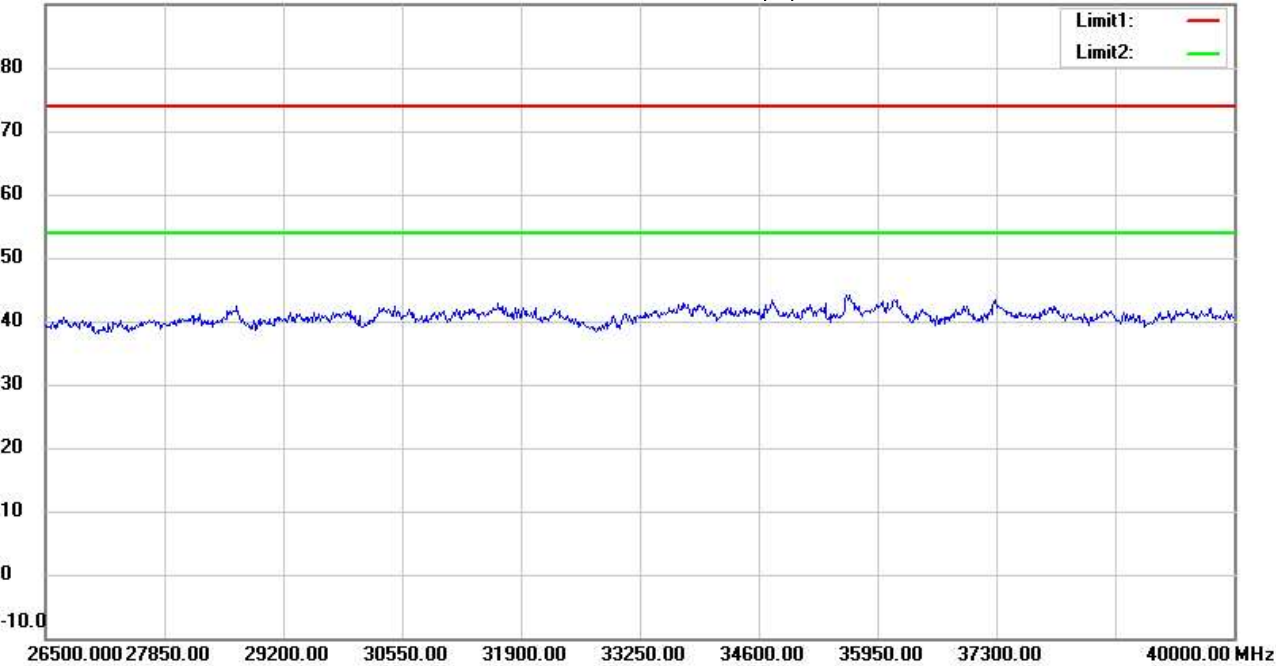
Site : 966A Chamber  
Condition : FCC\_part 15E RE\_Above 1GHz\_PK  
EUT : W6M22409-23739  
M/N:  
Test Mode : TX 802.11a CH45  
Note :

Polarization: Vertical  
Power : 120 Va.c.  
Distance: 3m
