Radiated Emission Measurement

Site : 966A Chamber  
Condition : FCC\_part 15E RE\_Above 1GHz\_PK  
EUT : W6M22409-23739  
M/N:  
Test Mode : TX 802.11a CH93  
Note :

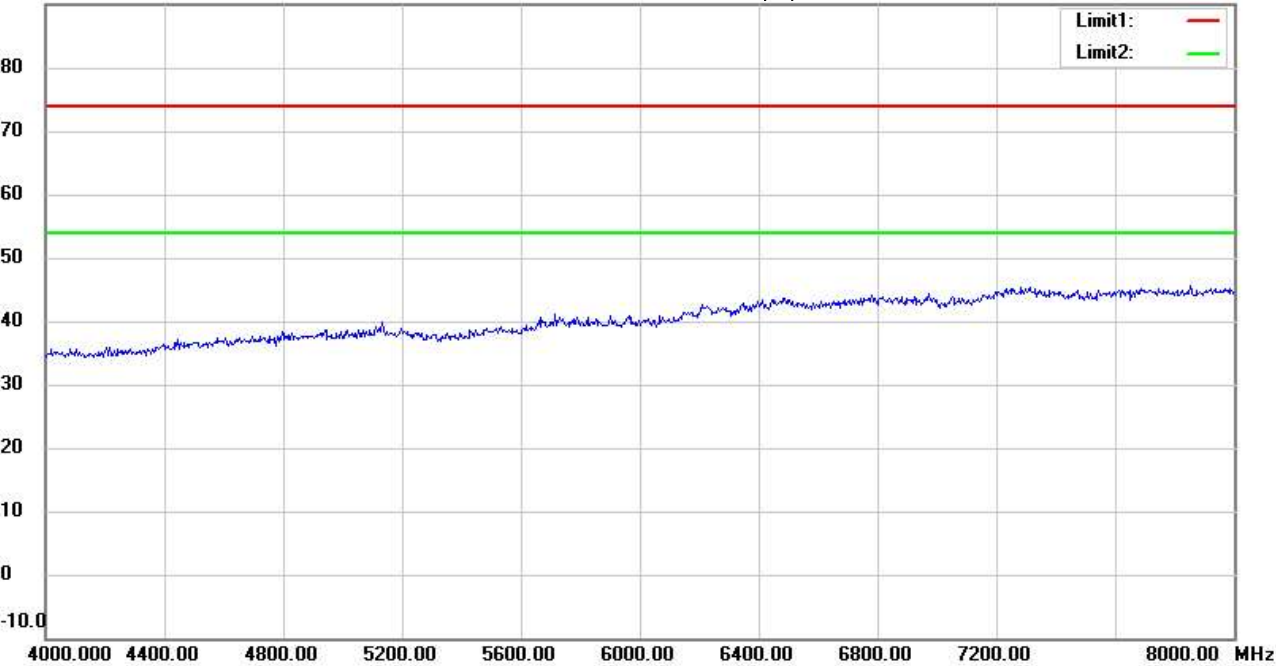
Data :#2

Polarization: *Horizontal*  
Power : 120 Va.c.  
Distance: 3m

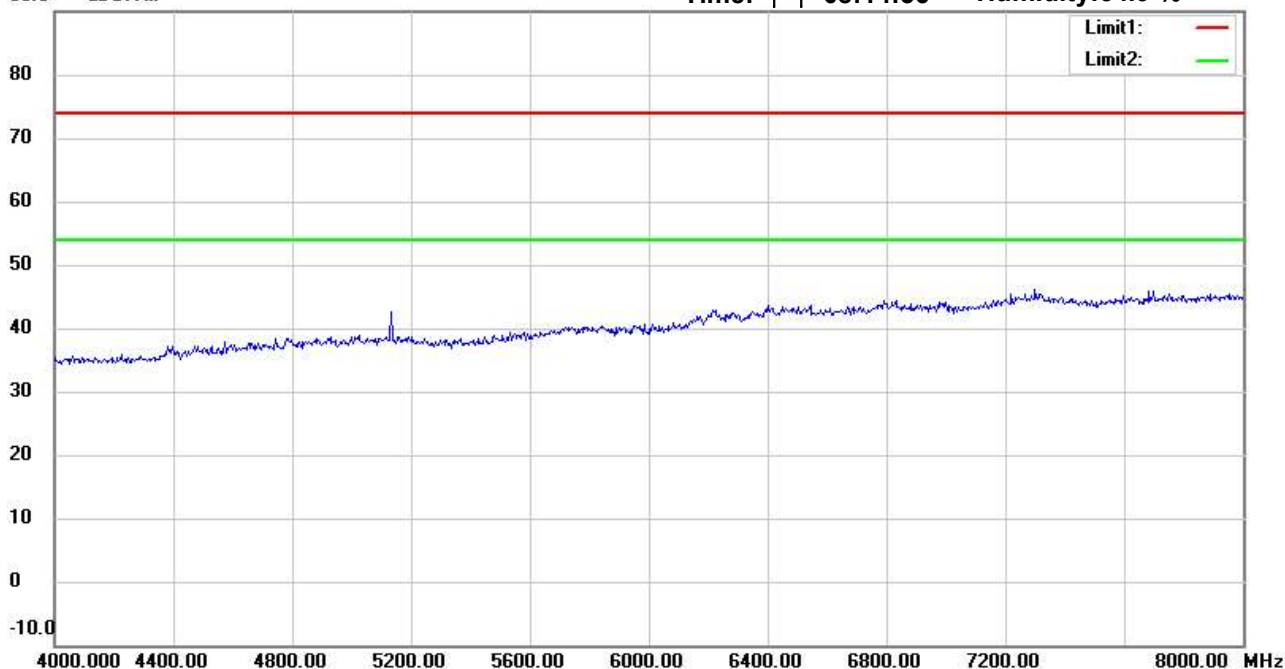
Data : #8

Test Mode : TX 802.11a CH93

Polarization: **Vertical**

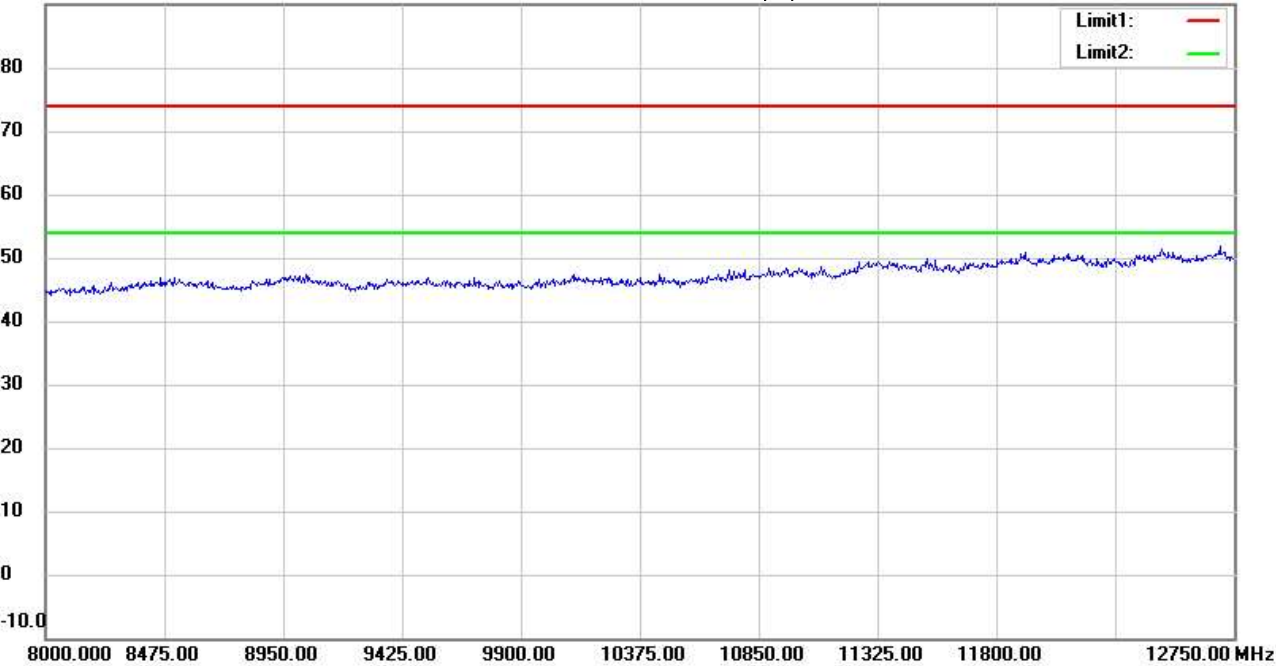
Data :#3

Site : 966A Chamber  
Condition : FCC\_part 15E RE\_Above 1GHz\_PK  
EUT : W6M22409-23739  
M/N:  
Test Mode : TX 802.11a CH93  
Note :

Polarization: **Horizontal**  
Power : 120 V.a.c.  
Distance: 3m

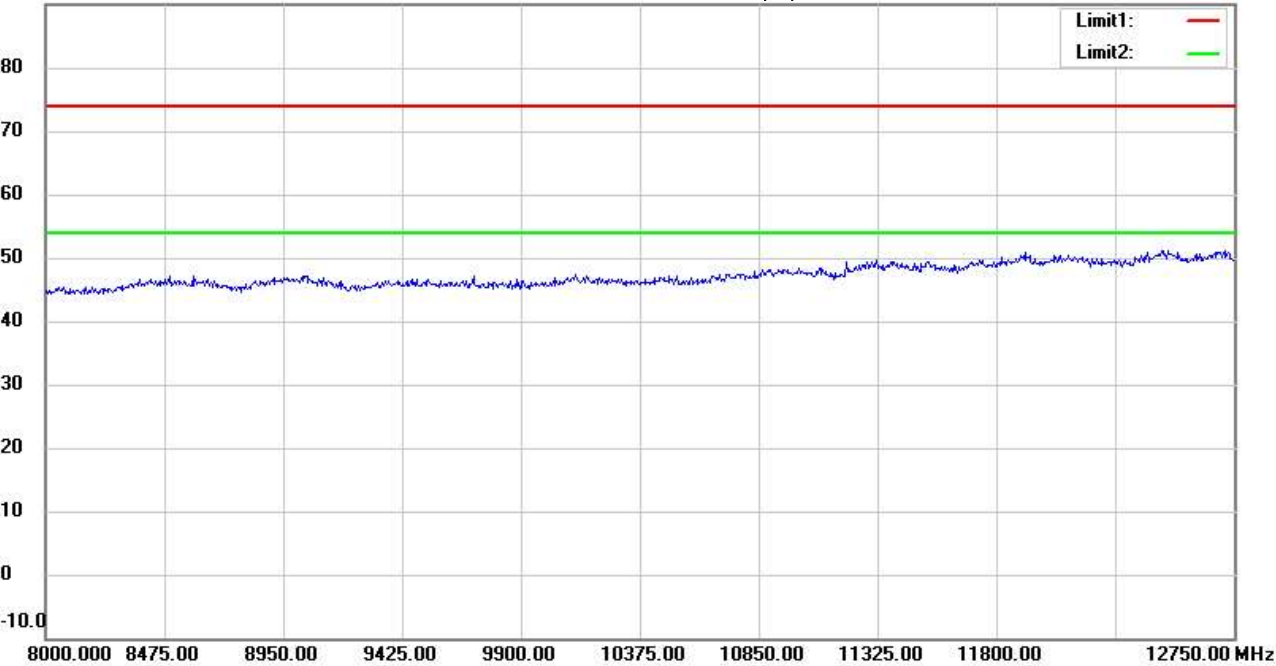
Data :#9

Site : 966A Chamber  
Condition : FCC\_part 15E RE\_Above 1GHz\_PK  
EUT : W6M22409-23739  
M/N:  
Test Mode : TX 802.11a CH93  
Note :

Polarization: Vertical  
Power : 120 V.a.c.  
Distance: 3m

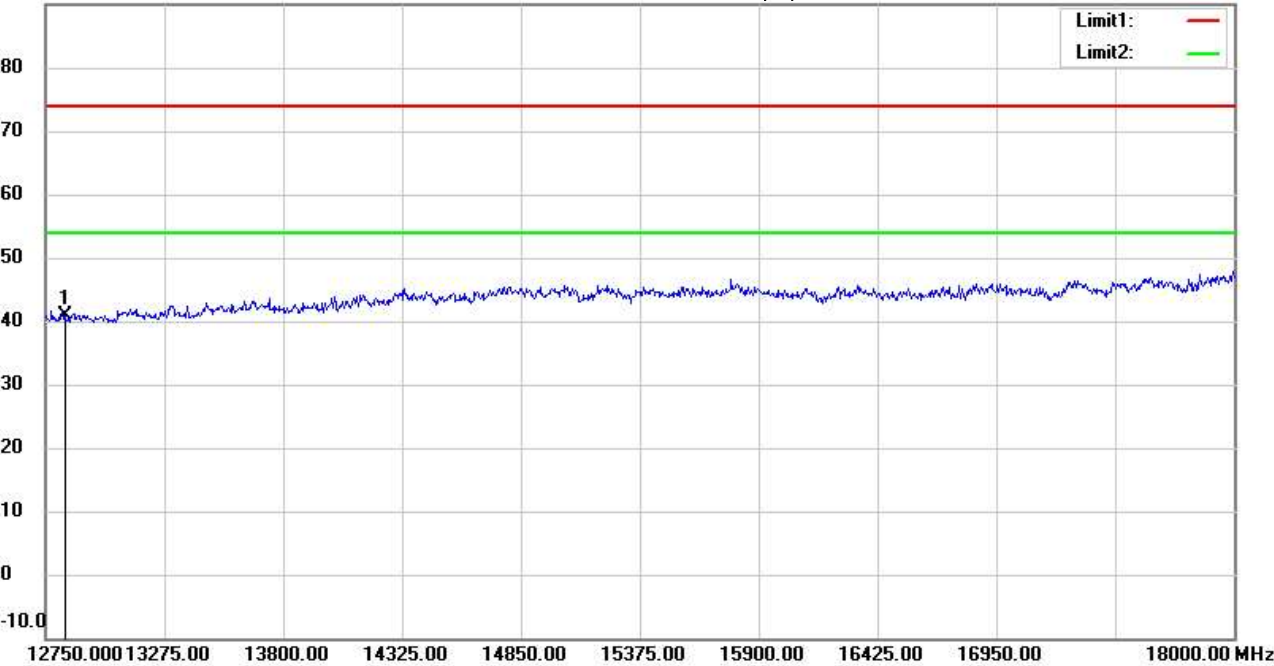
Data :#4

Site : 966A Chamber

Condition : FCC\_part 15E RE\_Above 1GHz\_PK

Test Mode : TX 802.11a CH93

Polarization: **Horizontal**

| Mk. | Frequency (MHz) | Reading (dBuV) | Detector | Corr. factor (dB/m) | Result (dBuV/m) | Limit (dBuV/m) | Ant.Pos (cm) | Tab.Pos (deg.) | Margin (dB) | Comment |
|---|---|---|---|---|---|---|---|---|---|---|
| * | 12830.000 | 23.86 | peak | 17.09 | 40.95 | 74.00 | 150 | 289 | -33.05 | |

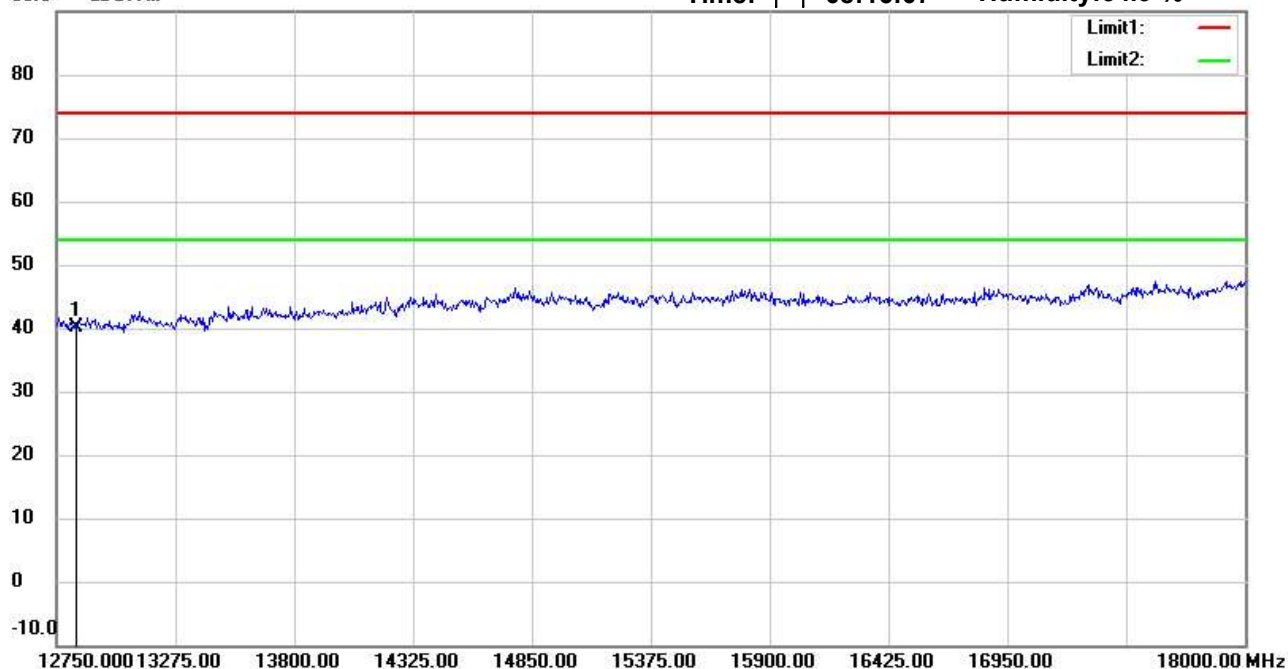
Data : #10

Site : 966A Chamber

Condition : FCC\_part 15E RE\_Above 1GHz\_PK

Test Mode : TX 802.11a CH93

Polarization: **Vertical**

| Mk. | Frequency (MHz) | Reading (dBuV) | Detector | Corr. factor (dB/m) | Result (dBuV/m) | Limit (dBuV/m) | Ant.Pos (cm) | Tab.Pos (deg.) | Margin (dB) | Comment |
|---|---|---|---|---|---|---|---|---|---|---|
| * | 12830.000 | 22.96 | peak | 17.09 | 40.05 | 74.00 | 150 | 318 | -33.95 | |

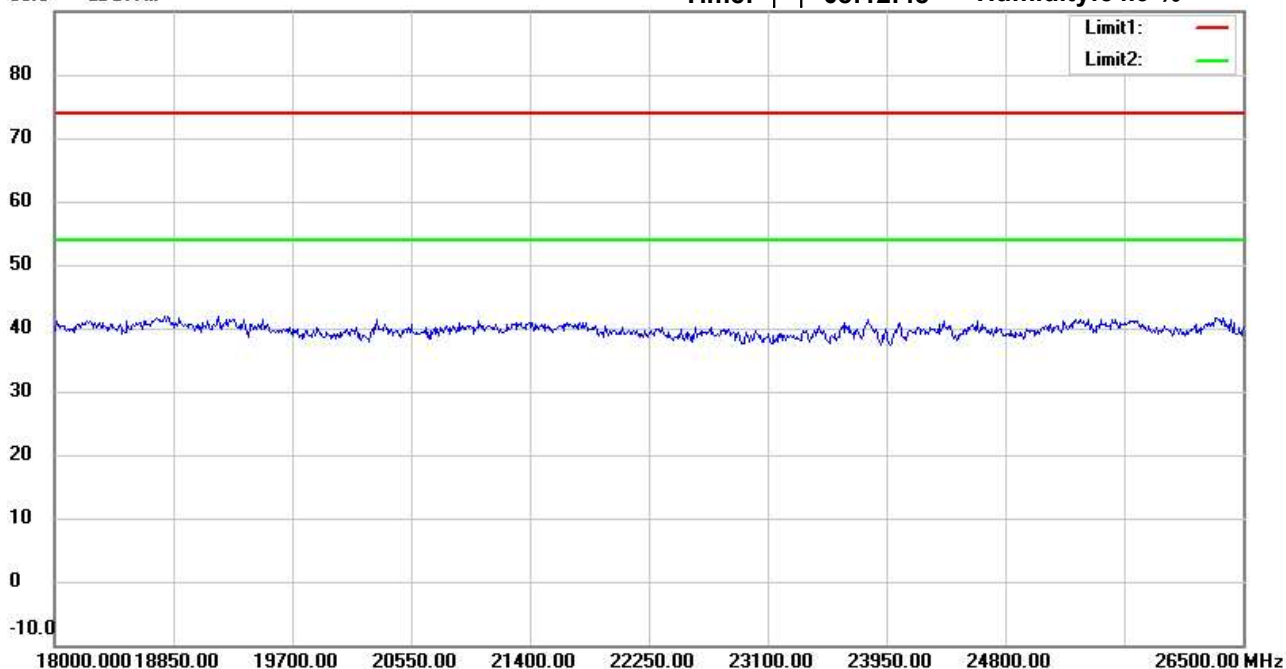
Data : #5

Test Mode : TX 802.11a CH93

Polarization: **Horizontal**

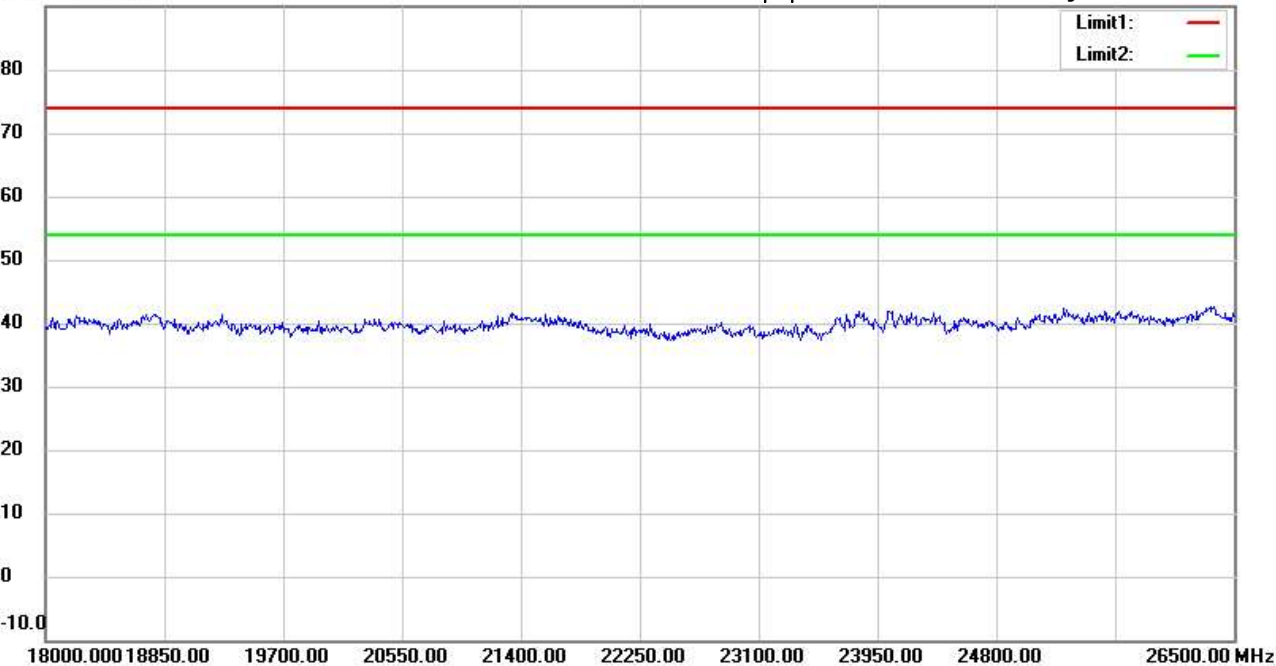
Data :#11

Test Mode : TX 802.11a CH93

Polarization: Vertical

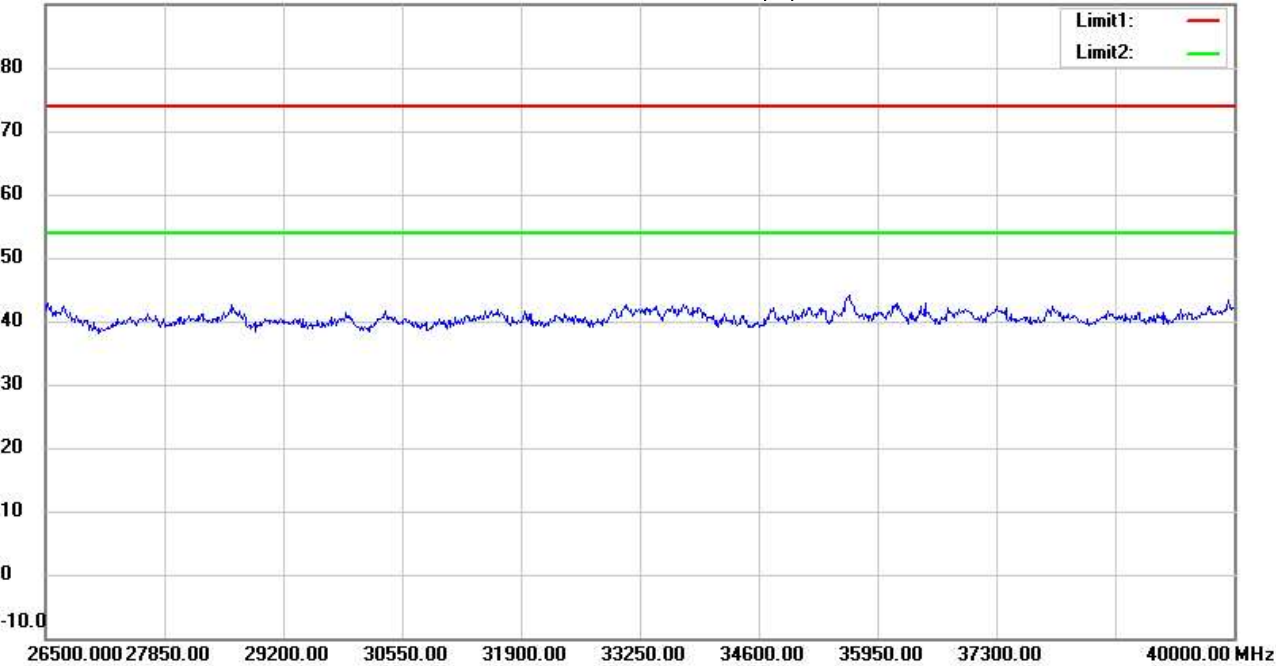
Data :#6

Site : 966A Chamber  
Condition : FCC\_part 15E RE\_Above 1GHz\_PK  
EUT : W6M22409-23739  
M/N:  
Test Mode : TX 802.11a CH93  
Note :

Polarization: *Horizontal*  
Power : 120 Va.c.  
Distance: 3m

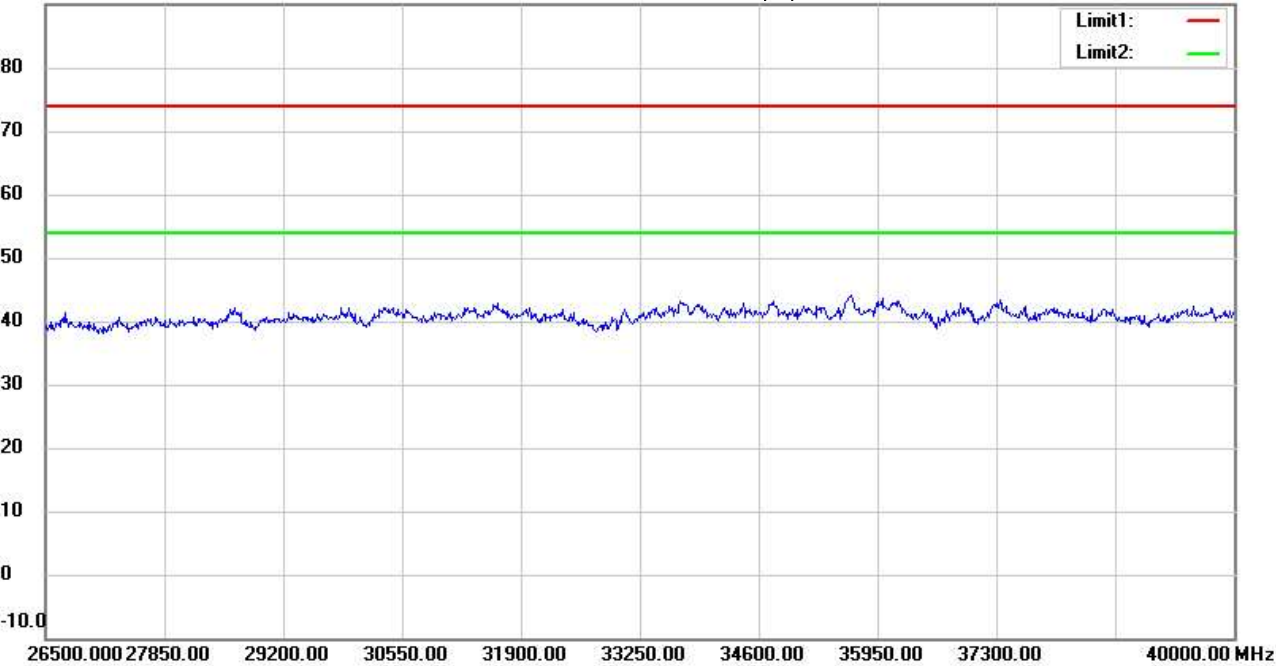
Site : 966A Chamber  
Condition : FCC\_part 15E RE\_Above 1GHz\_PK  
EUT : W6M22409-23739  
M/N:  
Test Mode : TX 802.11a CH93  
Note :

Polarization: Vertical  
Power : 120 Va.c.  
Distance: 3m

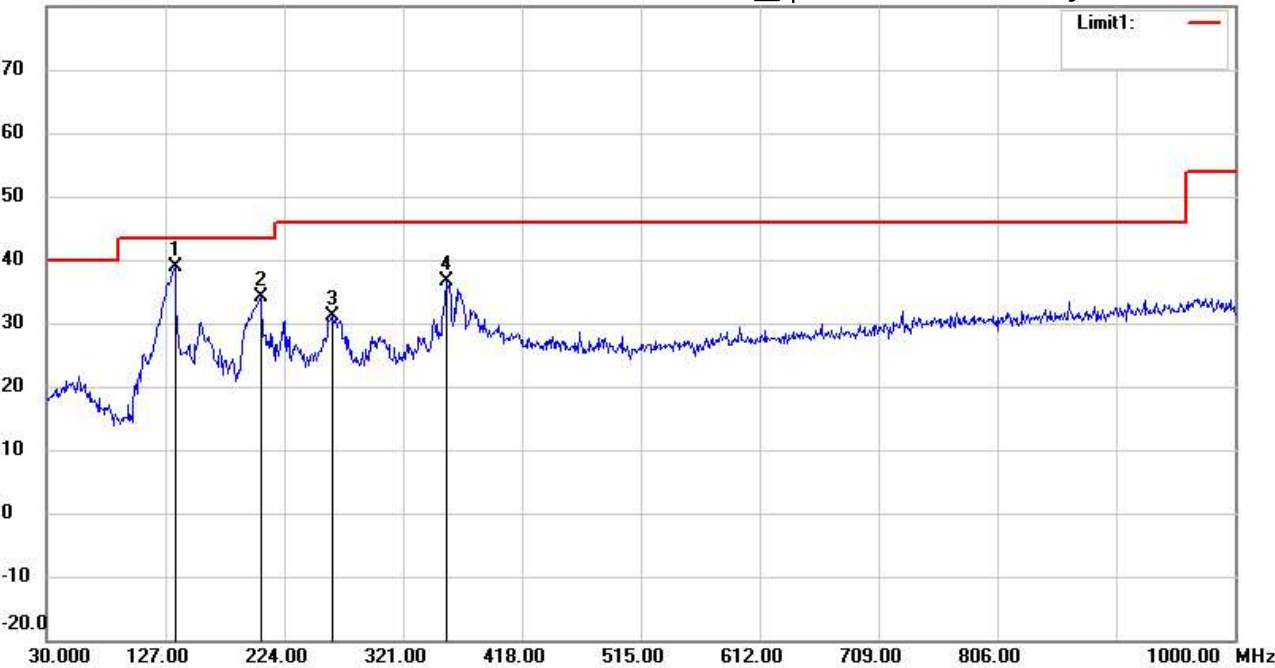
Data :#1

Site : 966A Chamber

Condition : FCC\_part 15 RE-Class C\_30-1000MHz

Test Mode : TX 802.11a CH1

Polarization: **Horizontal**

| Mk. | Frequency (MHz) | Reading (dBuV) | Detector | Corr. factor (dB/m) | Result (dBuV/m) | Limit (dBuV/m) | Ant.Pos (cm) | Tab.Pos (deg.) | Margin (dB) | Comment |
|---|---|---|---|---|---|---|---|---|---|---|
| * | 134.7600 | 52.26 | peak | -13.33 | 38.93 | 43.50 | 100 | 108 | -4.57 | |
| | 205.0850 | 50.05 | peak | -15.85 | 34.20 | 43.50 | 100 | 208 | -9.30 | |
| | 262.8000 | 44.35 | peak | -13.30 | 31.05 | 46.00 | 100 | 274 | -14.95 | |
| | 355.9200 | 47.61 | peak | -10.98 | 36.63 | 46.00 | 100 | 261 | -9.37 | |

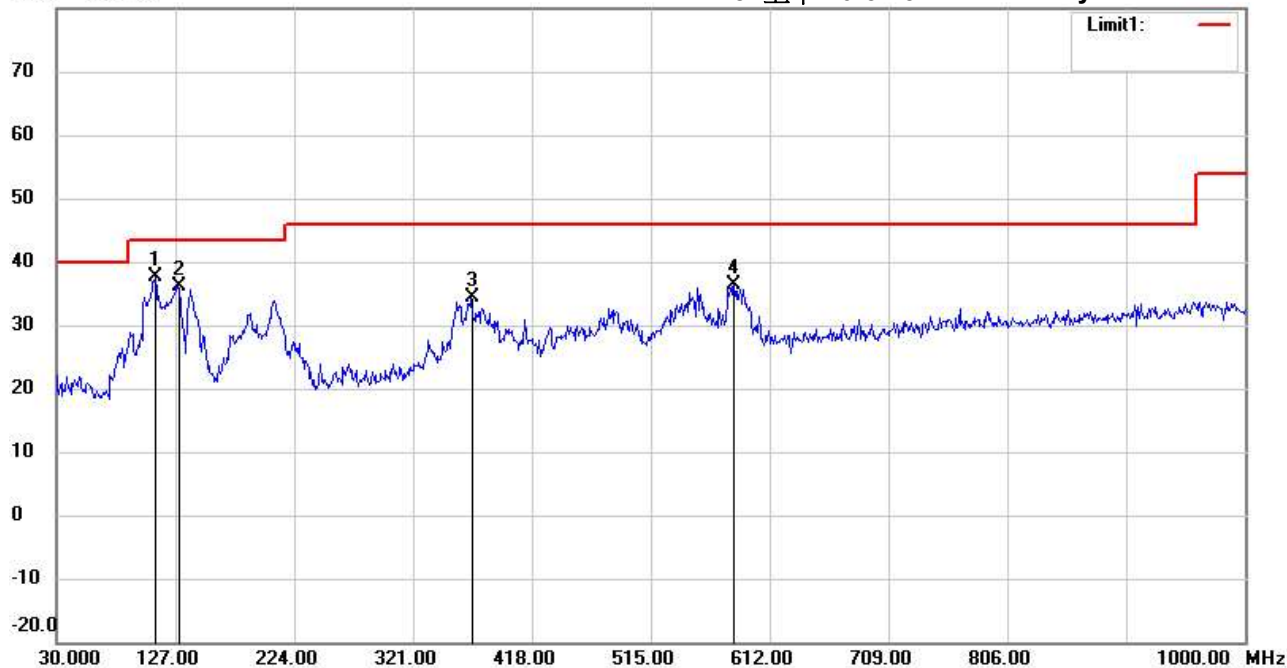
Data :#2

Site : 966A Chamber

Condition : FCC\_part 15 RE-Class C\_30-1000MHz

Test Mode : TX 802.11a CH1

Polarization: Vertical

| Mk. | Frequency (MHz) | Reading (dBuV) | Detector | Corr. factor (dB/m) | Result (dBuV/m) | Limit (dBuV/m) | Ant.Pos (cm) | Tab.Pos (deg.) | Margin (dB) | Comment |
|---|---|---|---|---|---|---|---|---|---|---|
| * | 110.5100 | 53.14 | peak | -15.57 | 37.57 | 43.50 | 100 | 143 | -5.93 | |
| | 129.4250 | 49.92 | peak | -13.83 | 36.09 | 43.50 | 100 | 237 | -7.41 | |
| | 369.0150 | 45.04 | peak | -10.54 | 34.50 | 46.00 | 100 | 191 | -11.50 | |
| | 582.9000 | 41.87 | peak | -5.59 | 36.28 | 46.00 | 100 | 177 | -9.72 | |

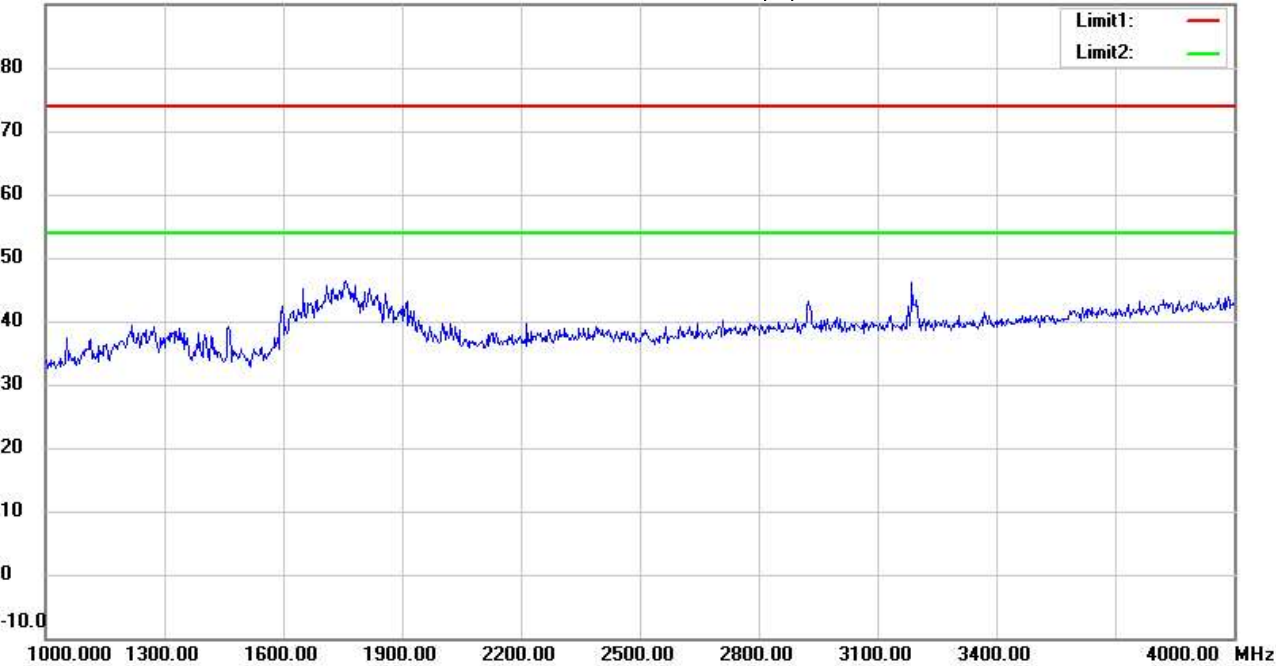
Site : 966A Chamber  
Condition : FCC\_part 15E RE\_Above 1GHz\_PK  
EUT : W6M22409-23739  
M/N:  
Test Mode : TX 802.11a CH1  
Note :

Polarization: Vertical  
Power : 120 Va.c.  
Distance: 3m

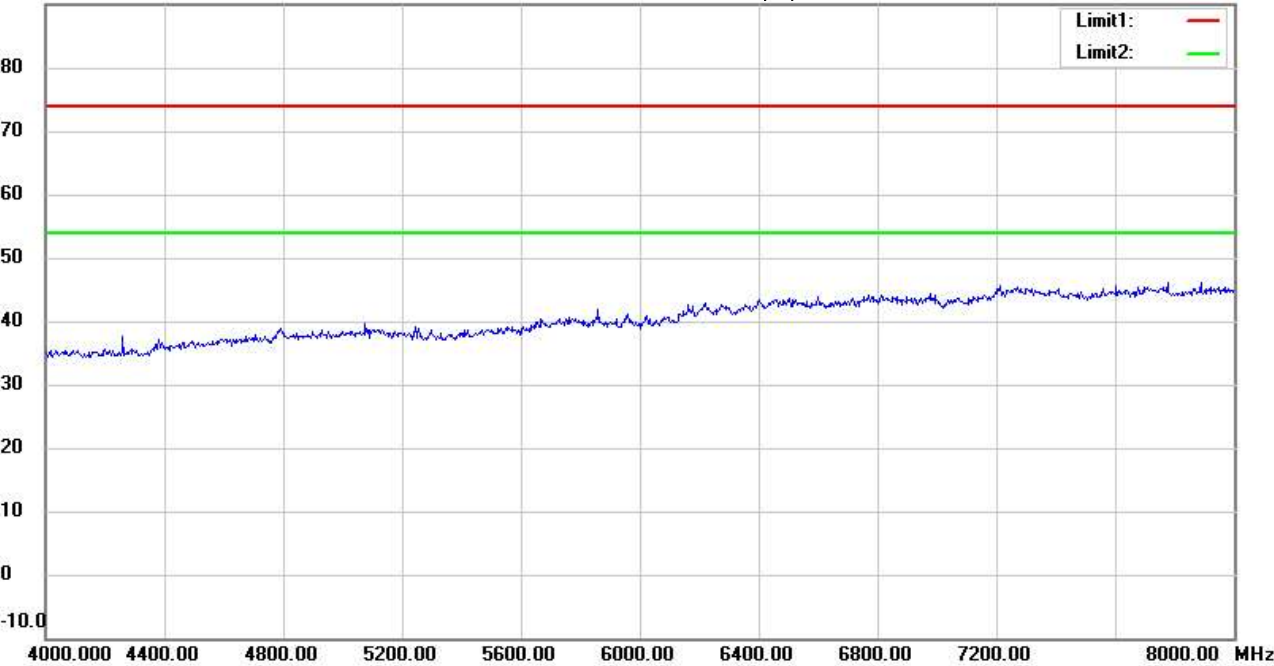
Site : 966A Chamber  
Condition : FCC\_part 15E RE\_Above 1GHz\_PK  
EUT : W6M22409-23739  
M/N:  
Test Mode : TX 802.11a CH1  
Note :

Polarization: Vertical  
Power : 120 Va.c.  
Distance: 3m

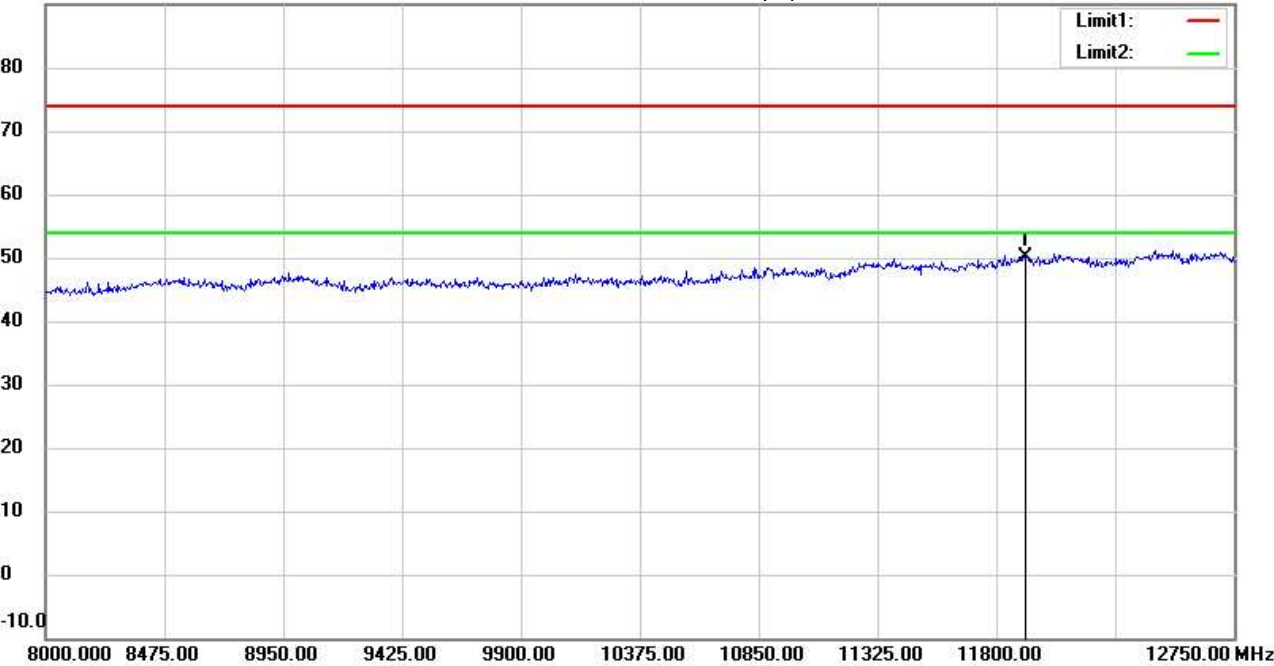
Data :#3

Site : 966A Chamber  
Condition : FCC\_part 15E RE\_Above 1GHz\_PK  
EUT : W6M22409-23739  
M/N:  
Test Mode : TX 802.11a CH1  
Note :

Polarization: *Horizontal*  
Power : 120 Va.c.  
Distance: 3m

| Mk. | Frequency (MHz) | Reading (dBuV) | Detector | Corr. factor (dB/m) | Result (dBuV/m) | Limit (dBuV/m) | Ant.Pos (cm) | Tab.Pos (deg.) | Margin (dB) | Comment |
|---|---|---|---|---|---|---|---|---|---|---|
| * | 11910.000 | 33.96 | peak | 16.09 | 50.05 | 74.00 | 150 | 200 | -23.95 | |

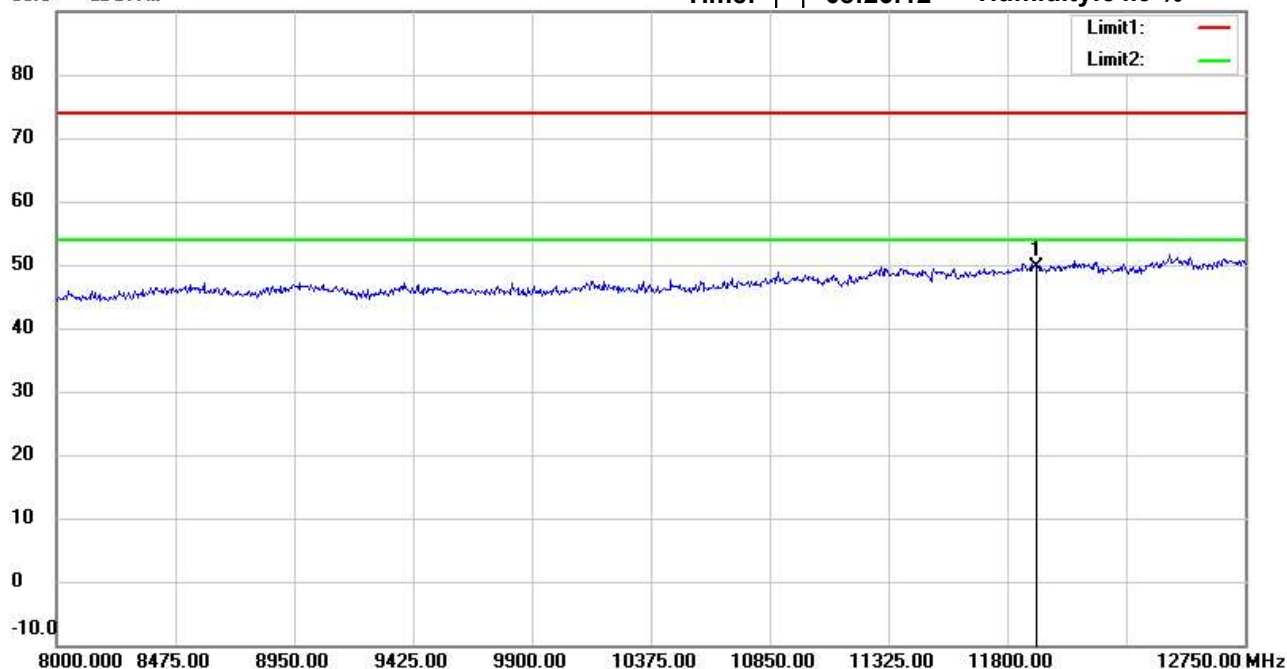
Data : #9

Site : 966A Chamber

Condition : FCC\_part 15E RE\_Above 1GHz\_PK

Test Mode : TX 802.11a CH1

Polarization: Vertical

| Mk. | Frequency (MHz) | Reading (dBuV) | Detector | Corr. factor (dB/m) | Result (dBuV/m) | Limit (dBuV/m) | Ant.Pos (cm) | Tab.Pos (deg.) | Margin (dB) | Comment |
|---|---|---|---|---|---|---|---|---|---|---|
| * | 11910.000 | 33.55 | peak | 16.09 | 49.64 | 74.00 | 150 | 189 | -24.36 | |

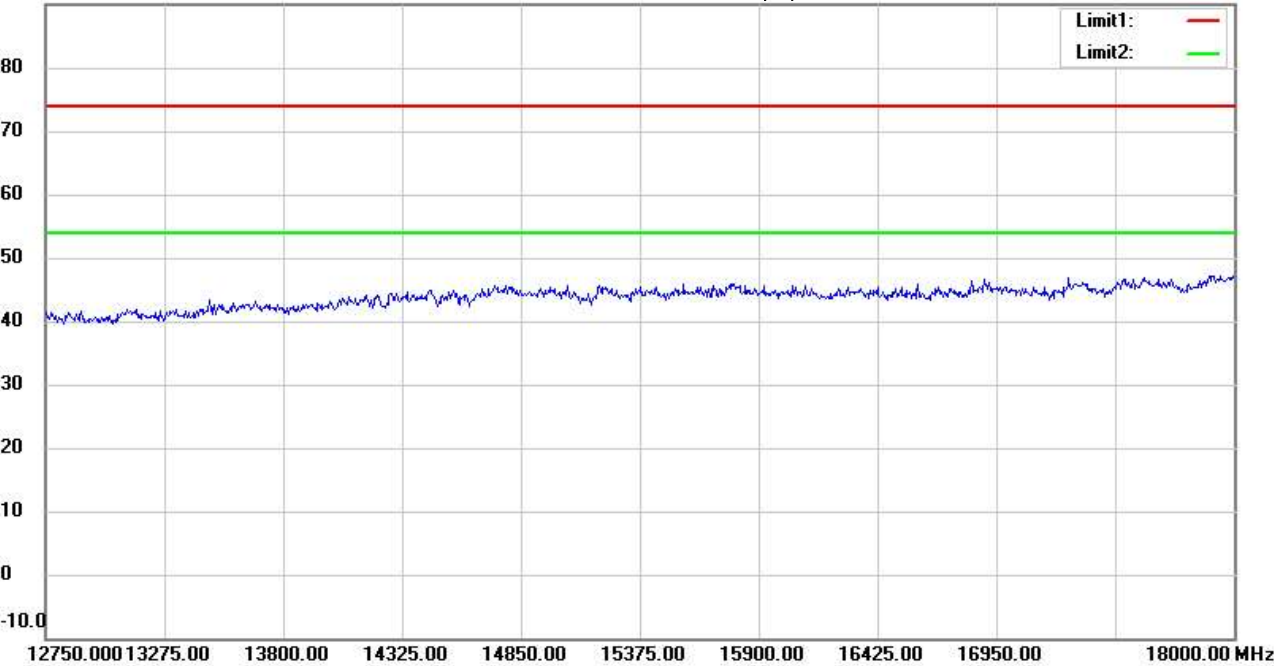
Site : 966A Chamber  
Condition : FCC\_part 15E RE\_Above 1GHz\_PK  
EUT : W6M22409-23739  
M/N:  
Test Mode : TX 802.11a CH1  
Note :

Polarization: Vertical  
Power : 120 Va.c.  
Distance: 3m

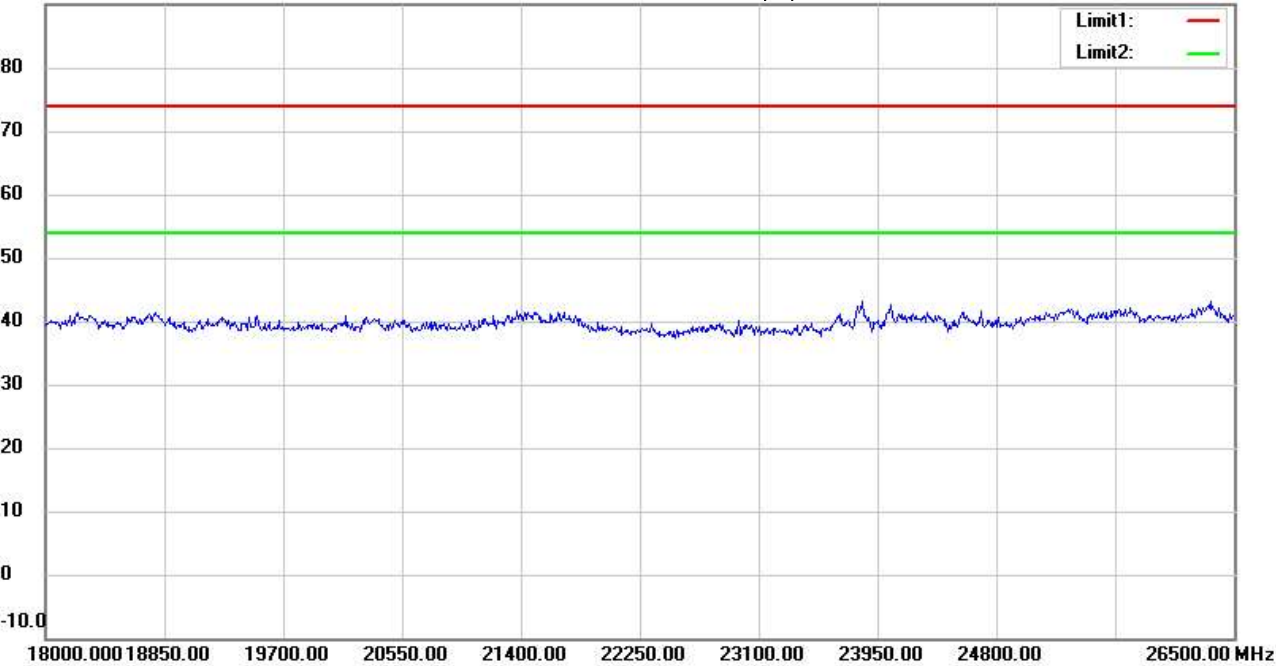
Site : 966A Chamber  
Condition : FCC\_part 15E RE\_Above 1GHz\_PK  
EUT : W6M22409-23739  
M/N:  
Test Mode : TX 802.11a CH1  
Note :

Polarization: Vertical  
Power : 120 Va.c.  
Distance: 3m

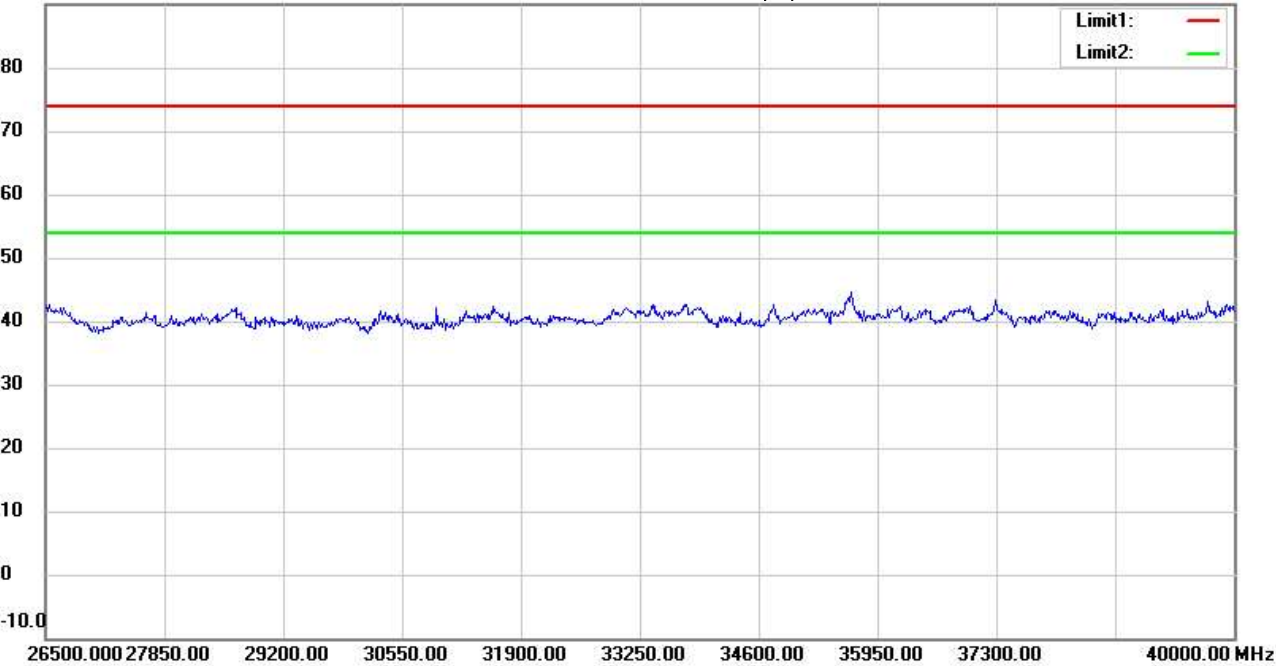
Site : 966A Chamber  
Condition : FCC\_part 15E RE\_Above 1GHz\_PK  
EUT : W6M22409-23739  
M/N:  
Test Mode : TX 802.11a CH1  
Note :

Polarization: Horizontal  
Power : 120 Va.c.  
Distance: 3m
