Radiated Emission Measurement

Condition : FCC\_part 15E RE\_Above 1GHz\_PK

EUT : W6M22409-23739

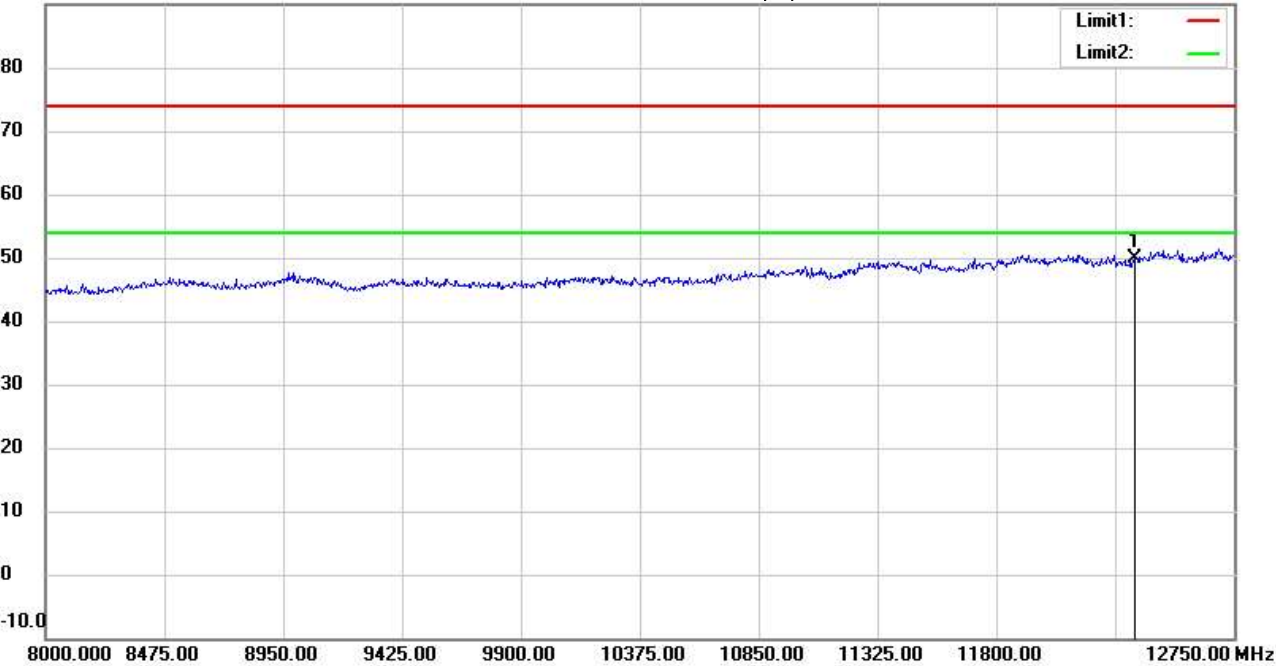
Data :#3

Condition : FCC\_part 15E RE\_Above 1GHz\_PK

Test Mode : TX 802.11a CH45

Polarization: **Horizontal**

| Mk. | Frequency (MHz) | Reading (dBuV) | Detector | Corr. factor (dB/m) | Result (dBuV/m) | Limit (dBuV/m) | Ant.Pos (cm) | Tab.Pos (deg.) | Margin (dB) | Comment |
|---|---|---|---|---|---|---|---|---|---|---|
| * | 12350.000 | 33.41 | peak | 16.43 | 49.84 | 74.00 | 150 | 89 | -24.16 | |

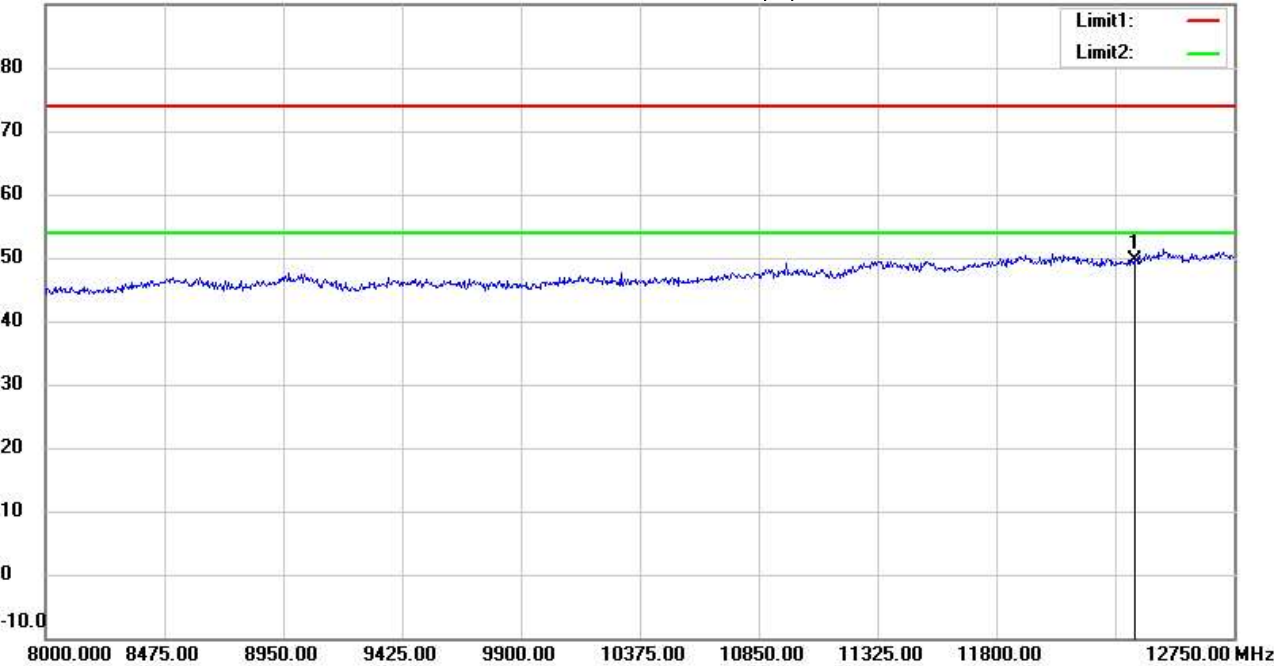
Data :#9

Site : 966A Chamber  
Condition : FCC\_part 15E RE\_Above 1GHz\_PK  
EUT : W6M22409-23739  
M/N:  
Test Mode : TX 802.11a CH45  
Note :

Polarization: Vertical  
Power : 120 Va.c.  
Distance: 3m

| Mk. | Frequency (MHz) | Reading (dBuV) | Detector | Corr. factor (dB/m) | Result (dBuV/m) | Limit (dBuV/m) | Ant.Pos (cm) | Tab.Pos (deg.) | Margin (dB) | Comment |
|---|---|---|---|---|---|---|---|---|---|---|
| * | 12350.000 | 33.21 | peak | 16.43 | 49.64 | 74.00 | 150 | 339 | -24.36 | |

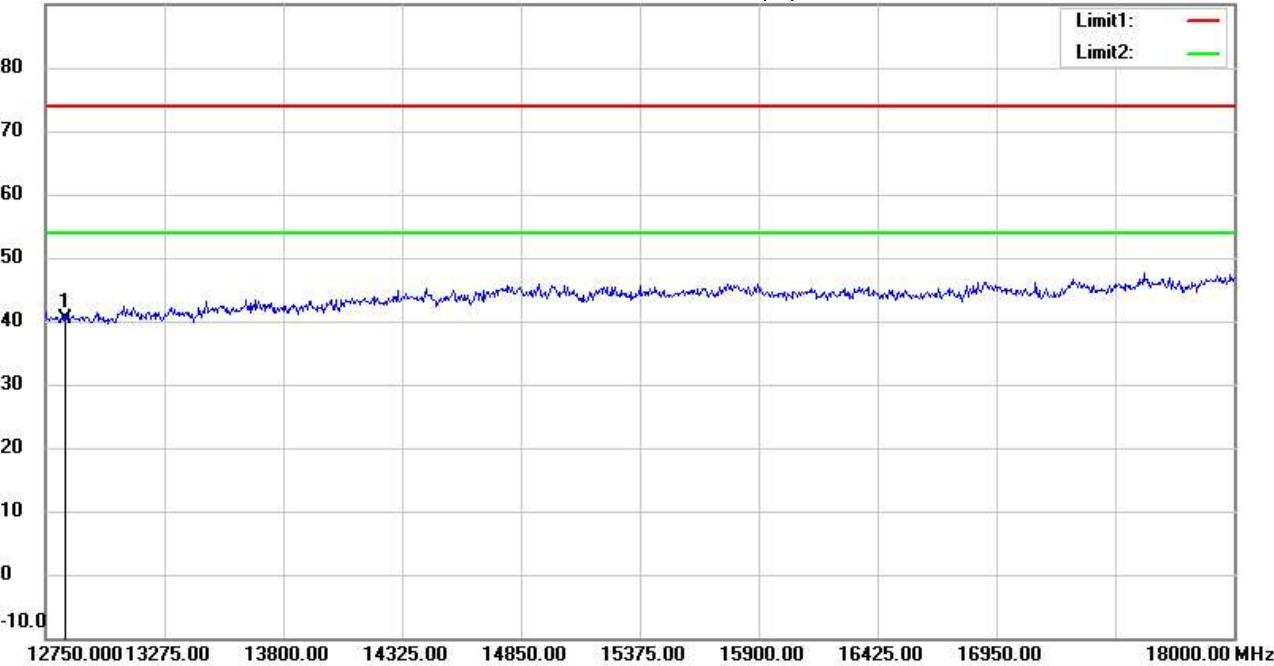
Data :#4

Condition : FCC\_part 15E RE\_Above 1GHz\_PK

Test Mode : TX 802.11a CH93

Polarization: *Horizontal*

| Mk. | Frequency (MHz) | Reading (dBuV) | Detector | Corr. factor (dB/m) | Result (dBuV/m) | Limit (dBuV/m) | Ant.Pos (cm) | Tab.Pos (deg.) | Margin (dB) | Comment |
|---|---|---|---|---|---|---|---|---|---|---|
| * | 12830.000 | 23.25 | peak | 17.09 | 40.34 | 74.00 | 150 | 0 | -33.66 | |

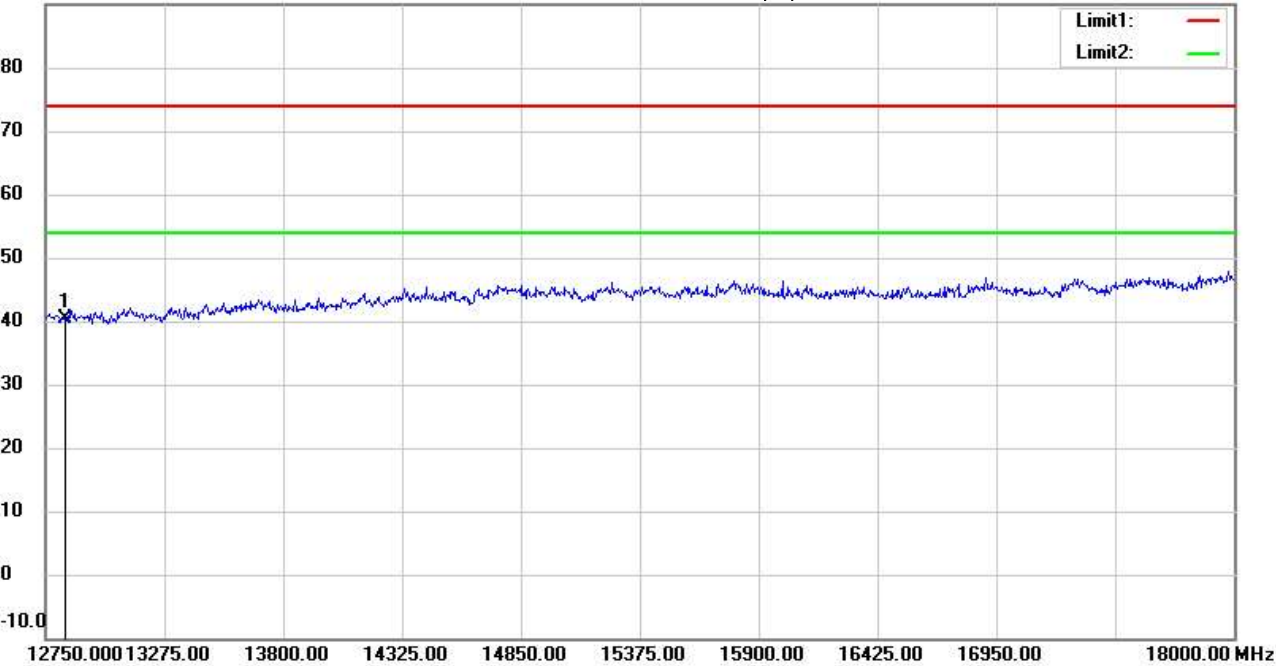
Data :#10

Site : 966A Chamber  
Condition : FCC\_part 15E RE\_Above 1GHz\_PK  
EUT : W6M22409-23739  
M/N:  
Test Mode : TX 802.11a CH93  
Note :

Polarization: Vertical  
Power : 120 Va.c.  
Distance: 3m

| Mk. | Frequency (MHz) | Reading (dBuV) | Detector | Corr. factor (dB/m) | Result (dBuV/m) | Limit (dBuV/m) | Ant.Pos (cm) | Tab.Pos (deg.) | Margin (dB) | Comment |
|---|---|---|---|---|---|---|---|---|---|---|
| * | 12830.000 | 23.34 | peak | 17.09 | 40.43 | 74.00 | 150 | 359 | -33.57 | |

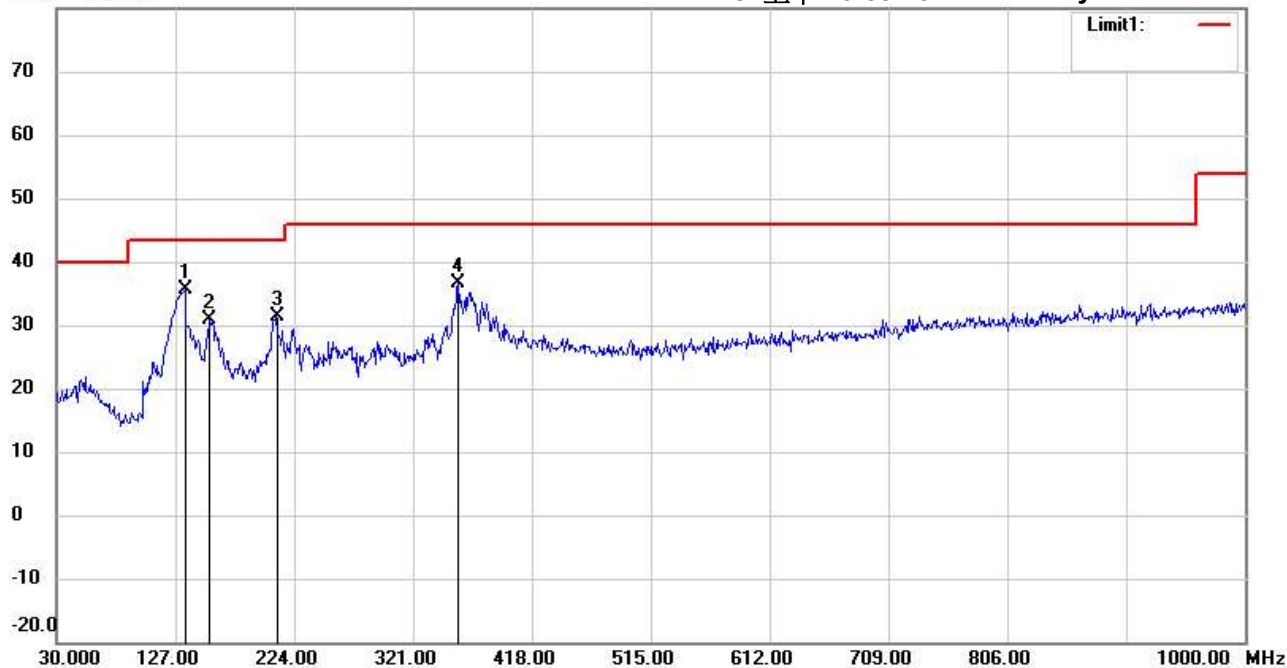
Data : #1

Condition : FCC\_part 15 RE-Class C\_30-1000MHz

Test Mode : TX 802.11a CH1

Polarization: Horizontal

| Mk. | Frequency (MHz) | Reading (dBuV) | Detector | Corr. factor (dB/m) | Result (dBuV/m) | Limit (dBuV/m) | Ant.Pos (cm) | Tab.Pos (deg.) | Margin (dB) | Comment |
|---|---|---|---|---|---|---|---|---|---|---|
| * | 134.7600 | 48.91 | peak | -13.33 | 35.58 | 43.50 | 100 | 75 | -7.92 | |
| | 155.1300 | 43.02 | peak | -12.19 | 30.83 | 43.50 | 100 | 68 | -12.67 | |
| | 209.9350 | 47.21 | peak | -15.93 | 31.28 | 43.50 | 100 | 108 | -12.22 | |
| | 357.8600 | 47.59 | peak | -10.93 | 36.66 | 46.00 | 100 | 248 | -9.34 | |

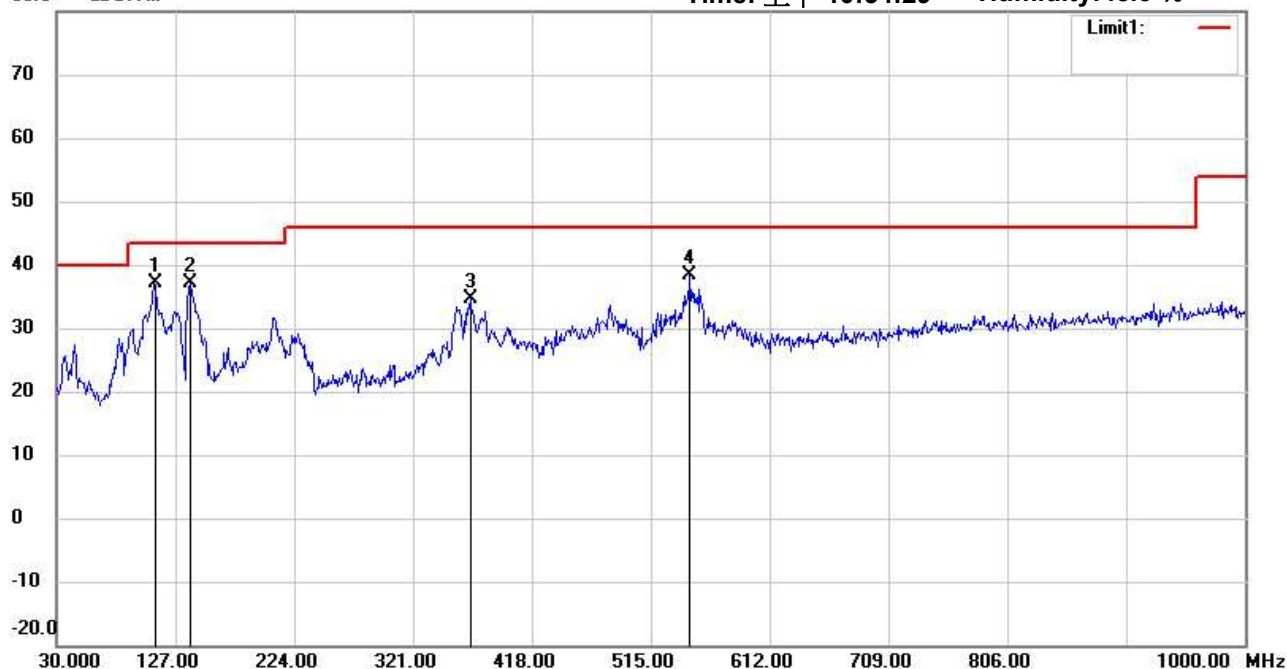
Data: #2

Condition: FCC\_part 15 RE-Class C\_30-1000MHz

Test Mode: TX 802.11a CH1

Polarization: Vertical

| Mk. | Frequency (MHz) | Reading (dBuV) | Detector | Corr. factor (dB/m) | Result (dBuV/m) | Limit (dBuV/m) | Ant.Pos (cm) | Tab.Pos (deg.) | Margin (dB) | Comment |
|---|---|---|---|---|---|---|---|---|---|---|
| | 110.0250 | 52.62 | peak | -15.61 | 37.01 | 43.50 | 100 | 85 | -6.49 | |
| * | 138.6400 | 49.99 | peak | -12.97 | 37.02 | 43.50 | 100 | 297 | -6.48 | |
| | 367.5600 | 45.12 | peak | -10.59 | 34.53 | 46.00 | 100 | 178 | -11.47 | |
| | 547.0100 | 44.92 | peak | -6.66 | 38.26 | 46.00 | 100 | 178 | -7.74 | |
