Radiated Emission Measurement

Condition : FCC\_part 15E RE\_Above 1GHz\_PK

EUT : W6M22409-23739

Test Mode : TX 802.11ax20 CH93

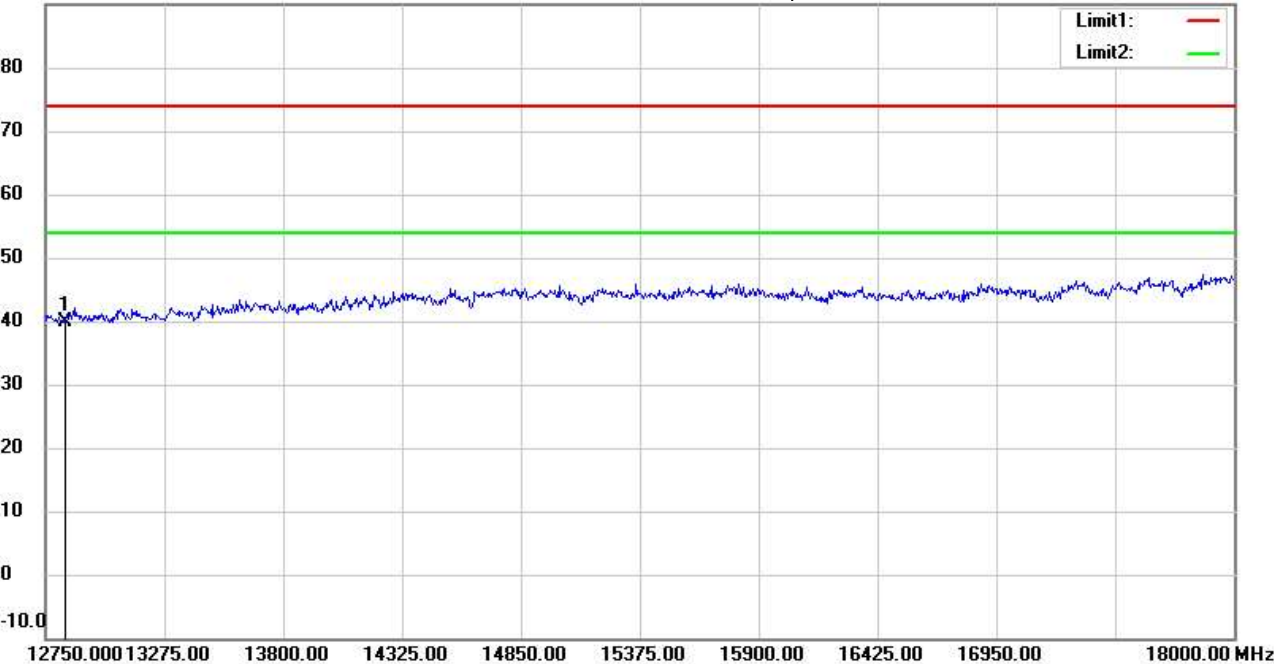
Data :#10

Polarization: Vertical

| Mk. | Frequency (MHz) | Reading (dBuV) | Detector | Corr. factor (dB/m) | Result (dBuV/m) | Limit (dBuV/m) | Ant.Pos (cm) | Tab.Pos (deg.) | Margin (dB) | Comment |
|---|---|---|---|---|---|---|---|---|---|---|
| * | 12830.000 | 22.70 | peak | 17.09 | 39.79 | 74.00 | 150 | 30 | -34.21 | |

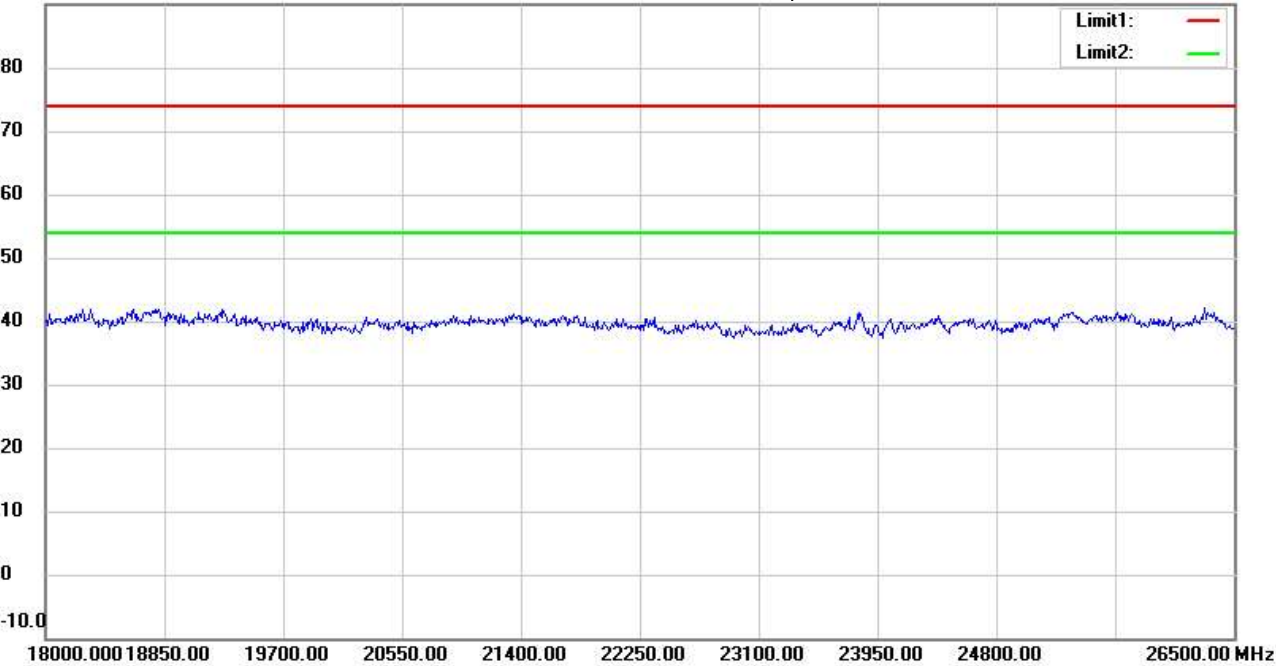
Data :#5

Condition : FCC\_part 15E RE\_Above 1GHz\_PK

Test Mode : TX 802.11ax20 CH93

Polarization: **Horizontal**

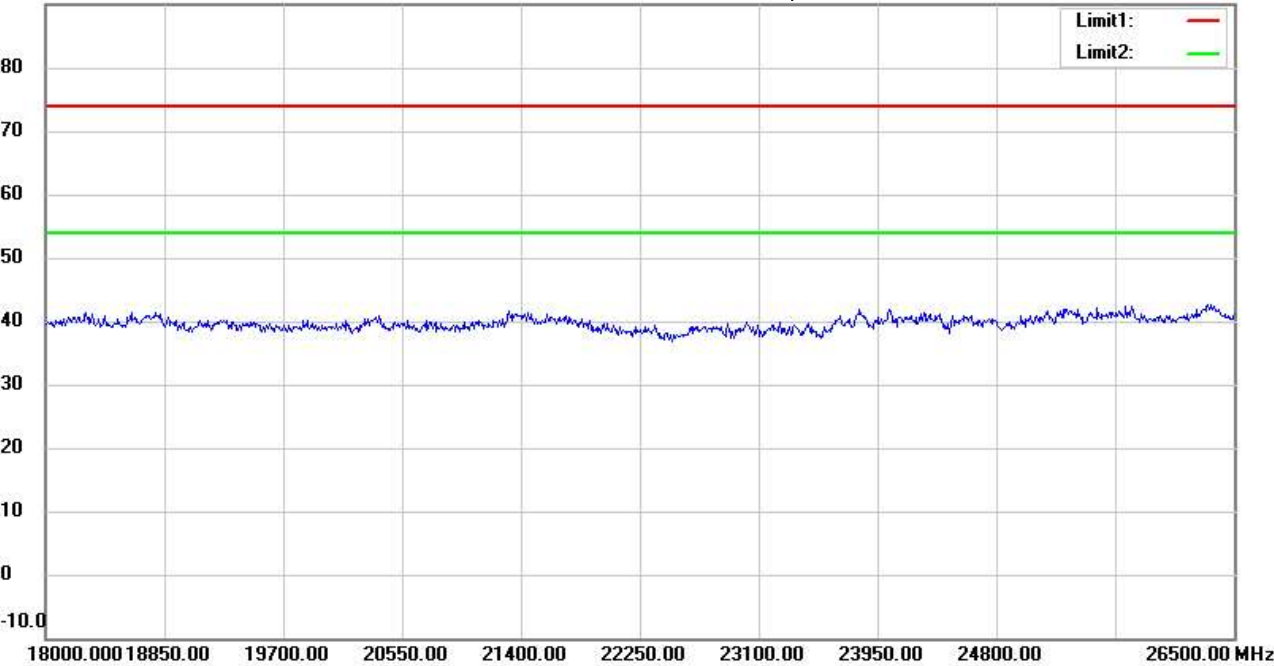
Data :#11

Condition : FCC\_part 15E RE\_Above 1GHz\_PK

Test Mode : TX 802.11ax20 CH93

Polarization: Vertical

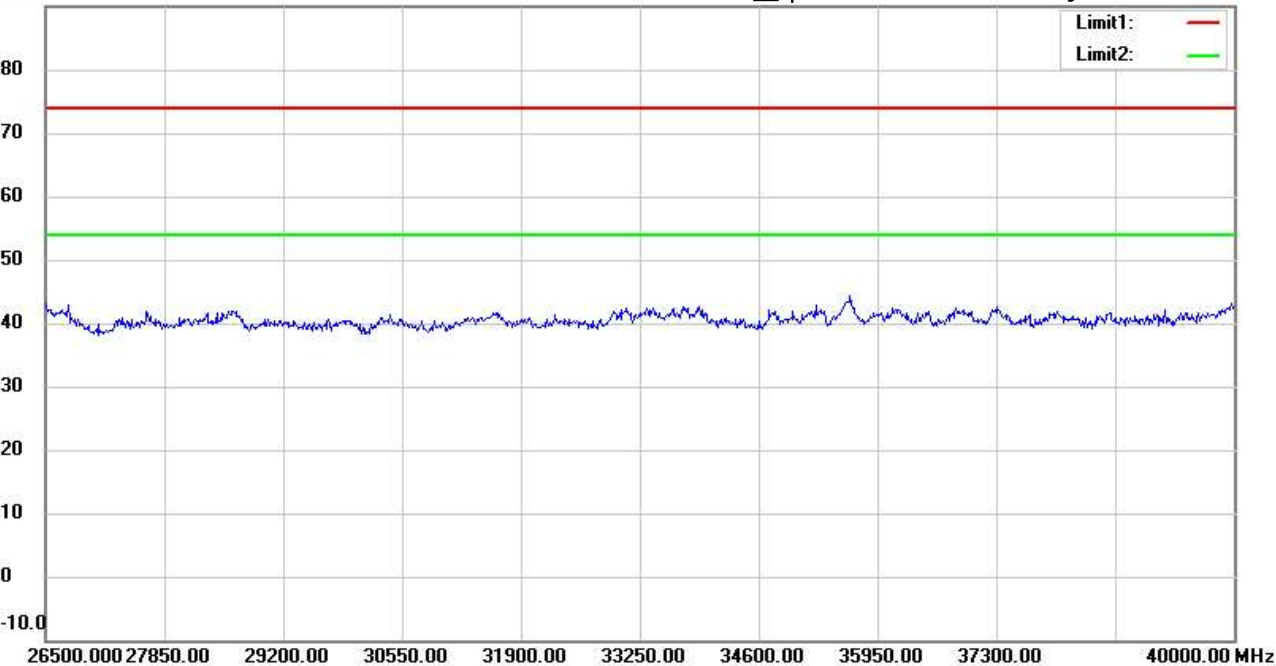
Data :#6

Condition : FCC\_part 15E RE\_Above 1GHz\_PK

Test Mode : TX 802.11ax20 CH93

Polarization: Horizontal

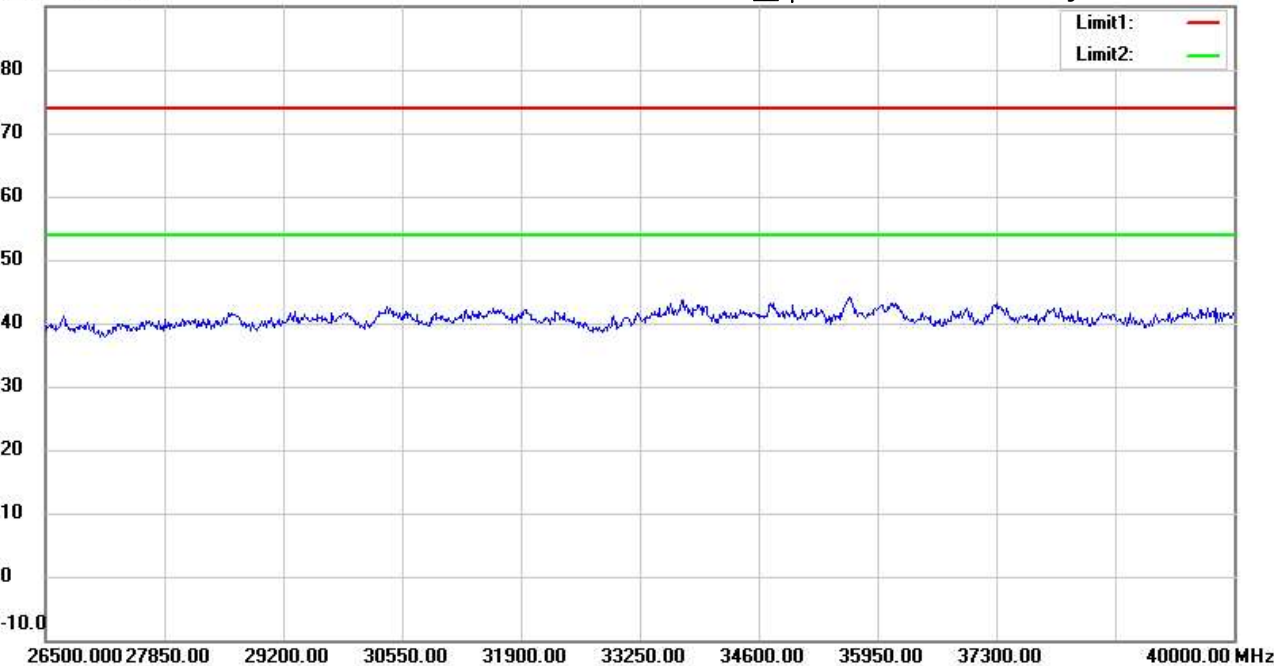
Data :#12

Condition : FCC\_part 15E RE\_Above 1GHz\_PK

Test Mode : TX 802.11ax20 CH93

Polarization: Vertical

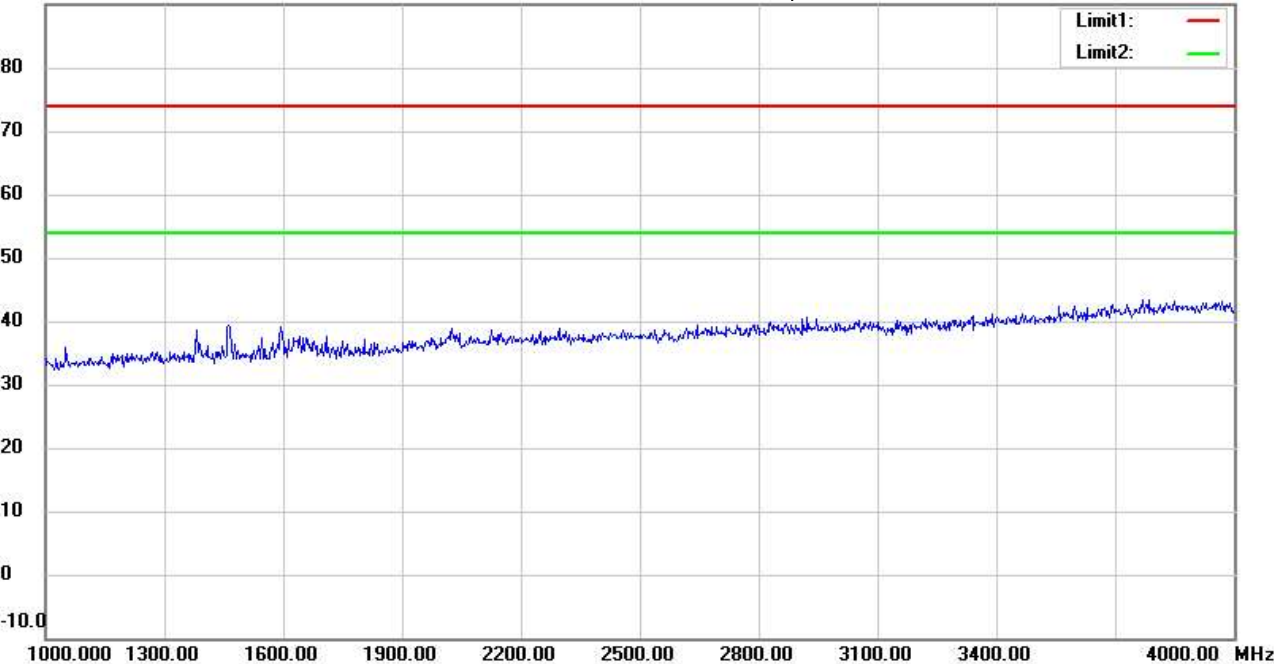
Data :#1

Condition : FCC\_part 15E RE\_Above 1GHz\_PK

Test Mode : TX 802.11ax40 CH3

Polarization: *Horizontal*

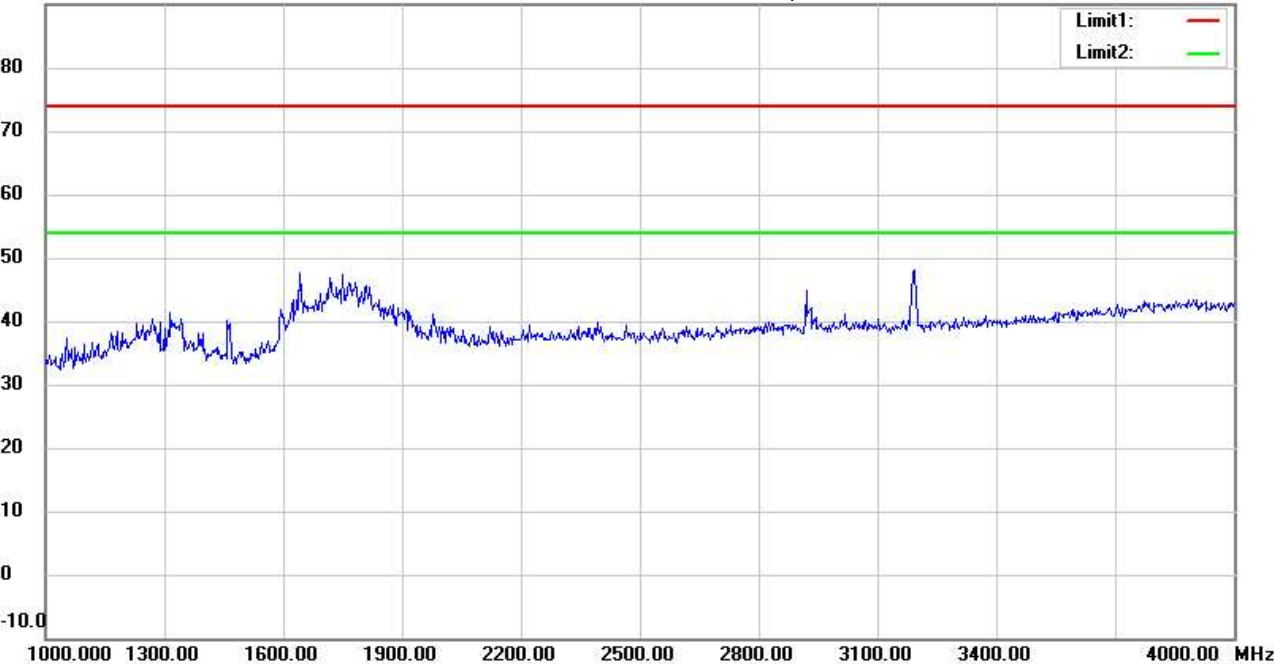
Data :#7

Condition : FCC\_part 15E RE\_Above 1GHz\_PK

Test Mode : TX 802.11ax40 CH3

Polarization: Vertical

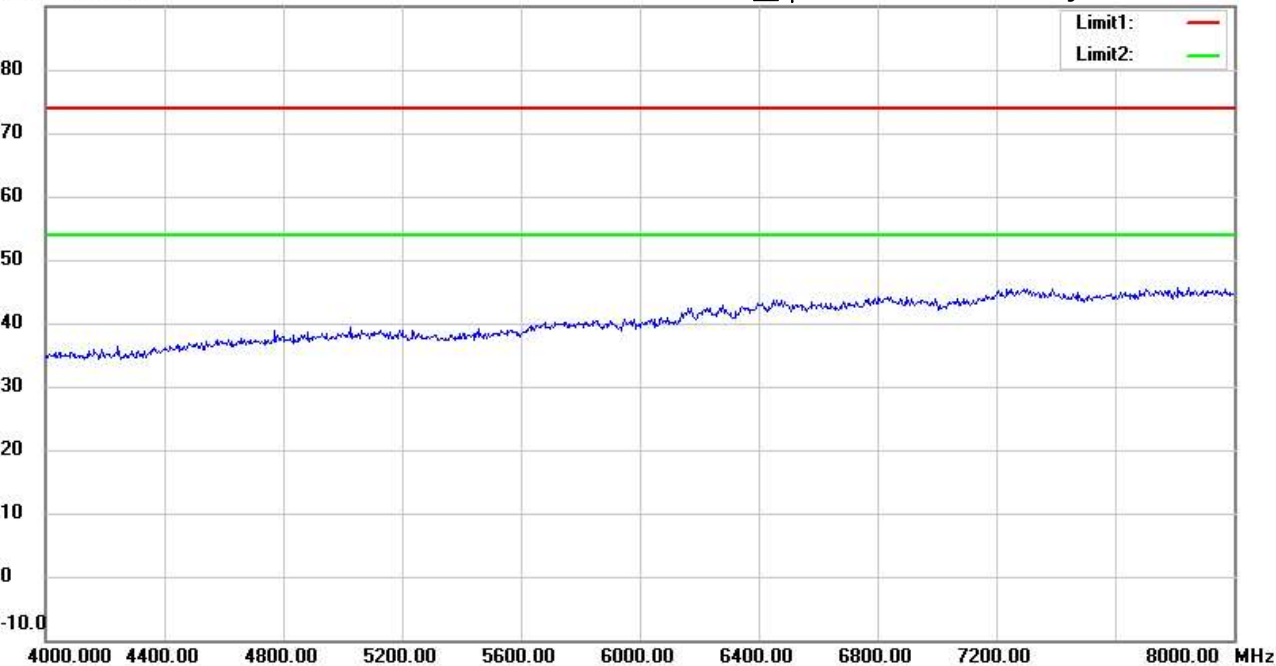
Data :#2

Condition : FCC\_part 15E RE\_Above 1GHz\_PK

Test Mode : TX 802.11ax40 CH3

Polarization: **Horizontal**

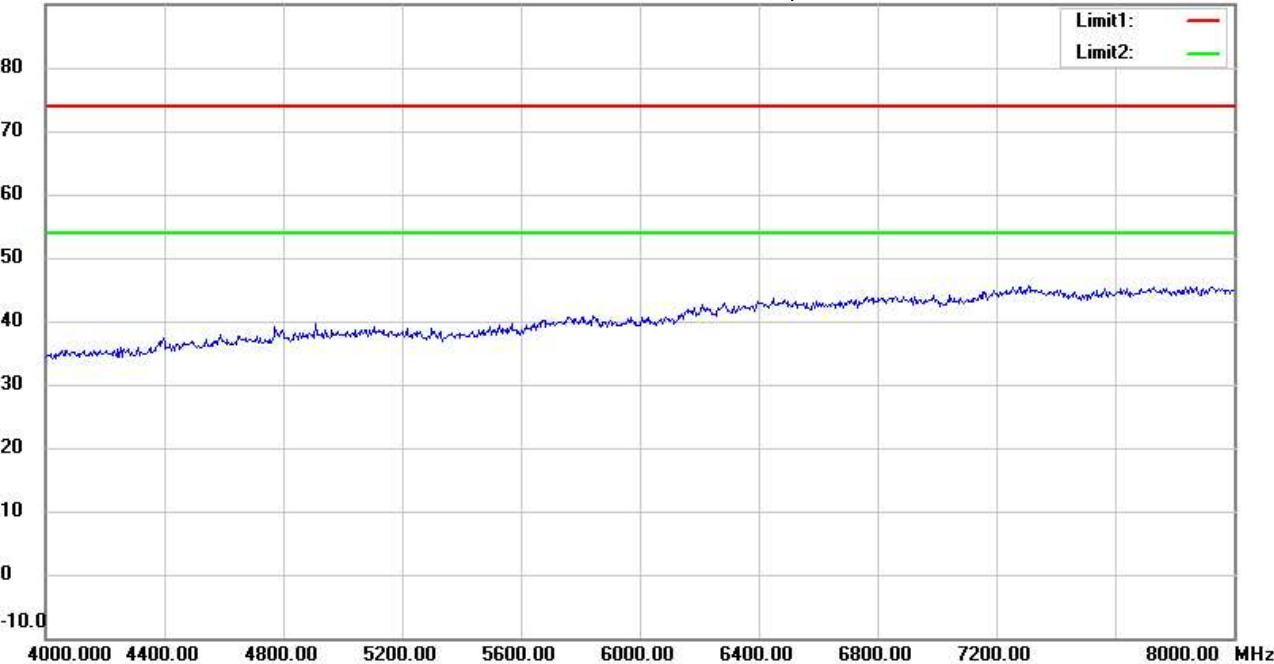
Data :#8

Condition : FCC\_part 15E RE\_Above 1GHz\_PK

Test Mode : TX 802.11ax40 CH3

Polarization: Vertical

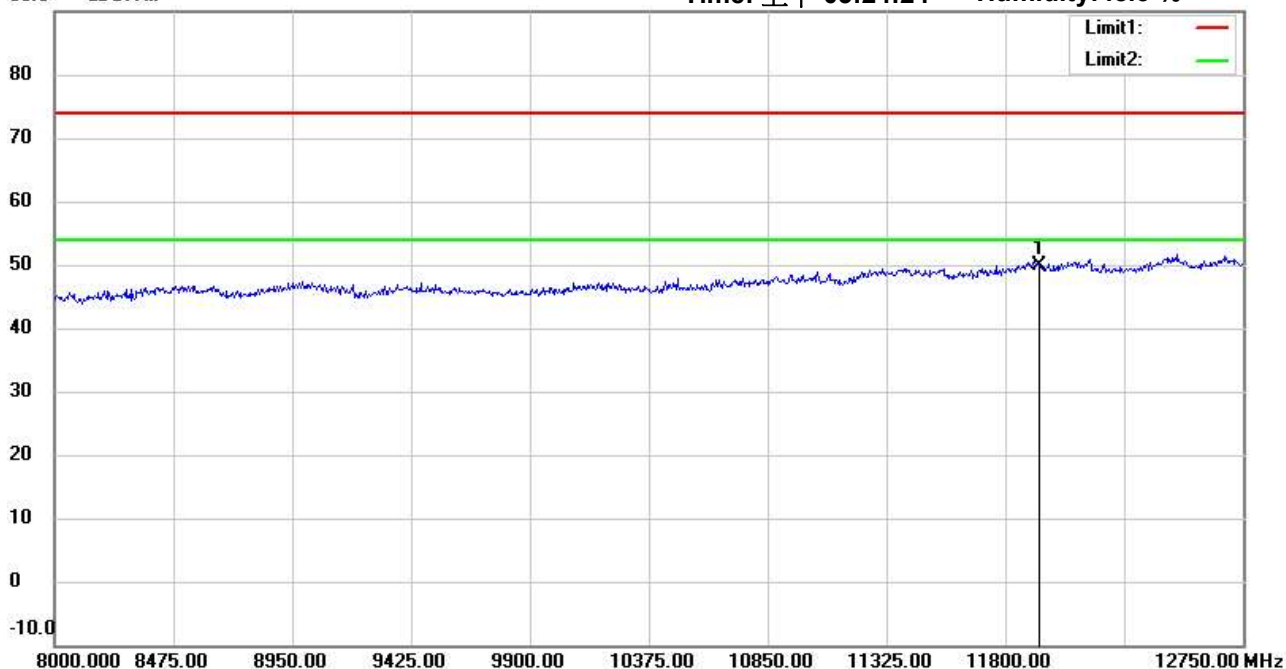
Data : #3

Condition : FCC\_part 15E RE\_Above 1GHz\_PK

Test Mode : TX 802.11ax40 CH3

Polarization: **Horizontal**

| Mk. | Frequency (MHz) | Reading (dBuV) | Detector | Corr. factor (dB/m) | Result (dBuV/m) | Limit (dBuV/m) | Ant.Pos (cm) | Tab.Pos (deg.) | Margin (dB) | Comment |
|---|---|---|---|---|---|---|---|---|---|---|
| * | 11930.000 | 33.75 | peak | 16.10 | 49.85 | 74.00 | 150 | 73 | -24.15 | |

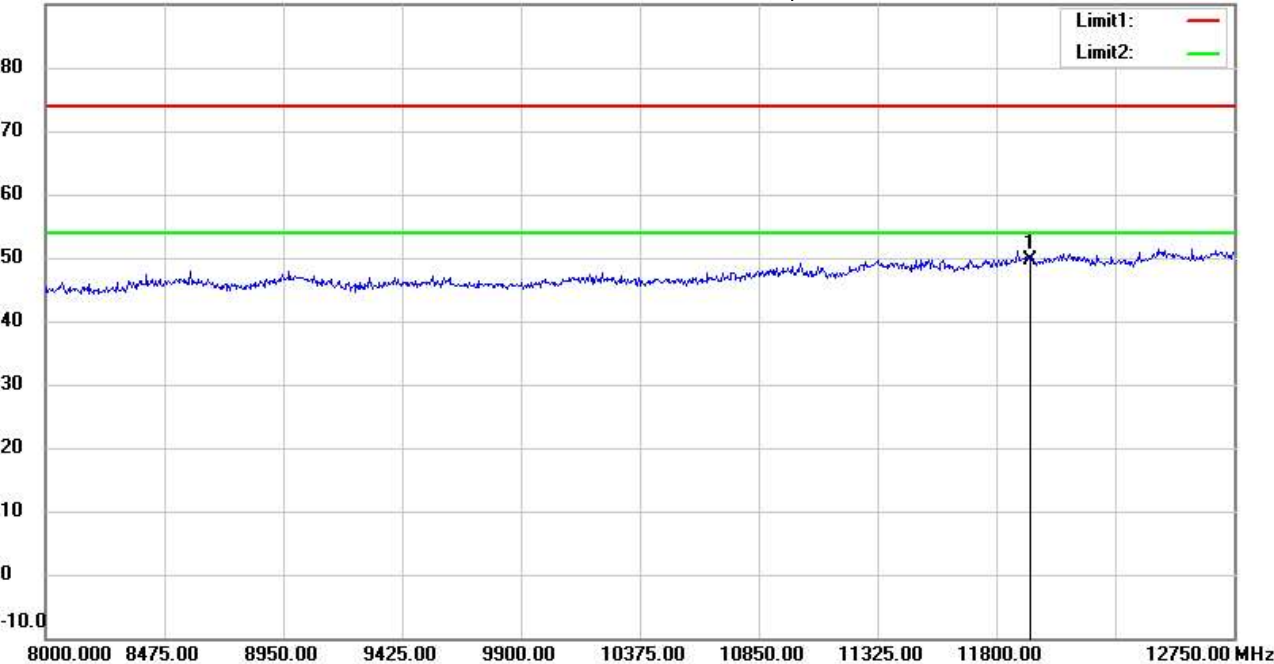
Data :#9

Condition : FCC\_part 15E RE\_Above 1GHz\_PK

Test Mode : TX 802.11ax40 CH3

Polarization: Vertical

| Mk. | Frequency (MHz) | Reading (dBuV) | Detector | Corr. factor (dB/m) | Result (dBuV/m) | Limit (dBuV/m) | Ant.Pos (cm) | Tab.Pos (deg.) | Margin (dB) | Comment |
|---|---|---|---|---|---|---|---|---|---|---|
| * | 11930.000 | 33.51 | peak | 16.10 | 49.61 | 74.00 | 150 | 254 | -24.39 | |

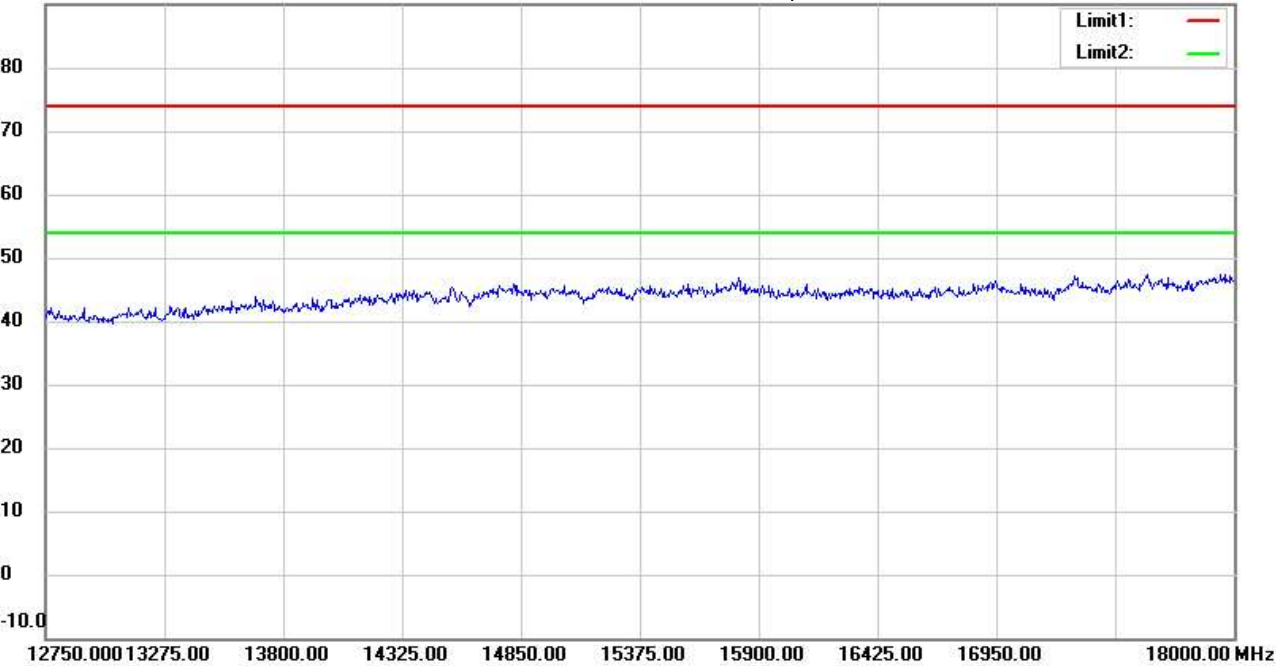
Data :#4

Condition : FCC\_part 15E RE\_Above 1GHz\_PK

Test Mode : TX 802.11ax40 CH3

Polarization: Horizontal

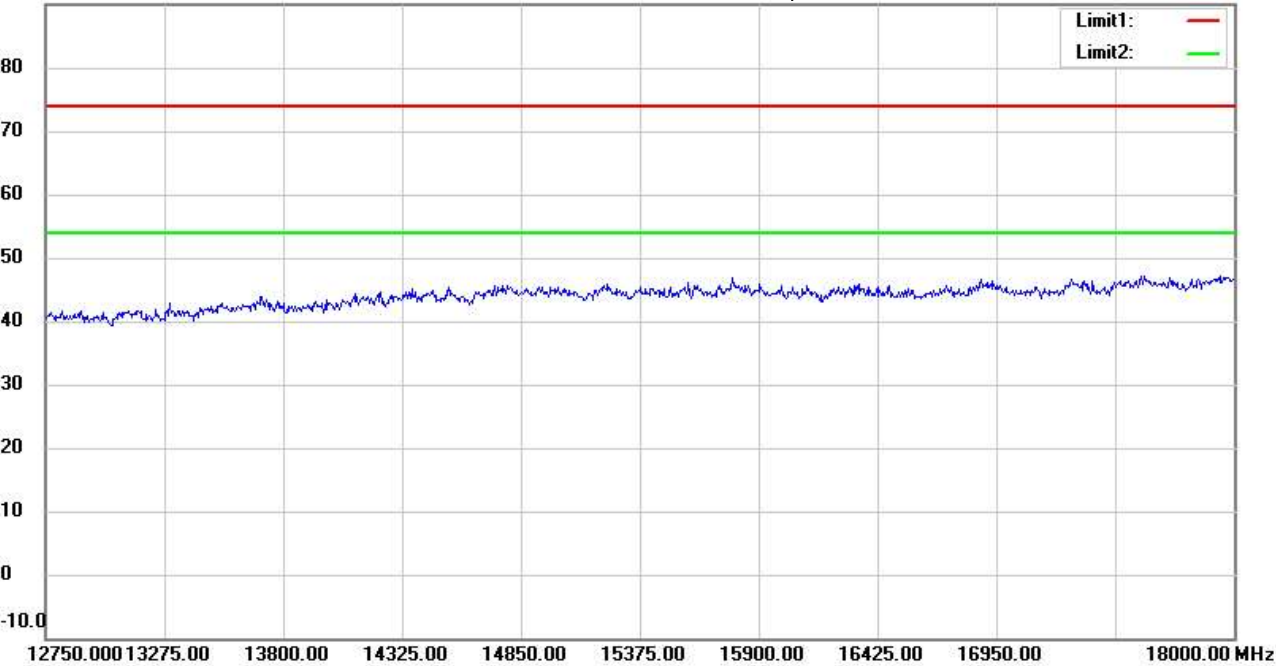
Data :#10

Condition : FCC\_part 15E RE\_Above 1GHz\_PK

Test Mode : TX 802.11ax40 CH3

Polarization: Vertical

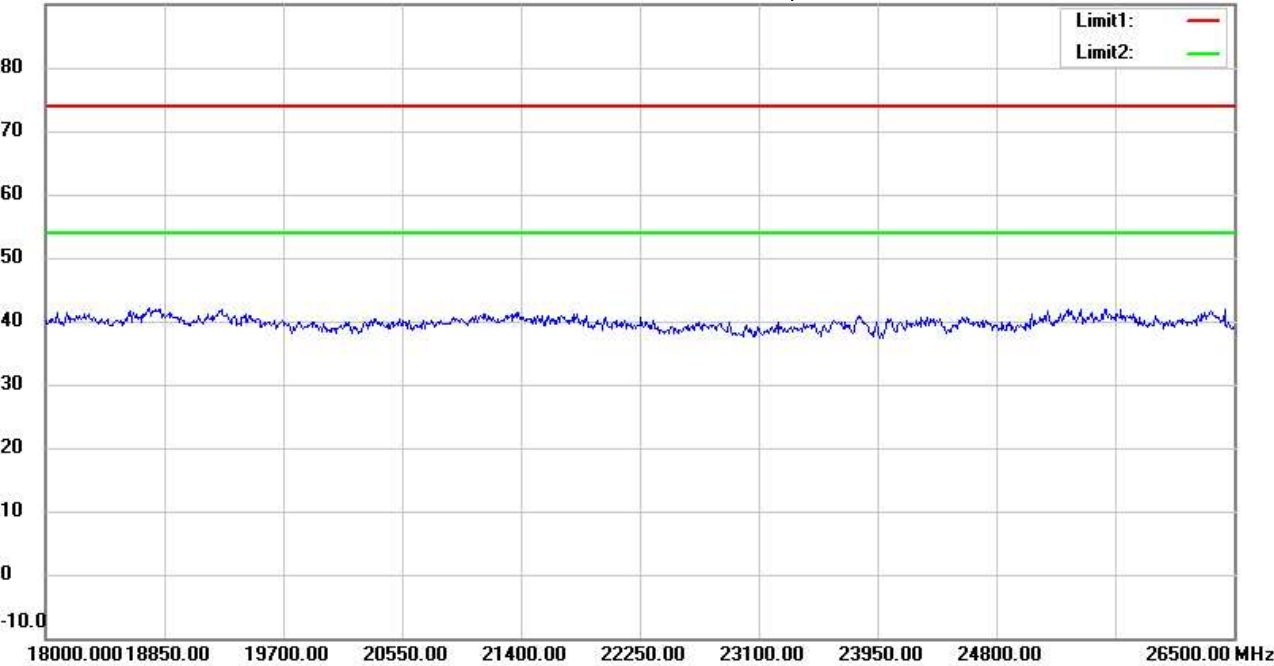
Data :#5

Condition : FCC\_part 15E RE\_Above 1GHz\_PK

Test Mode : TX 802.11ax40 CH3

Polarization: *Horizontal*

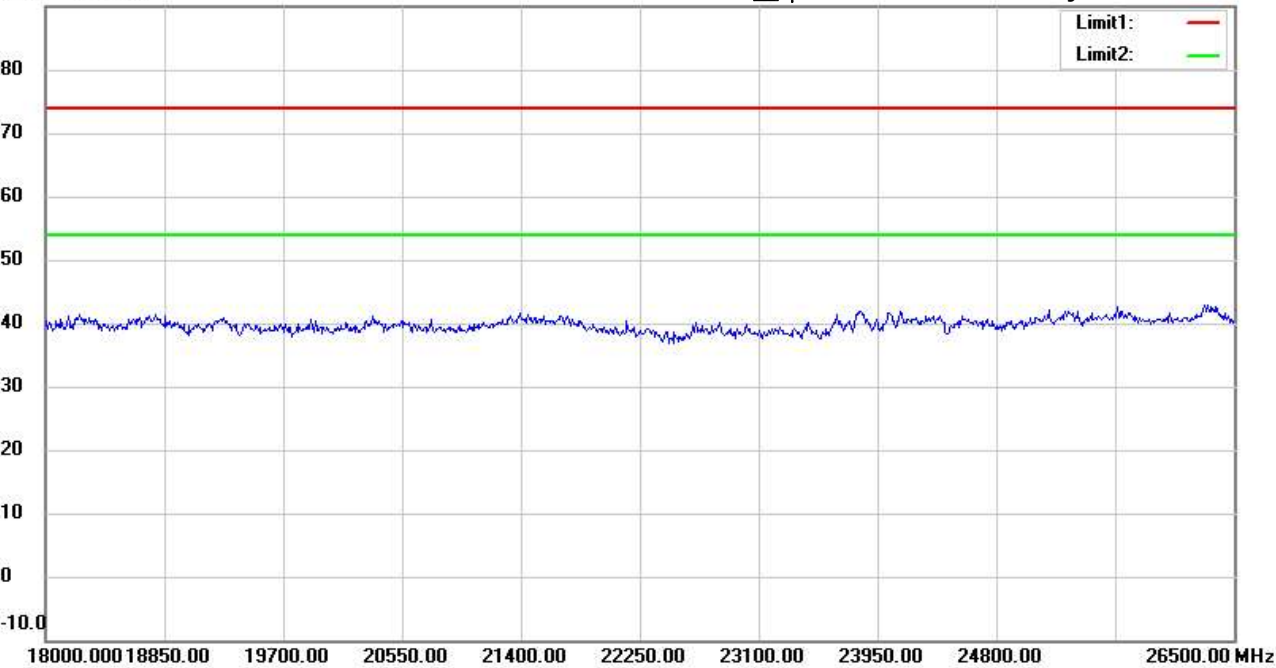
Data :#11

Condition : FCC\_part 15E RE\_Above 1GHz\_PK

Test Mode : TX 802.11ax40 CH3

Polarization: Vertical

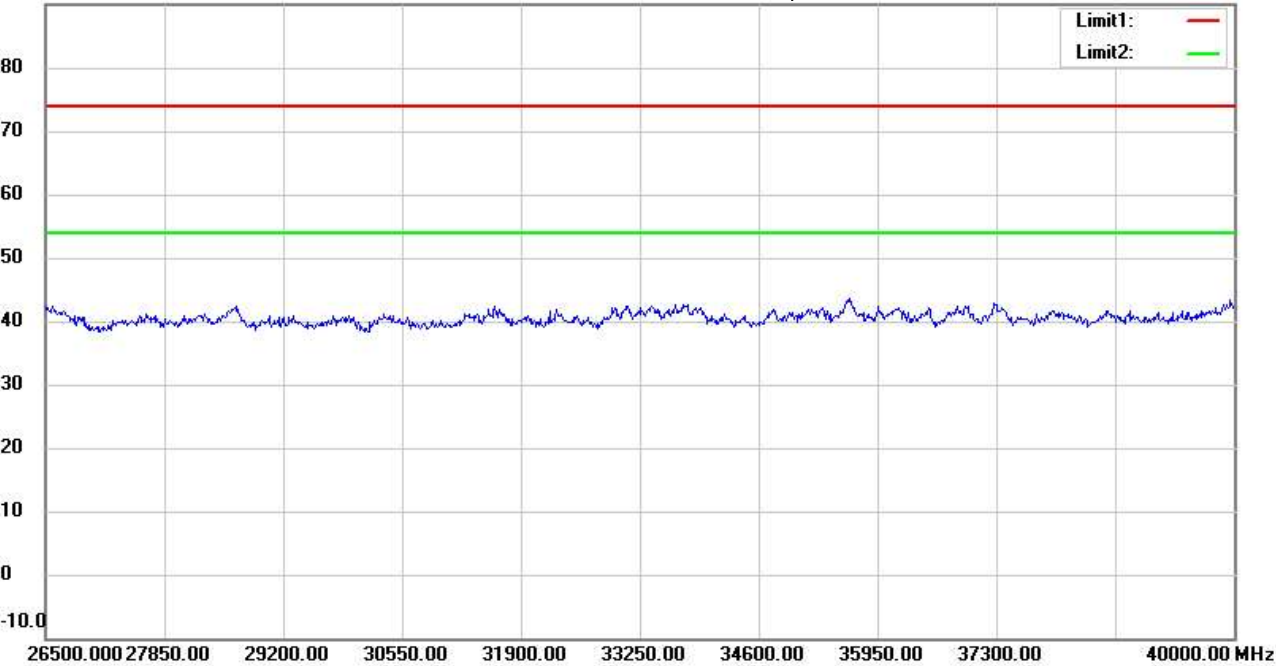
Data :#6

Condition : FCC\_part 15E RE\_Above 1GHz\_PK

Test Mode : TX 802.11ax40 CH3

Polarization: *Horizontal*

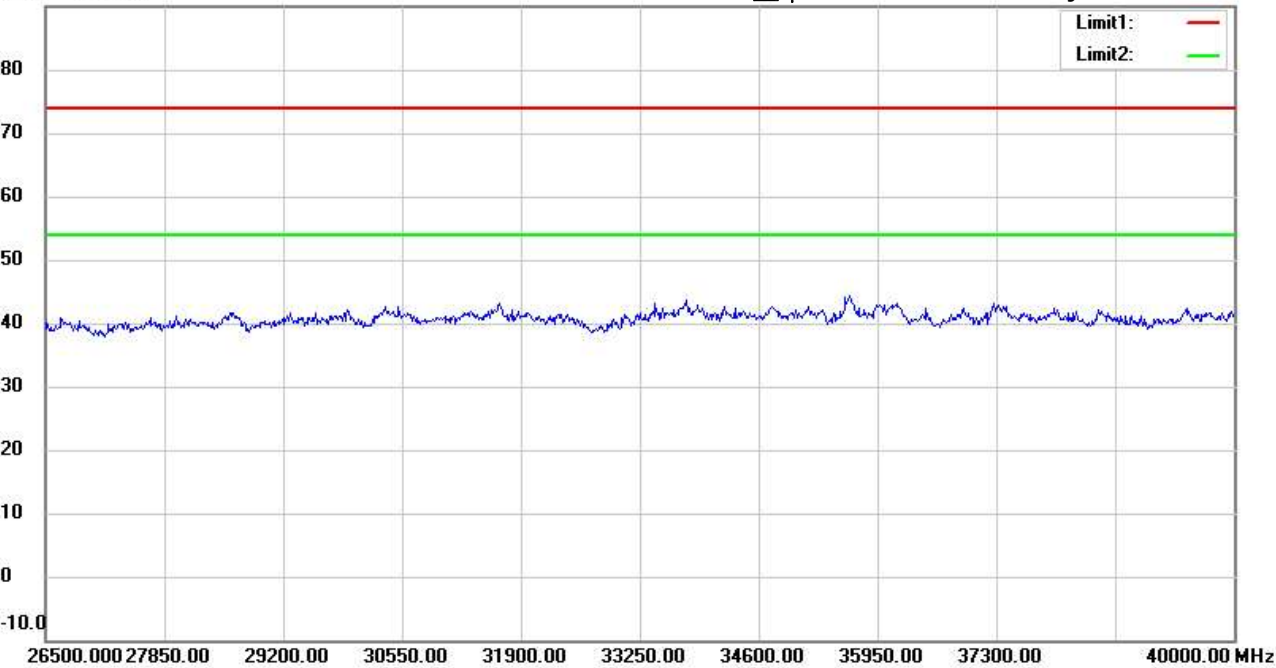
Data :#12

Condition : FCC\_part 15E RE\_Above 1GHz\_PK

Test Mode : TX 802.11ax40 CH3

Polarization: Vertical

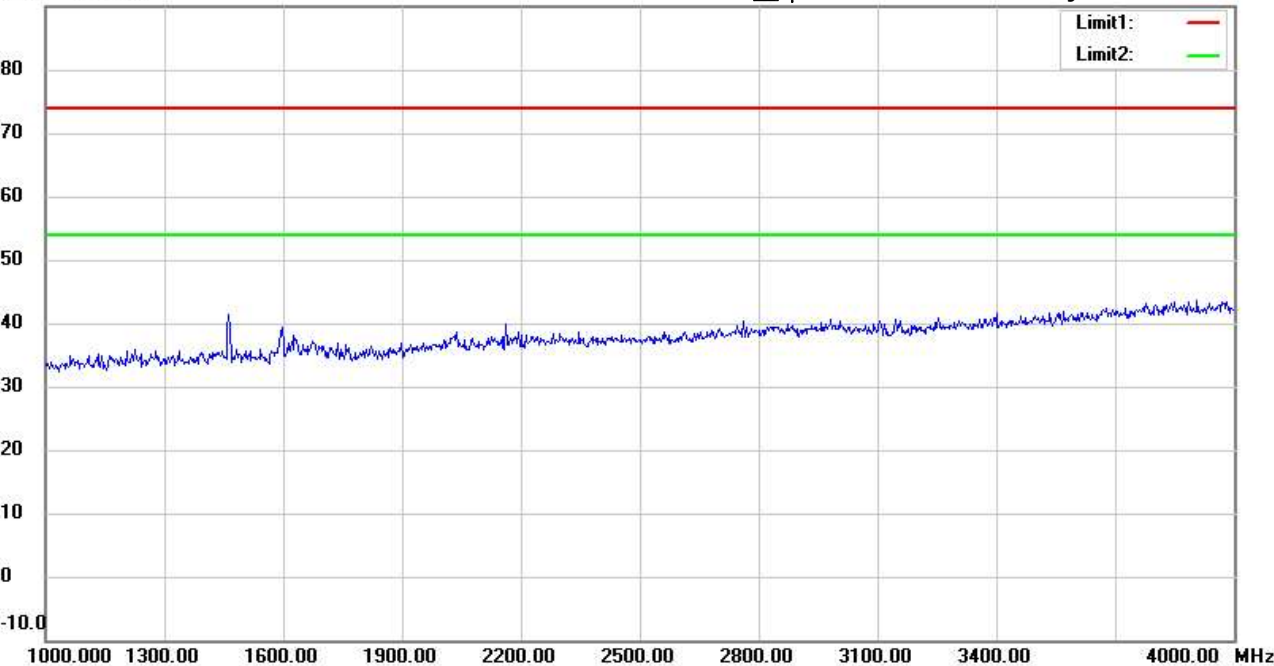
Data :#1

Condition : FCC\_part 15E RE\_Above 1GHz\_PK

Test Mode : TX 802.11ax40 CH43

Polarization: *Horizontal*

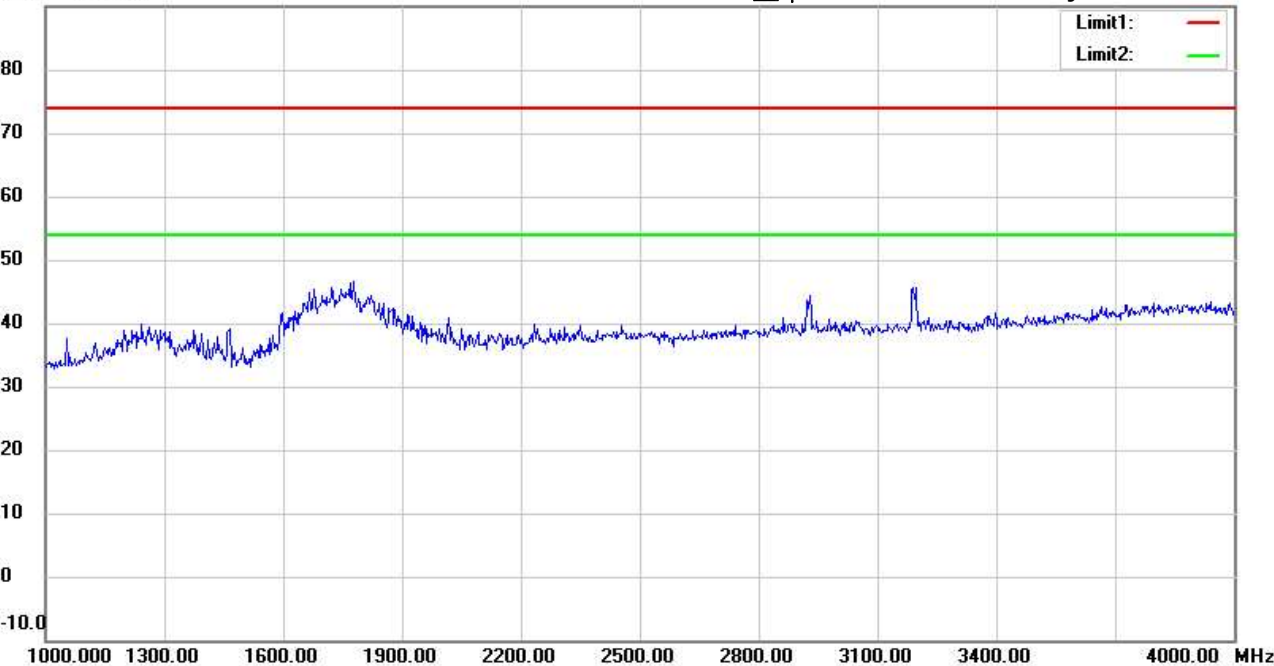
Data :#7

Condition : FCC\_part 15E RE\_Above 1GHz\_PK

Test Mode : TX 802.11ax40 CH43

Polarization: Vertical

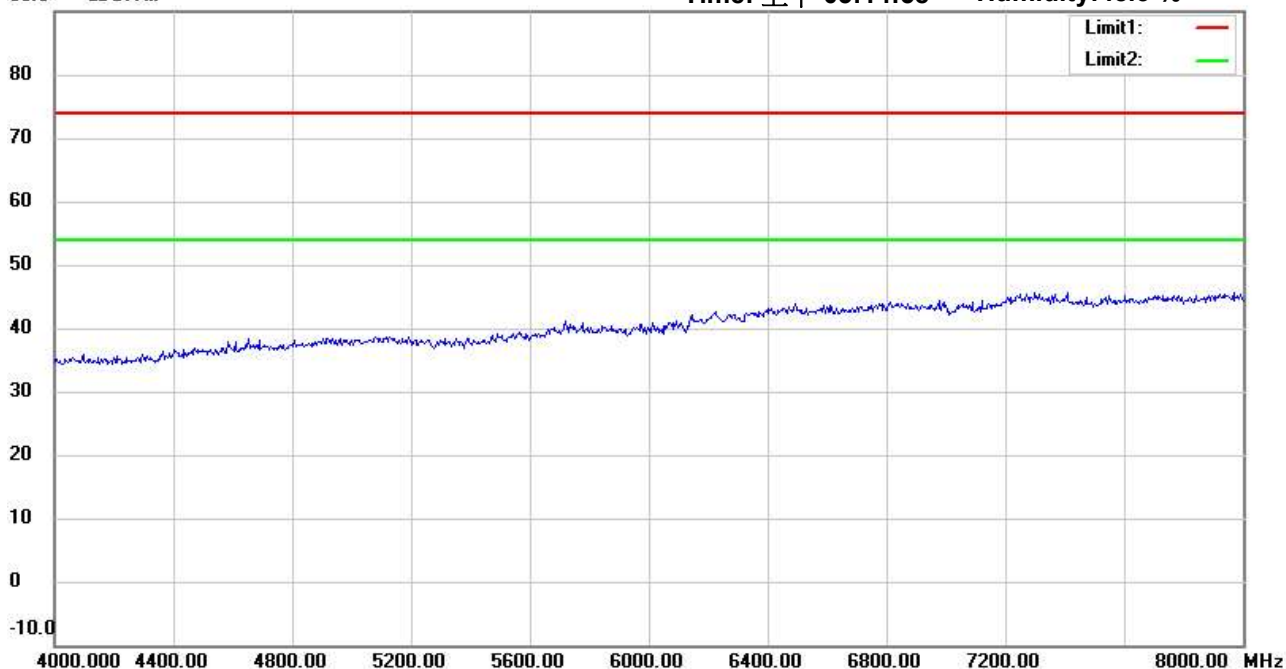
Data : #2

Condition : FCC\_part 15E RE\_Above 1GHz\_PK

Test Mode : TX 802.11ax40 CH43

Polarization: **Horizontal**

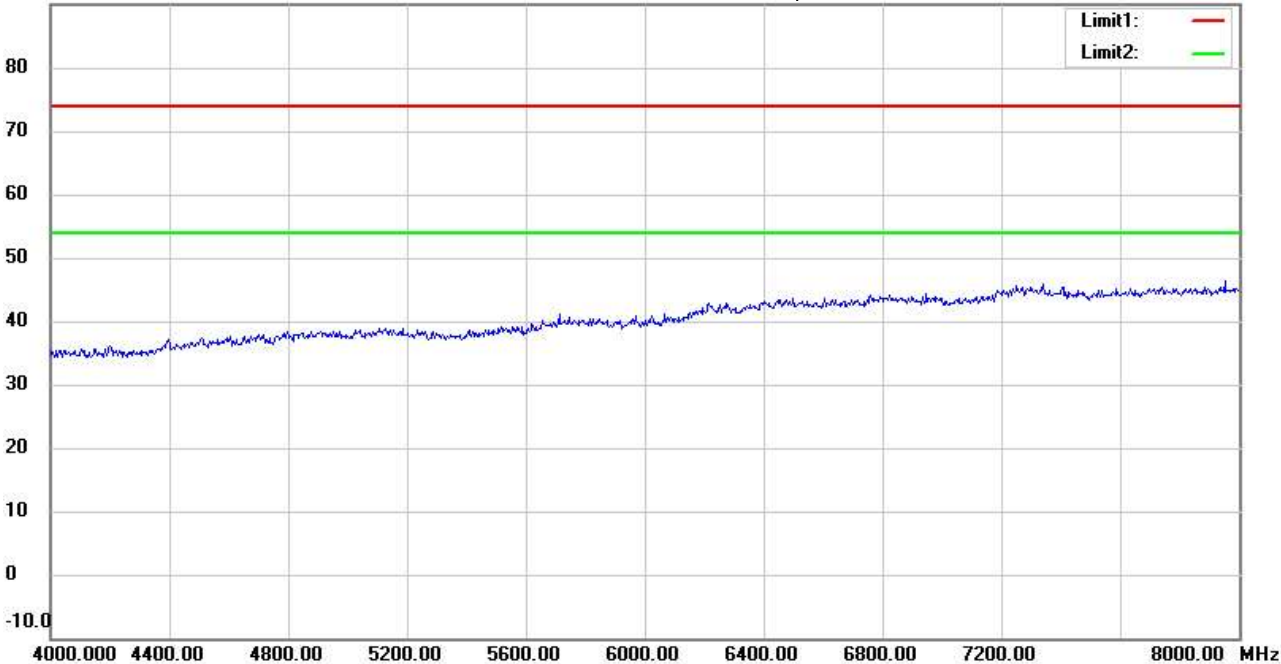
Data :#8

Condition : FCC\_part 15E RE\_Above 1GHz\_PK

Test Mode : TX 802.11ax40 CH43

Polarization: Vertical

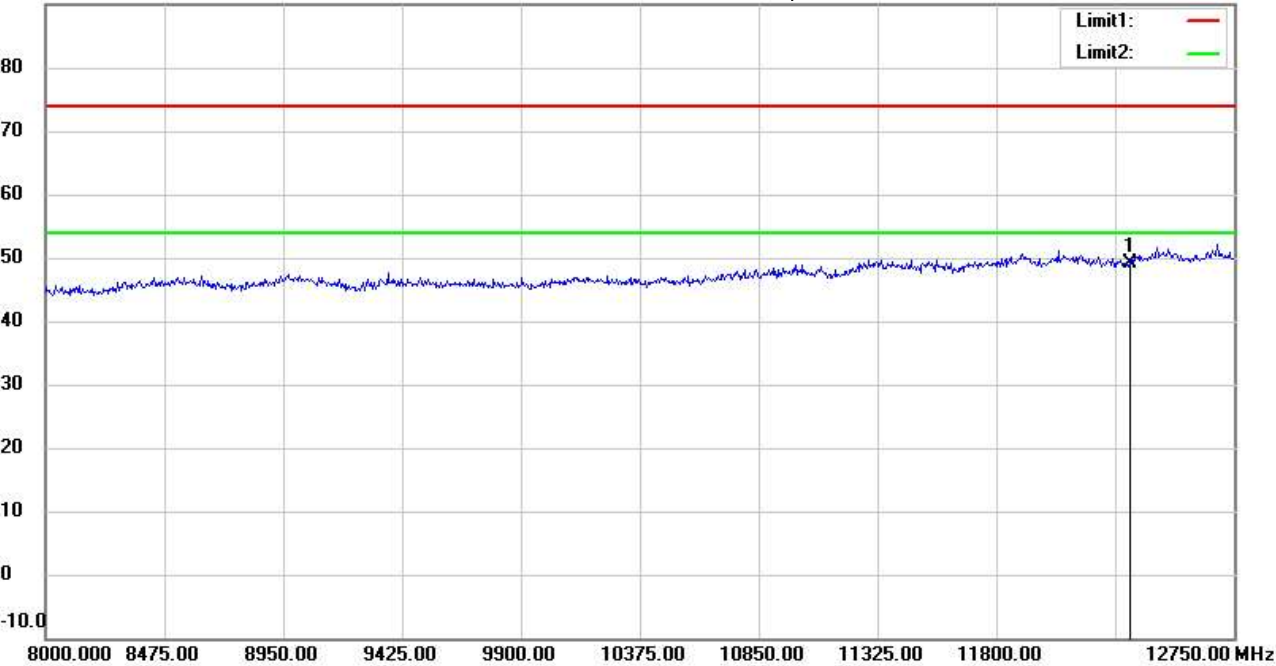
Data :#3

Condition : FCC\_part 15E RE\_Above 1GHz\_PK

Test Mode : TX 802.11ax40 CH43

Polarization: **Horizontal**

| Mk. | Frequency (MHz) | Reading (dBuV) | Detector | Corr. factor (dB/m) | Result (dBuV/m) | Limit (dBuV/m) | Ant.Pos (cm) | Tab.Pos (deg.) | Margin (dB) | Comment |
|---|---|---|---|---|---|---|---|---|---|---|
| * | 12330.000 | 32.86 | peak | 16.28 | 49.14 | 74.00 | 150 | 2 | -24.86 | |

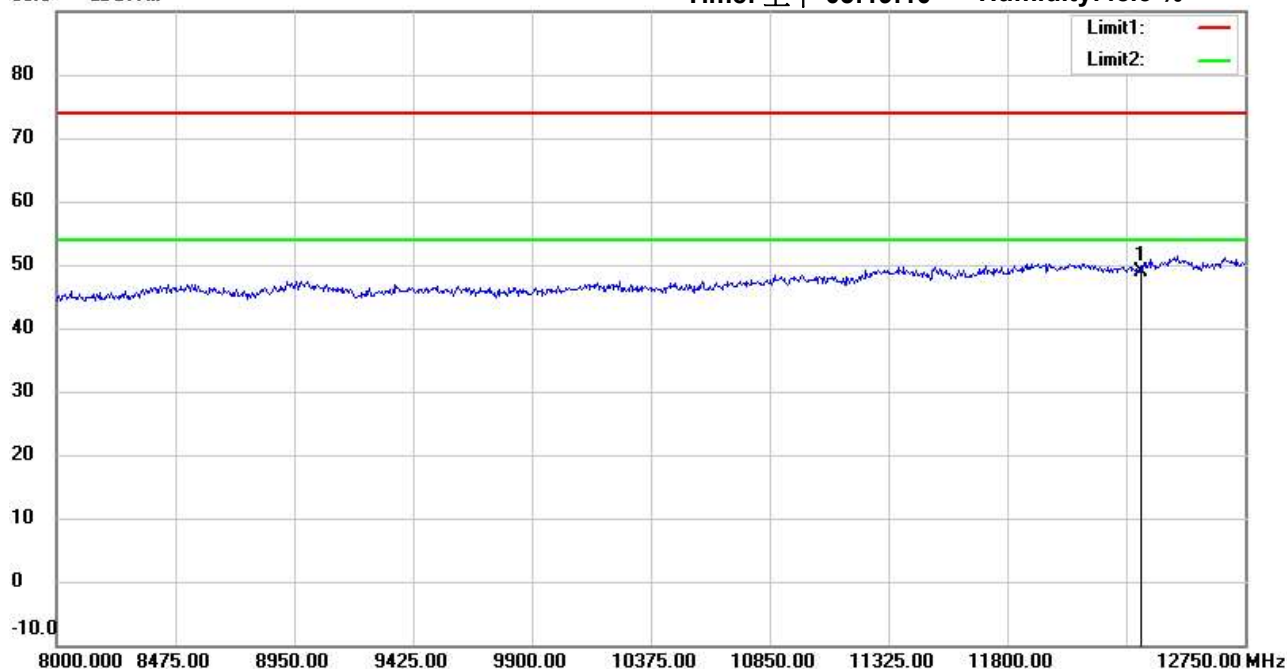
Data : #9

Condition : FCC\_part 15E RE\_Above 1GHz\_PK

Test Mode : TX 802.11ax40 CH43

Polarization: Vertical

| Mk. | Frequency (MHz) | Reading (dBuV) | Detector | Corr. factor (dB/m) | Result (dBuV/m) | Limit (dBuV/m) | Ant.Pos (cm) | Tab.Pos (deg.) | Margin (dB) | Comment |
|---|---|---|---|---|---|---|---|---|---|---|
| * | 12330.000 | 32.59 | peak | 16.28 | 48.87 | 74.00 | 150 | 285 | -25.13 | |

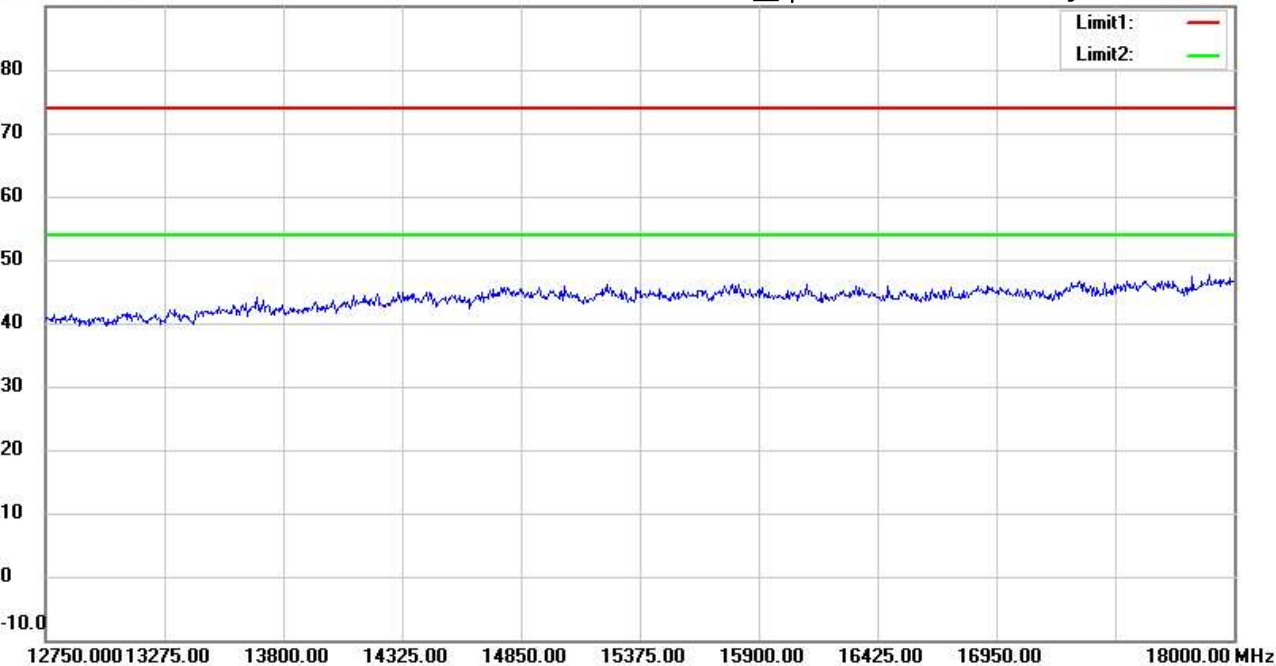
Data :#4

Condition : FCC\_part 15E RE\_Above 1GHz\_PK

Test Mode : TX 802.11ax40 CH43

Polarization: *Horizontal*

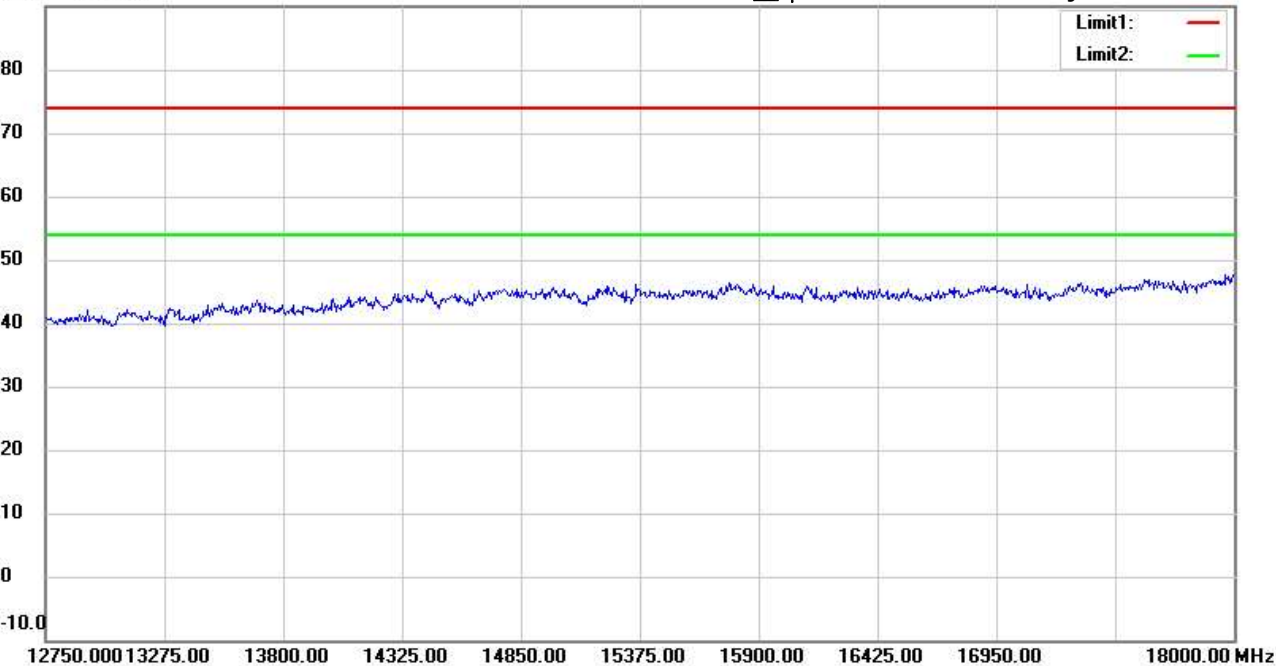
Data :#10

Condition : FCC\_part 15E RE\_Above 1GHz\_PK

Test Mode : TX 802.11ax40 CH43

Polarization: Vertical

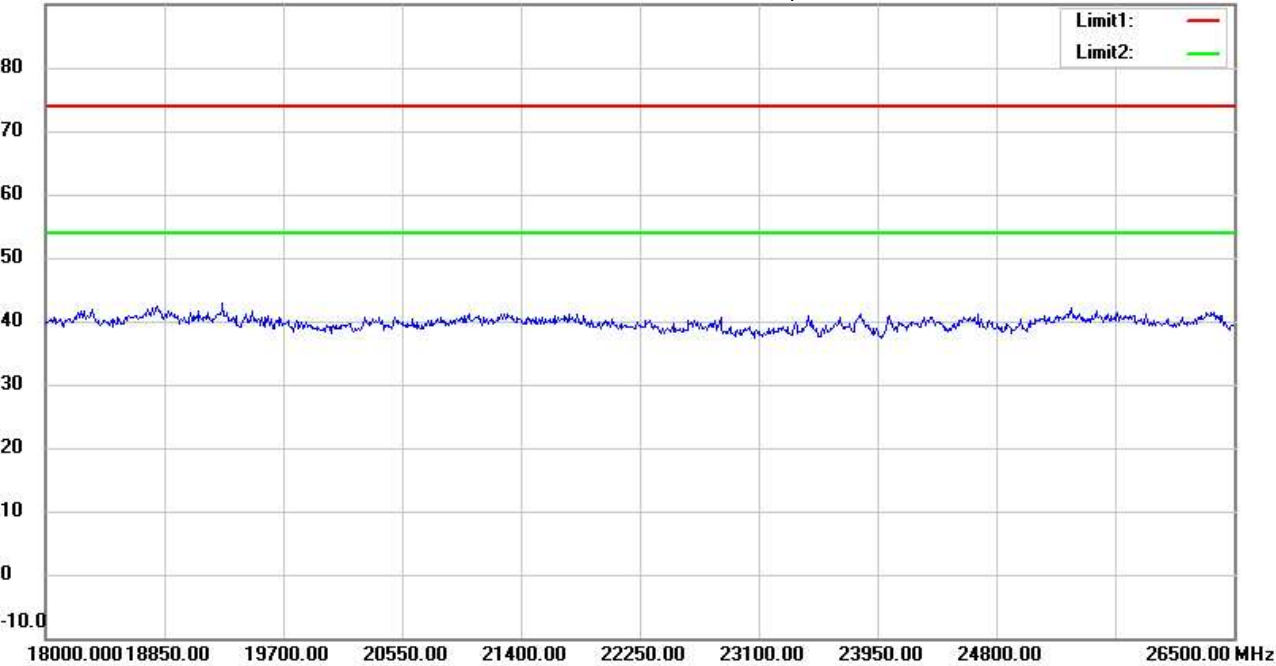
Data :#5

Condition : FCC\_part 15E RE\_Above 1GHz\_PK

Test Mode : TX 802.11ax40 CH43

Polarization: *Horizontal*
