Radiated Emission Measurement

Condition : FCC\_part 15E RE\_Above 1GHz\_PK

EUT : W6M22409-23739

Test Mode : TX 802.11ax20 CH93

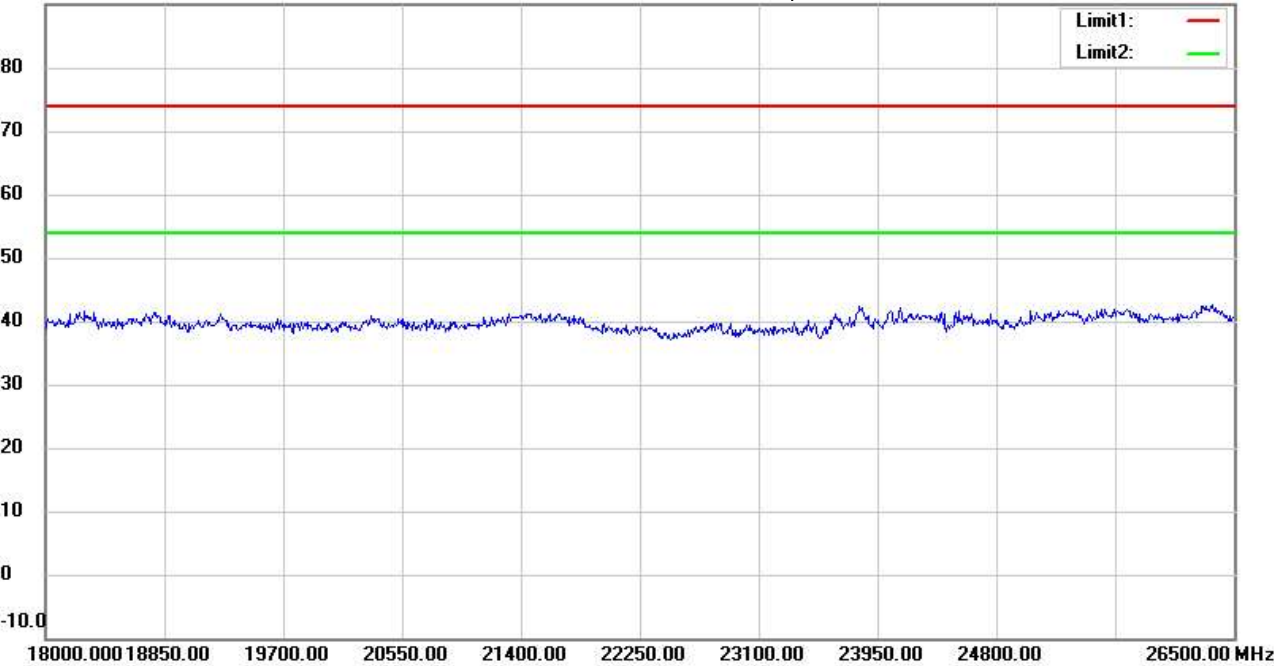
Data :#11

Condition : FCC\_part 15E RE\_Above 1GHz\_PK

Test Mode : TX 802.11ax40 CH43

Polarization: Vertical
