Radiated Emission Measurement

Condition : FCC\_part 15E RE\_Above 1GHz\_PK

EUT : W6M22409-23739

Test Mode : TX 802.11ax40 CH43

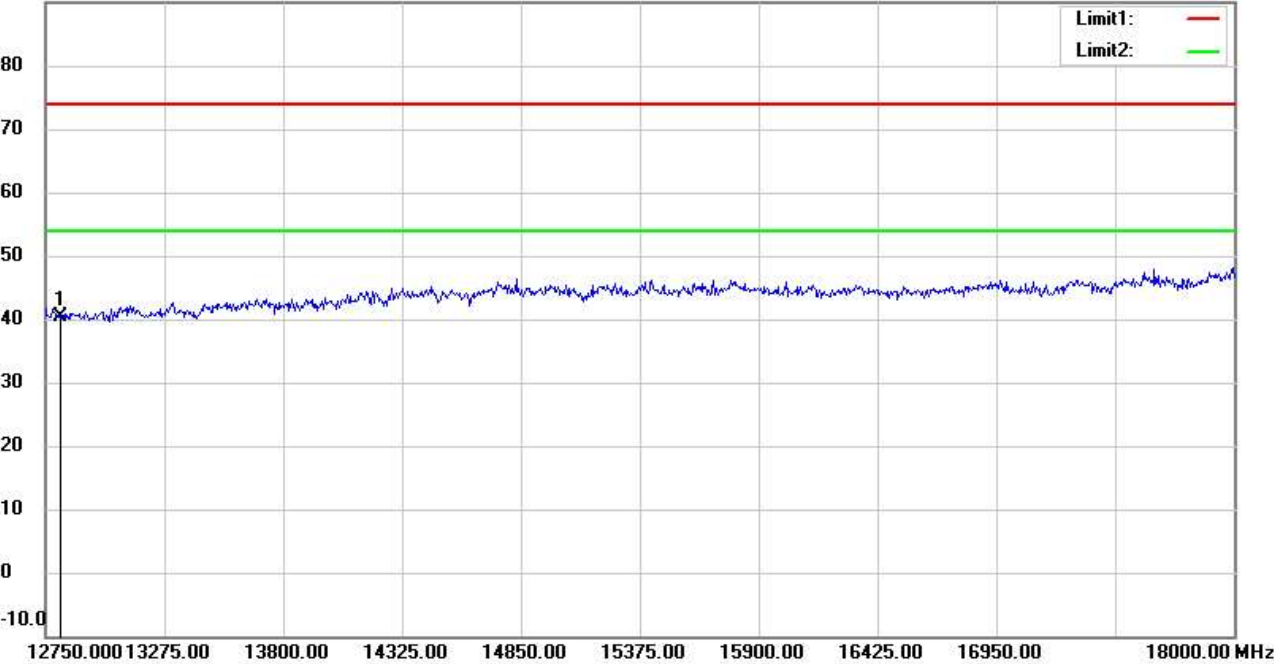
Test Mode : TX 802.11ax40 CH91

Polarization: Horizontal

| Mk. | Frequency (MHz) | Reading (dBuV) | Detector | Corr. factor (dB/m) | Result (dBuV/m) | Limit (dBuV/m) | Ant.Pos (cm) | Tab.Pos (deg.) | Margin (dB) | Comment |
|---|---|---|---|---|---|---|---|---|---|---|
| * | 12810.000 | 23.48 | peak | 16.95 | 40.43 | 74.00 | 150 | 359 | -33.57 | |

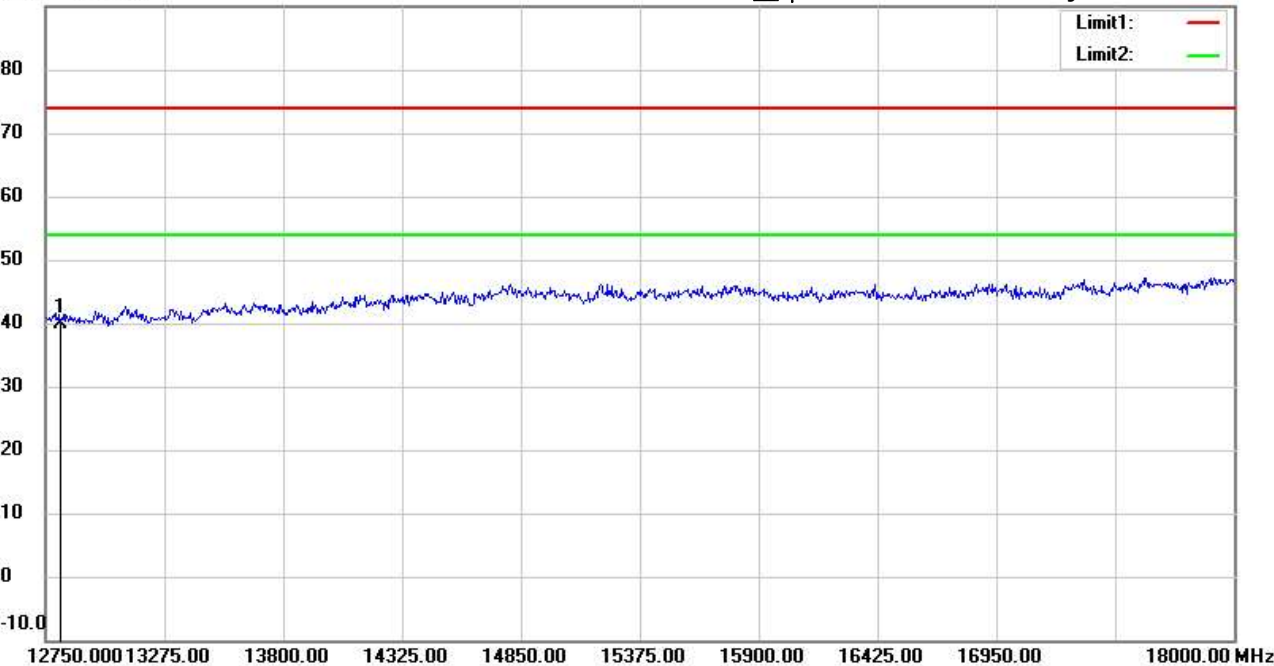
Test Mode : TX 802.11ax40 CH91

Polarization: Vertical

| Mk. | Frequency (MHz) | Reading (dBuV) | Detector | Corr. factor (dB/m) | Result (dBuV/m) | Limit (dBuV/m) | Ant.Pos (cm) | Tab.Pos (deg.) | Margin (dB) | Comment |
|---|---|---|---|---|---|---|---|---|---|---|
| * | 12810.000 | 22.99 | peak | 16.95 | 39.94 | 74.00 | 150 | 318 | -34.06 | |

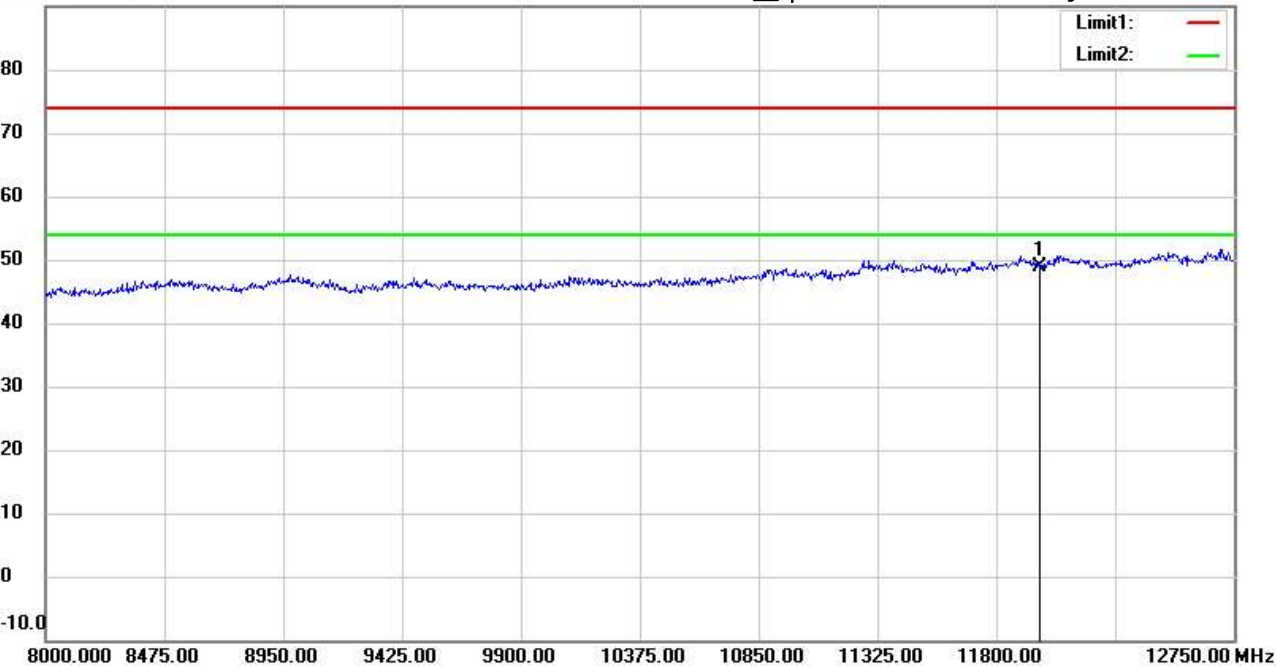
Test Mode : TX 802.11ax80 CH7

Polarization: *Horizontal*

| Mk. | Frequency (MHz) | Reading (dBuV) | Detector | Corr. factor (dB/m) | Result (dBuV/m) | Limit (dBuV/m) | Ant.Pos (cm) | Tab.Pos (deg.) | Margin (dB) | Comment |
|---|---|---|---|---|---|---|---|---|---|---|
| * | 11970.000 | 32.82 | peak | 16.12 | 48.94 | 74.00 | 150 | 0 | -25.06 | |

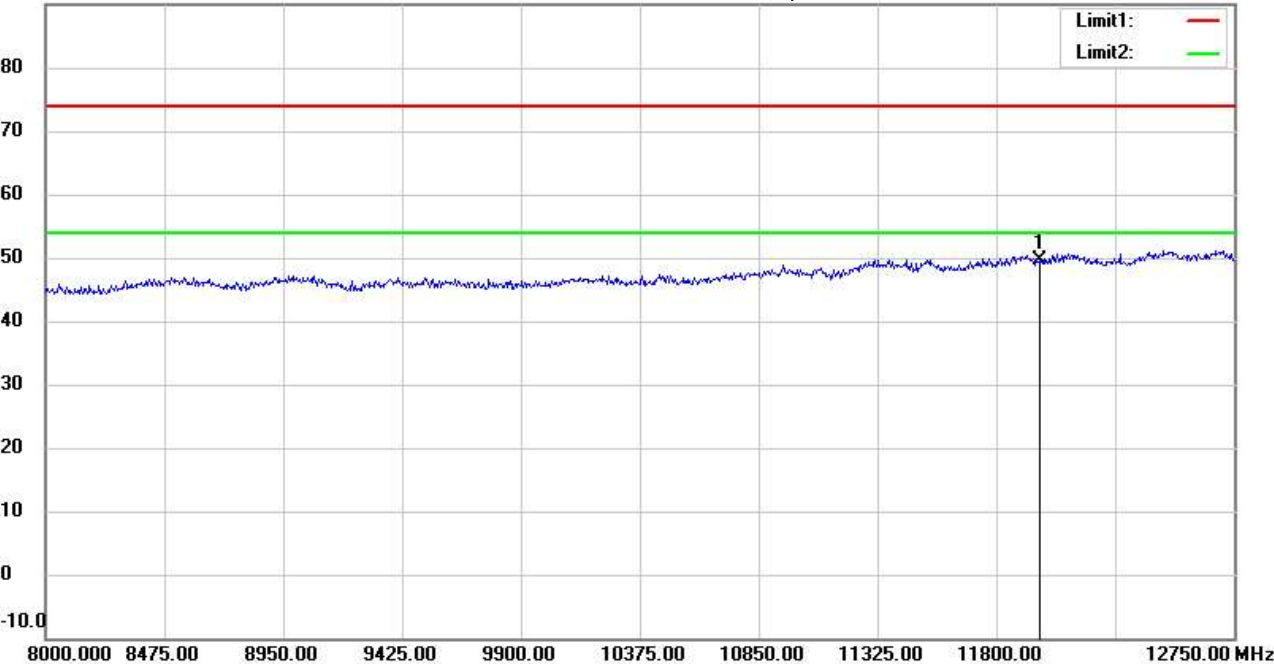
Test Mode : TX 802.11ax80 CH7

Polarization: Vertical

| Mk. | Frequency (MHz) | Reading (dBuV) | Detector | Corr. factor (dB/m) | Result (dBuV/m) | Limit (dBuV/m) | Ant.Pos (cm) | Tab.Pos (deg.) | Margin (dB) | Comment |
|---|---|---|---|---|---|---|---|---|---|---|
| * | 11970.000 | 33.48 | peak | 16.12 | 49.60 | 74.00 | 150 | 217 | -24.40 | |
